Holyrood Thermal Generating Station (Holyrood) Condition Assessment & Life Extension Study, - Final Report

**Holyrood Thermal
 Generating Station
 Condition Assessment &
 Life Extension Study**

January 28, 2011

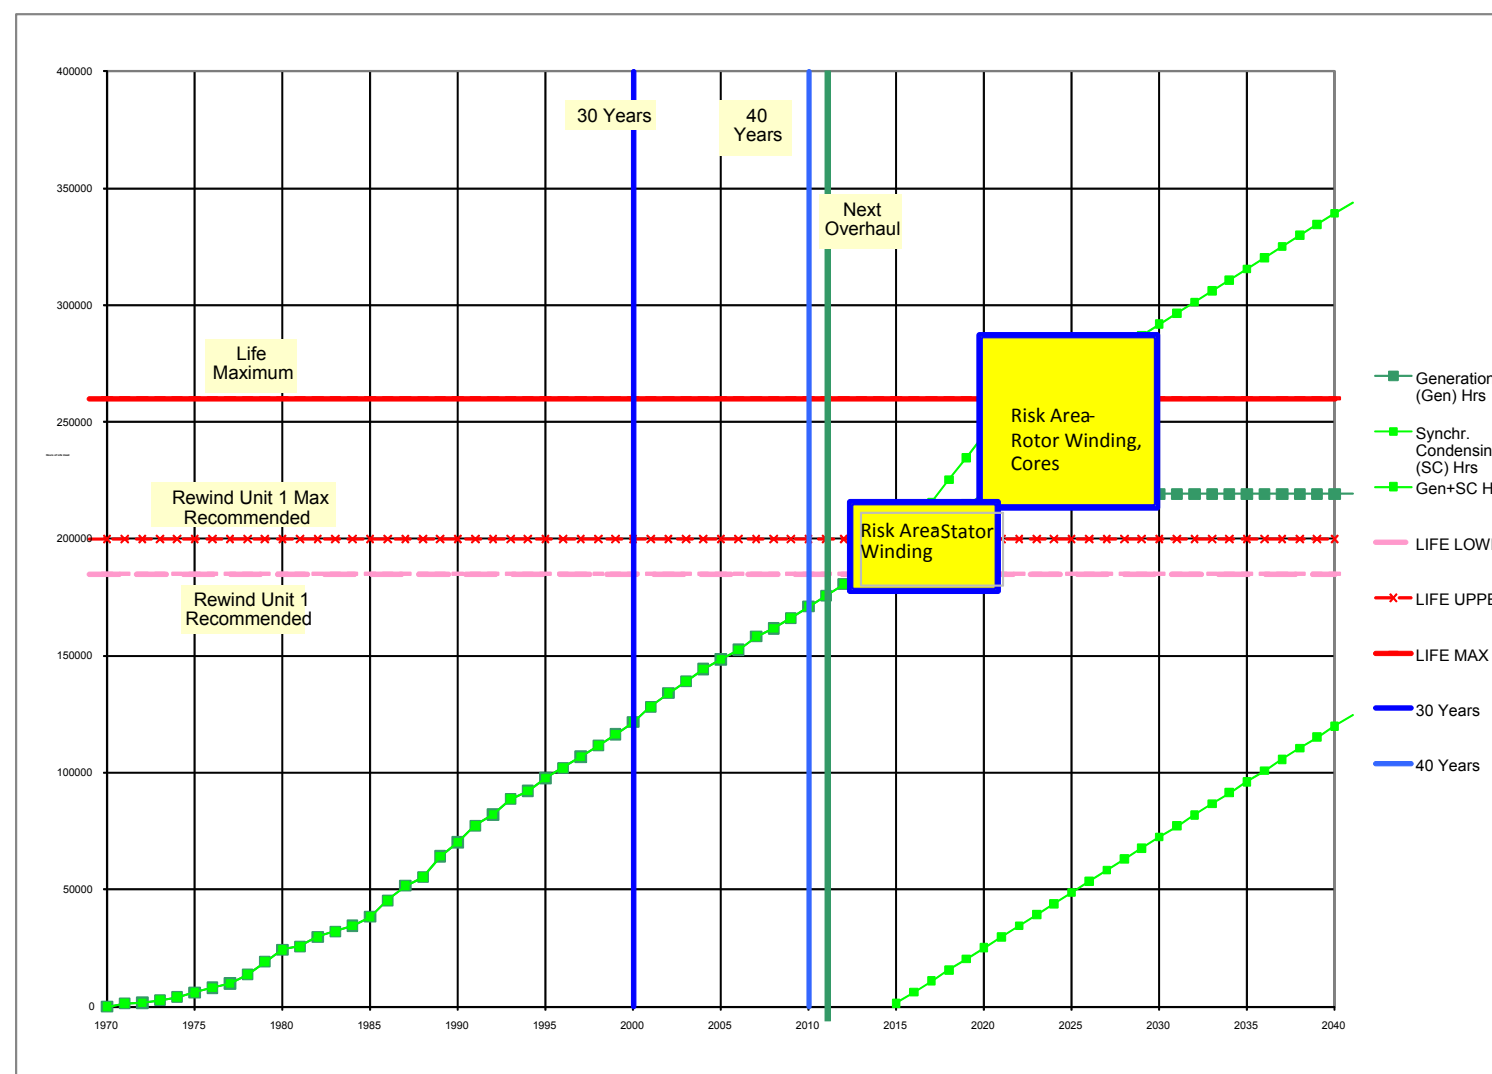
FIGURE 8-2 LIFE CYCLE CURVE – UNIT 1 GENERATOR

The generator figure below shows the operating hours as an electricity generator, in synchronous condensing mode (beginning in 2015), as well as the sum of the two. Only one set of curves is required, given that the major elements of the generator (stator and rotor windings and core) and much of the hydrogen system are the same age. The new parts of the hydrogen system are not identified due to their shorter time in-service. One vertical line illustrates the timing of the next generator overhaul in 2012. The lowest two horizontal lines represent the ranges of expected generator life for Holyrood Unit 1 based on current and historical information and expert opinion. The “Rewind Unit 1 Recommended” line is based on the recommended estimated remaining reliable stator winding life of five years at current generation levels. The two upper lines also represent an assessment of a longer 10 + year of the lower reliability, higher failure risk, remaining life of the rotor winding as well as a maximum 20 years likely for the stator and rotor cores.

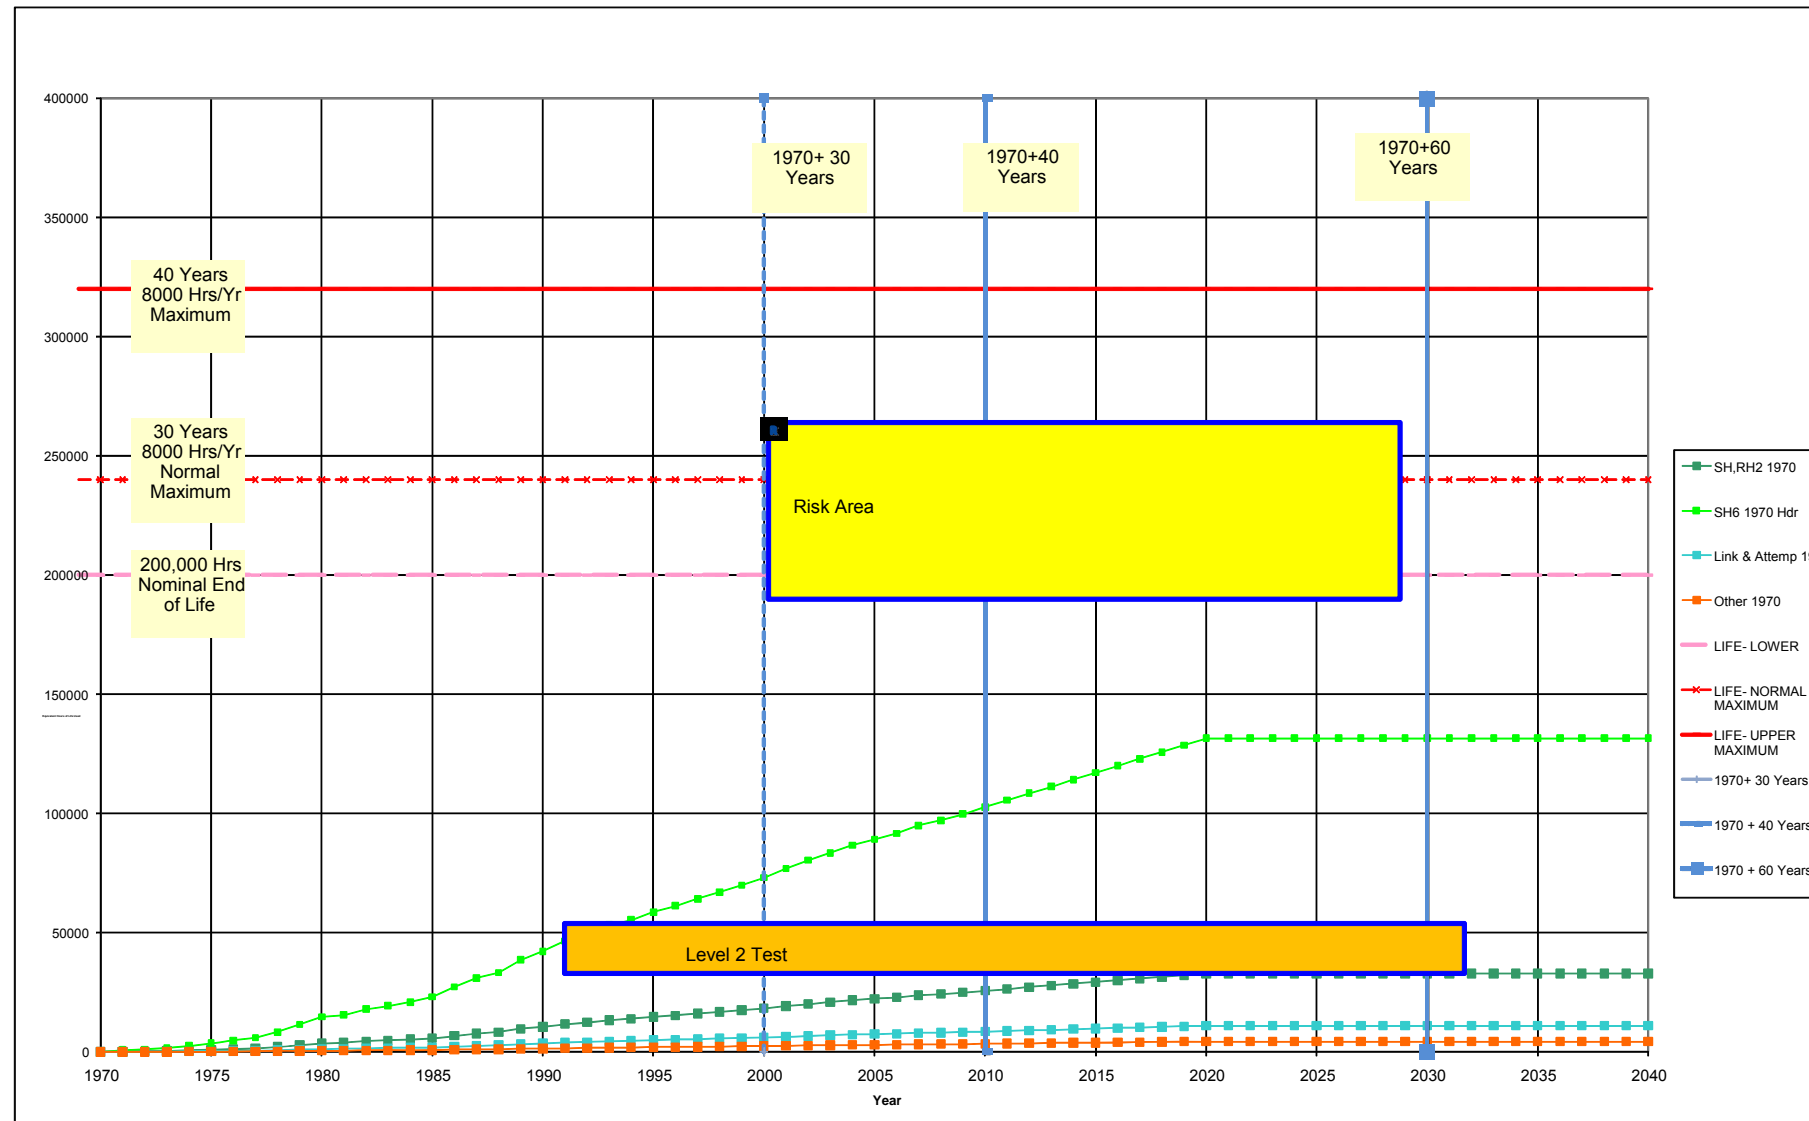
FIGURE 8-10 LIFE CYCLE CURVE –UNIT 1 BOILER SYSTEM (BOILER HEADERS AND COMPONENTS OUTSIDE THE FLUE GAS PATH)

The boiler headers and components are subject primarily to time spent under the effects of steam pressure and temperature. Their equivalent expended life presented in figure below is primarily related to the material properties and the steam conditions. As a result, several curves are required to represent the range of the various elements of the system. Details are included in Appendix 30. The life curves are plots on the y-axis of current and projected consumed equivalent life hours based on the theoretical metallurgical assessments. This differs from other sections that use nominal operating hours of usage on the y-axis versus calendar year on the x-axis. The figure has several vertical lines representing differing representative nominal age limits for various components. It also has several horizontal lines that represent a range of practical equipment equivalent base loaded operating hour life limits. The figure also includes two highlighted boxes. The risk box is representative of typical life expectations. The second identified as the “Level 2 Test” box identifies where EPRI recommends an initial Level 2 analyses or equivalent for these sorts of components (consumed life = 10% of expected or design life).

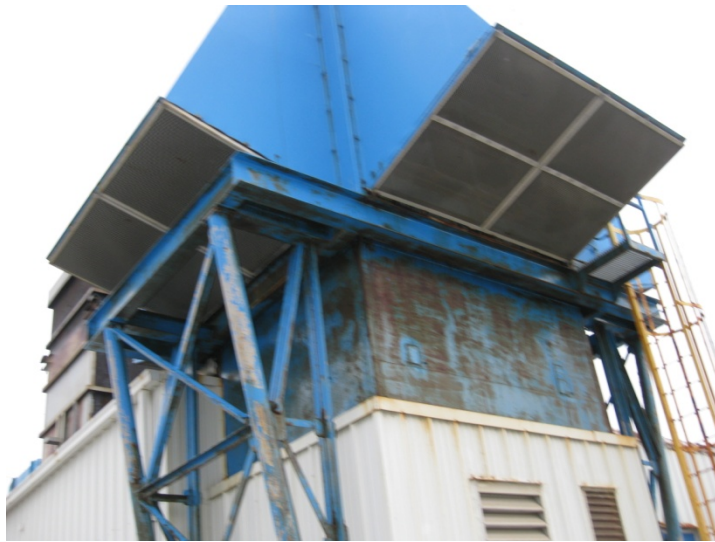
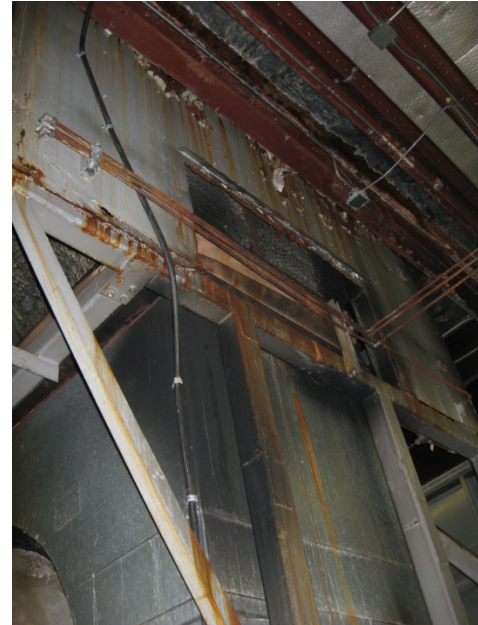
FIGURE 11-38 GTG EXHAUST STACK & DUCT

The black start gas turbine generator and its balance of plant is in need of a major overhaul, as well as refurbishment and replacement of its stack and air intake systems. In addition, it is likely that its fuel receiving and feeding system will need a major overhaul as soon as practical within the next two years.
