**MUSKRAT FALLS 2010 SITE INVESTIGATIONS
GEOTECHNICAL REPORT**

VOLUME 1 - GENERAL REPORT

MF1300 – MUSKRAT FALLS 2010 SITE INVESTIGATIONS

Document No: 503334-MF-1300-4GER-0001-0

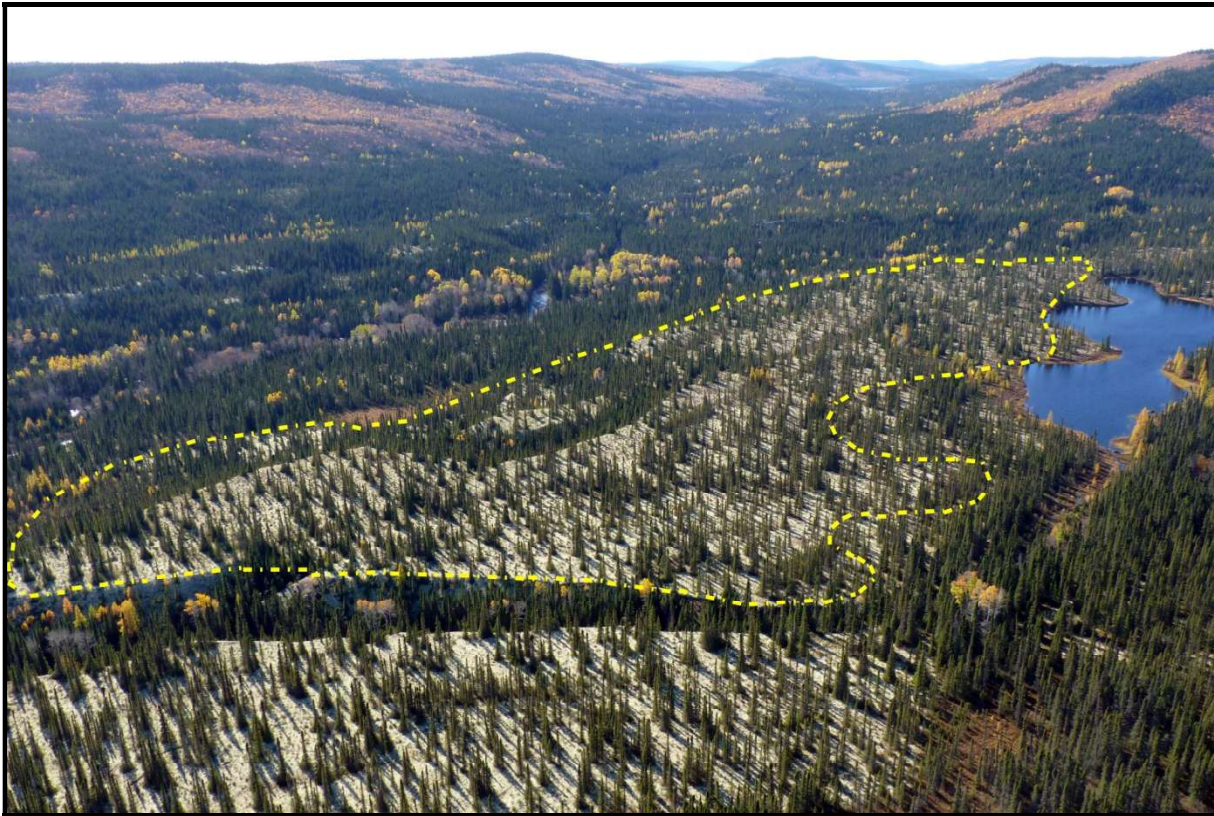
FIGURE 3: AERIAL PHOTOGRAPH OF BORROW AREA GR-5 EAST, VIEWING TO THE WEST

A photograph of Borrow Area GR-5 is presented on Figure 3 and shows approximate limits of the area.

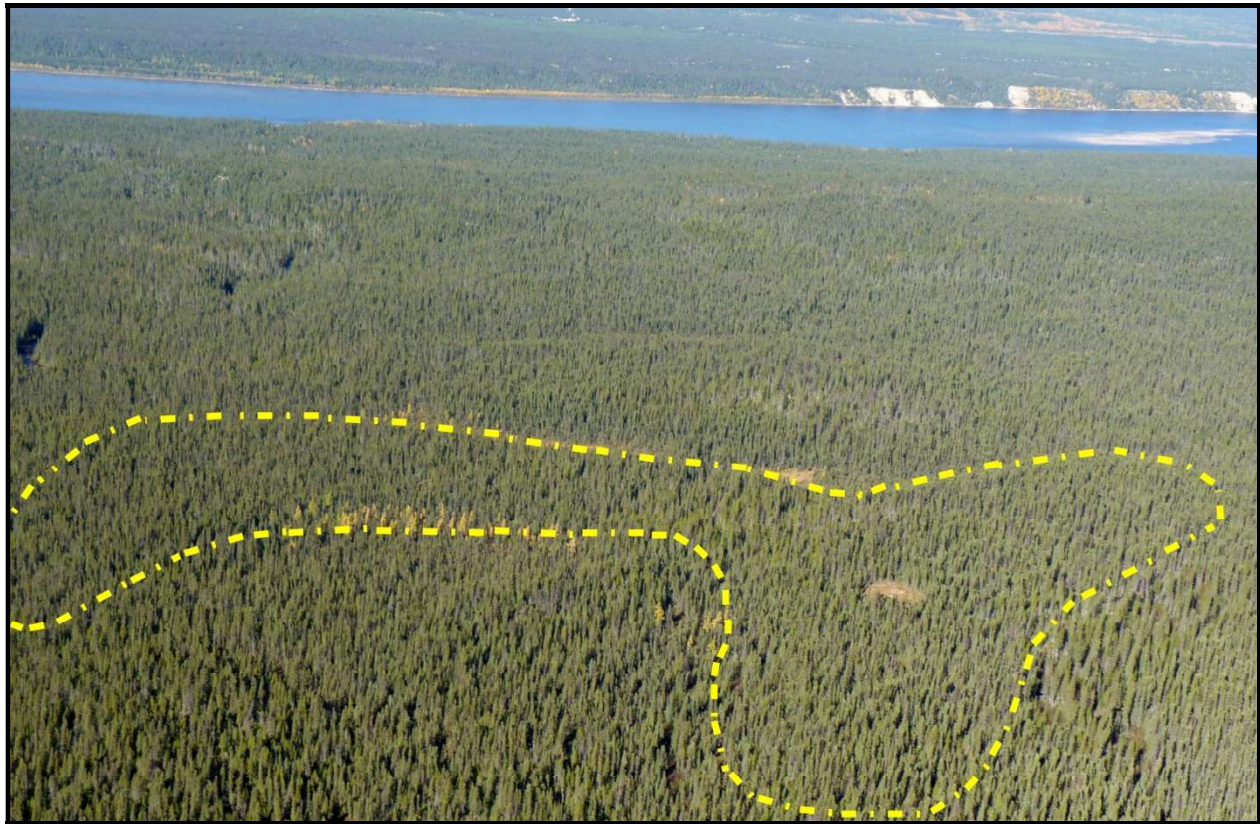
FIGURE 10: AERIAL PHOTOGRAPH OF BORROW AREA GD-7, VIEWING TO THE NORTH

Borrow Area GD-7 is located approximately 8.5 km south-east of the Muskrat Falls dam site, and 2.5 km south of the Churchill river (see Drawing no 503334-MF-1300-4GDD-0004 in Volume 6). The proposed project access road should cross the south western section of the area. The area of interest has an irregular shape, stretching approximately 900 m from the south-west to the north-east, with a width generally varying from 150 to 200 m. The borrow area is bounded at its north by boggy lands, while a stream bounds its eastern side. The surface is densely wooded. The photograph in Figure 10 shows the site and approximate limits of the area.

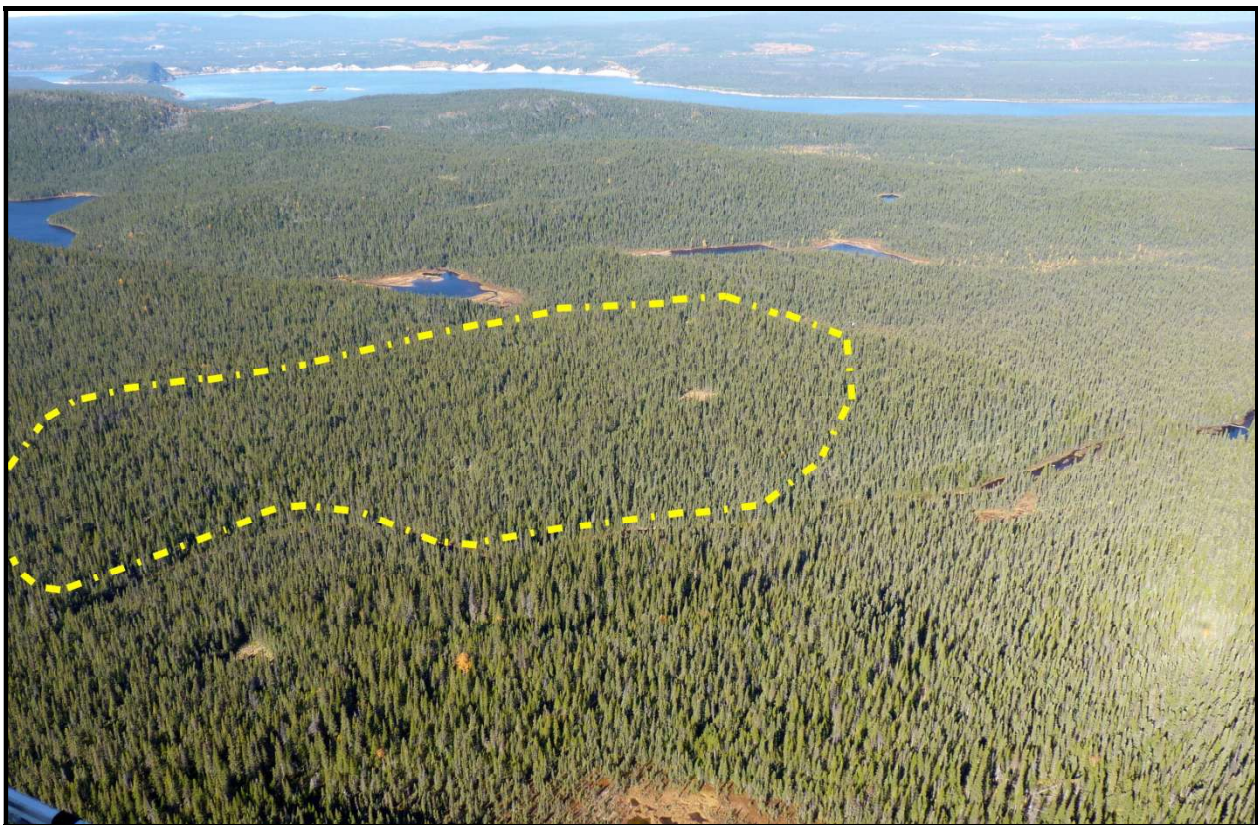
FIGURE 12: AERIAL PHOTOGRAPH OF BORROW AREA GD-8, VIEWING TO THE NORTH-WEST

Borrow Area GD-8 is located approximately 7.3 km south-east of the Muskrat Falls dam site, and 3.3 km south of the Churchill River (see Drawing no 503334-MF-1300-4GDD-0004 in Volume 6). It is also located 2.7 km south of the proposed access road to the project site. The deposit stretches approximately 700 m from the south-west to the north-east, with a width varying from 150 m (south-west) and to 400 m (north-east). The borrow area consists of a moderately to densely wooded plateau, bounded on the south-east side by a small river.

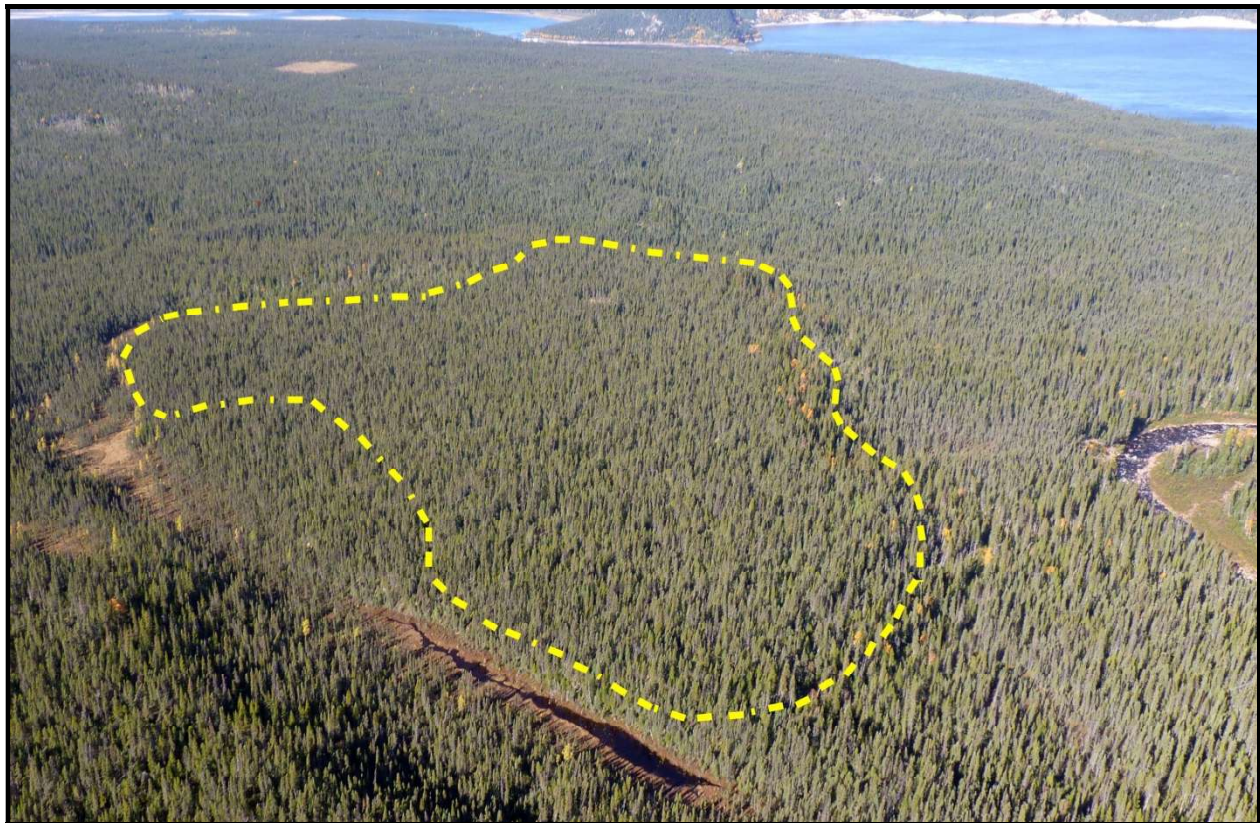
FIGURE 16: AERIAL PHOTOGRAPH OF BORROW AREA GD-11, VIEWING TO THE NORTHWEST

The area consists of a generally densely wooded terrace with a relatively even surface.

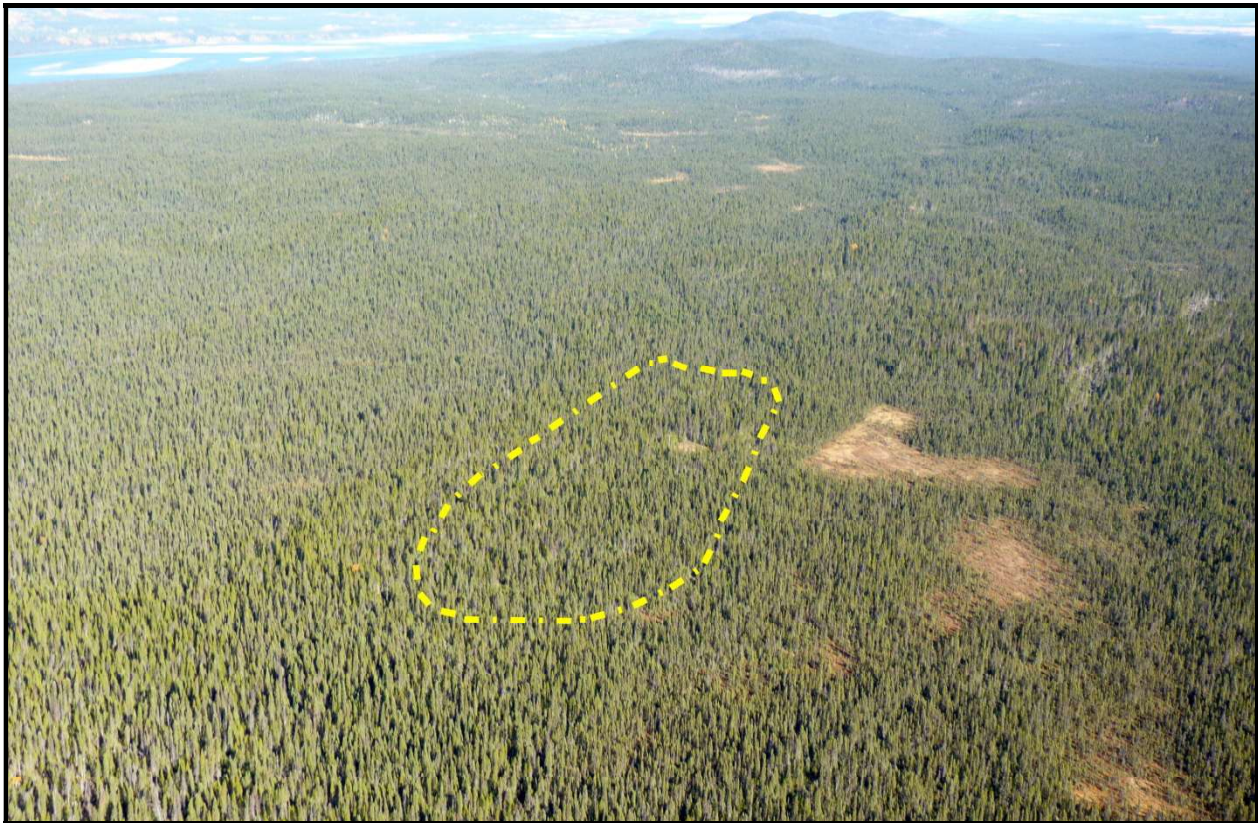
FIGURE 24: AERIAL PHOTOGRAPH OF BORROW AREA TD-6, VIEWING TO THE NORTHEAST

Borrow Area TD-6 is located approximately 10.0 km east of the Muskrat Falls dam site, 3.3 km south of the Churchill River and less than 100 m north of the proposed project access road (see Drawing no 503334-MF-1300-4GDD-0004 in Volume 6). The area consists of a drumlinoid shape glacial deposit that stretches approximately 320 m in a southwest-northeast direction, with an average width of about 120 m. The area is densely wooded, and the topography is relatively even.

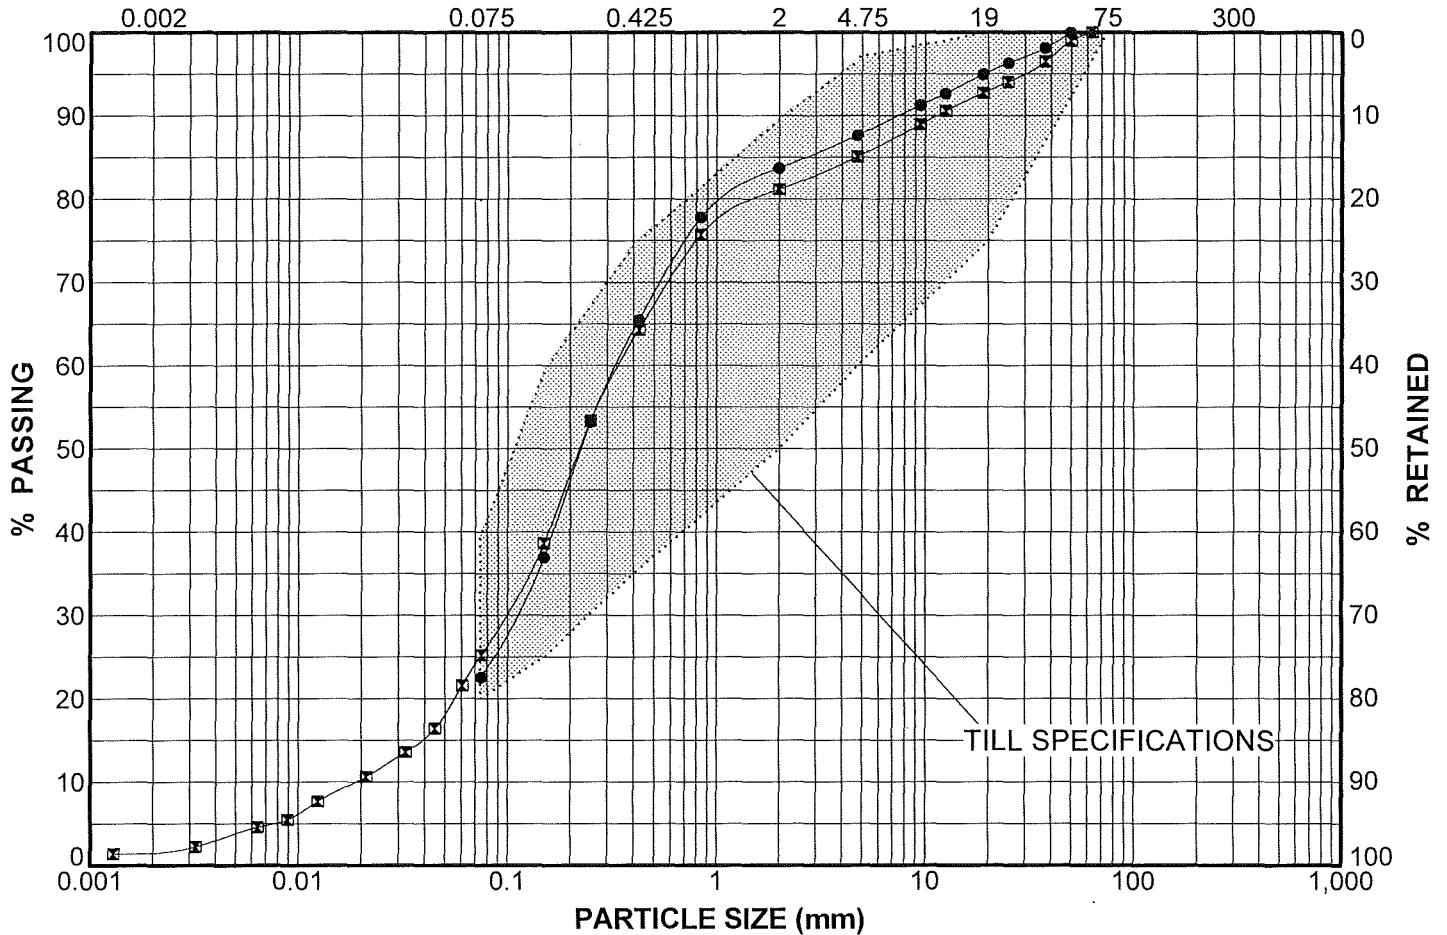
Sounding	Sample	Depth (m)		Gravel (%)	Sand (%)	Silt and Clay (%)		Description
			from	to					
●	TD-6-TP-1-10	BS-1	1.20	2.80	12	65	23		Silty sand with some gravel.
□	TD-6-TP-2-10	BS-1	1.10	2.60	15	60	23	2	Silty sand with some gravel and traces of clay.
