Holyrood Thermal Generating Station (Holyrood) Condition Assessment & Life Extension Study, - Final Report

**Holyrood Thermal
 Generating Station
 Condition Assessment &
 Life Extension Study**

January 28, 2011

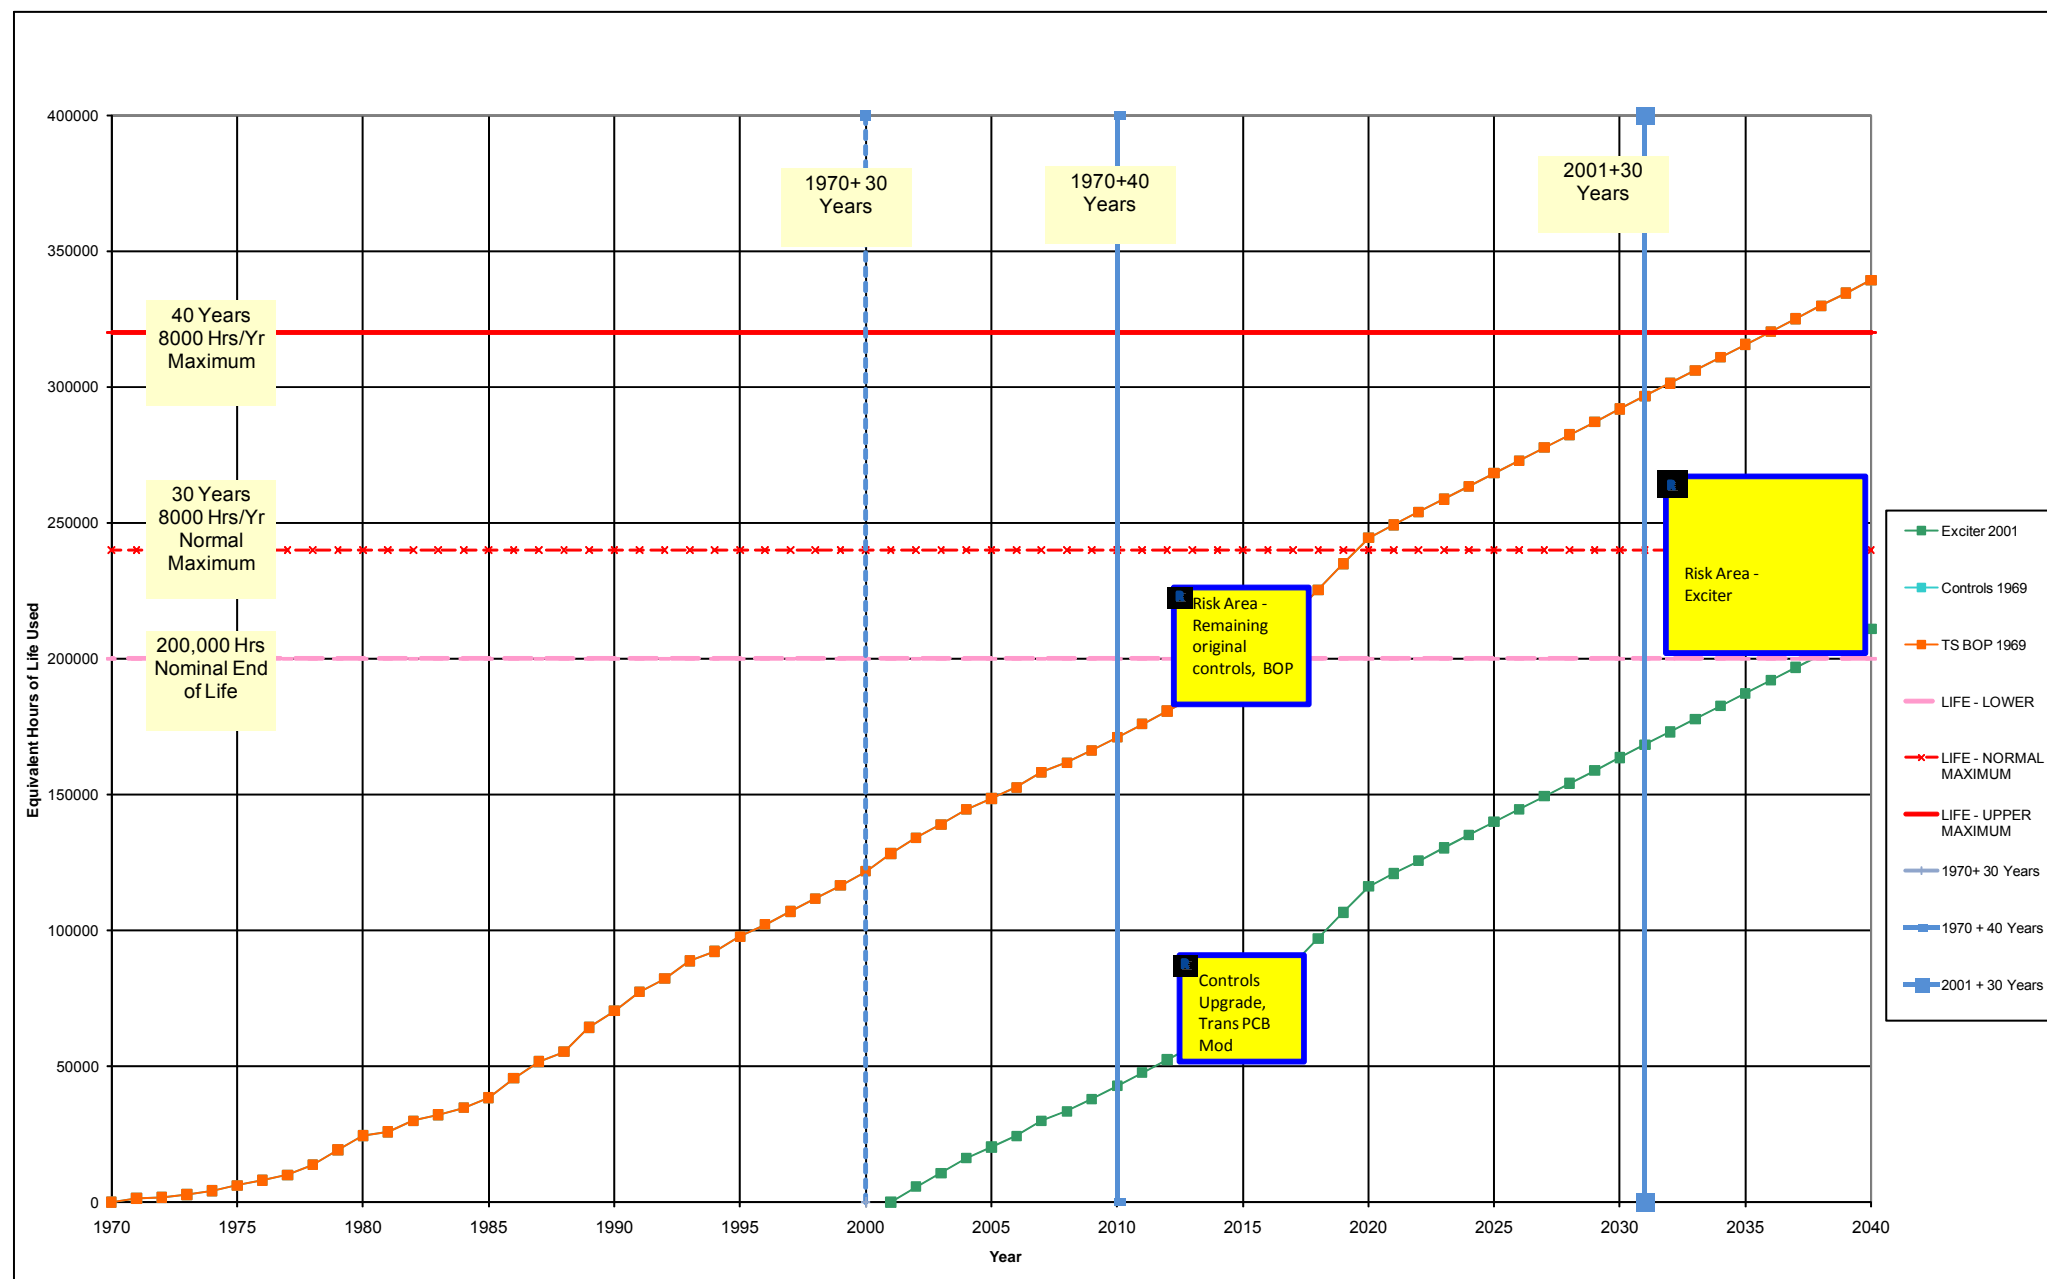
FIGURE 8-3 LIFE CYCLE CURVE – UNIT 1 GENERATOR - EXCITER

The exciter figure shows only the total operating hours as an electricity generator plus in synchronous condensing mode (beginning in 2015). It has two curves for any remaining original equipment as well as for the upgrades to the system made in 2001.

The curves indicate that the remaining life (RL) of the Unit 1 generator exceeds the desired life (DL) which is the lesser of the time to its next major planned overhaul/inspection (2012) or to the desired End of Life (EOL) date of 2041. Thus no specific dedicated Level 2 is required, but sufficient inspection and testing will be required in the 2012 overhaul to demonstrate the ability to meet the 2041 EOL date. The exciter should for the most part be able to meet an EOL of 2020, and with periodic refurbishment may meet 2041. The highlighted nearer term risk areas include the stator winding, exciter controls (upgrade only), the rectifying transformer, and some original BOP components. These systems are candidates for replacement or refurbishment – addressed in later sections. The curve also suggests that a nine year time between generator overhauls is impractical at this time in the generator's life and should be a six year cycle.

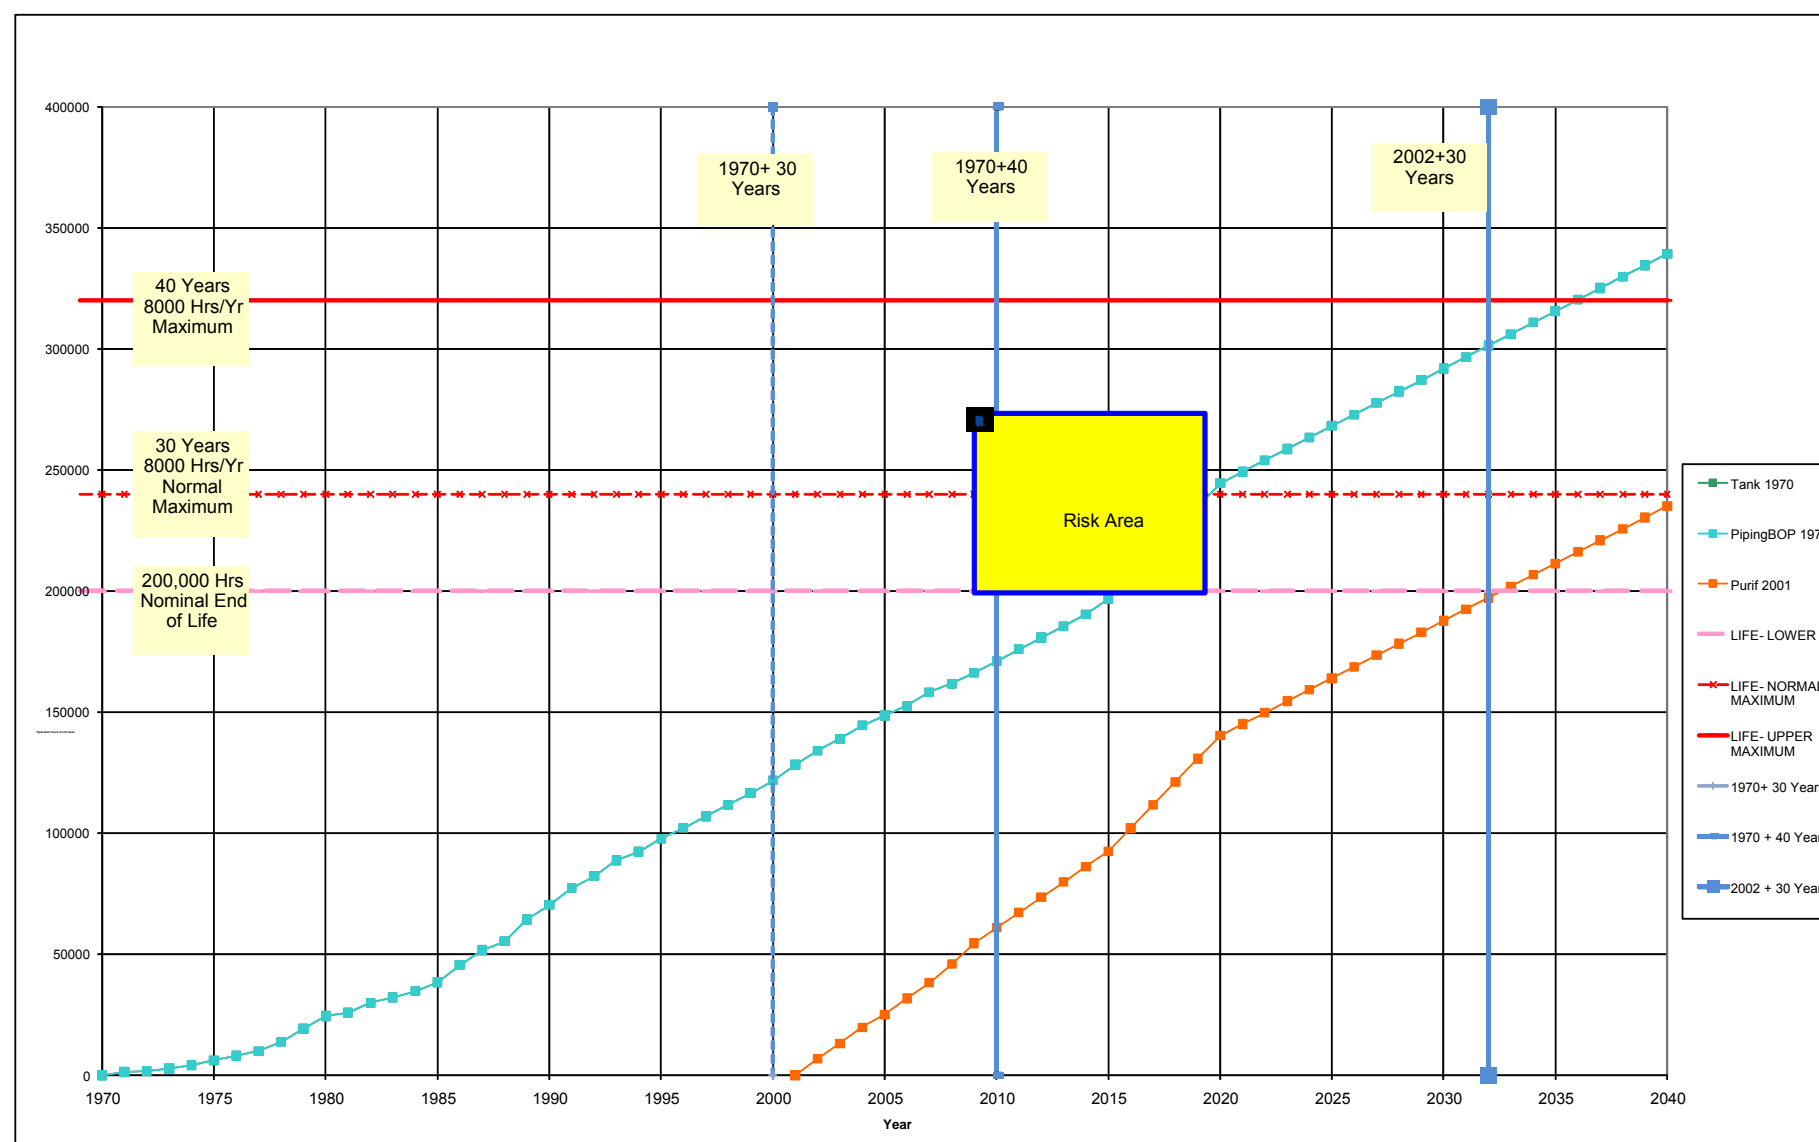
FIGURE 8-4 LIFE CYCLE CURVE – UNIT 1 GENERATOR LUBE OIL SYSTEM

Figure 8-4 below illustrates the life cycle curve for the Unit 1 generator lube oil system. Two curves are required given that the upgraded purification system entered service in 2001, while other major elements of the lube oil system are largely of the same age. There is insufficient information to develop specific accurate curves for the storage tank, and coolers. Further detailed examination during the 2012 turbine overhaul should provide the basis going forward. The life curve is a plot of current and projected operating hours (generation plus synchronous condensing model on the y-axis versus calendar year on the x-axis. Vertical lines represent bands of nominal years of normal base loaded life (typically 200,000 operating hours, thirty years and 200,000 to 240,000 operating hours, and forty years, and 280,000 to 320,000 operating hours). Horizontal lines represent the ranges of equipment life based on current and historical information and expert opinion. The risk area box provides an indication of the timing of potential issues either from an age or equivalent operating hours view.

The curves indicate that the remaining life (RL) of the Unit 1 generator lube oil system exceeds the desired life (DL) which is the lesser of the time to its next major planned overhaul/inspection (2012) or to the desired end of life (EOL) date of 2041. Thus no specific dedicated Level 2 is required of the system as a whole, but sufficient inspection and testing will be required in 2012 steam turbine generator overhaul to demonstrate the ability to meet the EOL date. The exception is the storage tank for which information was considered inadequate to form a firm conclusion and level 2 testing is recommended in 2011, albeit of a modest level and lower priority. The figure's highlighted risk areas is primarily operating hours driven and likely to shift further out in time after the 2012 turbine generator overhaul. The 2012 overhaul/inspection is a fundamental element in changing the current assessment.

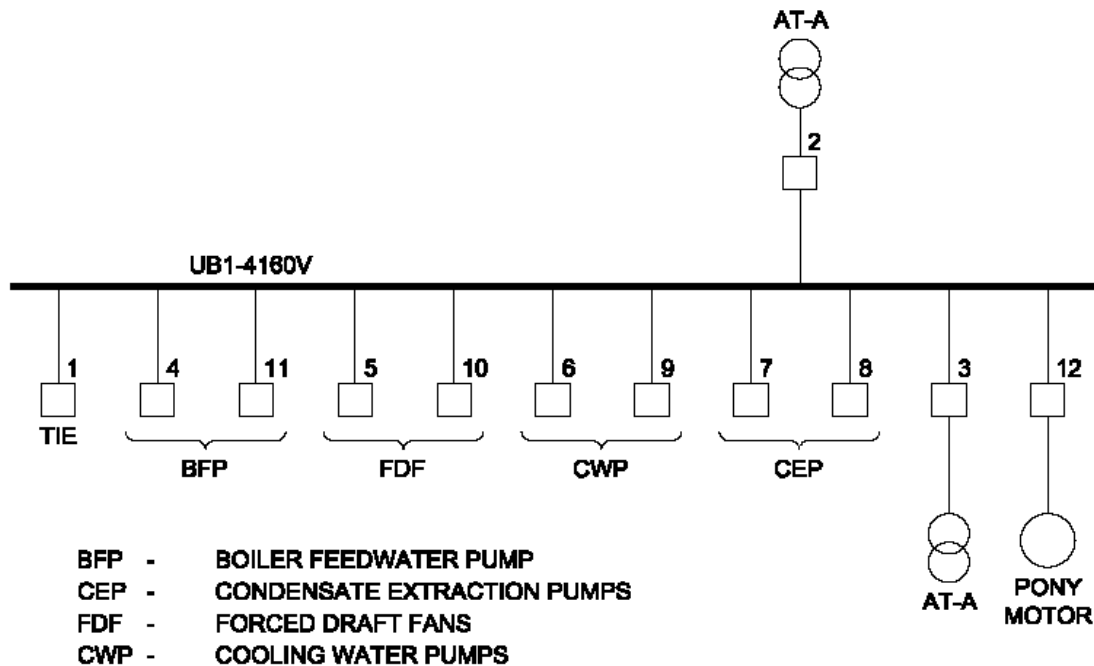
FIGURE 8-5 UNIT 1 UB1 SWITCHGEAR

Unit Board UB1 (4160V) was manufactured by ITE and installed in 1968. The 4160V switchgear, utilizes original draw-out power, air-magnetic breakers, Type 5HK, 1200A and 2000A. All protection, synch, and control relays are original CGE electro-mechanical. Schweitzer 701, Motor Protection Relaying is used on U1 Circulating Water Pumps and North and South Condensate Extraction Pumps. All other loads utilize the original P&B Golds relays.

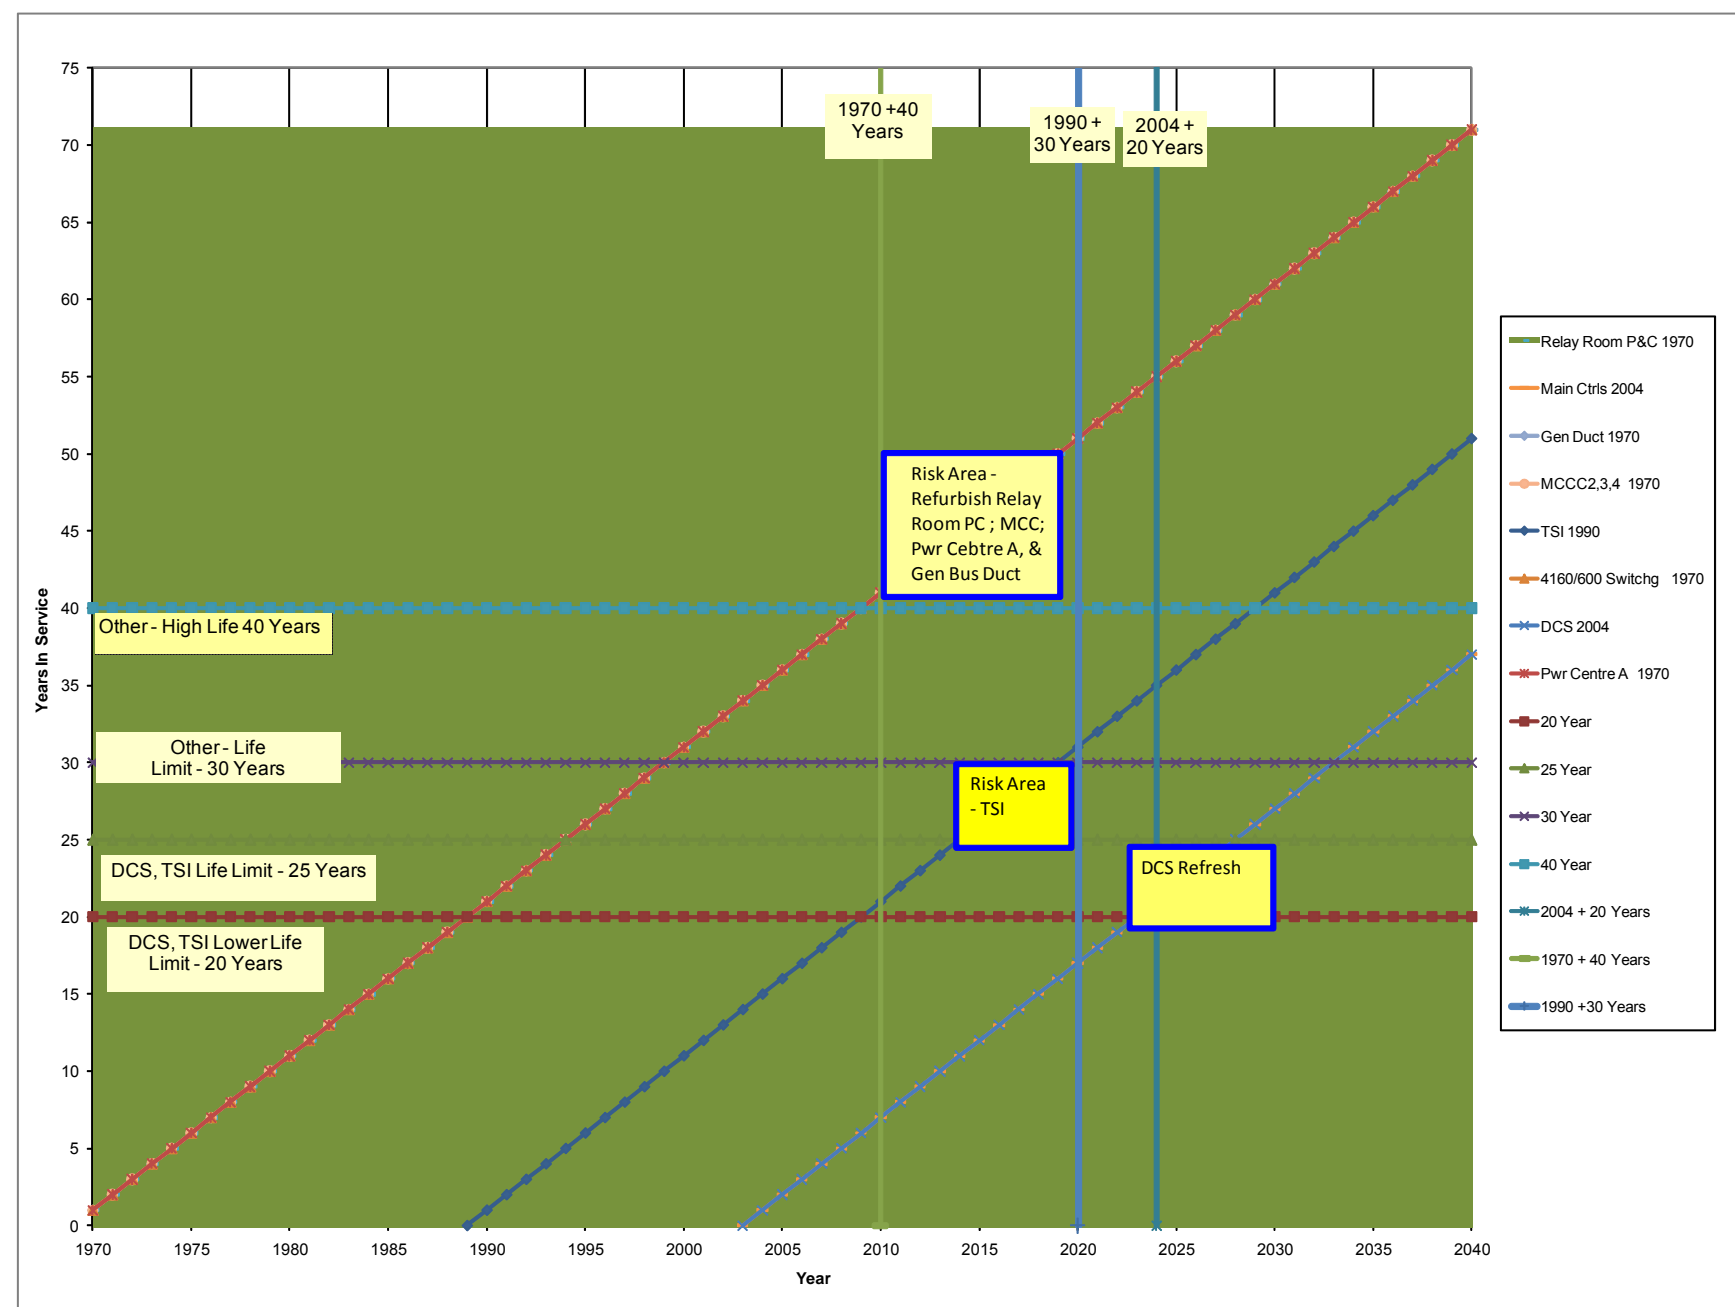
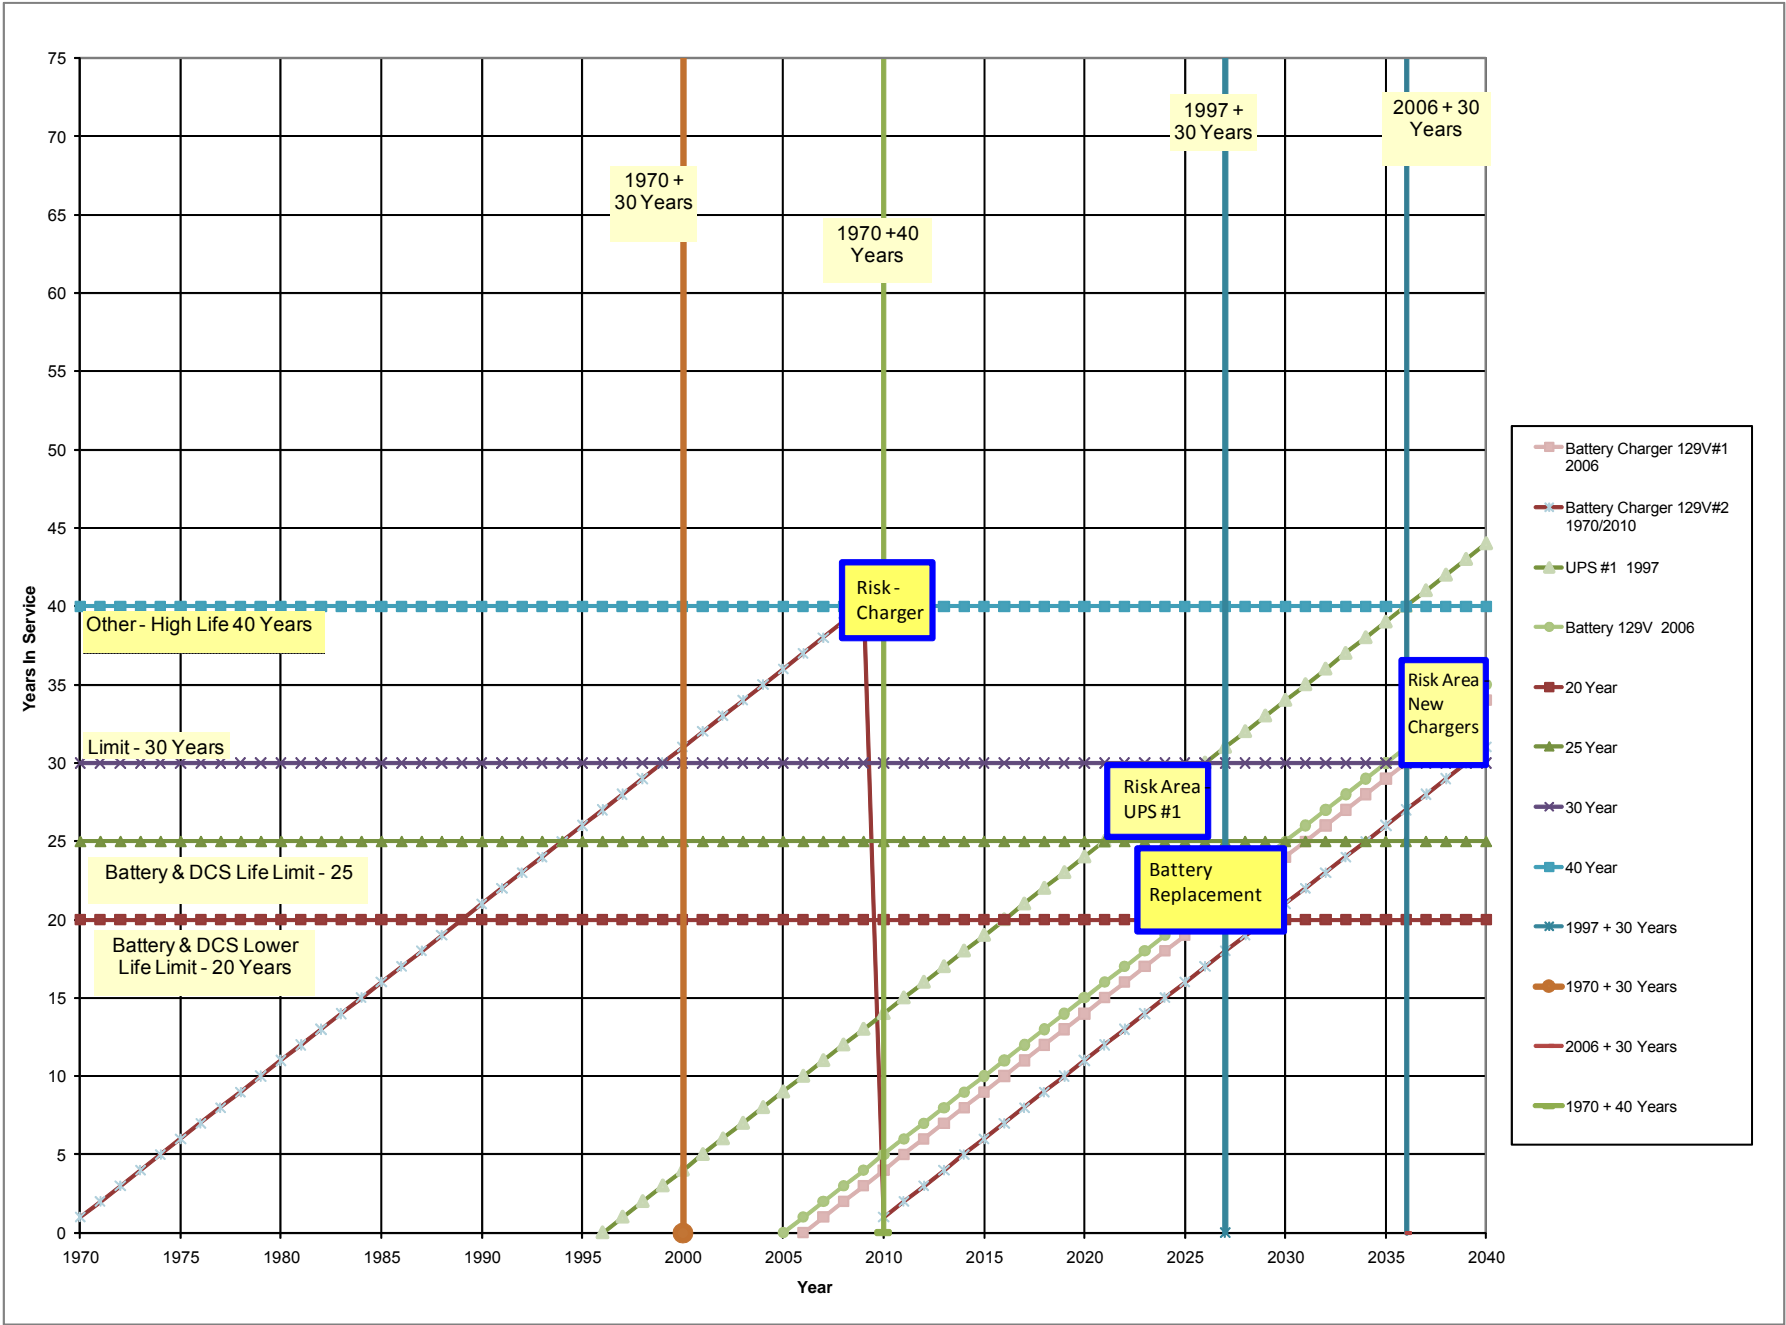
Figures 8-6 and 8-7 below, illustrate the life cycle curves for the Unit 1 electrical and control systems associated with generators. Several curves are required to represent the various elements. They have been broken into two parts – the electrical and control systems (MCC's, relays, breakers, TSI, DCS) and those primarily associated with batteries and chargers. The curves are plots of current and projected years in service on the y-axis versus calendar year on the x-axis. Age in-service due to either aging or obsolescence is more an issue than unit operating hours. Vertical lines represent bands of nominal years of in-service life for different in service dates. Horizontal lines represent the ranges of equipment life based on current and historical information and expert opinion. The risk area boxes provide an indication of the timing of potential issues either from an age or equivalent operating hours view.

FIGURE 8-6 LIFE CYCLE CURVE – UNIT 1 ELECTRICAL AND CONTROL SYSTEMS ASSOCIATED WITH GENERATORS (MCC'S, RELAYS, BREAKERS, TSI, DCS)

FIGURE 8-7 LIFE CYCLE CURVE – UNIT 1 ELECTRICAL AND CONTROL SYSTEMS ASSOCIATED WITH GENERATORS (BATTERIES AND CHARGERS)

The curves indicate that the remaining life (RL) of much of the equipment does not exceed the desired life (DL) for generation of 2020 and for synchronous condensing of 2041, without extensive refurbishment or replacement. This is well illustrated by the highlighted risk areas which highlights that many original MCC's and relays as well as the TSI are in need or replacement or extensive refurbishment in the very near term. The risk figures also illustrate that most of the rest of the equipment (DCS, batteries, and chargers) will require replacement or refurbishment in the 2020+ period.

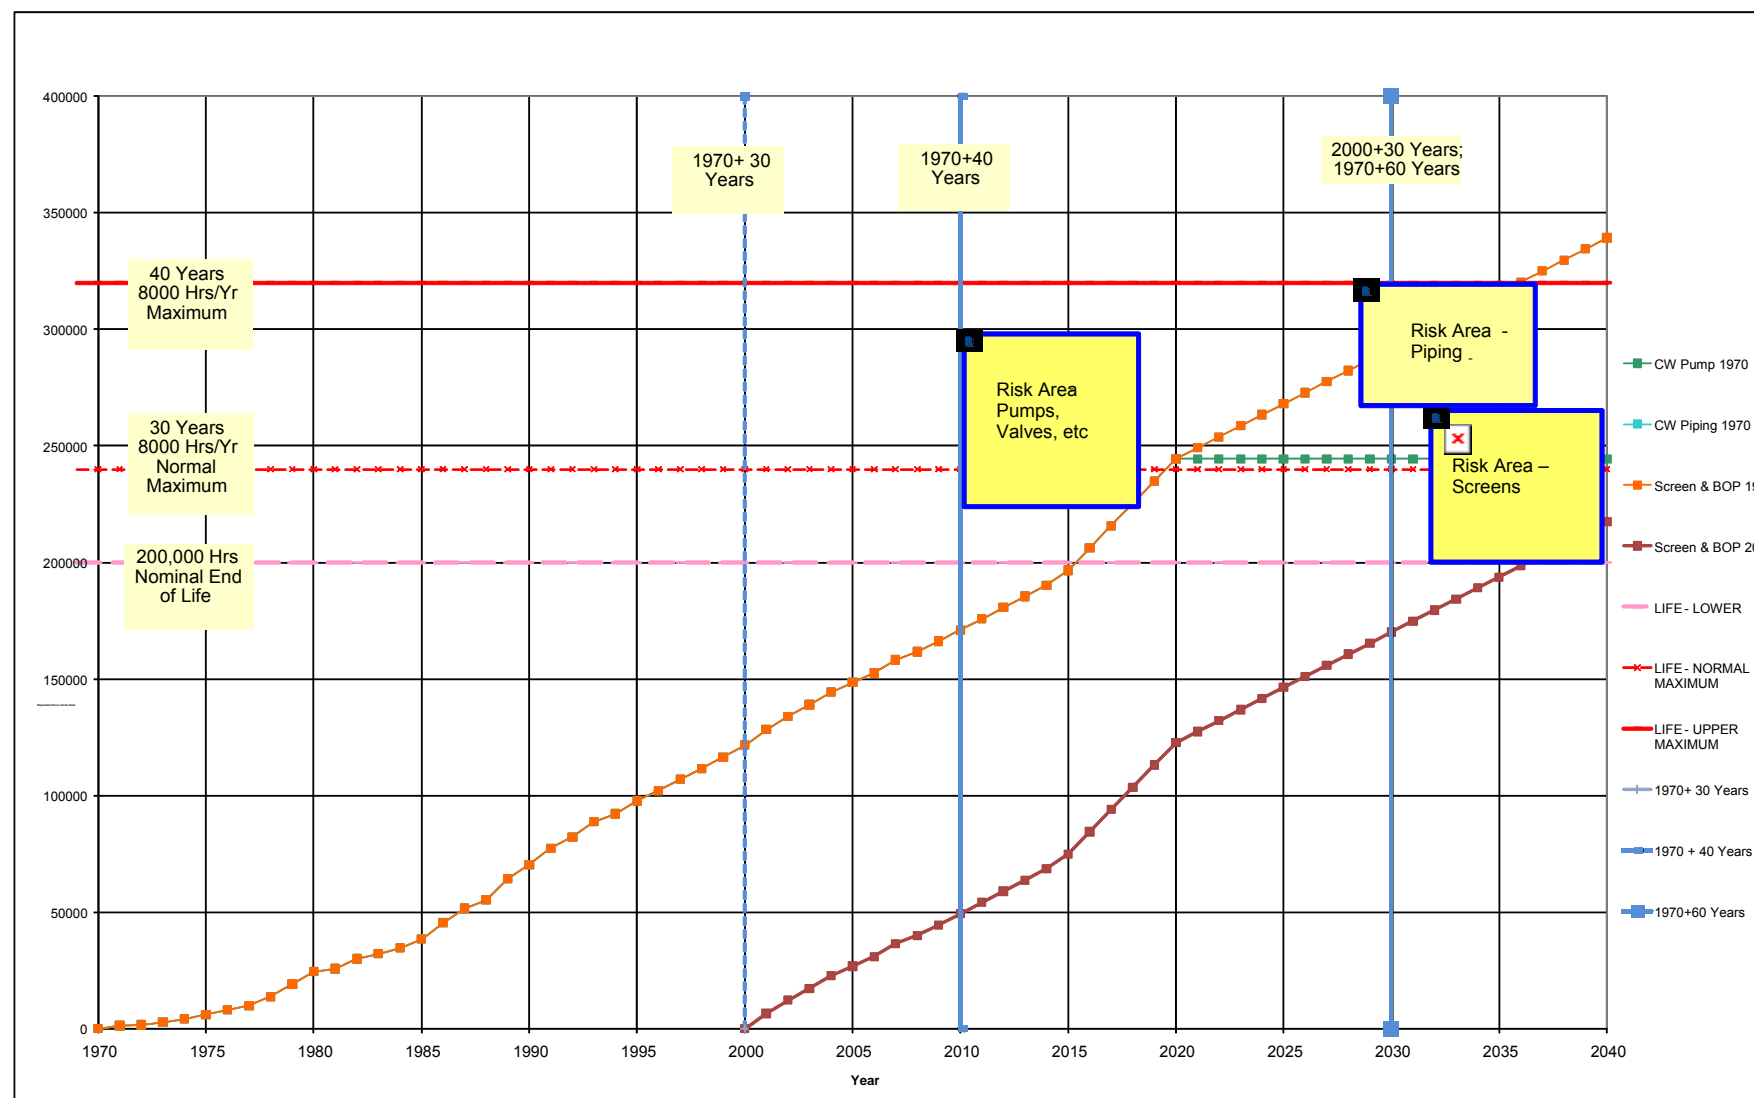
FIGURE 8-9 LIFE CYCLE CURVE – UNIT 1 COOLING WATER SYSTEMS ASSOCIATED WITH GENERATORS

Figure 8-9 below, illustrates the life cycle curves for the major elements of the Unit 1 cooling water systems associated with generators. The life curves are plots of current and projected operating hours (generation plus synchronous condensing mode) on the y-axis versus calendar year on the x-axis. The figure has vertical lines representing differing representative nominal age limits for various components. It has horizontal lines that represent a range of practical equivalent base loaded operating hour life limits. Data specific to the intake and outfall structures were not sufficient to include them at this time, but they are not expected to be an issue (perhaps the condition of some operational equipment such as stoplogs or their supports). Data specific to the pumps and motors for the general service cooling water and the turbine generator cooling water are also not presented as they are relatively new and/or modest equipment elements. The risk area boxes provide an indication of the timing of potential issues either from an age or equivalent operating hours view.

The curve indicates that the remaining life (RL) of most elements of the Unit 1 cooling water systems associated with generators is sufficient to reach the end date of 2020 for generation, but not necessarily the 2041 end date for synchronous condensing. The CW pumps and associated equipment are the primary nearer term issues highlighted by the risk boxes. The actual end date and remaining life will become clearer through the series of ongoing routine inspections that forms part of the plant's PM program and the Level 2 inspections recommended in the report. Curves for the intake and outfall structures and associated sub-components should be added subsequent to the undertaking of a Level 2 inspection.

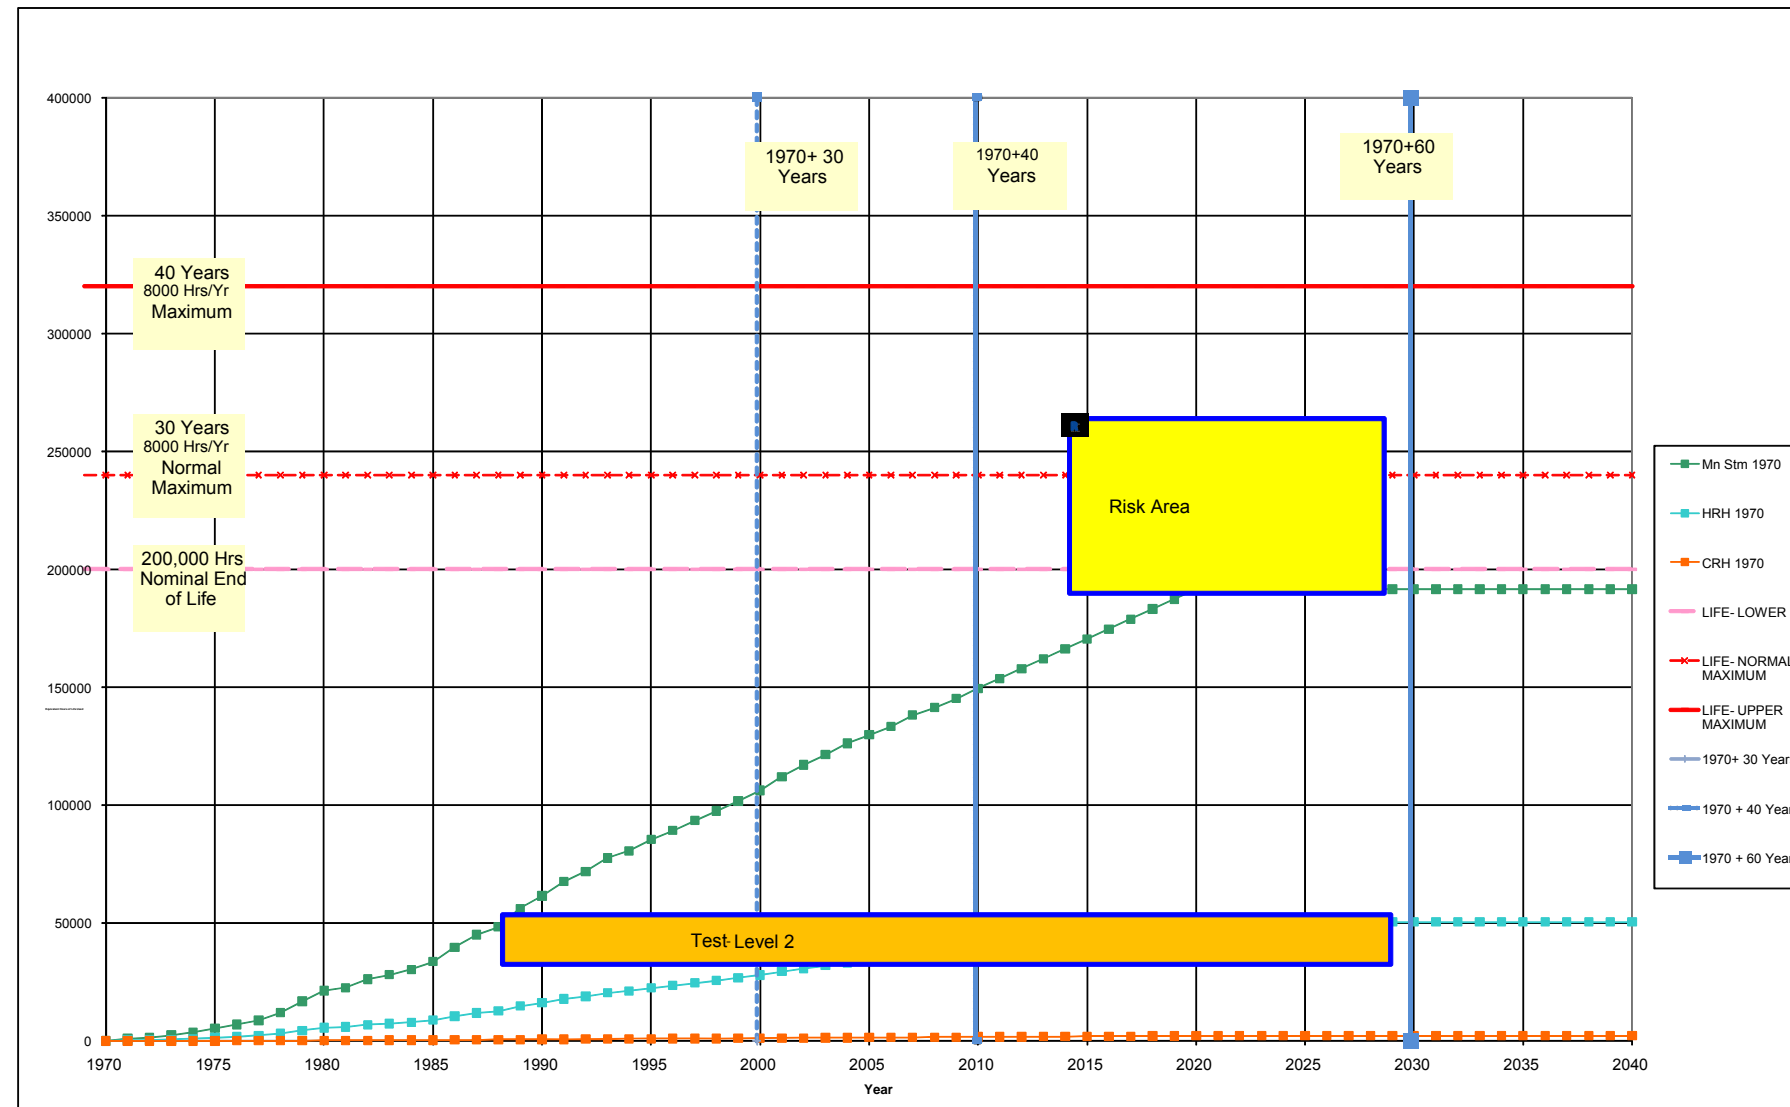
FIGURE 8-11 LIFE CYCLE CURVE –UNIT 1 BOILER SYSTEM (HIGH PRESSURE AND TEMPERATURE STEAM LINES)

Three curves represent the high pressure, high temperature steam lines (main steam, hot reheat, and cold reheat). Their life expenditure (illustrated in figure below) is primarily related to the time spent under the effects of steam pressure and temperature, similar to the boiler headers, and to the material properties of the steam lines. Details are included in Appendix 33. The life curves are plots on the y-axis of current and projected “consumed equivalent life hours” based on the theoretical metallurgical assessments. The figure has three vertical lines representing differing representative nominal age limits. It also has several horizontal lines that represent a range of practical equipment equivalent base loaded operating hour life limits. The figure also included two highlighted boxes. The risk box is representative of typical life expectations. The second identified as the “Level 2 Test” box identifies where an initial Level 2 analyses or equivalent is likely required (consumed life = 10% of expected life).

The high pressure steam line life curves indicate that the remaining life (RL) of the Unit 1 steam lines and their associated components are expected to exceed the desired life (DL) which is the generation end of life in 2020. Nevertheless, it also identifies that both the main steam and hot reheat steam lines exceed EPRI’s 10% consumed life guide for a Level 2 inspection of these systems. Given that they have not been tested for some time, this is considered appropriate at this time.

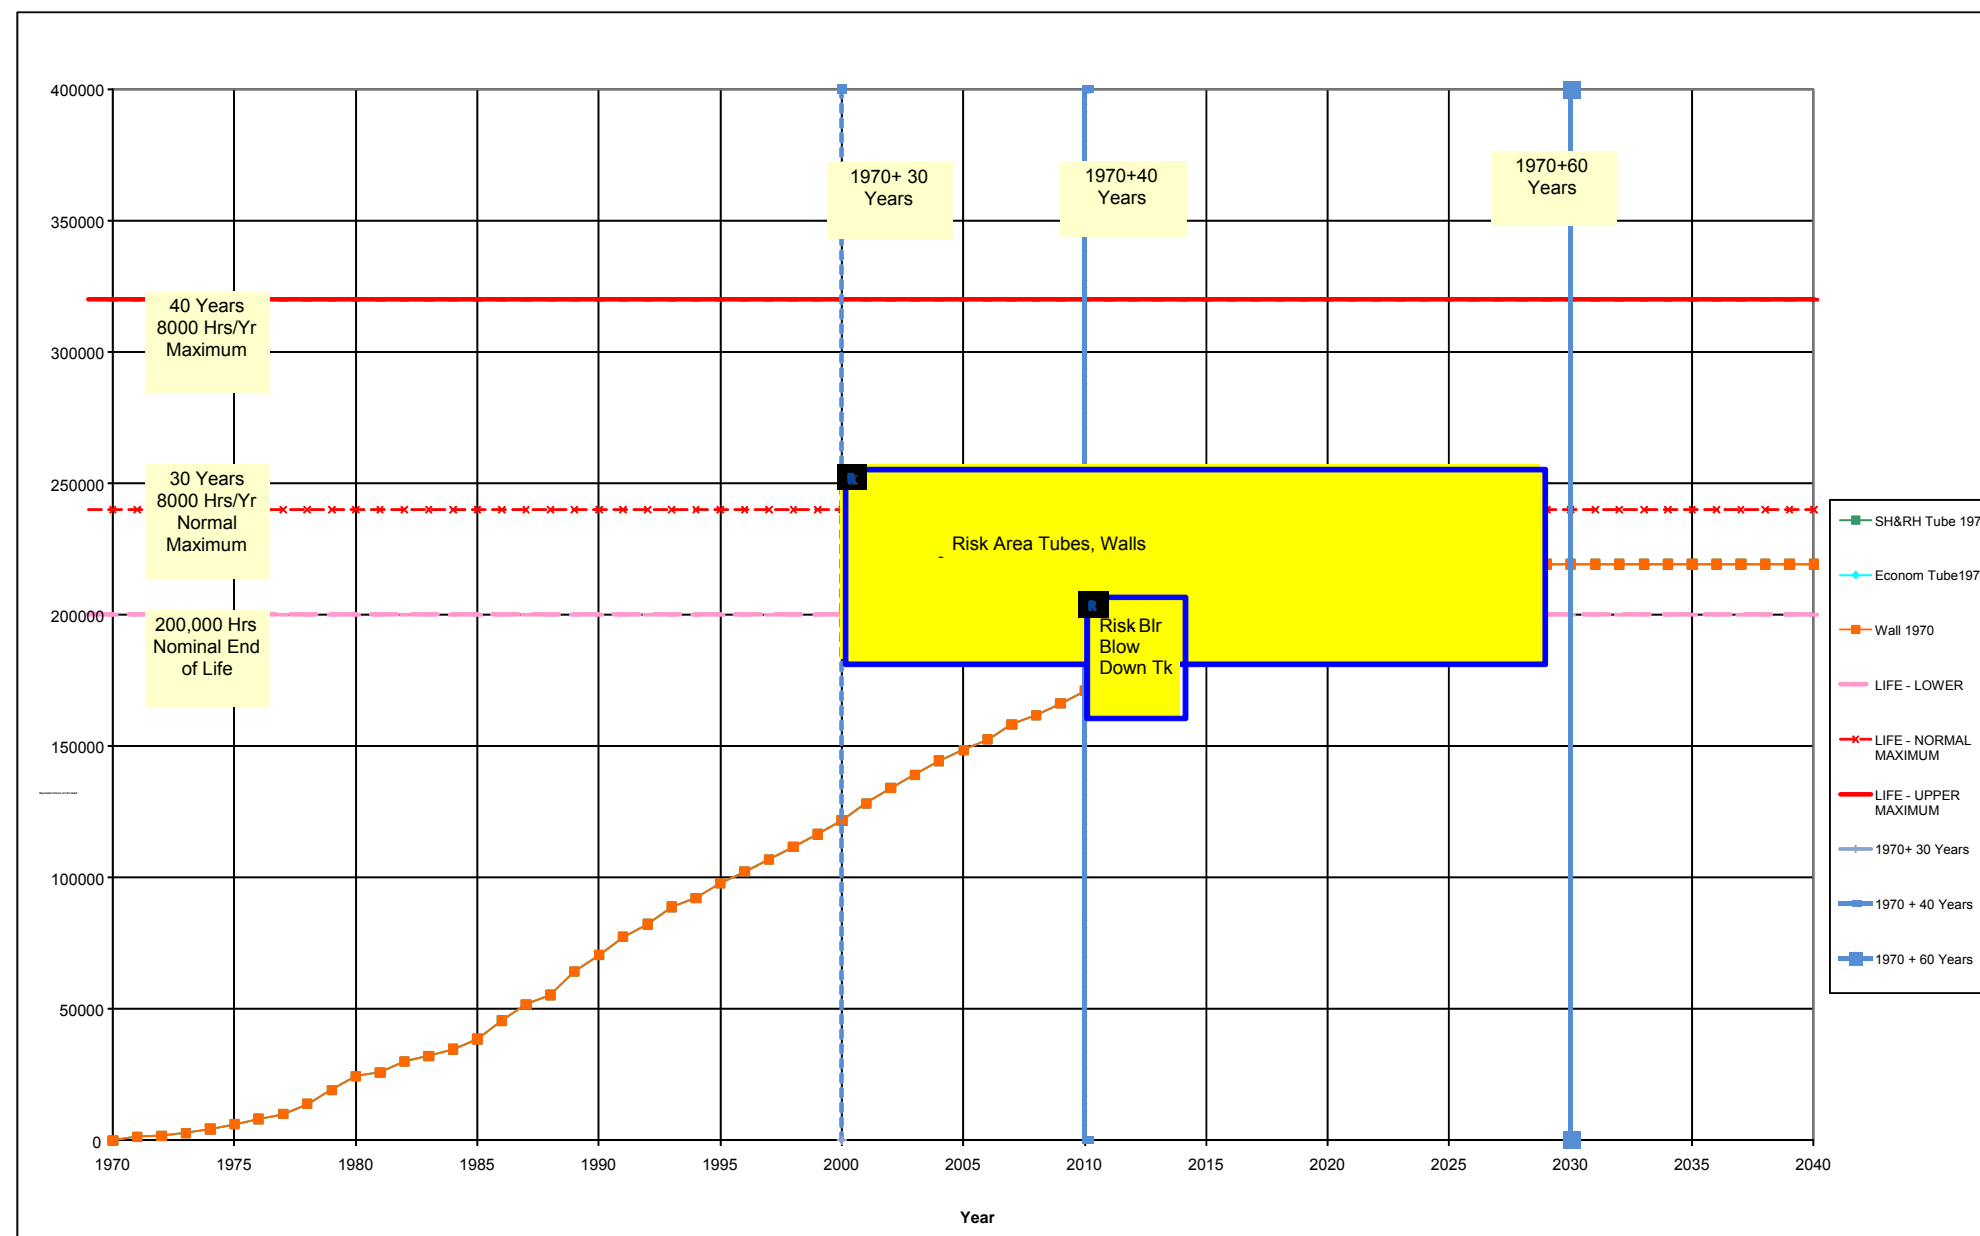
FIGURE 8-12 LIFE CYCLE CURVE –UNIT 1 BOILER SYSTEM (TUBES EXPOSED TO THE COMBUSTION PROCESS, BOILER BLOWDOWN)

A single life cycle curve is presented beginning with the in-service date of the unit. It is meant to represent initial design goals, using nominally operating hours. It was considered impractical to accurately document or reasonably present in one curve the many changes that have occurred, and are likely to continue to occur going forward due to legacy impacts. It shows the current status of the boiler blowdown tank, which is both a life issue and a safety issue. It uses nominal operating hours as opposed to metallurgical equivalent hours in the two previous boiler curves as a more appropriate way of expressing its normal lifetime.

The curve indicates that the boiler tubes within the furnace envelope would have been expected to be seeing some end of life component concerns with original equipment. Nevertheless, it is more likely legacy impacts that will have greater effects on component replacements and refurbishments going forward to 2020. With ongoing inspections and refurbishments, 2020 is achievable with good reliability with the new fuel. It also shows that the boiler blowdown tank should be replaced.

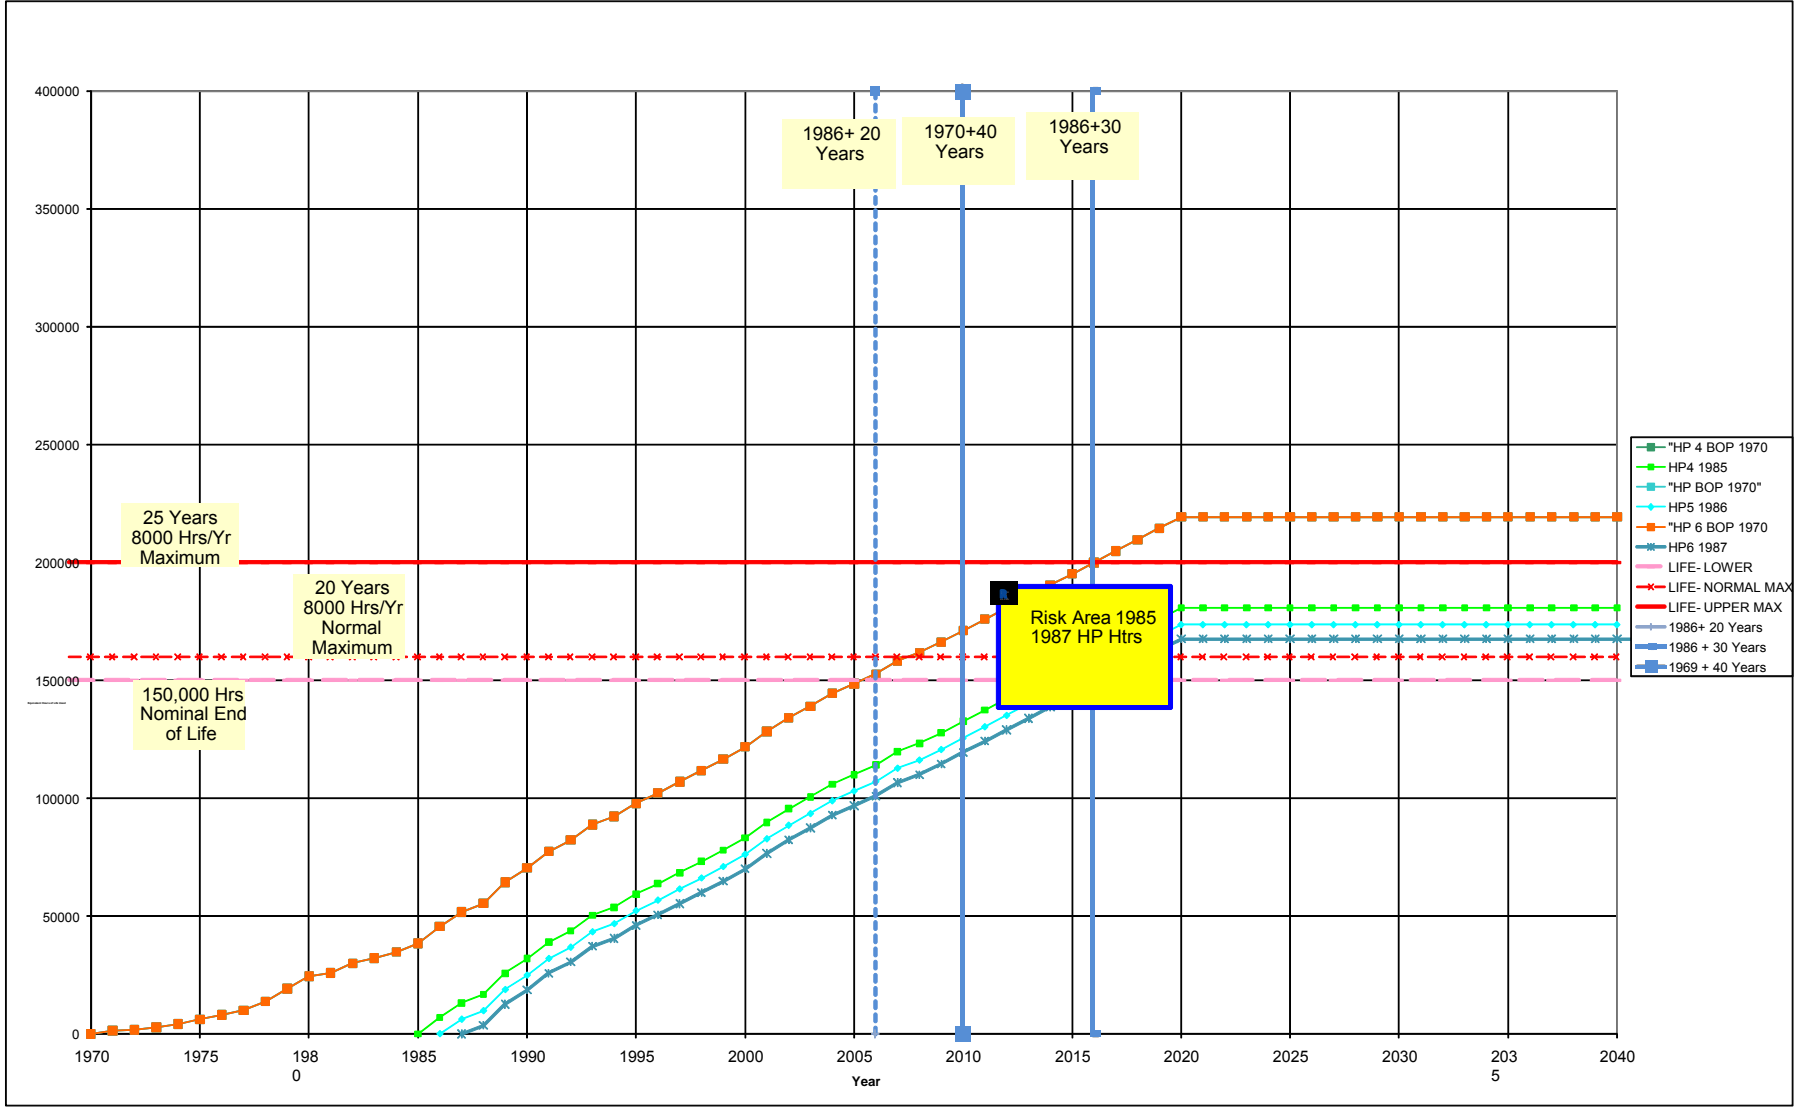
FIGURE 8-13 LIFE CYCLE CURVE – UNIT 1 FEEDWATER SYSTEM - HP FEEDWATER HEAT EXCHANGERS

For the Unit 1 feedwater system HP heat exchangers, individual curves represent the three heat exchangers and components, as well as a curve to represent any balance of plant that is original equipment.

The curves indicate that the remaining life (RL) of the Unit 1 HP heat exchangers (and the associated feedwater systems) may be able to reach the desired life (DL) 2020 end date for generation. Nevertheless, given that no detailed NDE information has been obtained on the HP heat exchangers for some time, a detailed Level 2 inspection is recommended for 2012.
