Holyrood Thermal Generating Station (Holyrood) Condition Assessment & Life Extension Study, - Final Report

**Holyrood Thermal
 Generating Station
 Condition Assessment &
 Life Extension Study**

January 28, 2011

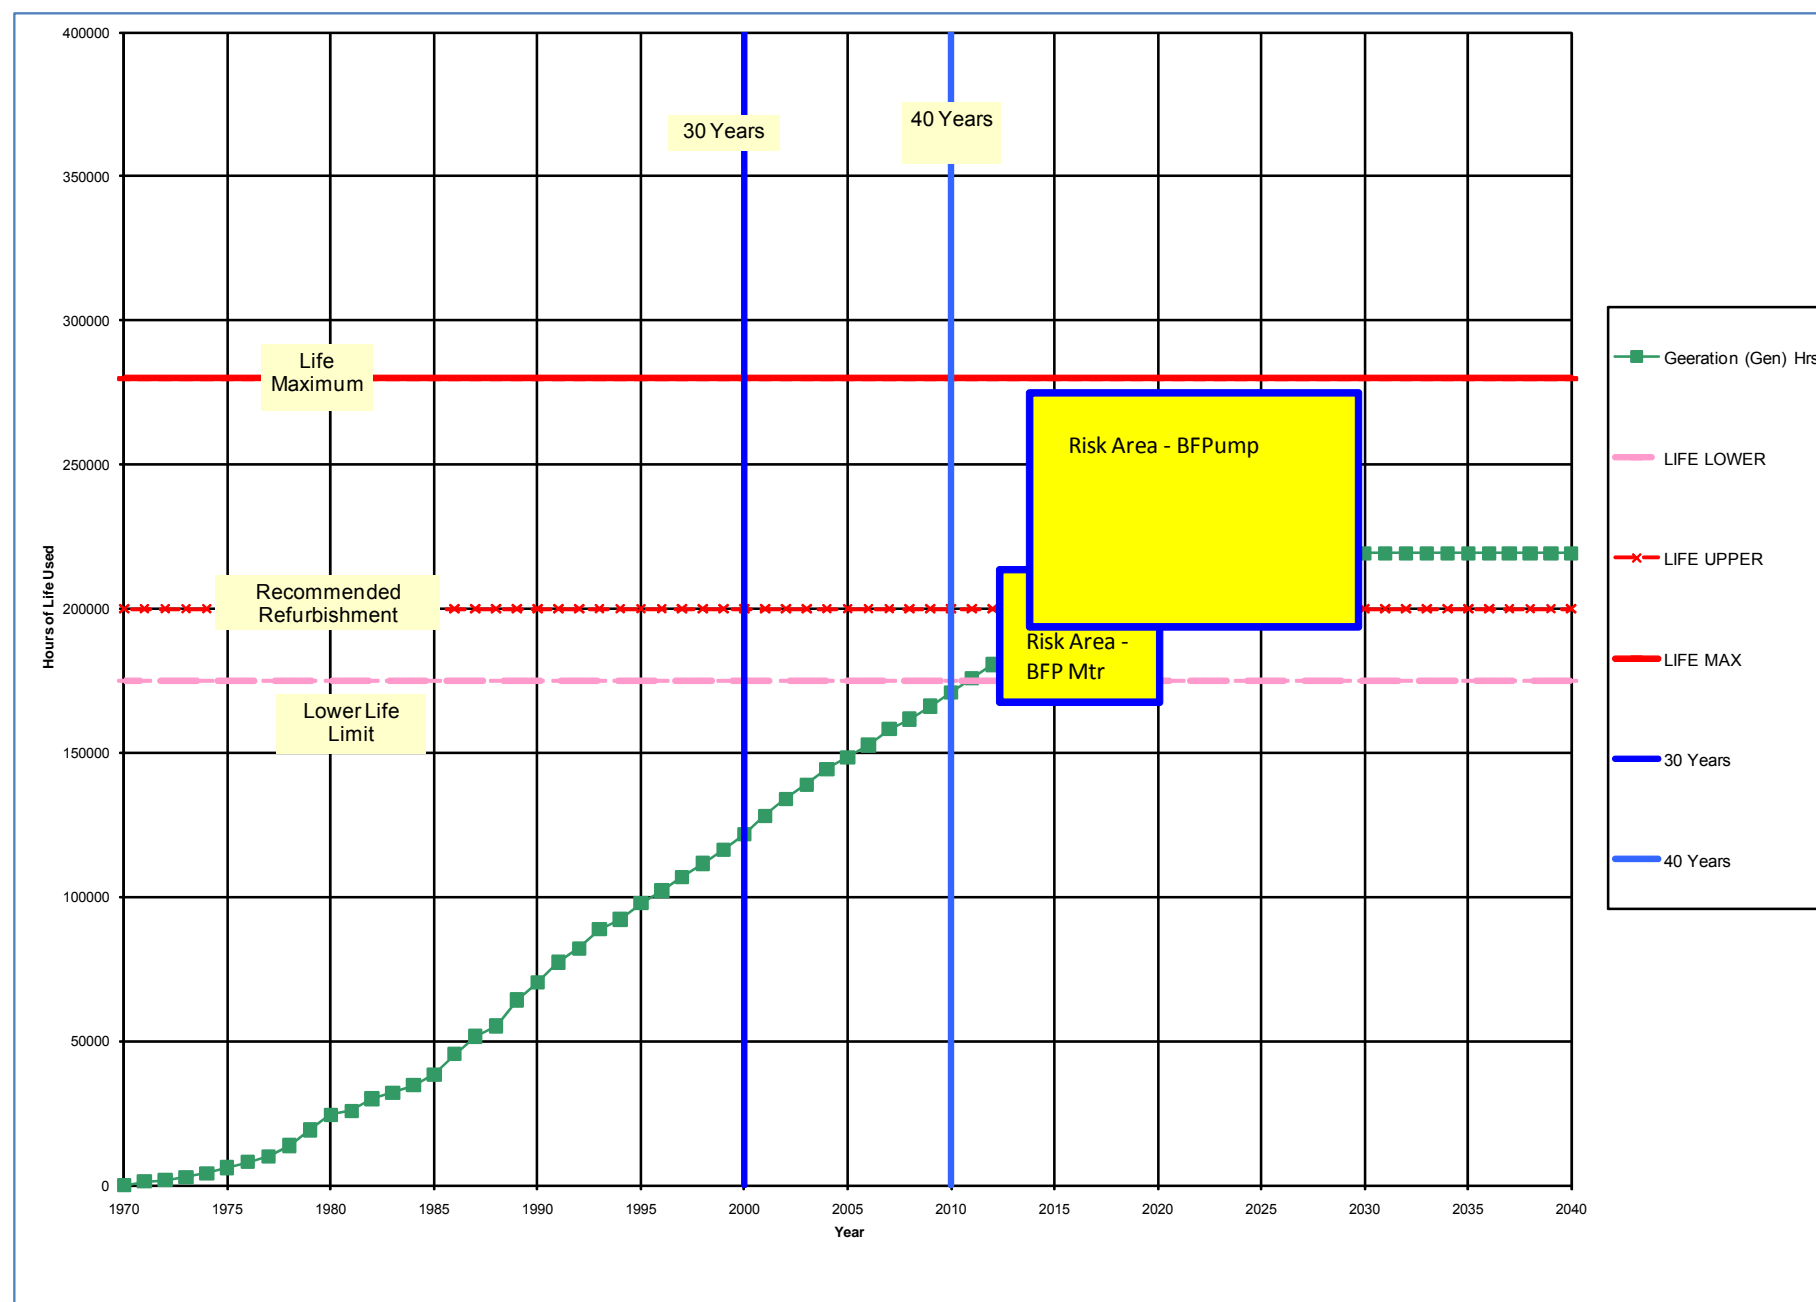
FIGURE 8-14 LIFE CYCLE CURVE – UNIT 1 FEEDWATER SYSTEM - HP BOILER FEED PUMPS

For the Unit 1 Boiler Feed Pumps, a single curve represents each of the two boiler feed pumps dating back to their original installation. While indicative of expected life with good maintenance practice, the pumps have been and continue to be refurbished on a six year cycle using a spare pump section. Their actual condition is therefore substantially better than might otherwise be expected.

The curve indicates that the remaining life (RL) of the Unit 1 HP boiler feed pumps is likely able to reach desired end date which is the 2020 end date for generation. Given their six year refurbishment cycle and a spare pump section, they are expected to continue to perform reliably well past the 2020 end date for generation. The BFP motors are approaching older age and entering areas where reliability and unexpected failure may become more an issue than expected life.

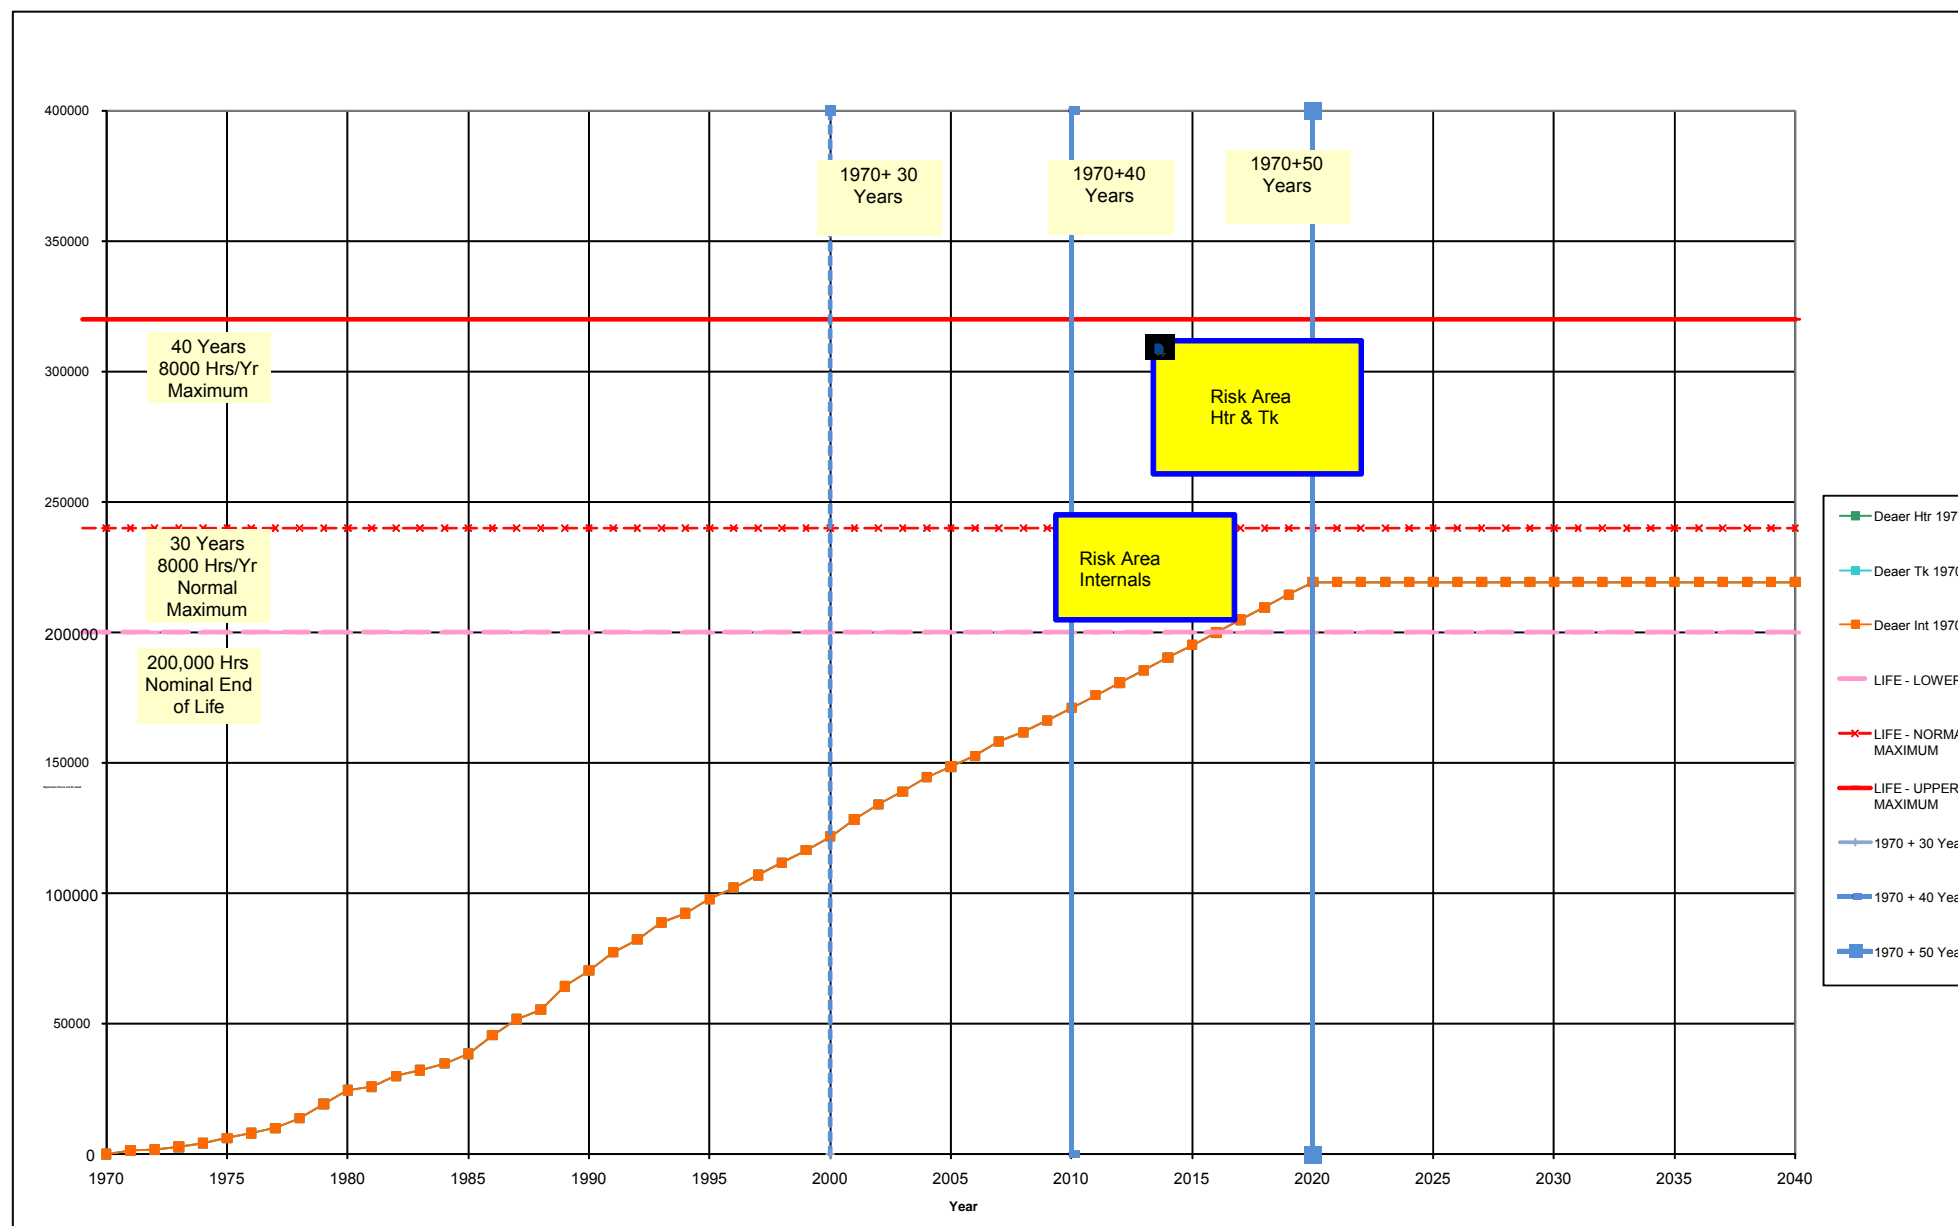
FIGURE 8-15 LIFE CYCLE CURVE – UNIT 1 FEEDWATER SYSTEM - DEAERATOR

The curve indicates that the remaining life (RL) of the Unit 1 feedwater system - deaerator exceeds the desired life (DL) which is end date for generation of 2020, with the potential though unlikely exception of some deaerator internals. The plant inspections form an excellent base of condition information supporting the ability of the deaerator as a whole to meet the EOL date. There is however insufficient detailed inspection information of some of the difficult to reach internals to fully assess their condition. A detailed Level 2 inspection in 2012 is recommended to provide information for that assessment.

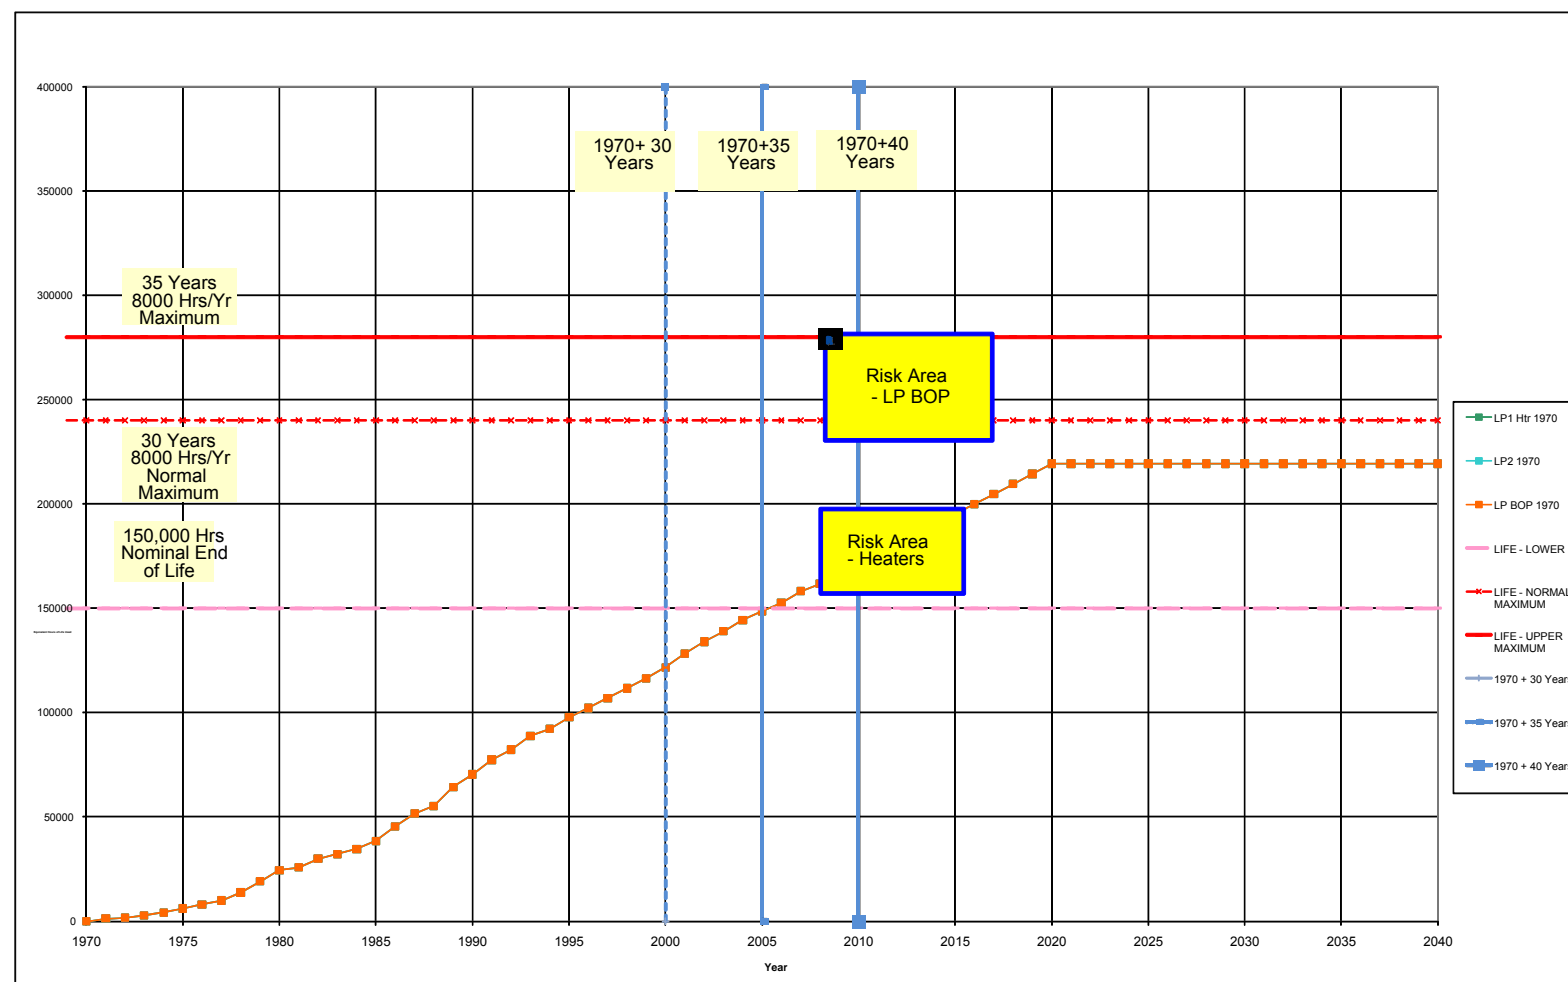
FIGURE 8-16 LIFE CYCLE CURVE – UNIT 1 FEEDWATER SYSTEM - LP FEEDWATER HEAT EXCHANGERS

The curves indicate that the remaining life (RL) of the feedwater system LP heat exchangers may not be able to reach the desired life (DL) 2020 end date for generation. Given that no detailed NDE information has been obtained on the LP heat exchangers, a detailed Level 2 inspection is recommended for 2011.

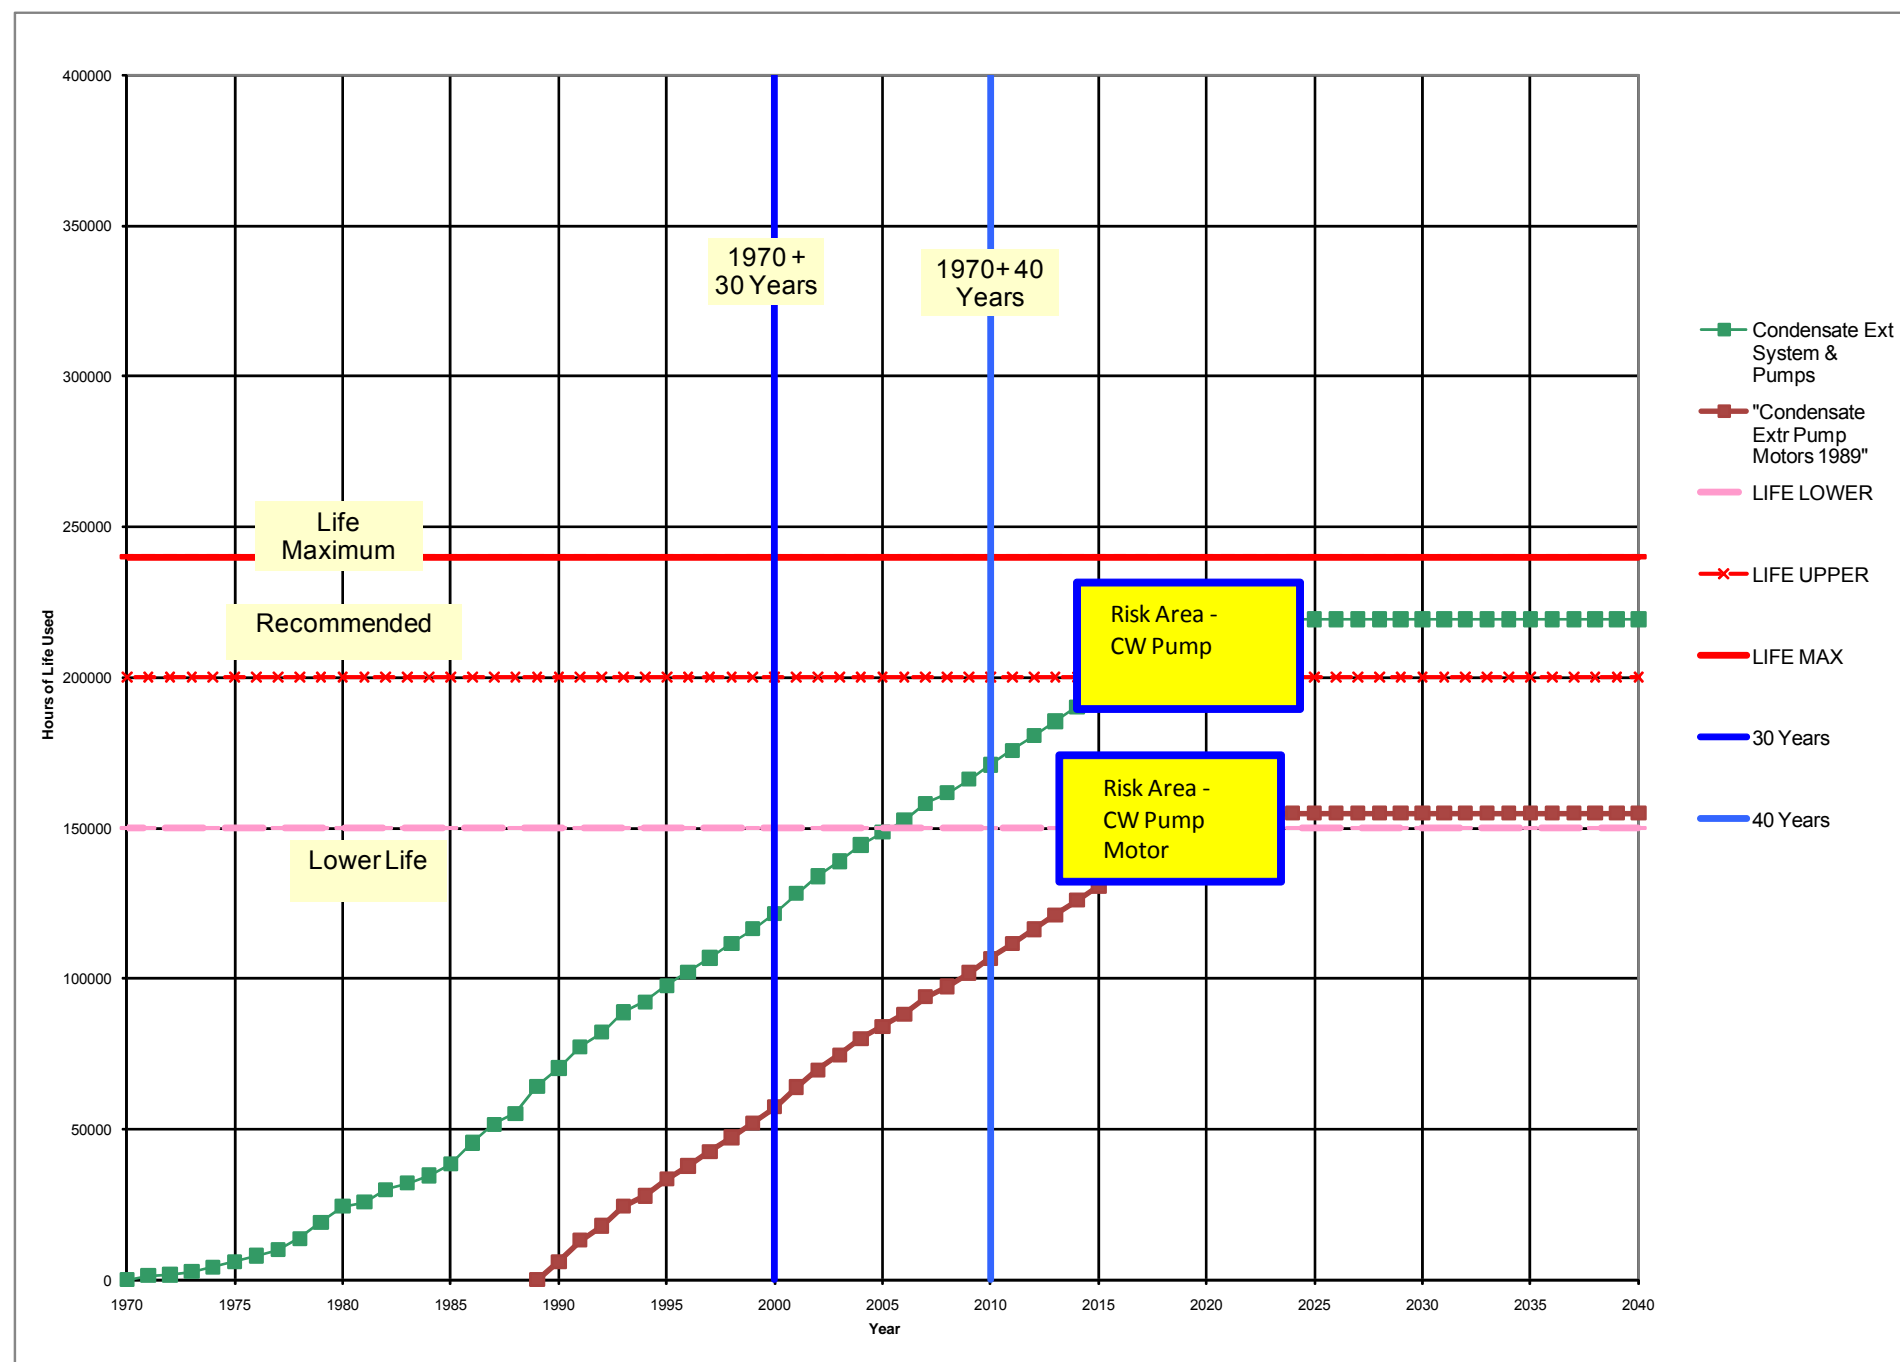
FIGURE 8-17 LIFE CYCLE CURVE – UNIT 1 FEEDWATER SYSTEM – CONDENSATE EXTRACTION PUMPS AND MOTORS

The curves indicate that the remaining life (RL) of the condenser condensate extraction pumps and motors can likely be able to reach the desired life (DL) 2020 end date for generation. The condensate extraction pump motors are expected however to be entering a period of higher unreliability.

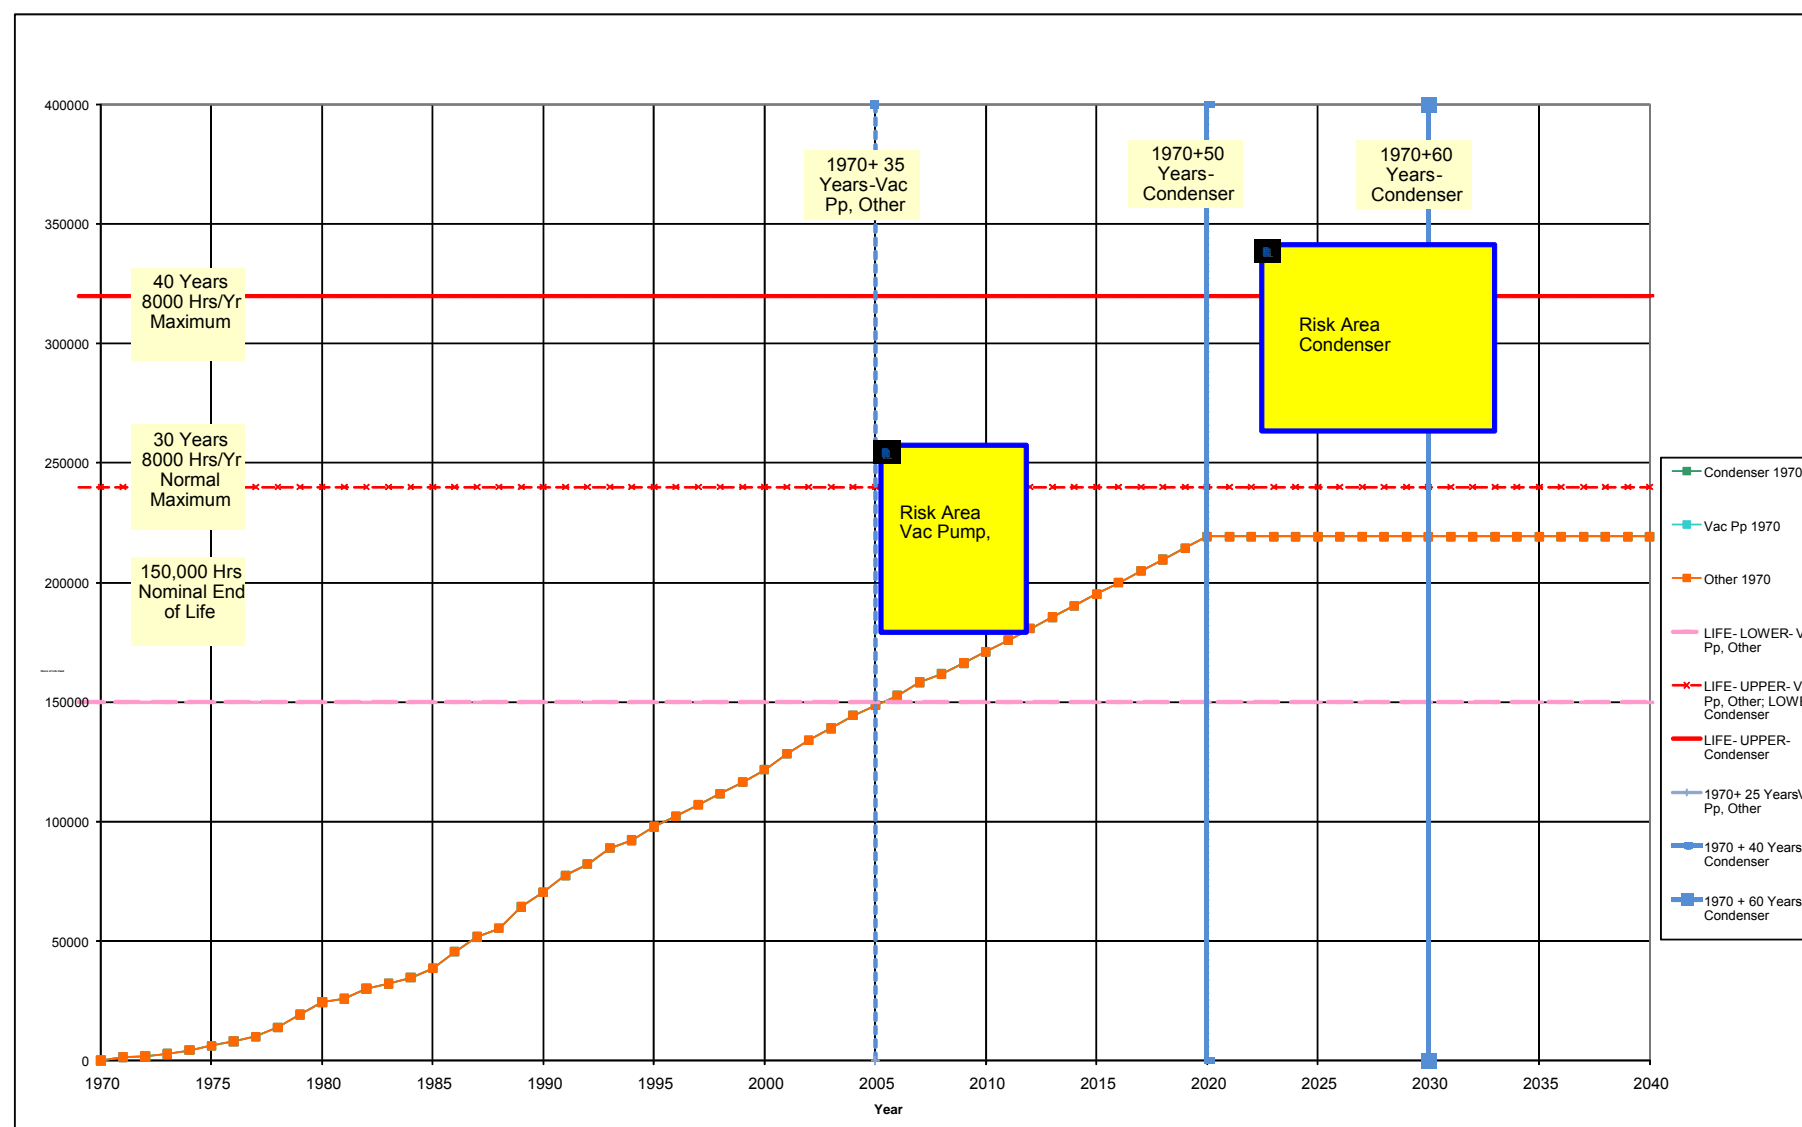
FIGURE 8-18 LIFE CYCLE CURVE – UNIT 1 CONDENSER

The curves indicate that the remaining life (RL) of the Unit 1 condenser can easily reach the desired life (DL) 2020 end date for generation. The exception to this, as illustrated by the risk boxes, is the vacuum pumps. These are original equipment, and likely at or near end of life.

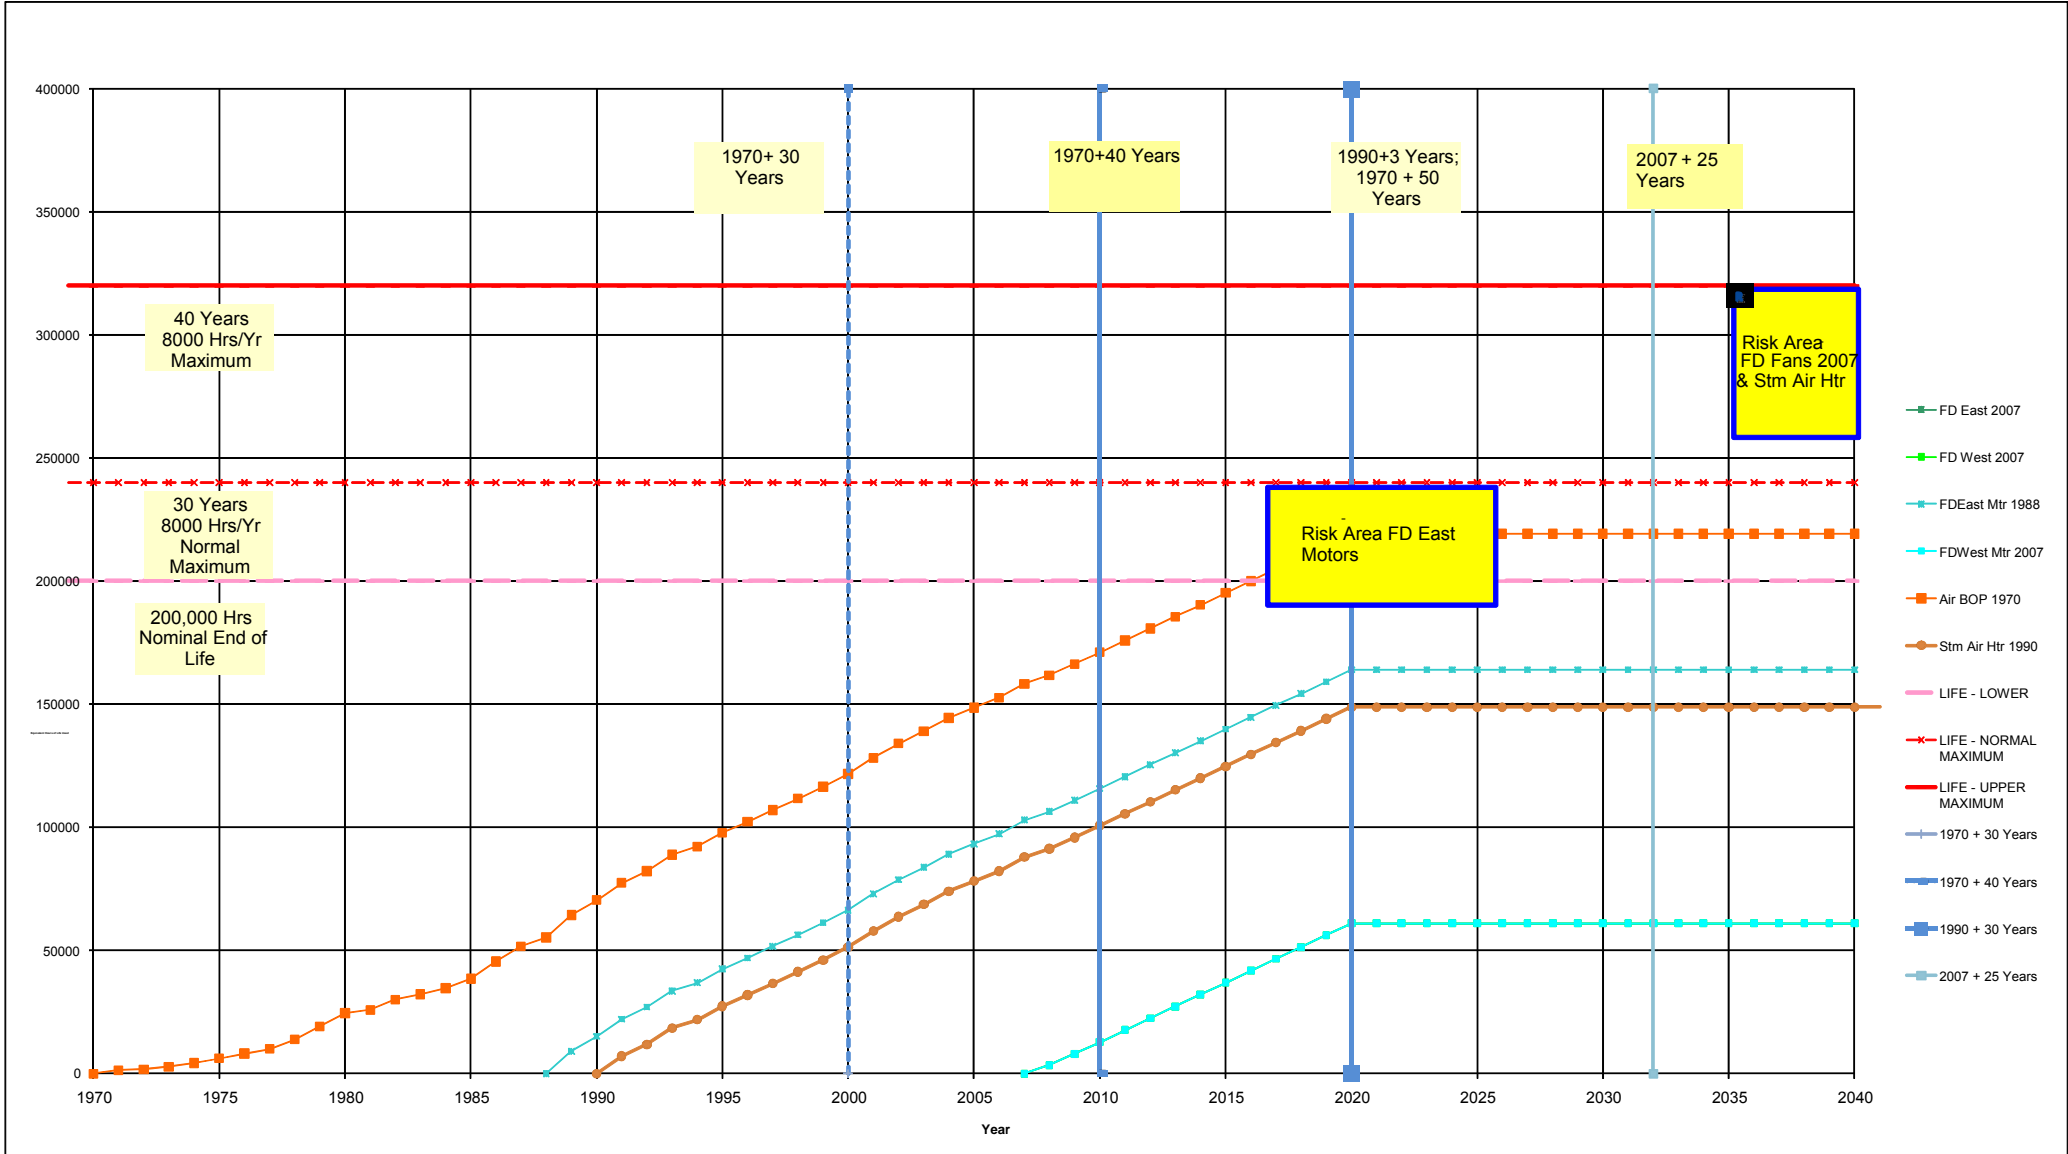
FIGURE 8-19 LIFE CYCLE CURVE – UNIT 1 FD FANS (AND SYSTEM)

The curves indicate that the remaining life (RL) of the Unit 1 FD fans (and system) is expected to meet or exceed the desired life (DL) 2020 end date for generation. The age of the large 4 kV motors makes them a logical cost-effective candidate for sparing to ensure reliability, although plant testing/monitoring programs are effectively monitoring their status.

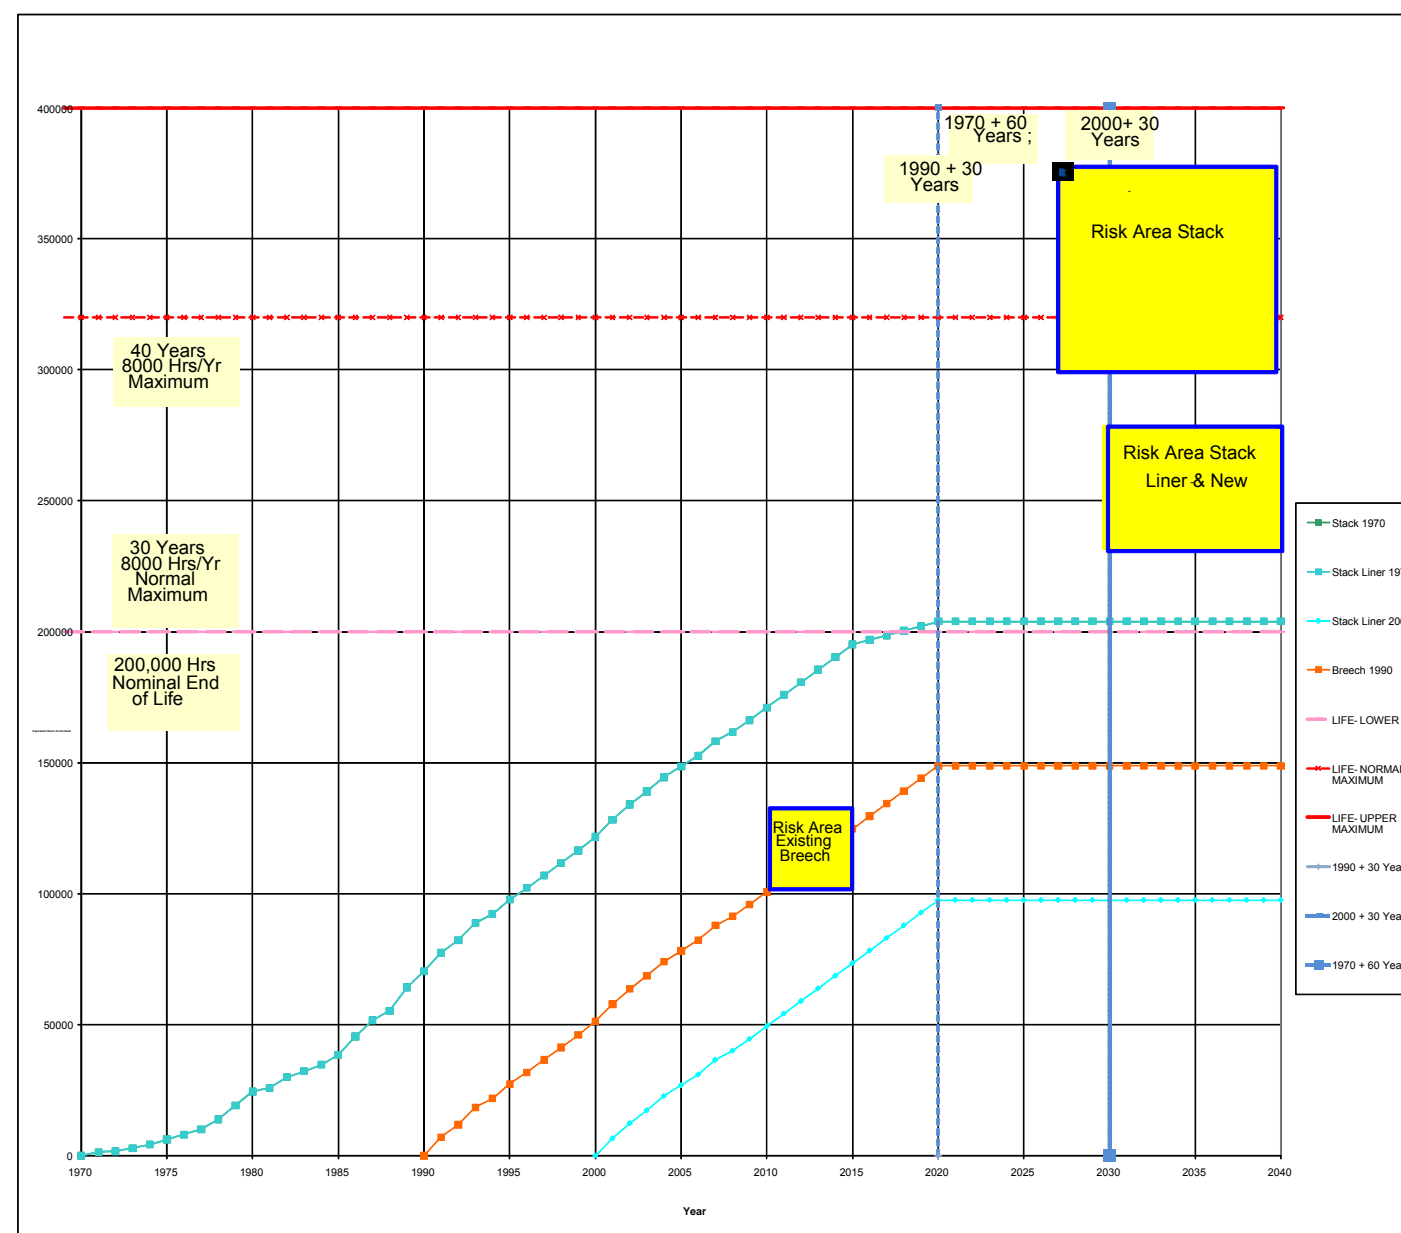
FIGURE 8-20 LIFE CYCLE CURVE – UNIT 1 STACK AND BREECHING

The curves indicate that the remaining life (RL) of the Unit 1 stack is may be able to reach the desired life (DL) 2020 end date for generation, as well as the end date of 2040 for synchronous condensing/plant life. It does show that the stack breaching is in need of immediate repair. The breaching requirement is not a normal life issue, but one of poor design. Other elements can achieve the 2020 end date for generation with the ongoing plant maintenance program.

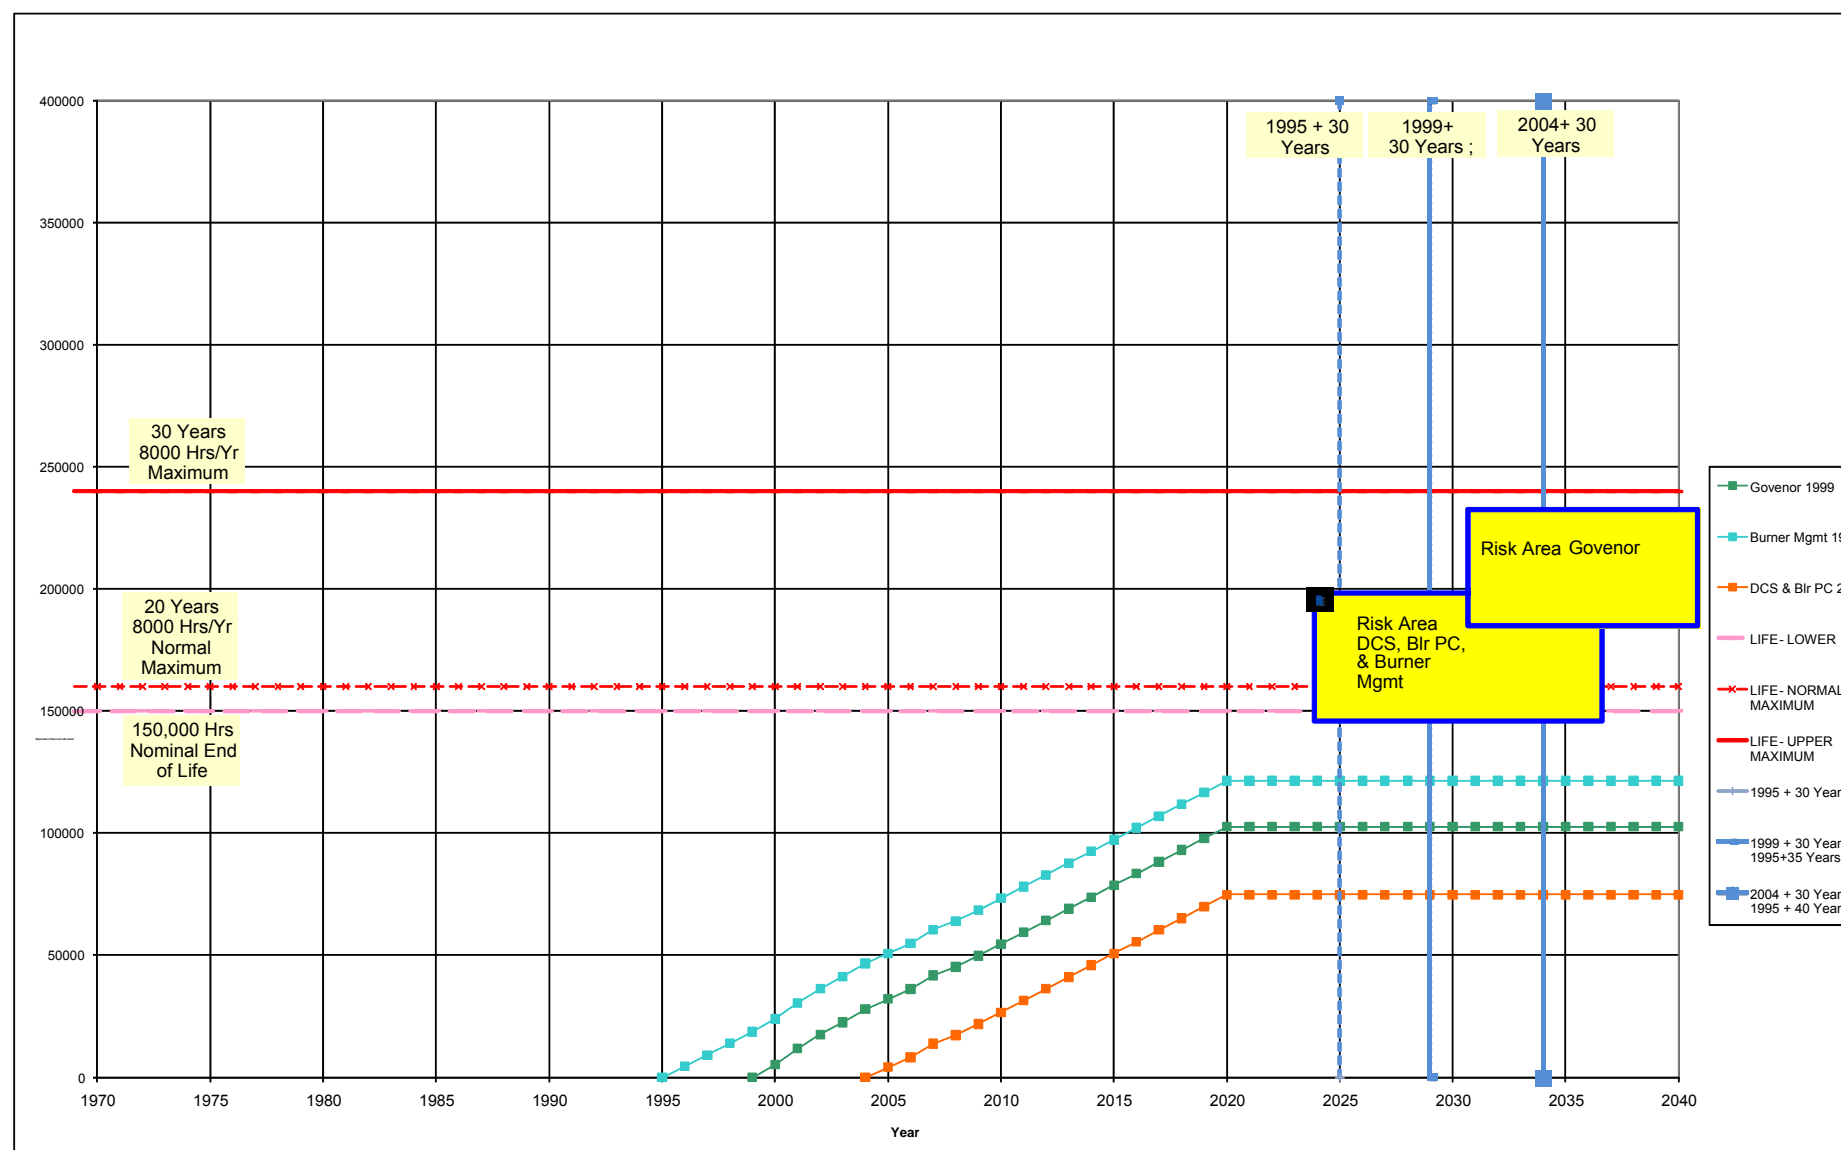
FIGURE 8-21 LIFE CYCLE CURVE – UNIT 1 ELECTRICAL AND CONTROL SYSTEMS (INCLUDING DCS) ASSOCIATED WITH STEAM SYSTEMS

The curves indicate that the remaining life (RL) of the Unit 1 control systems (including DCS) associated with steam systems can readily reach the desired life (DL) 2020 end date for generation, provided regular inspection and service as per the station PM plan is maintained. The electrical systems, particularly breakers and motor controls are addressed in more detail as part of Section 8.1.3. It is clear that in order to meet the end date for generation service, some components must be replaced, or in some cases refurbished.

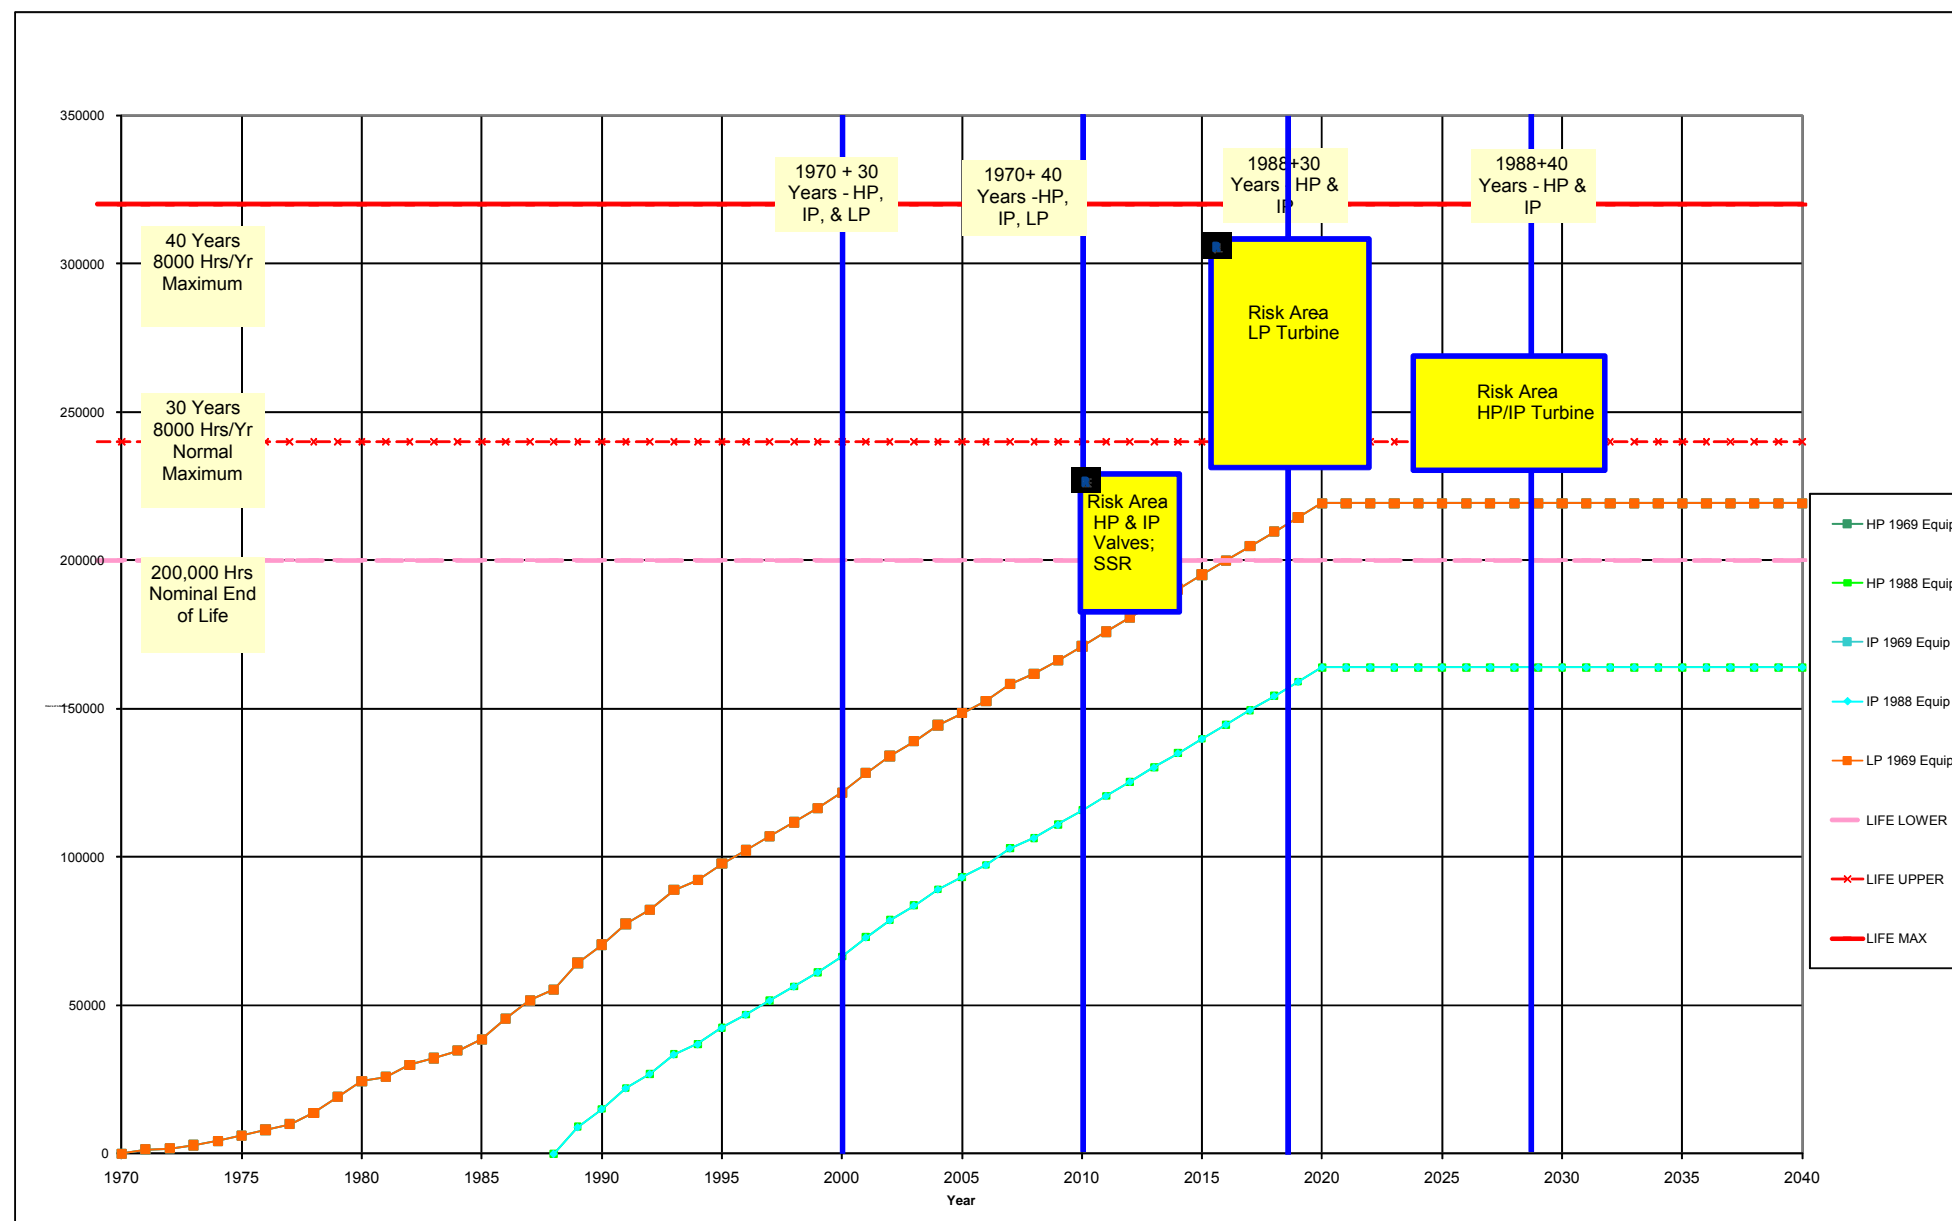
FIGURE 8-22 LIFE CYCLE CURVE – UNIT 1 STEAM TURBINE

The curves indicate that the remaining life (RL) of the various elements of the Unit 1 steam turbine exceeds the desired life (DL) which is the lesser of the time to its next major planned overhaul/inspection (2012) or to the desired End of Life (EOL) date of 2020. In fact the 2020 end date should be readily achievable. Hence, no specific dedicated Level 2 is required, but sufficient inspection and testing will be required in the 2012 overhaul to confirm the ability to meet the 2020 EOL date. The exceptions to that are the HP and IP valves which continue to have reliability and life issues, the steam seal regulator, as well potentially as high temperature stud bolts. It is clear that the current inspection schedule seems suitable.

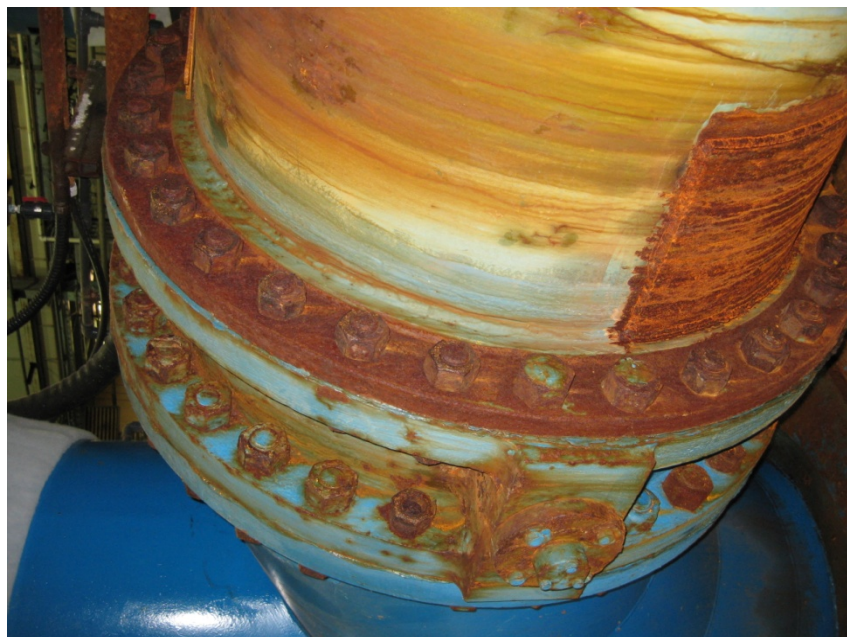
FIGURE 8-25 CIRCULATING WATER PIPE PATCH
