Holyrood Thermal Generating Station (Holyrood) Condition Assessment & Life Extension Study, - Final Report

**Holyrood Thermal
 Generating Station
 Condition Assessment &
 Life Extension Study**

January 28, 2011

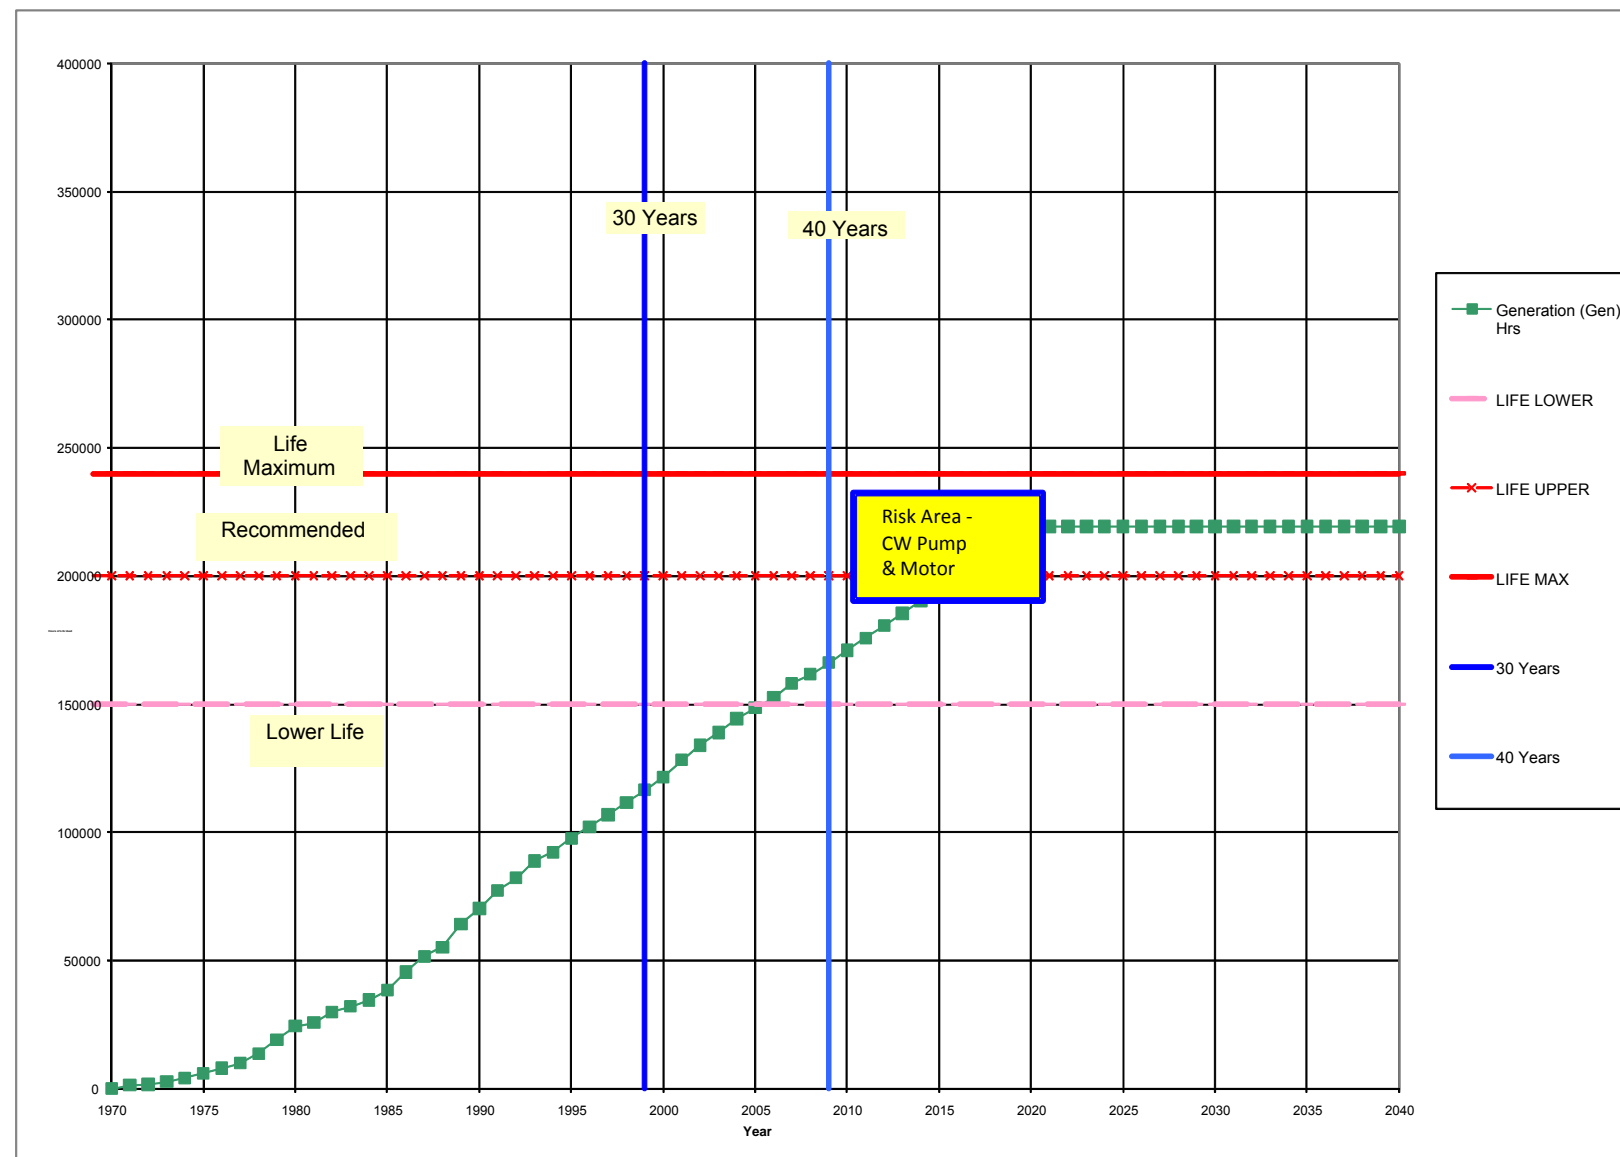
FIGURE 8-26 LIFE CYCLE CURVE – UNIT 1 COOLING WATER SYSTEM ASSOCIATED WITH STEAM SYSTEMS

The curves indicate that the remaining life (RL) of the Unit 1 cooling water system - associated with steam systems can likely reach the end date for generation of 2020, but with some reliability risk, particularly as it pertains to the 4 kV motor. It is recommended that a spare motor shared between units would be a reasonable precaution. Corrosion of the steel pipe, valves, and fittings was also evident suggesting that some maintenance on these issues is required.

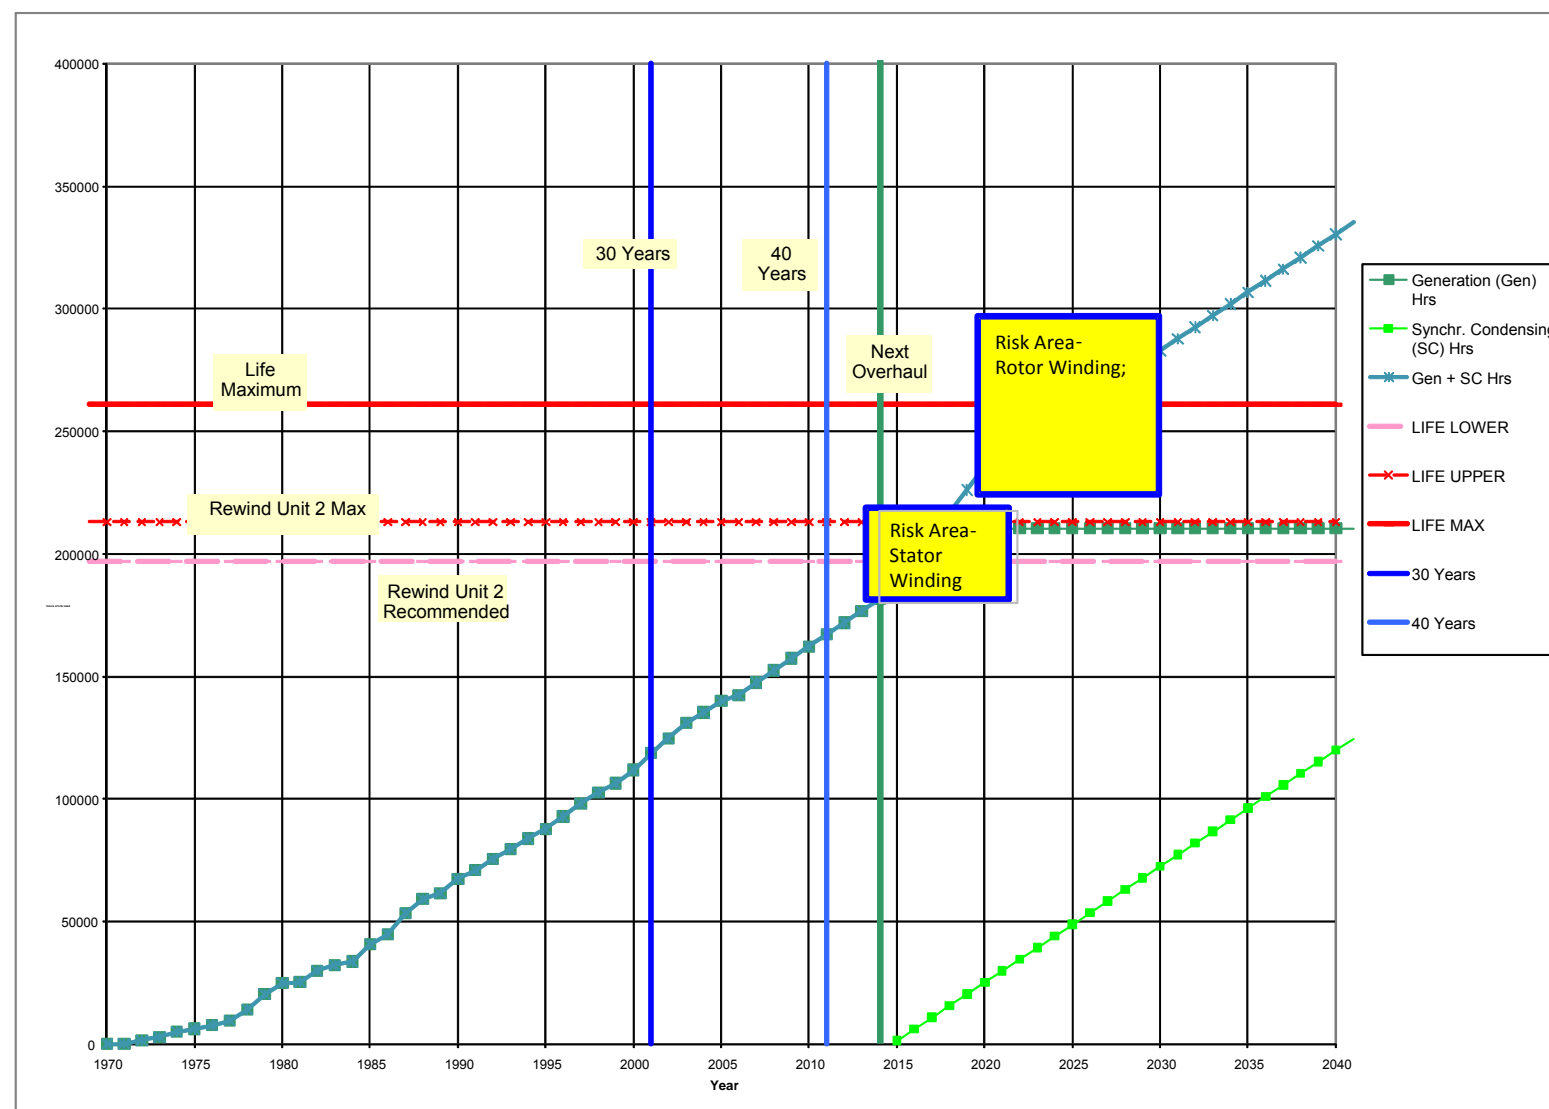
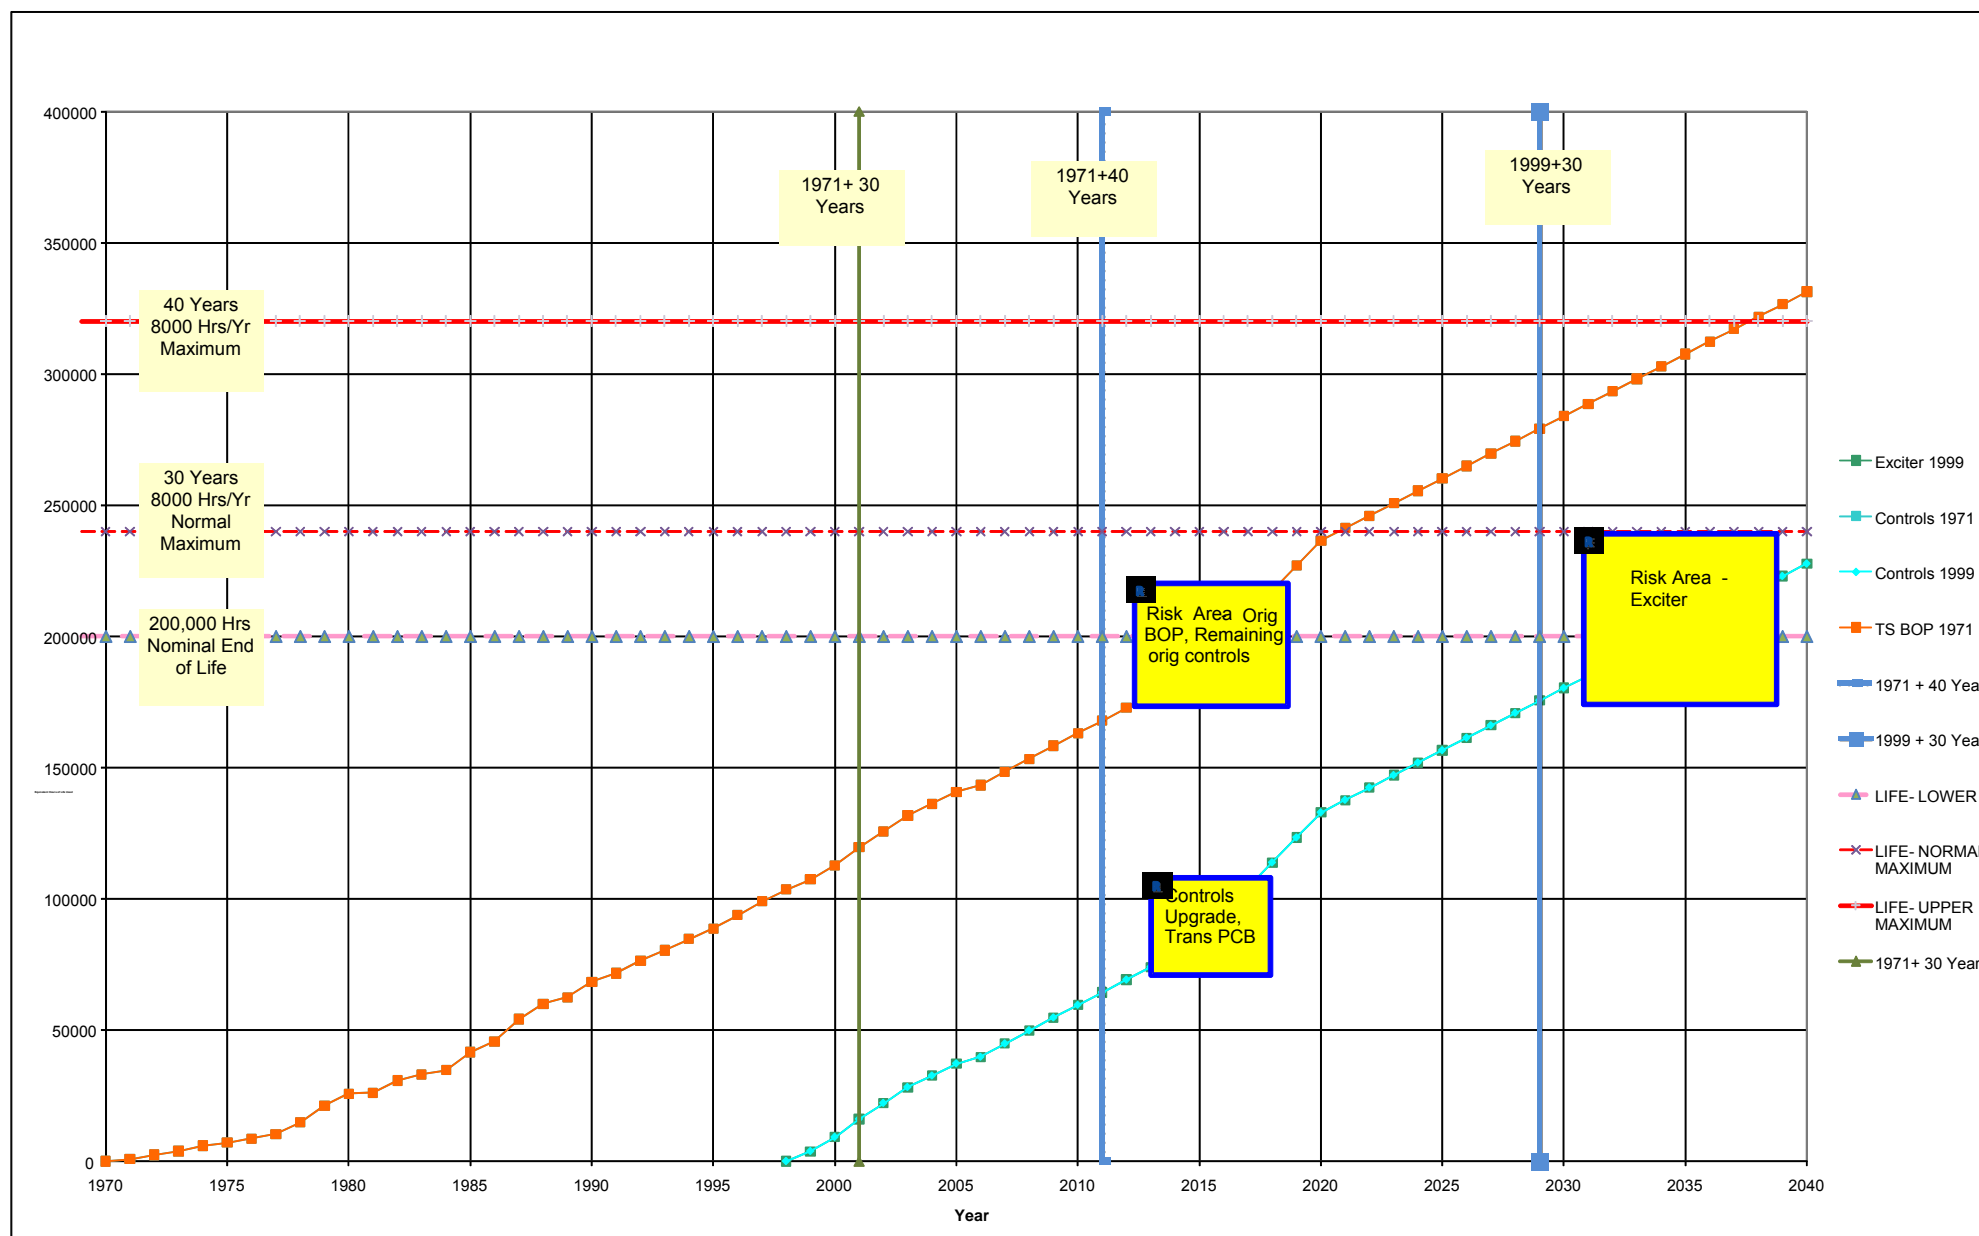
The curves indicate that the remaining life (RL) of the Unit 2 generator exceeds the desired life (DL) which is the lesser of the time to its next major planned overhaul/inspection (2014) or to the desired End of Life (EOL) date of 2041. No specific dedicated Level 2 is required, but sufficient inspection and testing will be required in the 2014 overhaul to demonstrate the ability to meet the 2041 EOL date. The exciter should for the most part be able to meet an EOL of 2020, and with periodic refurbishment may meet 2041. The highlighted nearer term risk areas include the stator winding, exciter controls (upgrade only), the rectifying transformer, and some original BOP components. These systems are candidates for replacement or refurbishment – addressed in later sections. The curve also suggests that a nine year time between generator overhauls is impractical at this time in the generator's life and should be a six year cycle.

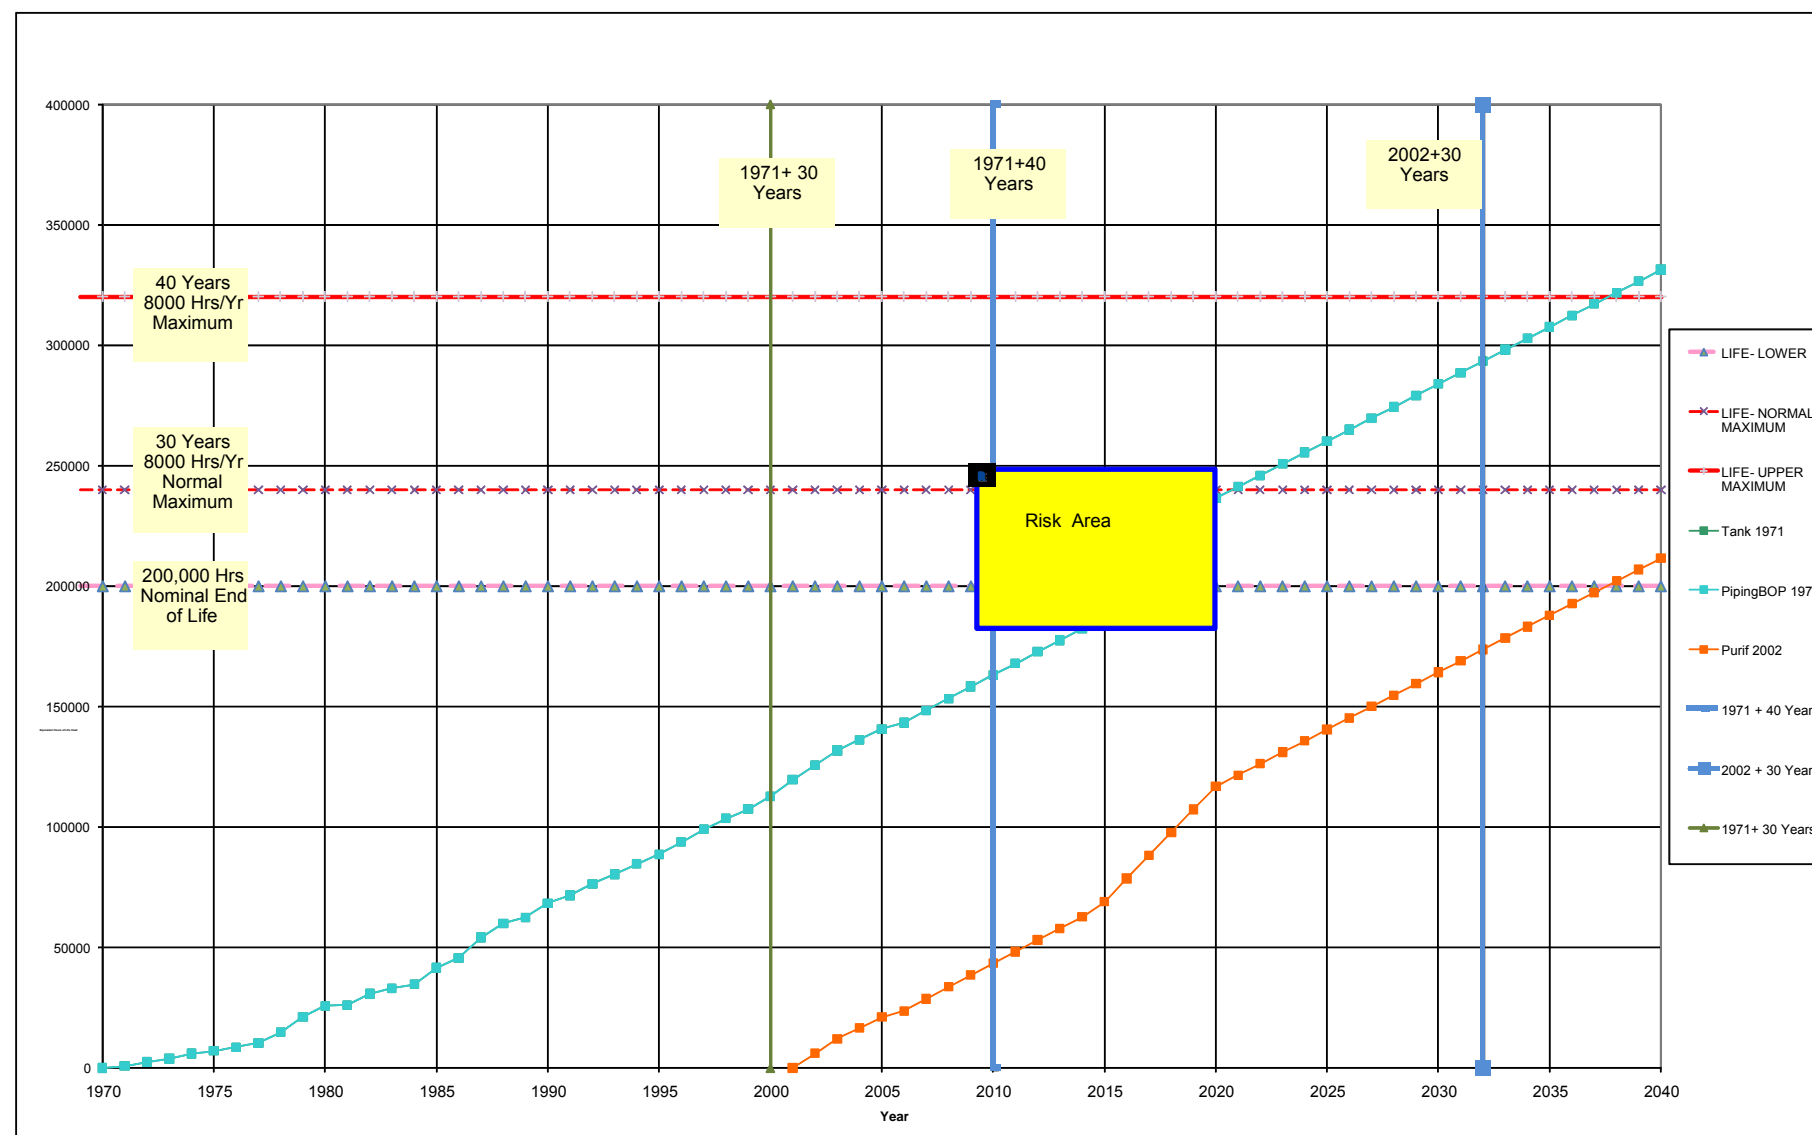
FIGURE 9-4 LIFE CYCLE CURVE – UNIT 2 GENERATOR LUBE OIL SYSTEM

The curves indicate that the remaining life (RL) of the Unit 2 generator lube oil system exceeds the desired life (DL) which is the lesser of the time to its next major planned overhaul/inspection (2014) or to the desired End of Life (EOL) date of 2041. Hence, no specific dedicated Level 2 is required of the system as a whole, but sufficient inspection and testing will be required in 2014 steam turbine generator overhaul to demonstrate the ability to meet the EOL date. The exception is the storage tank for which information was considered inadequate to form a firm conclusion and level 2 testing is recommended in 2011. The figure's highlighted risk areas is primarily operating hours driven and likely to shift further out in time after the 2014 turbine generator overhaul. The 2014 overhaul/inspection is a fundamental element in changing the current assessment.

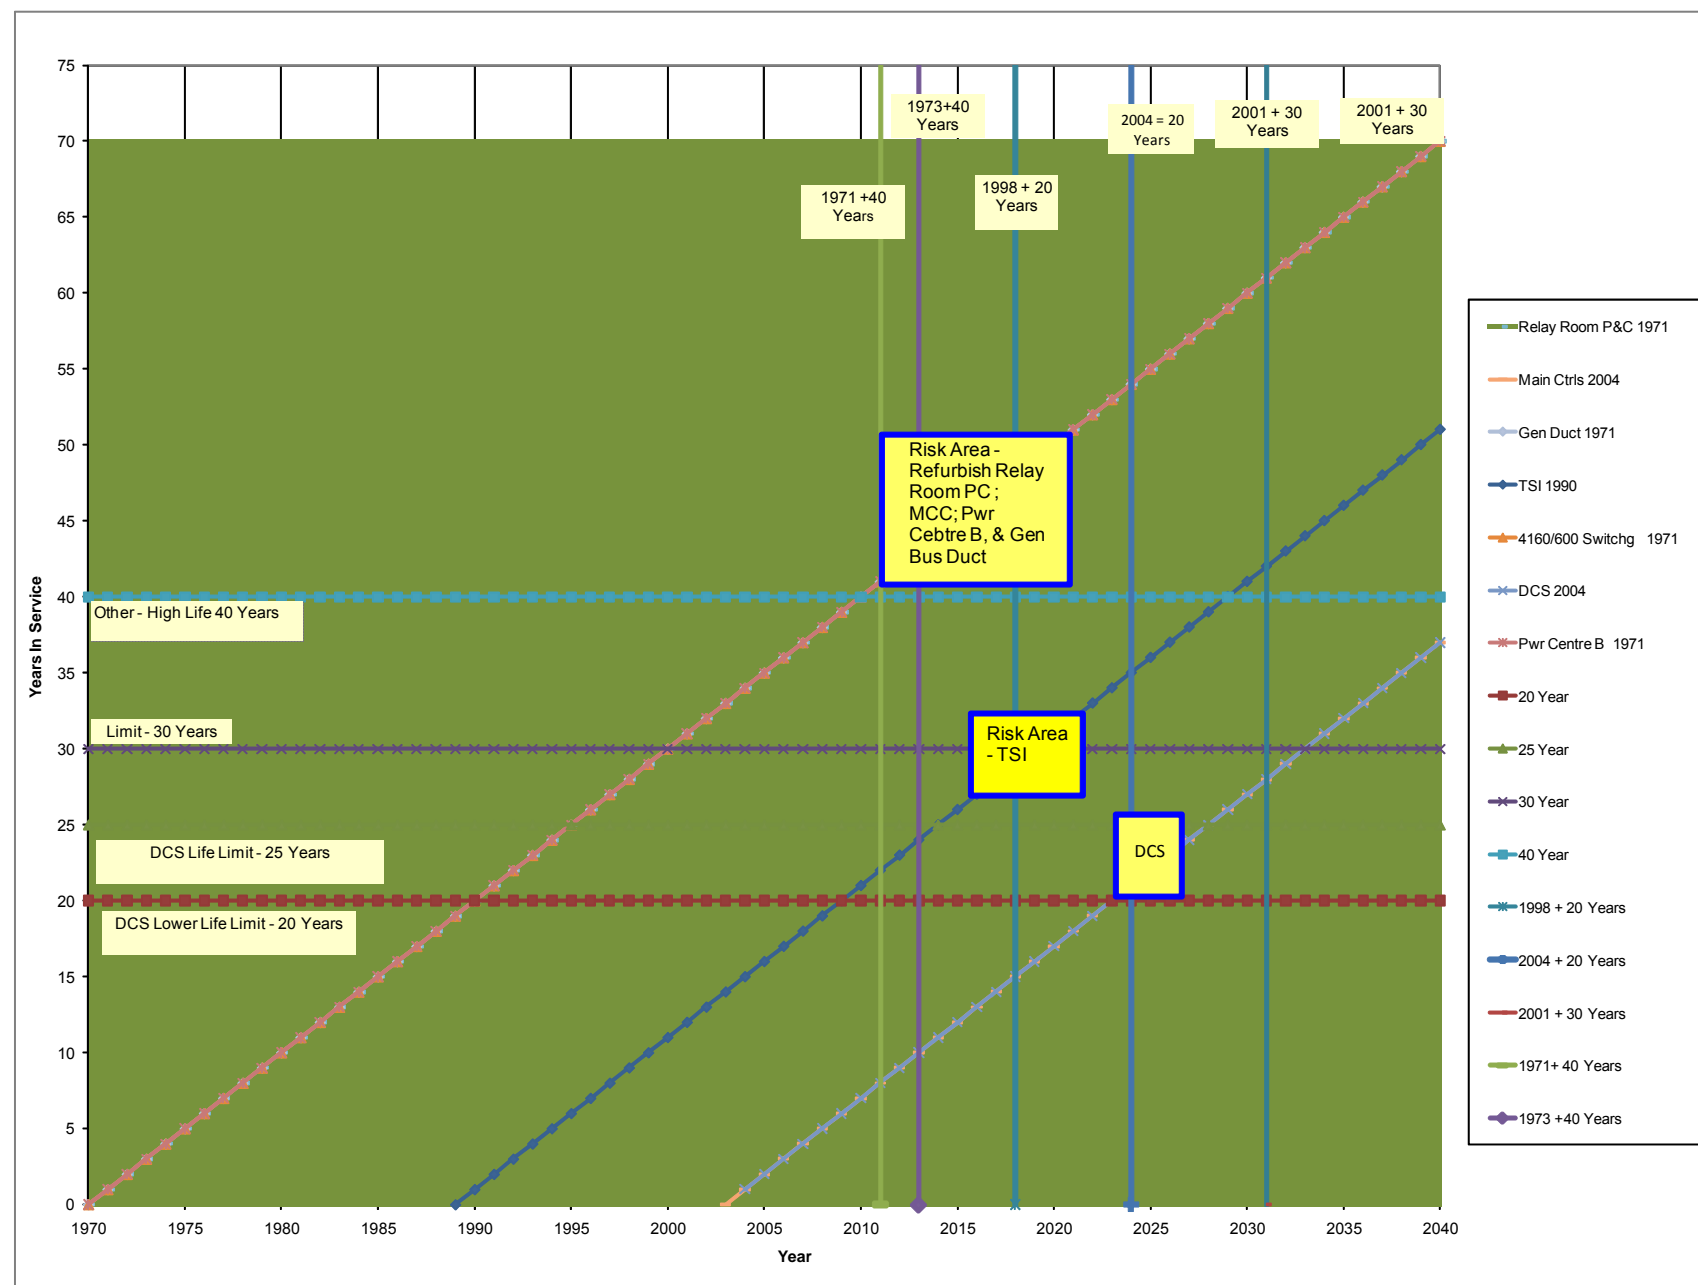
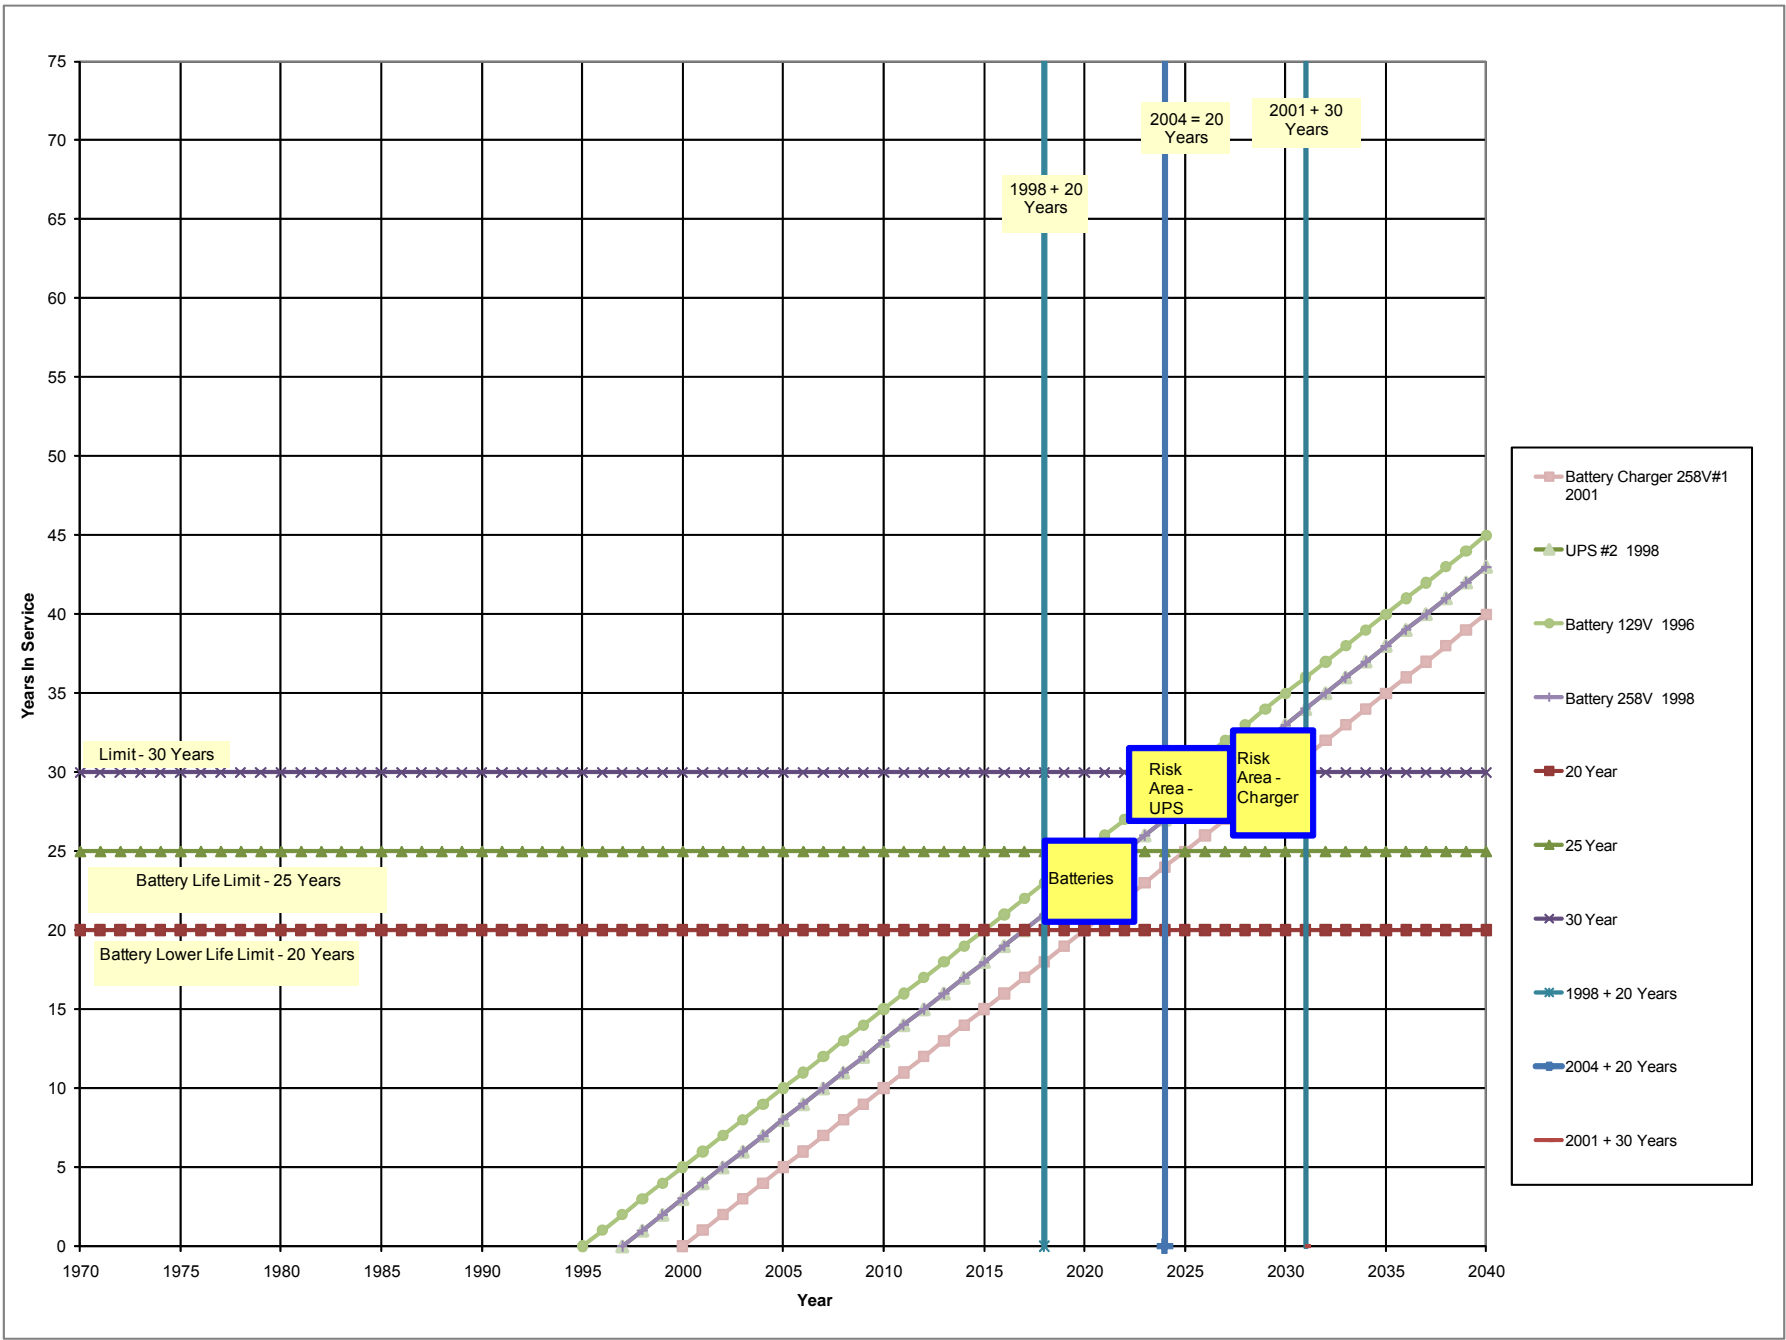
The curves indicate that the remaining life (RL) of much of the equipment does not exceed the desired life (DL) for generation of 2020 and for synchronous condensing of 2041, without extensive refurbishment or replacement. This is well illustrated by the highlighted risk areas which highlights that many original MCC's and relays as well as the TSI are in need or replacement or extensive refurbishment in the very near term. The risk figures also illustrate that most of the rest of the equipment (DCS, batteries, and chargers) will require replacement or refurbishment in the 2020+ period.

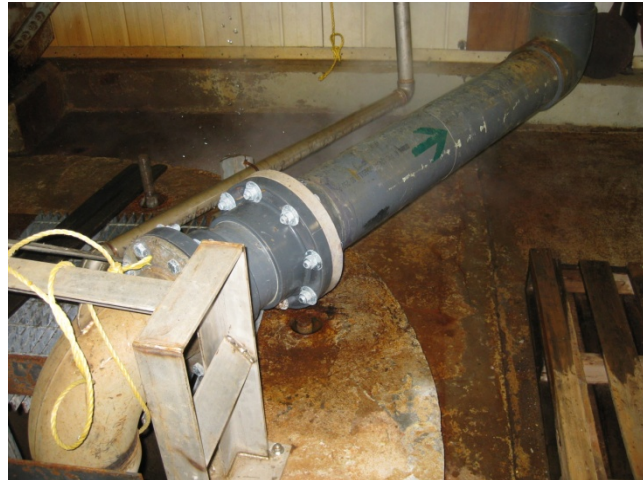
FIGURE 9-8 DEDICATED SEAWATER COOLING WATER LINE FOR UNIT 3 SYNCHRONOUS CONDENSING GT AUXILIARY COOLING WATER

and 2 cooling water system. Typically, when only Unit 3 is running as synchronous condenser, the smaller sump pump and dedicated line from the Stage 2 pumphouse is used.

For the purpose of long term synchronous condensing operation to 2041 for all three units, the intent is to supply seawater from a small, permanent pump arrangement similar to Unit 3 as shown in Section 8.1.4.1. It may come from one pumphouse or in the form of two separate, but interconnected systems.

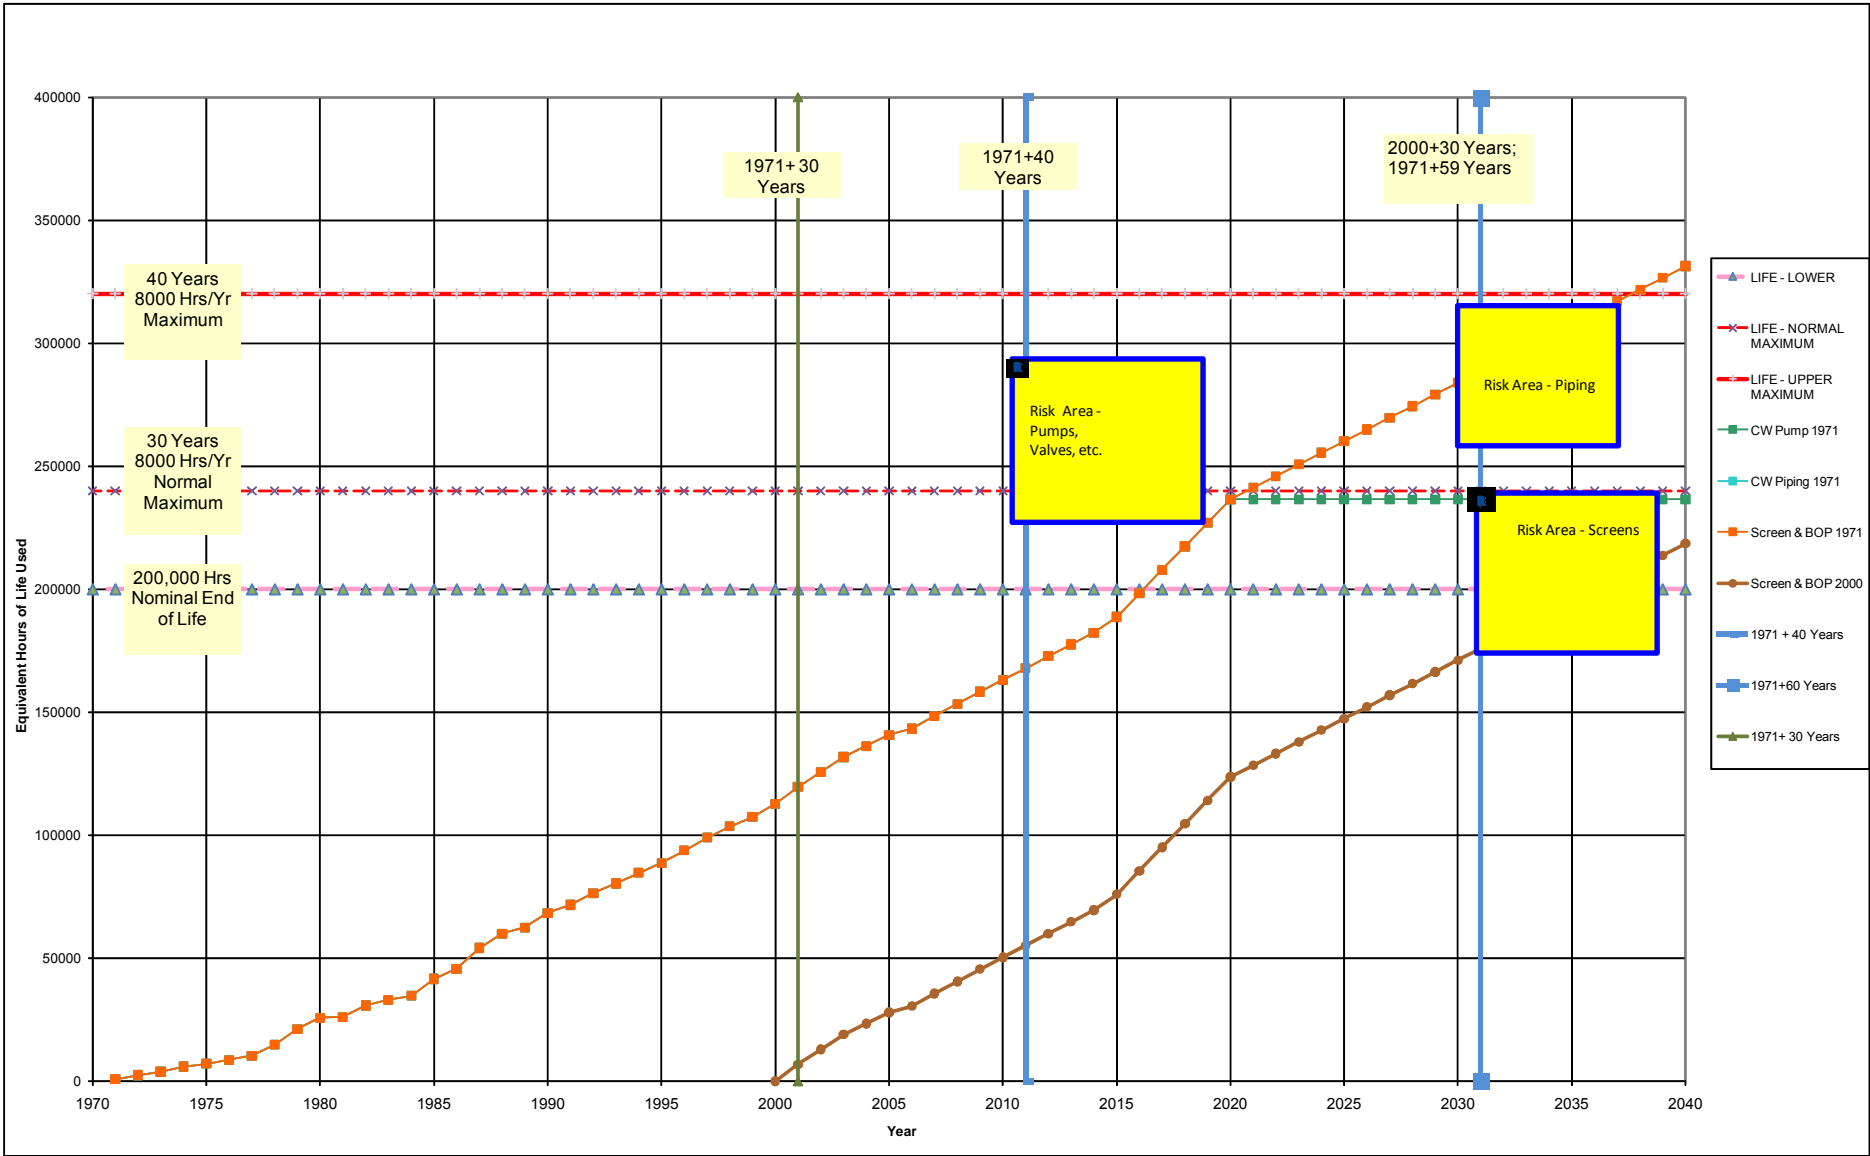
FIGURE 9-9 LIFE CYCLE CURVE – UNIT 2 COOLING WATER SYSTEMS ASSOCIATED WITH GENERATORS

The curve indicates that the remaining life (RL) of most elements of the Unit 2 cooling water systems associated with generators is sufficient to reach the end date of 2020 for generation, but not necessarily the 2041 desired life (DL) end date for synchronous condensing. The CW pumps and associated equipment are the primary nearer term issues highlighted by the risk boxes. The actual end date and remaining life will become clearer through the series of ongoing routine inspections that forms part of the plant's PM program and the Level 2 inspections recommended in the report. The intake and outfall structures and associated sub-components should be added as a result of a Level 2 inspection.

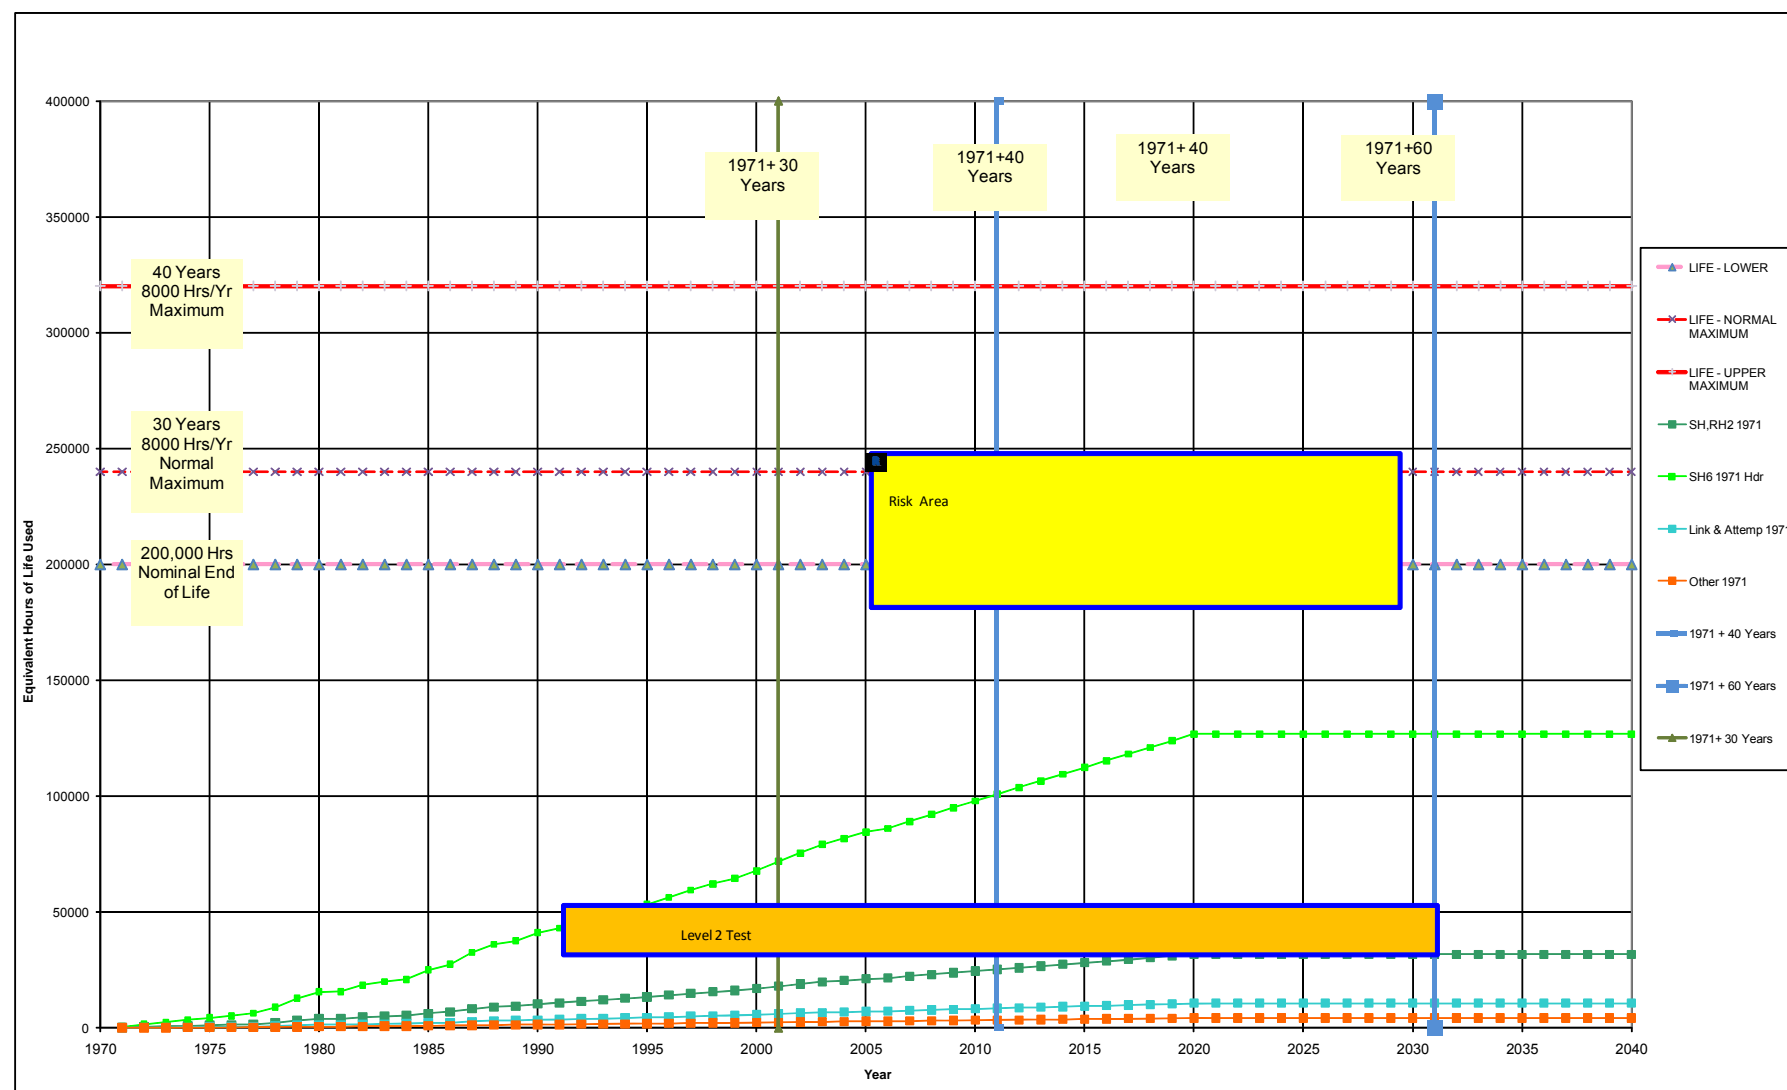
FIGURE 9-10 LIFE CYCLE CURVE – UNIT 2 BOILER SYSTEM – BOILER HEADERS

The header life curves indicate that the remaining life (RL) of the Unit 2 boiler headers and associated components is expected to exceed the desired life (DL) which is the generation end of life in 2020. Nevertheless, it also identifies that some of higher temperature components should undergo a Level 2 inspection (identified later in this section of the report) if not already planned or undertaken.

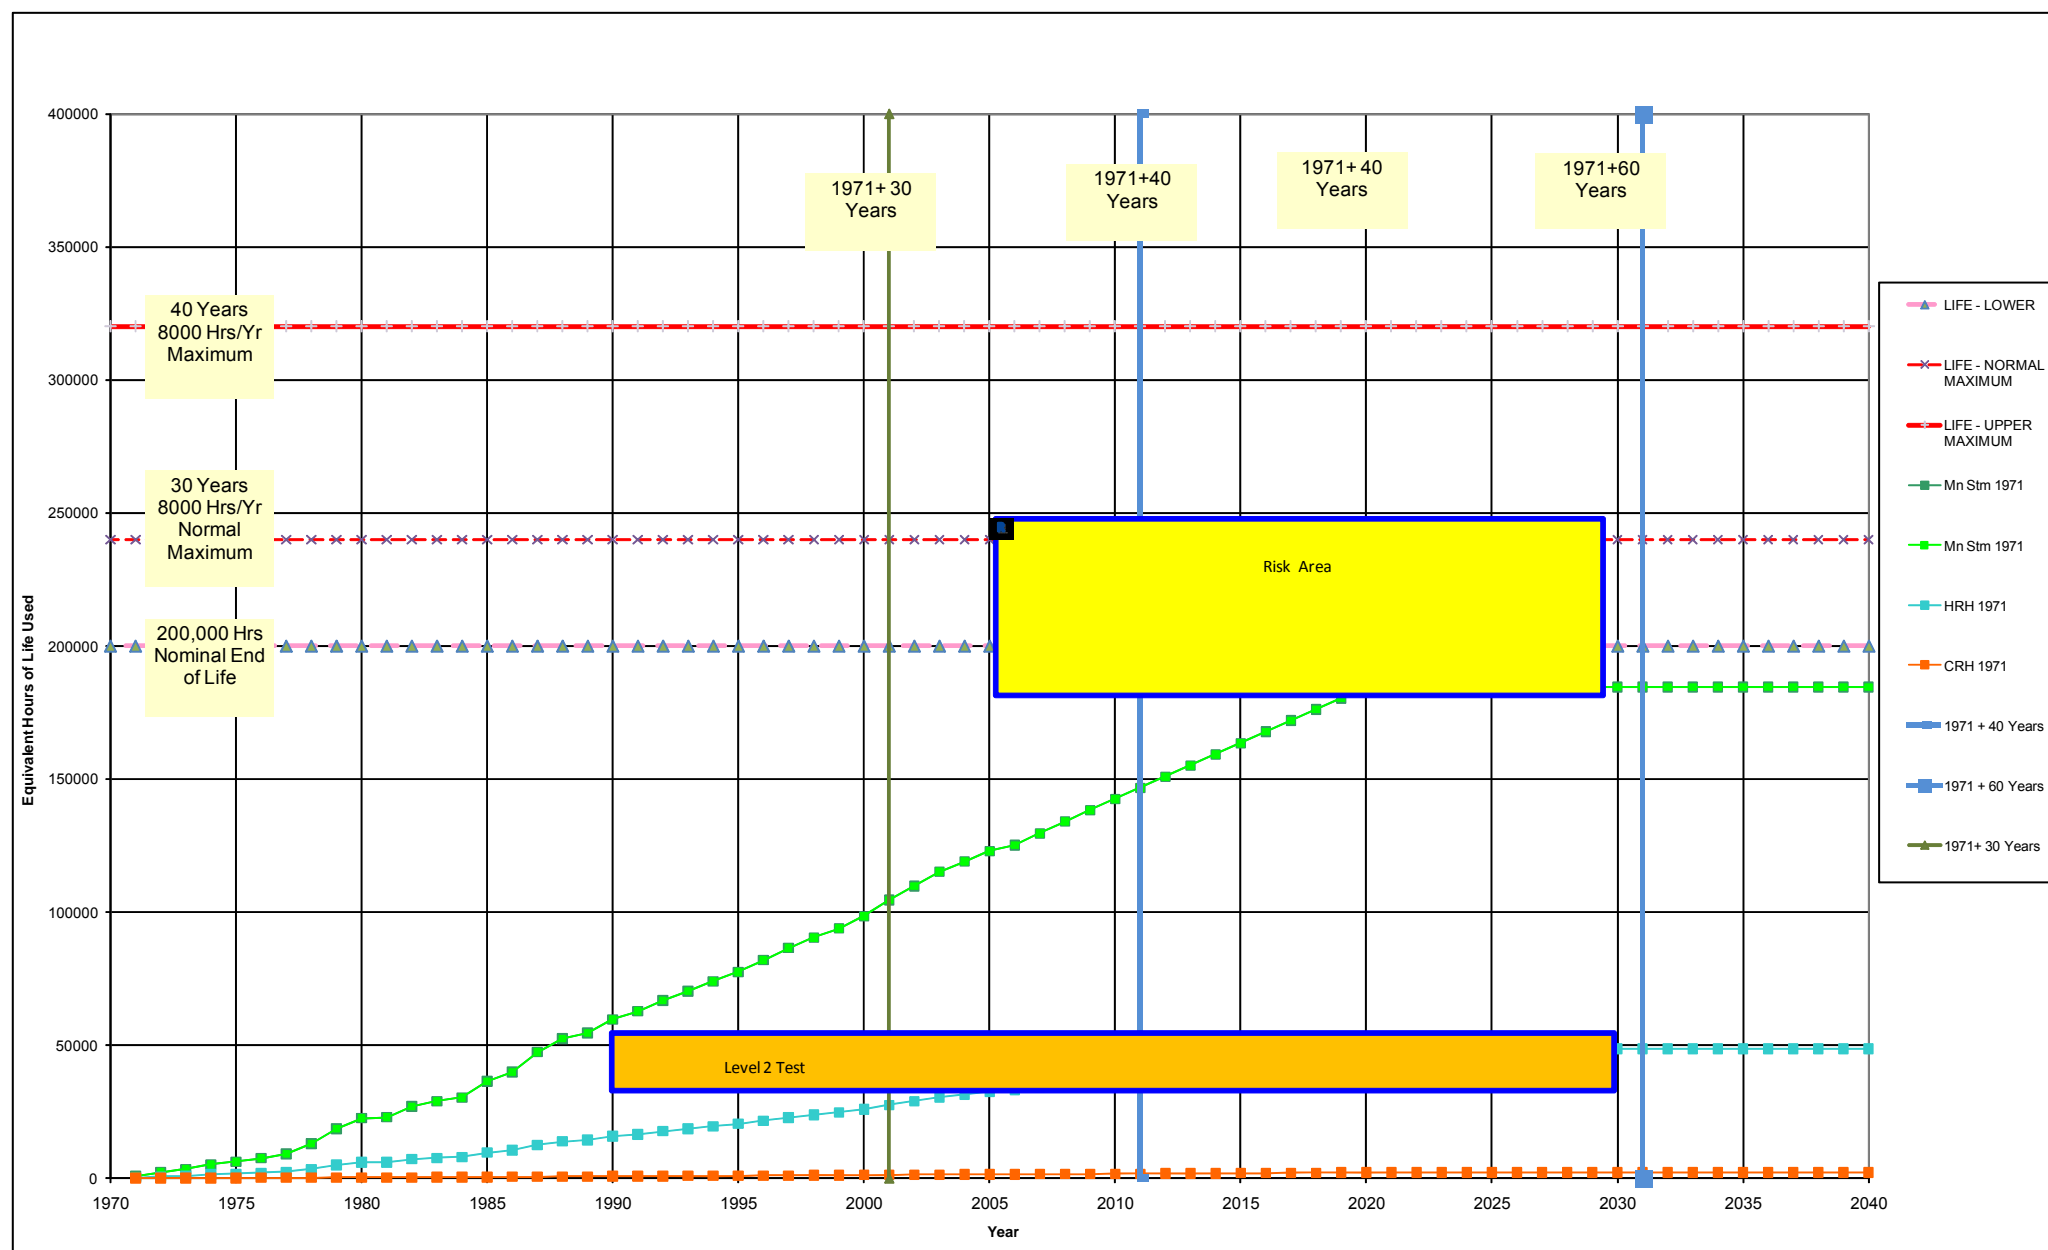
FIGURE 9-11 LIFE CYCLE CURVE – UNIT 2 BOILER SYSTEM – HIGH PRESSURE AND TEMPERATURE STEAM LINES

The high pressure steam line life curves indicate that the remaining life (RL) of the Unit 2 steam lines and their associated components are expected to exceed the desired life (DL) which is the generation end of life in 2020. Nevertheless it also identifies that both the main steam and hot reheat steam lines exceed EPRI’s 10% consumed life guide for a Level 2 inspection of these systems. Given that they have not been tested for some time, this is considered appropriate at this time.

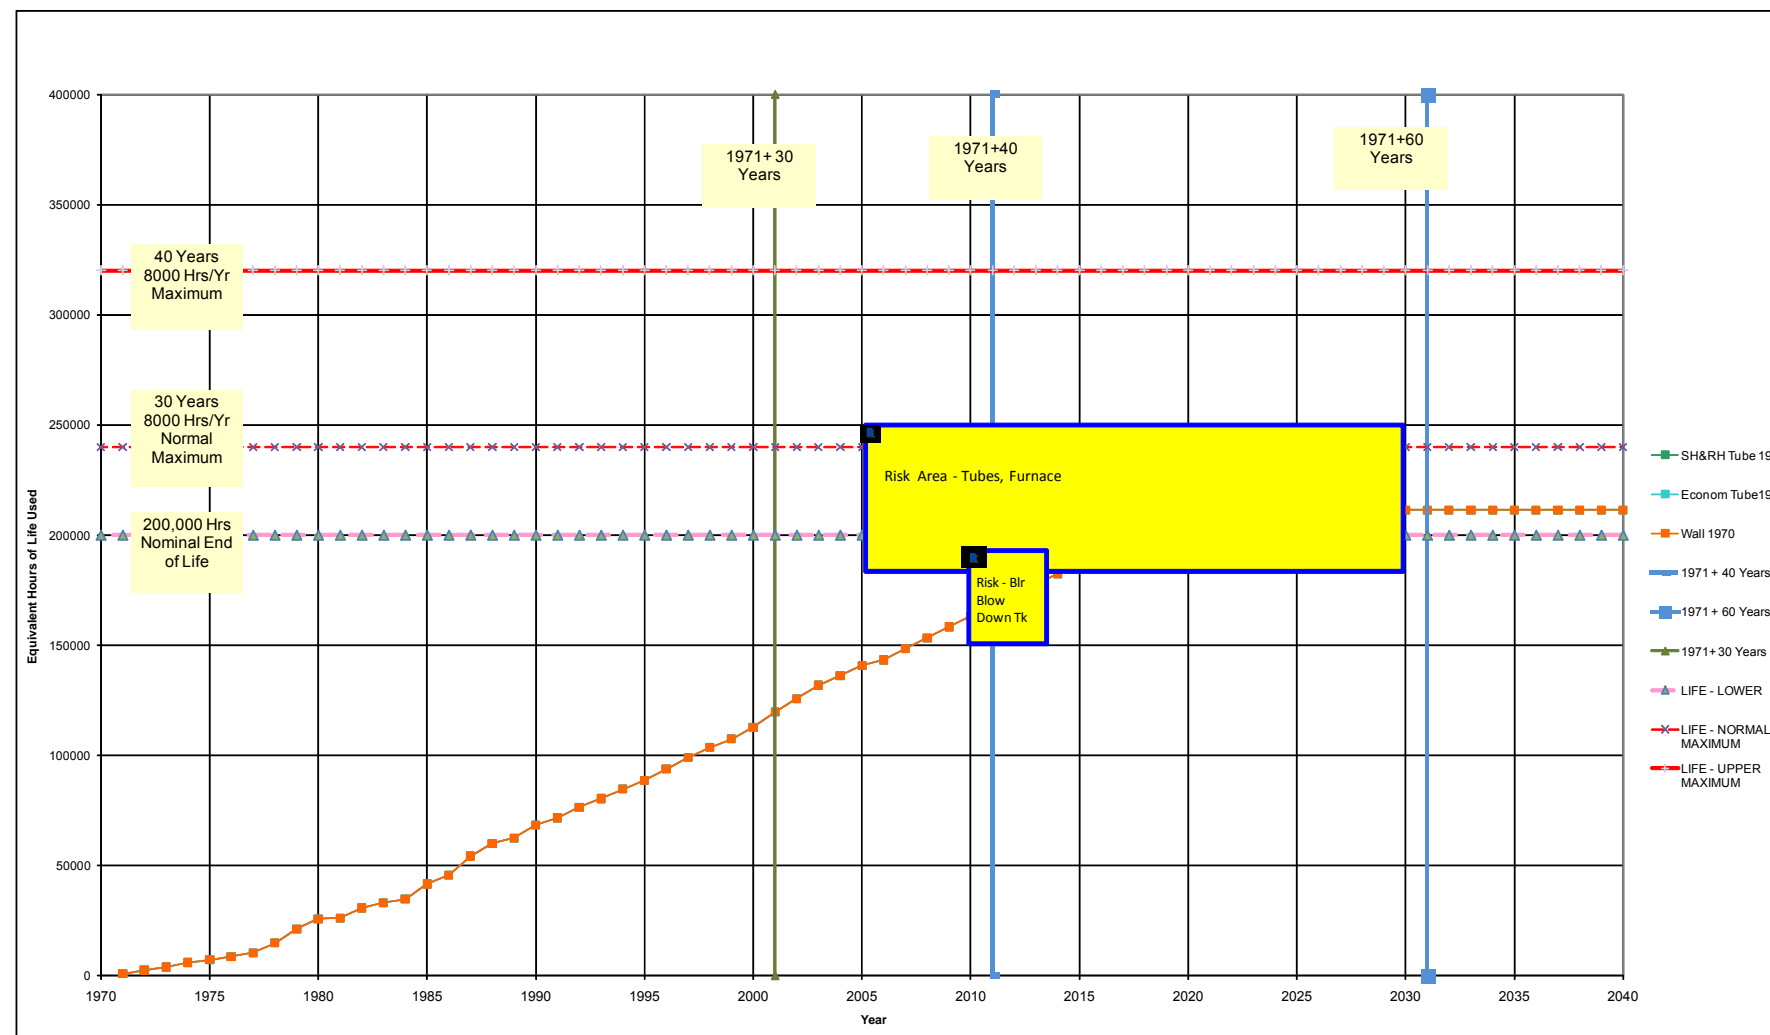
FIGURE 9-12 LIFE CYCLE CURVE – UNIT 2 BOILER SYSTEM (TUBES EXPOSED TO THE COMBUSTION PROCESS, BOILER BLOWDOWN)

The curve indicates that the boiler tubes within the furnace envelope would have been expected to be seeing some end of life component concerns with original equipment. Nevertheless, it is more likely legacy impacts that will have greater effects on component replacements and refurbishments going forward to 2020. With ongoing inspections and refurbishments, 2020 is achievable with good reliability with the new fuel. It also shows that the boiler blowdown tank should be replaced.
