Holyrood Thermal Generating Station (Holyrood) Condition Assessment & Life Extension Study, - Final Report

**Holyrood Thermal
 Generating Station
 Condition Assessment &
 Life Extension Study**

January 28, 2011

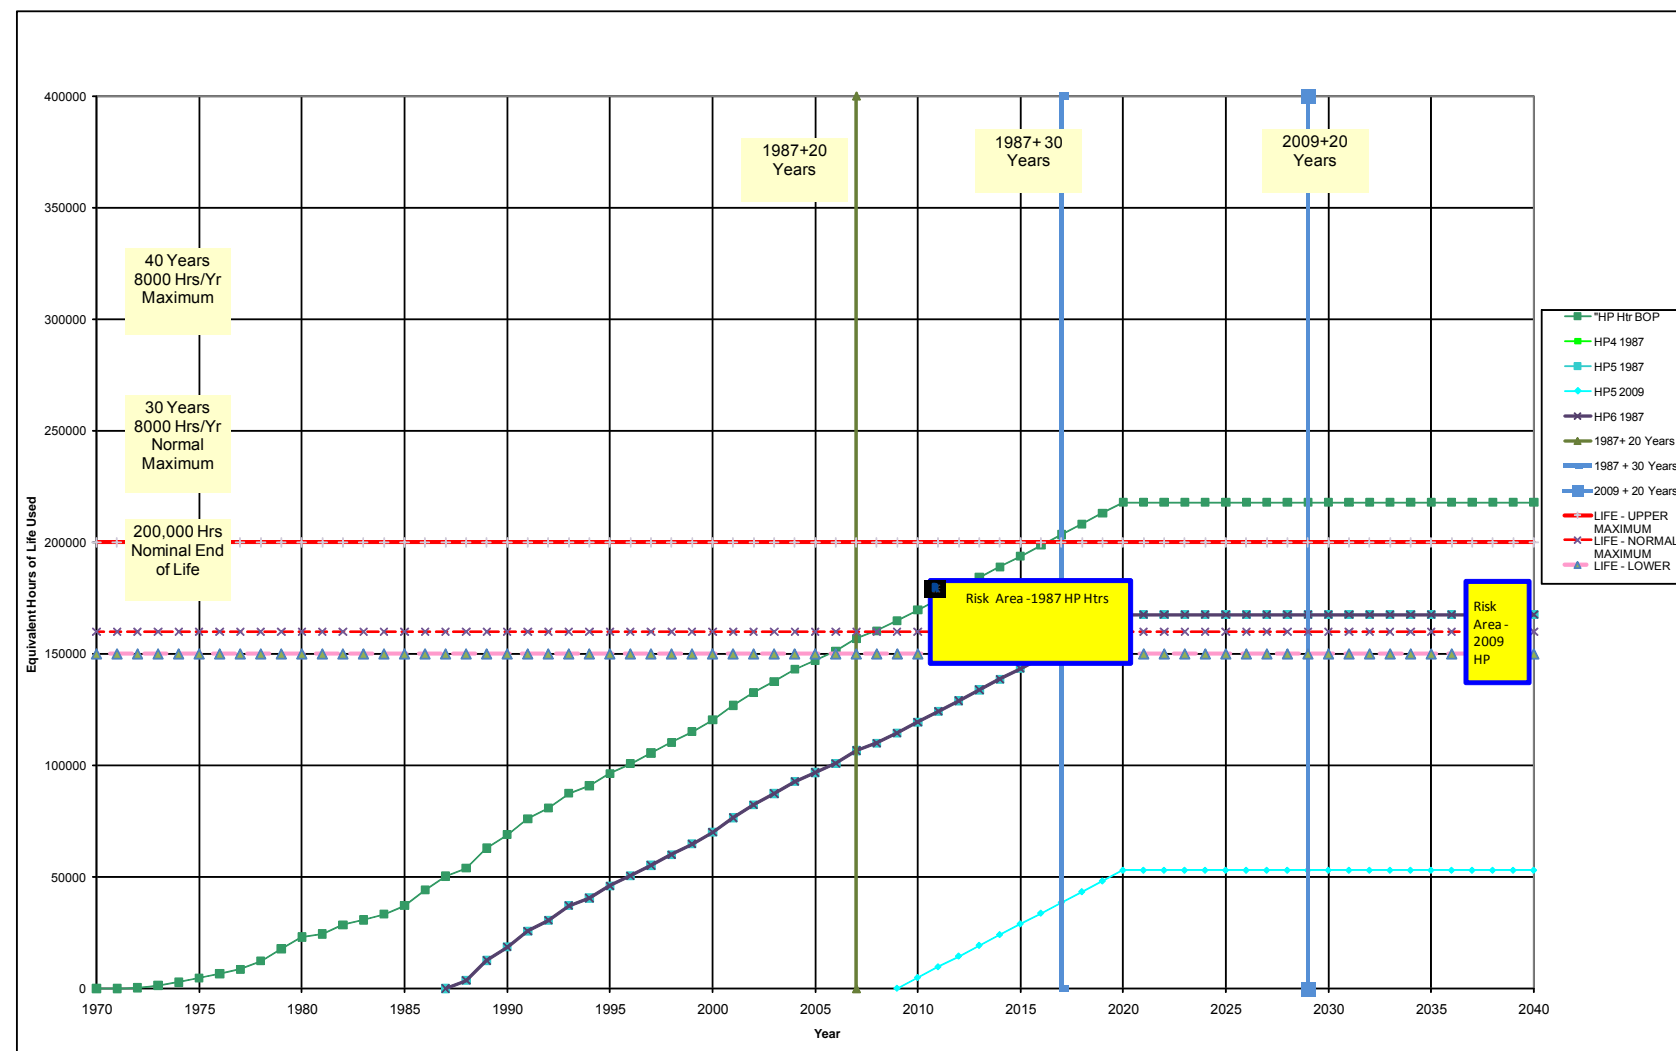
FIGURE 9-13 LIFE CYCLE CURVE – UNIT 2 FEEDWATER SYSTEM - HP FEEDWATER HEAT EXCHANGERS -

The curves indicate that the remaining life (RL) of the Unit 2 HP feedwater heat exchangers (and the associated feedwater systems) may be able to reach the desired life (DL) 2020 end date for generation. Nevertheless, given that no detailed NDE information has been obtained on the HP heat exchangers for some time, a detailed Level 2 inspection is recommended for 2013.

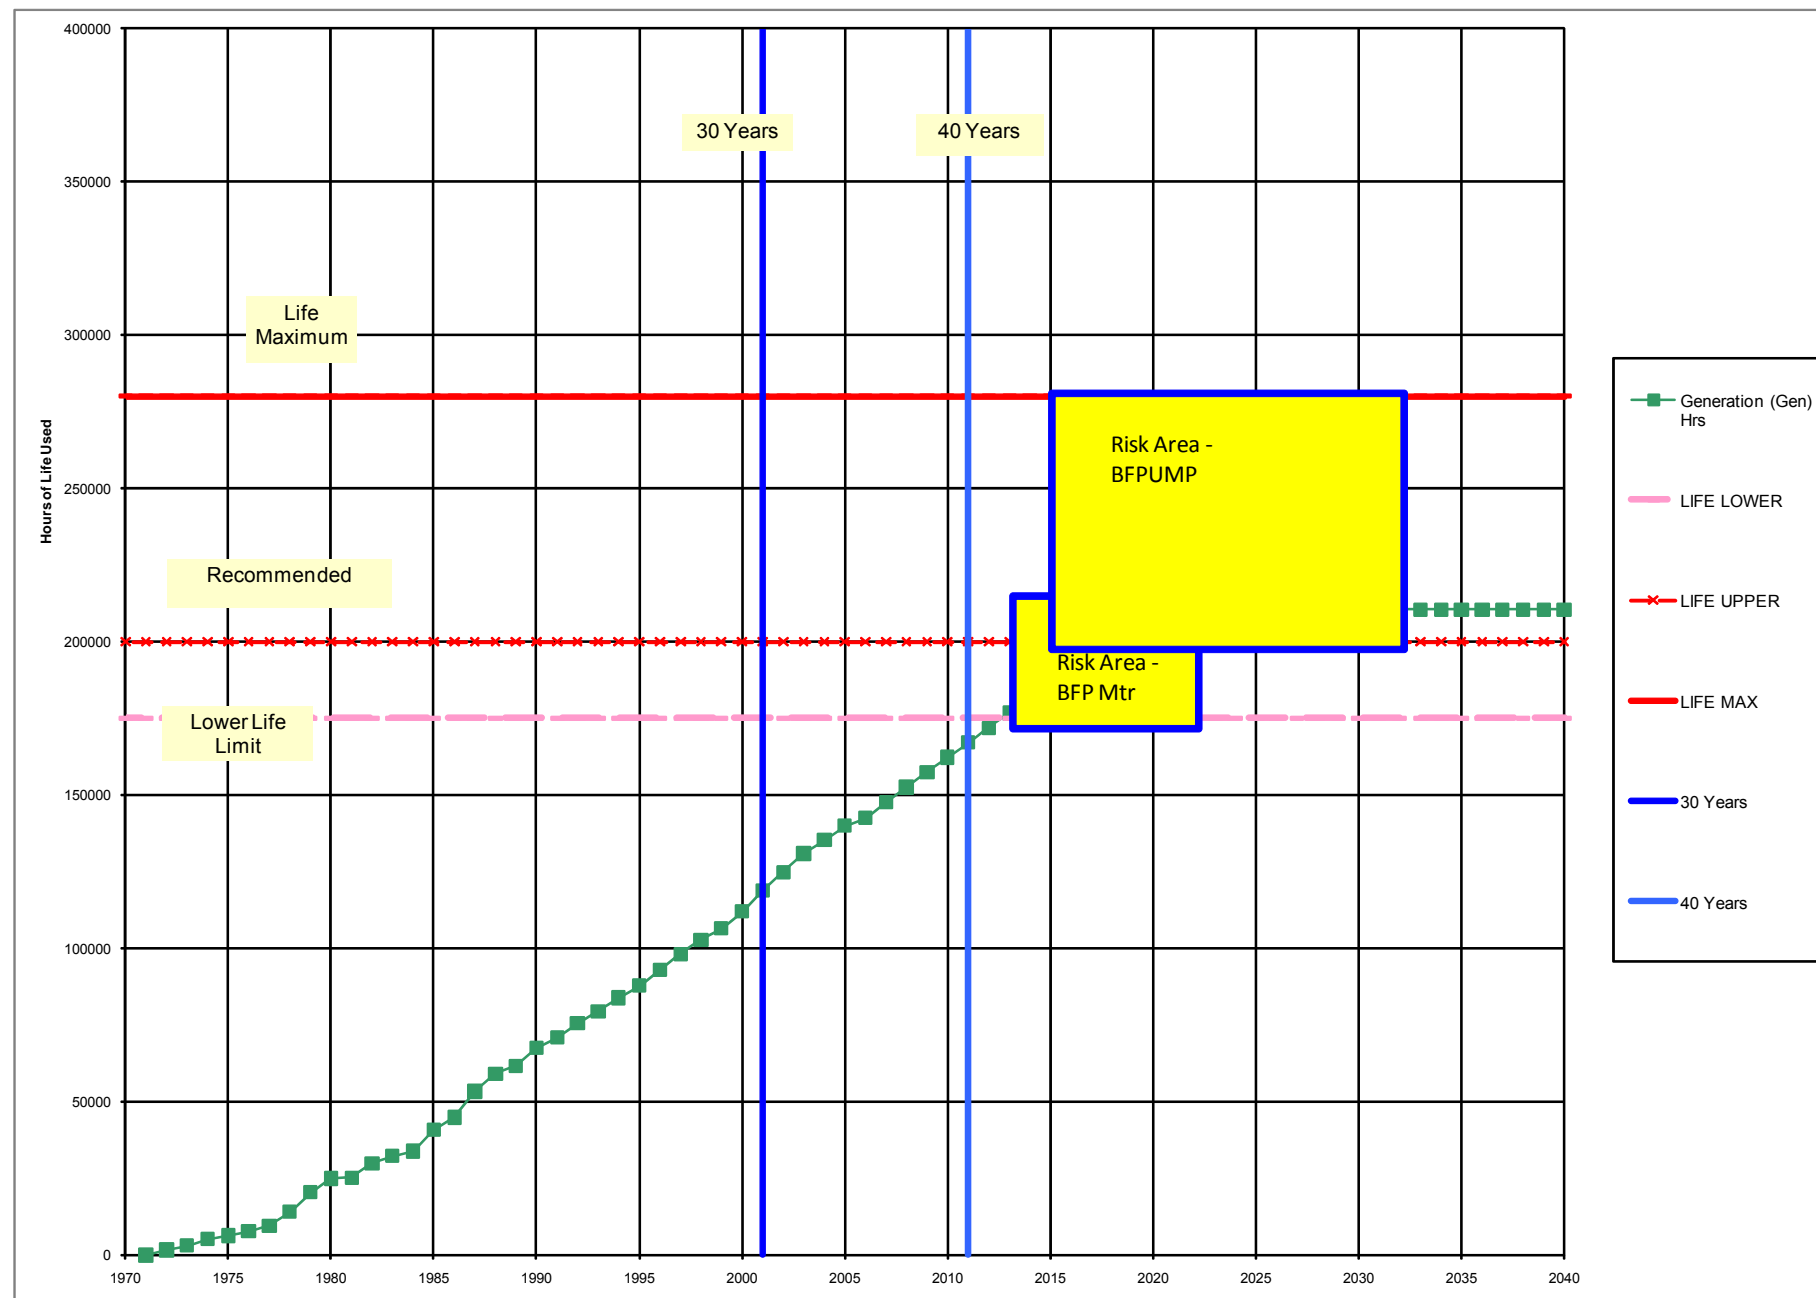
FIGURE 9-14 LIFE CYCLE CURVE – UNIT 2 FEEDWATER SYSTEM - BOILER FEED PUMPS

For the Unit 2 boiler feed pumps, a single curve represents each of the two boiler feed pumps dating back to their original installation. While indicative of expected life with good maintenance practice, the pumps have been and continue to be refurbished on a six year cycle using a spare pump section. Their actual condition is therefore substantially better than might otherwise be expected.

The curve indicates that the remaining life (RL) of the Unit 2 HP boiler feed pumps is likely able to reach desired end date which is the 2020 end date for generation. Given their six year refurbishment cycle and a spare pump section, they are expected to continue to perform reliably well past the 2020 end date for generation. The BFP motors are approaching older age and entering areas where reliability and unexpected failure may become more an issue than expected life.

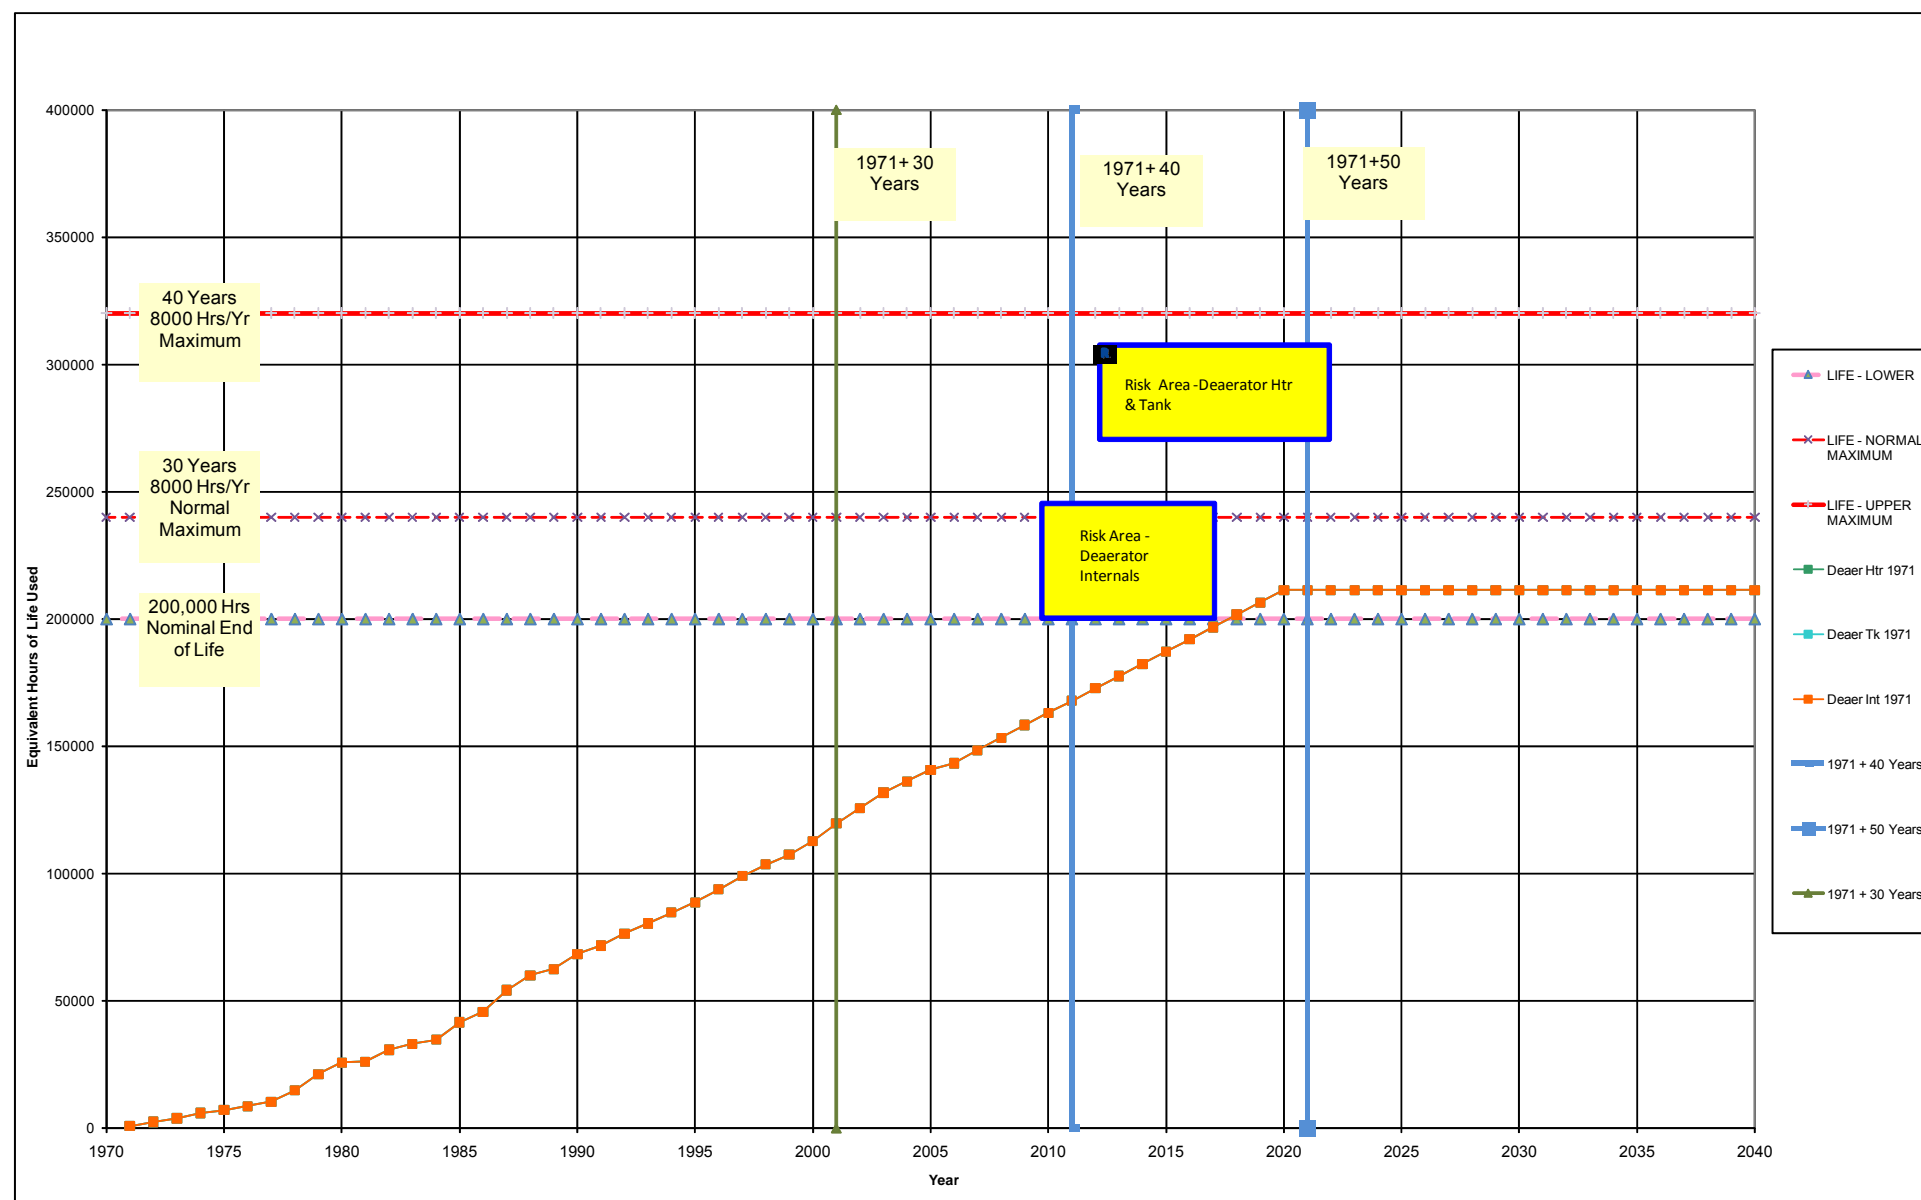
FIGURE 9-15 LIFE CYCLE CURVE – UNIT 2 FEEDWATER SYSTEM - DEAERATOR

The curve indicates that the remaining life (RL) of the Unit 2 feedwater system - deaerator exceeds the desired life (DL) which is end date for generation of 2020, with the potential though unlikely exception of some deaerator internals. The plant inspections form an excellent base of condition information supporting the ability of the deaerator as a whole to meet the EOL date. There is however insufficient detailed inspection information of some of the difficult to reach internals to fully assess their condition. A detailed Level 2 inspection in 2013 is recommended to provide information for that assessment.

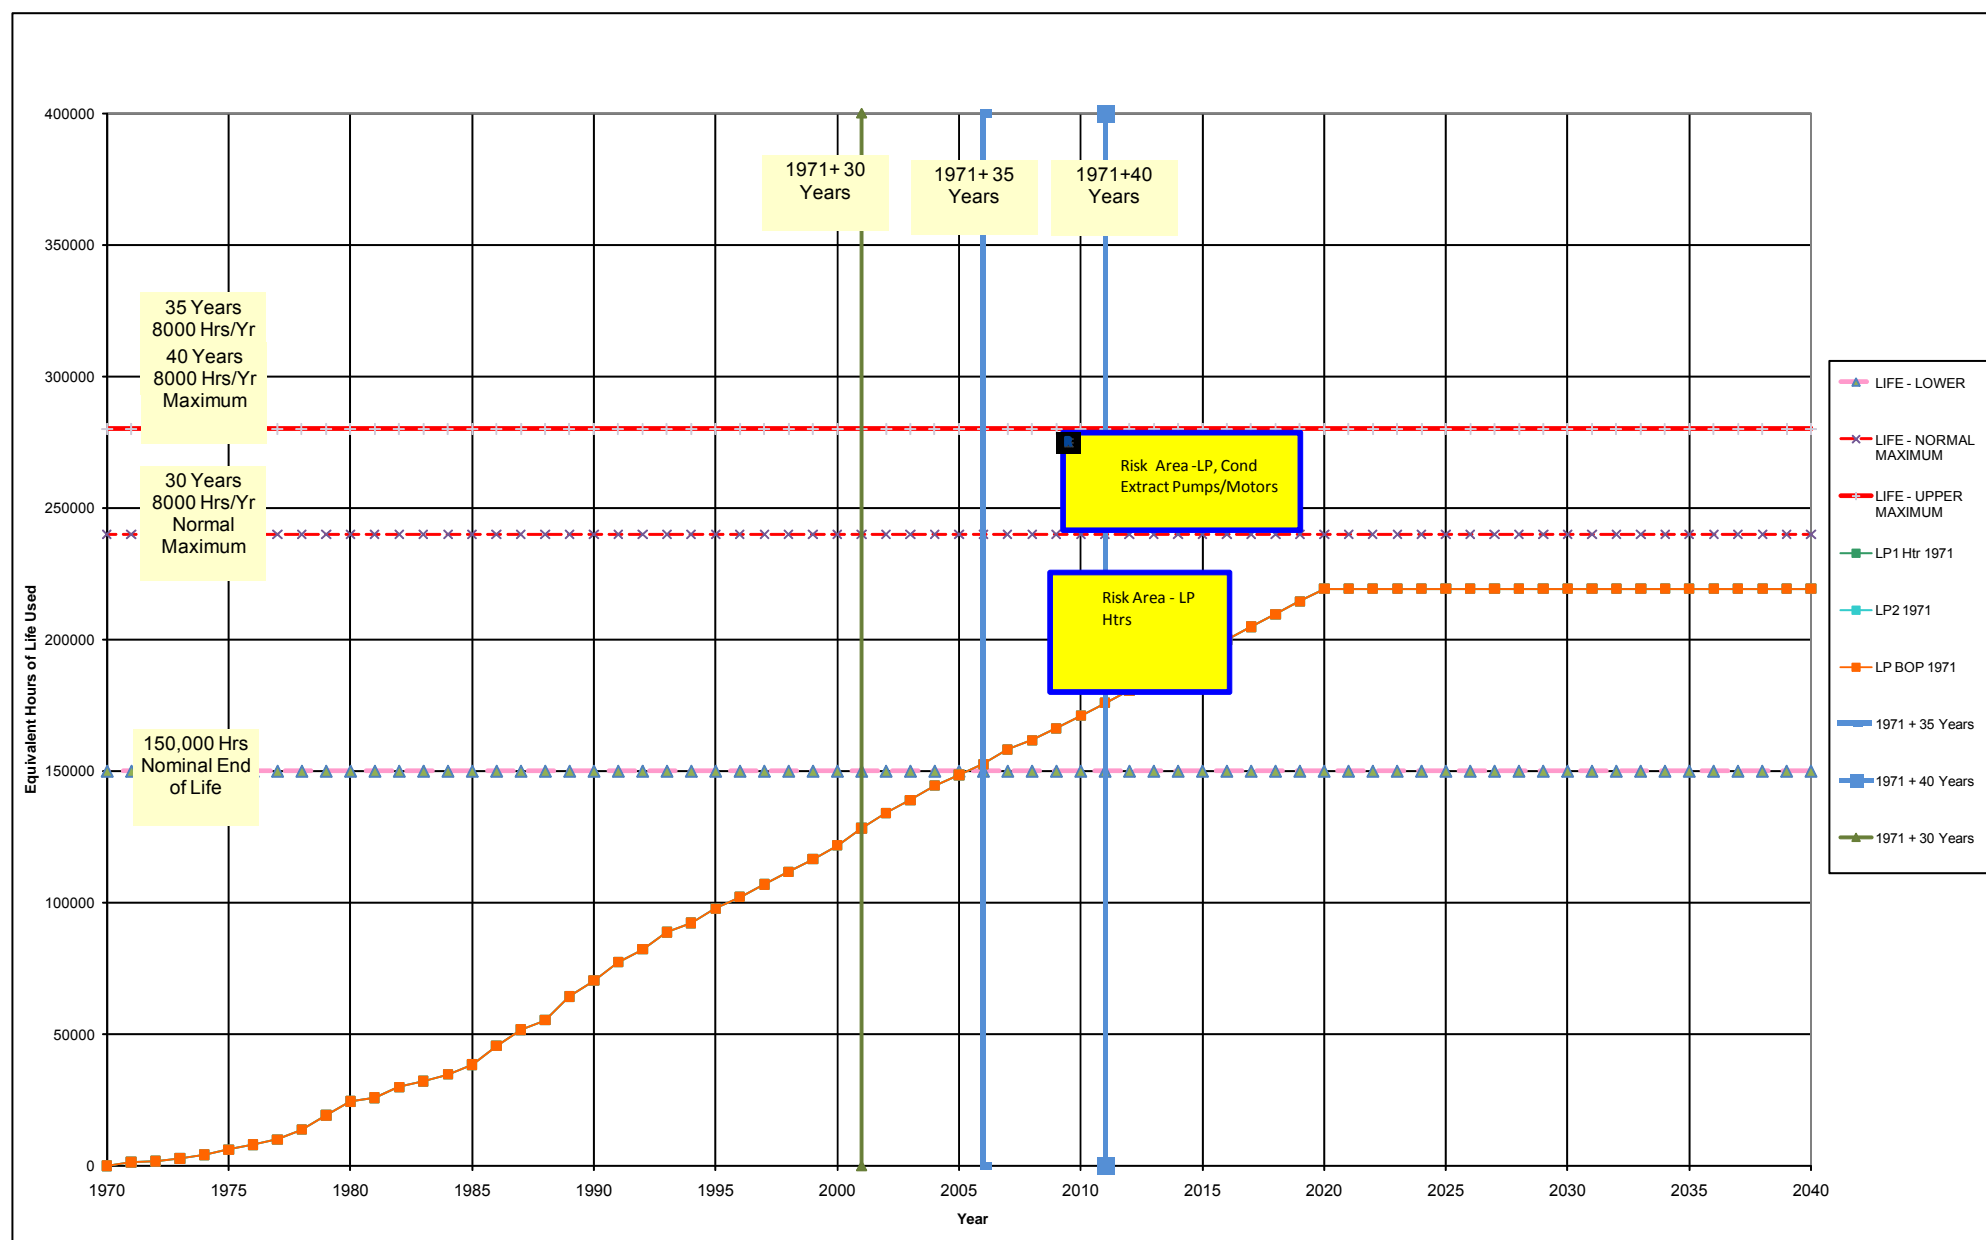
FIGURE 9-16 LIFE CYCLE CURVE – UNIT 2 FEEDWATER SYSTEM - LP FEEDWATER HEAT EXCHANGERS

The curve indicates that the remaining life (RL) of the Unit 2 feedwater system - LP heat exchangers may not be able to reach the desired life (DL) 2020 end date for generation. Given that no detailed NDE information has been obtained on the LP heat exchangers, a detailed Level 2 inspection is recommended for 2011.

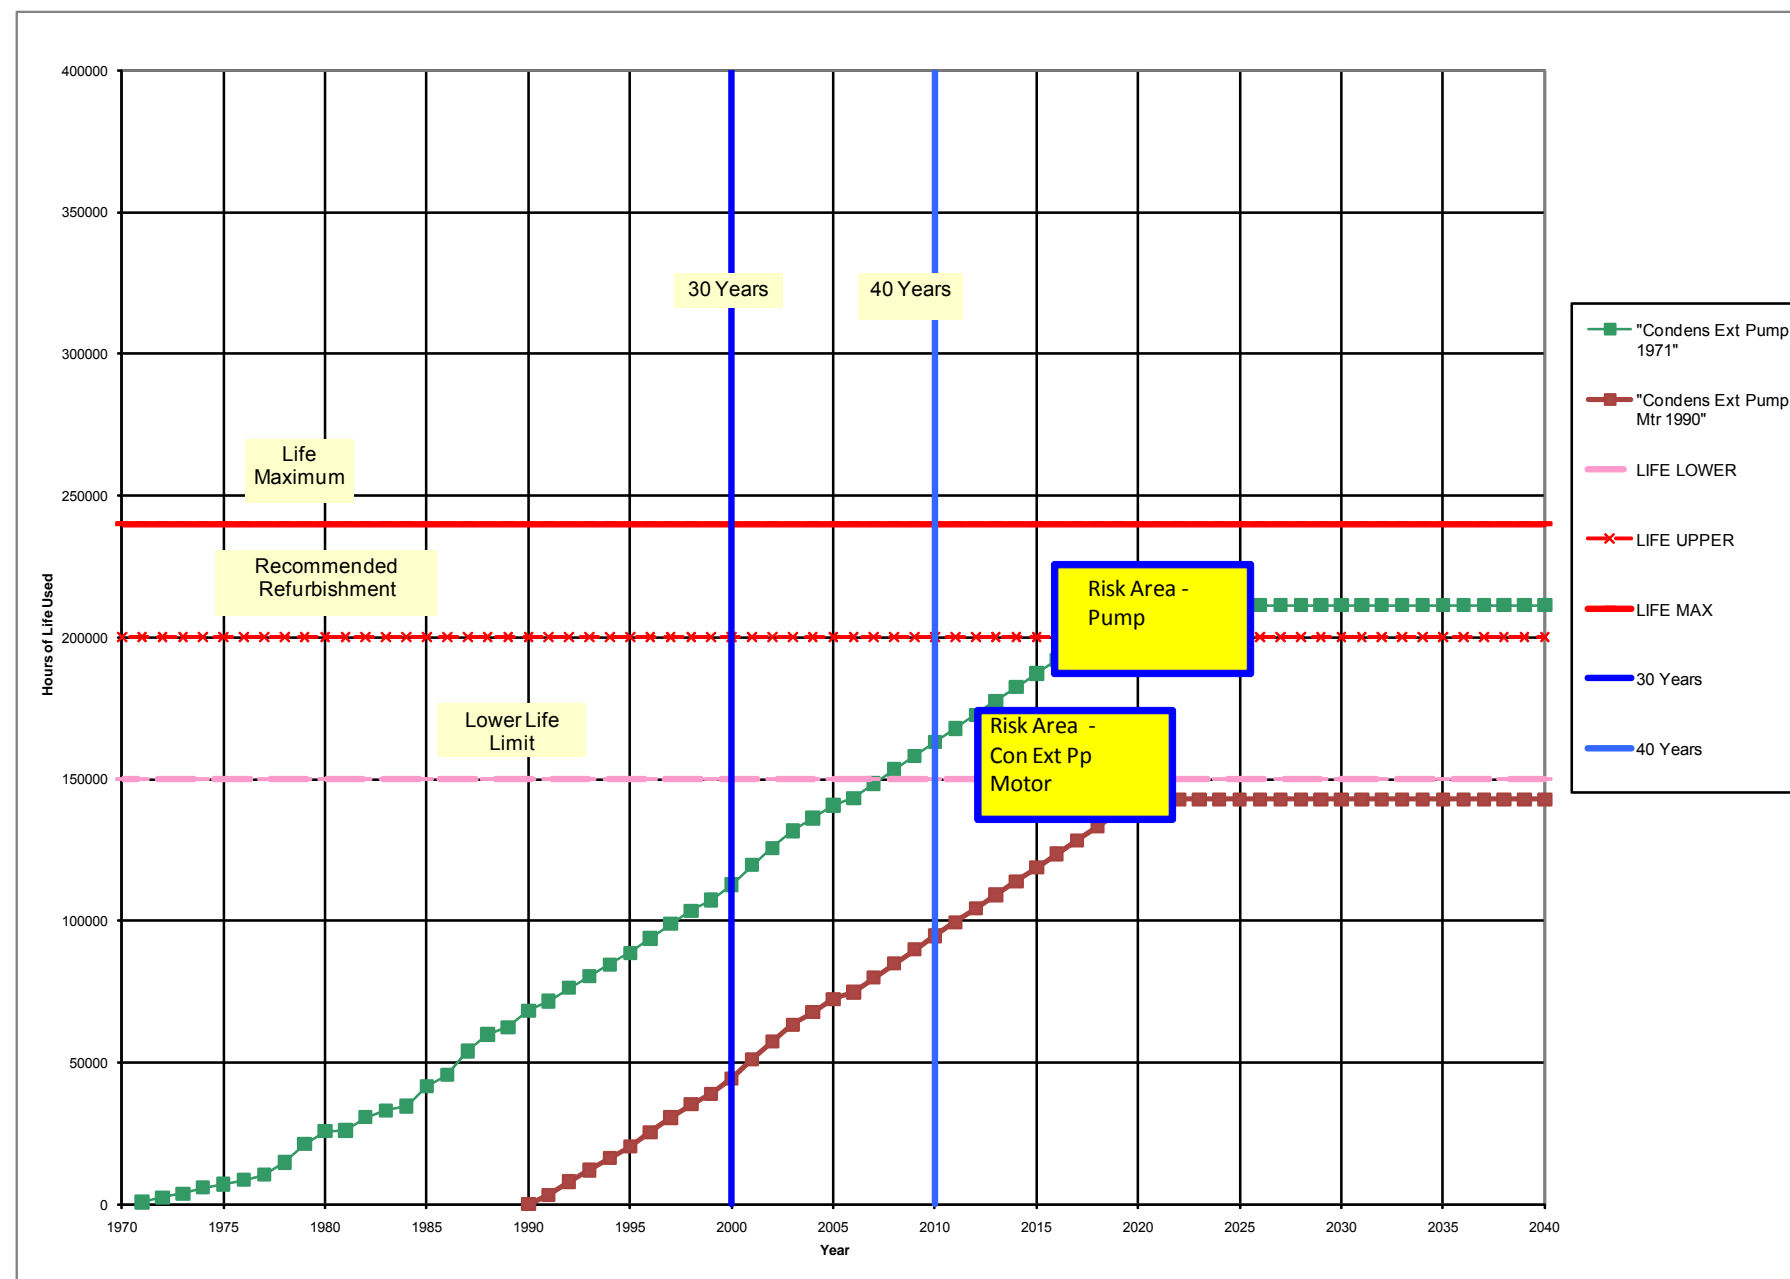
FIGURE 9-17 LIFE CYCLE CURVE – UNIT 2 CONDENSATE EXTRACTION SYSTEM

The curves indicate that the remaining life (RL) of the condenser condensate extraction pumps and motors can likely be able to reach the desired life (DL) 2020 end date for generation. The condensate extraction pump motors are expected however to be entering a period of higher unreliability.

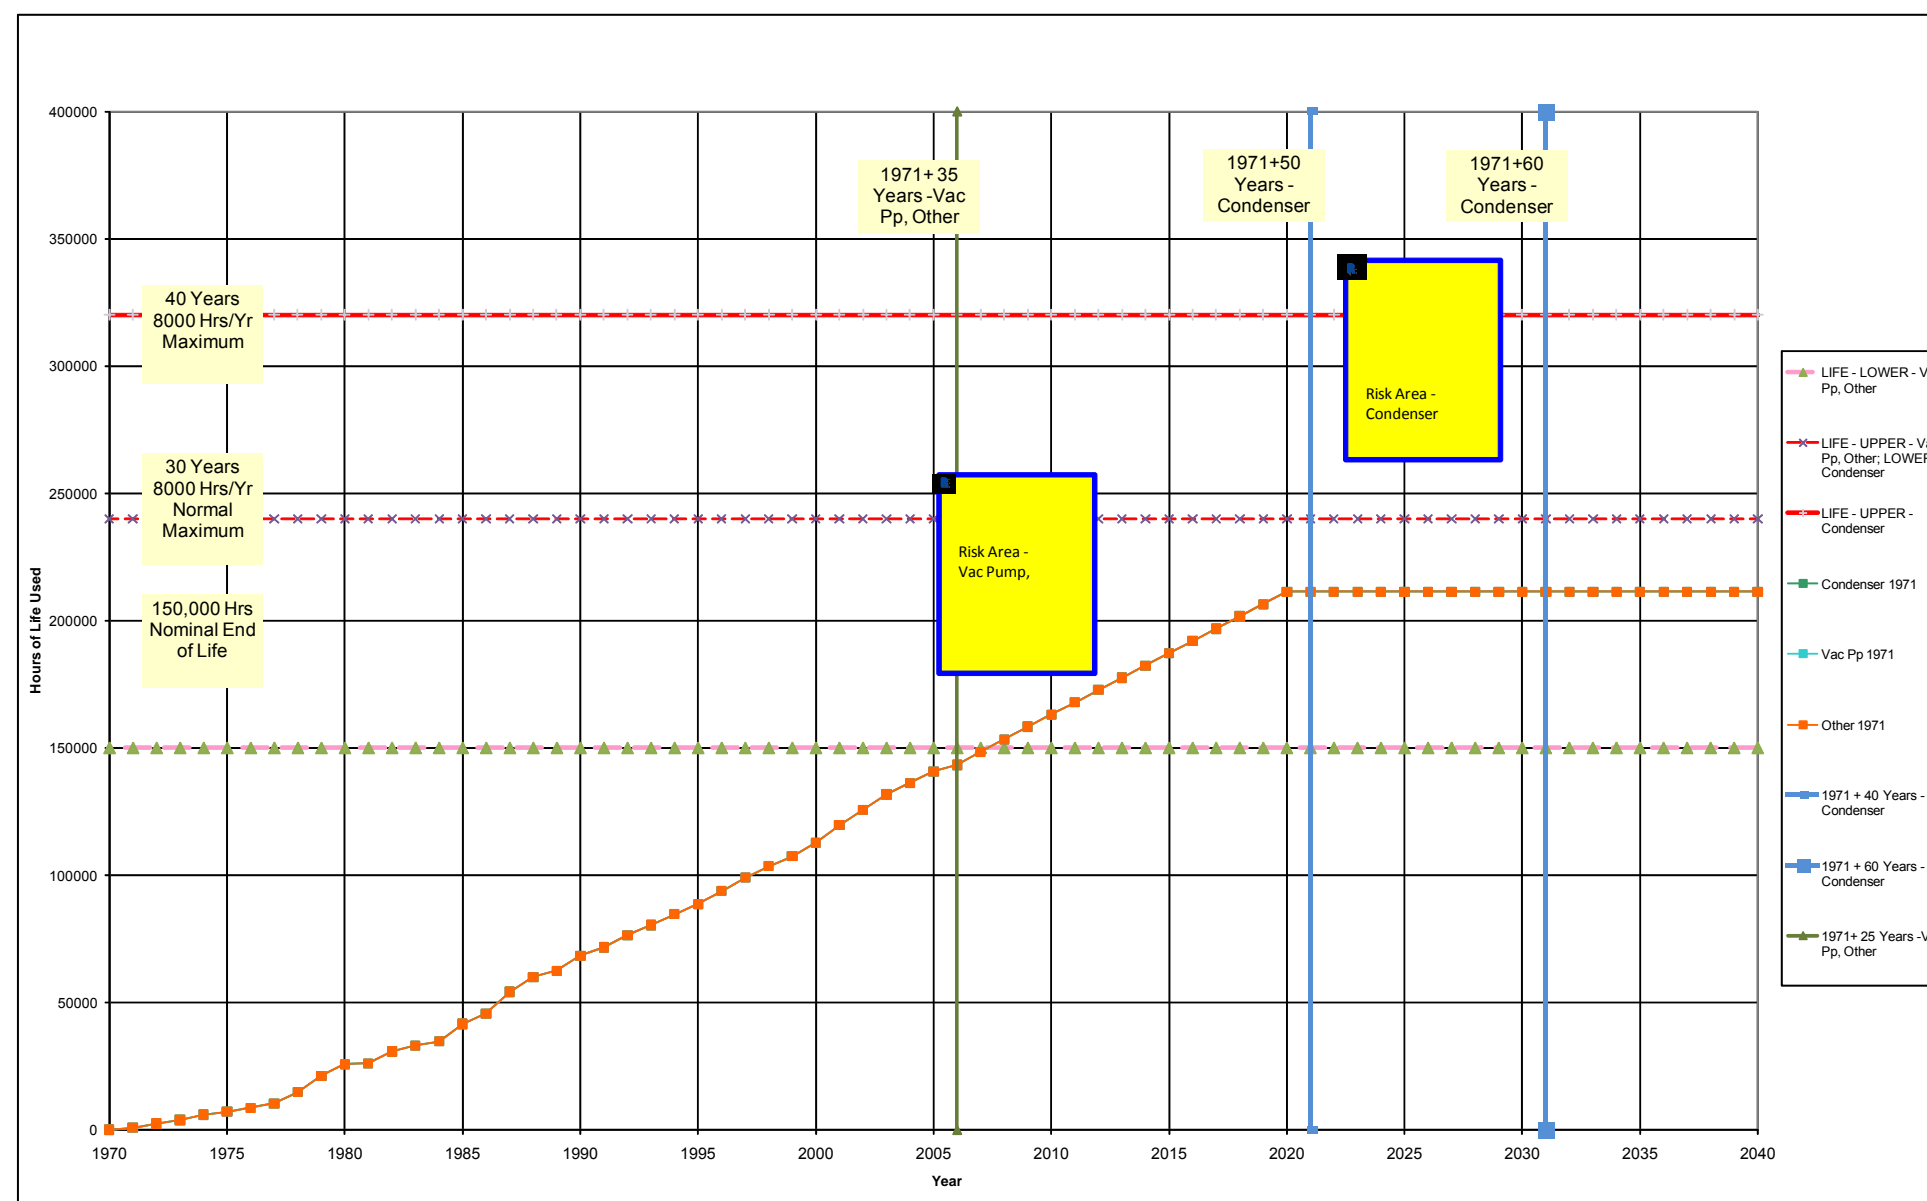
FIGURE 9-18 LIFE CYCLE CURVE – UNIT 2 CONDENSER

The curves indicate that the remaining life (RL) of the Unit 2 condenser can easily reach the desired life (DL) 2020 end date for generation. The exception to this, as illustrated by the risk boxes, is the vacuum pumps. These are original equipment, and likely at or near end of life.

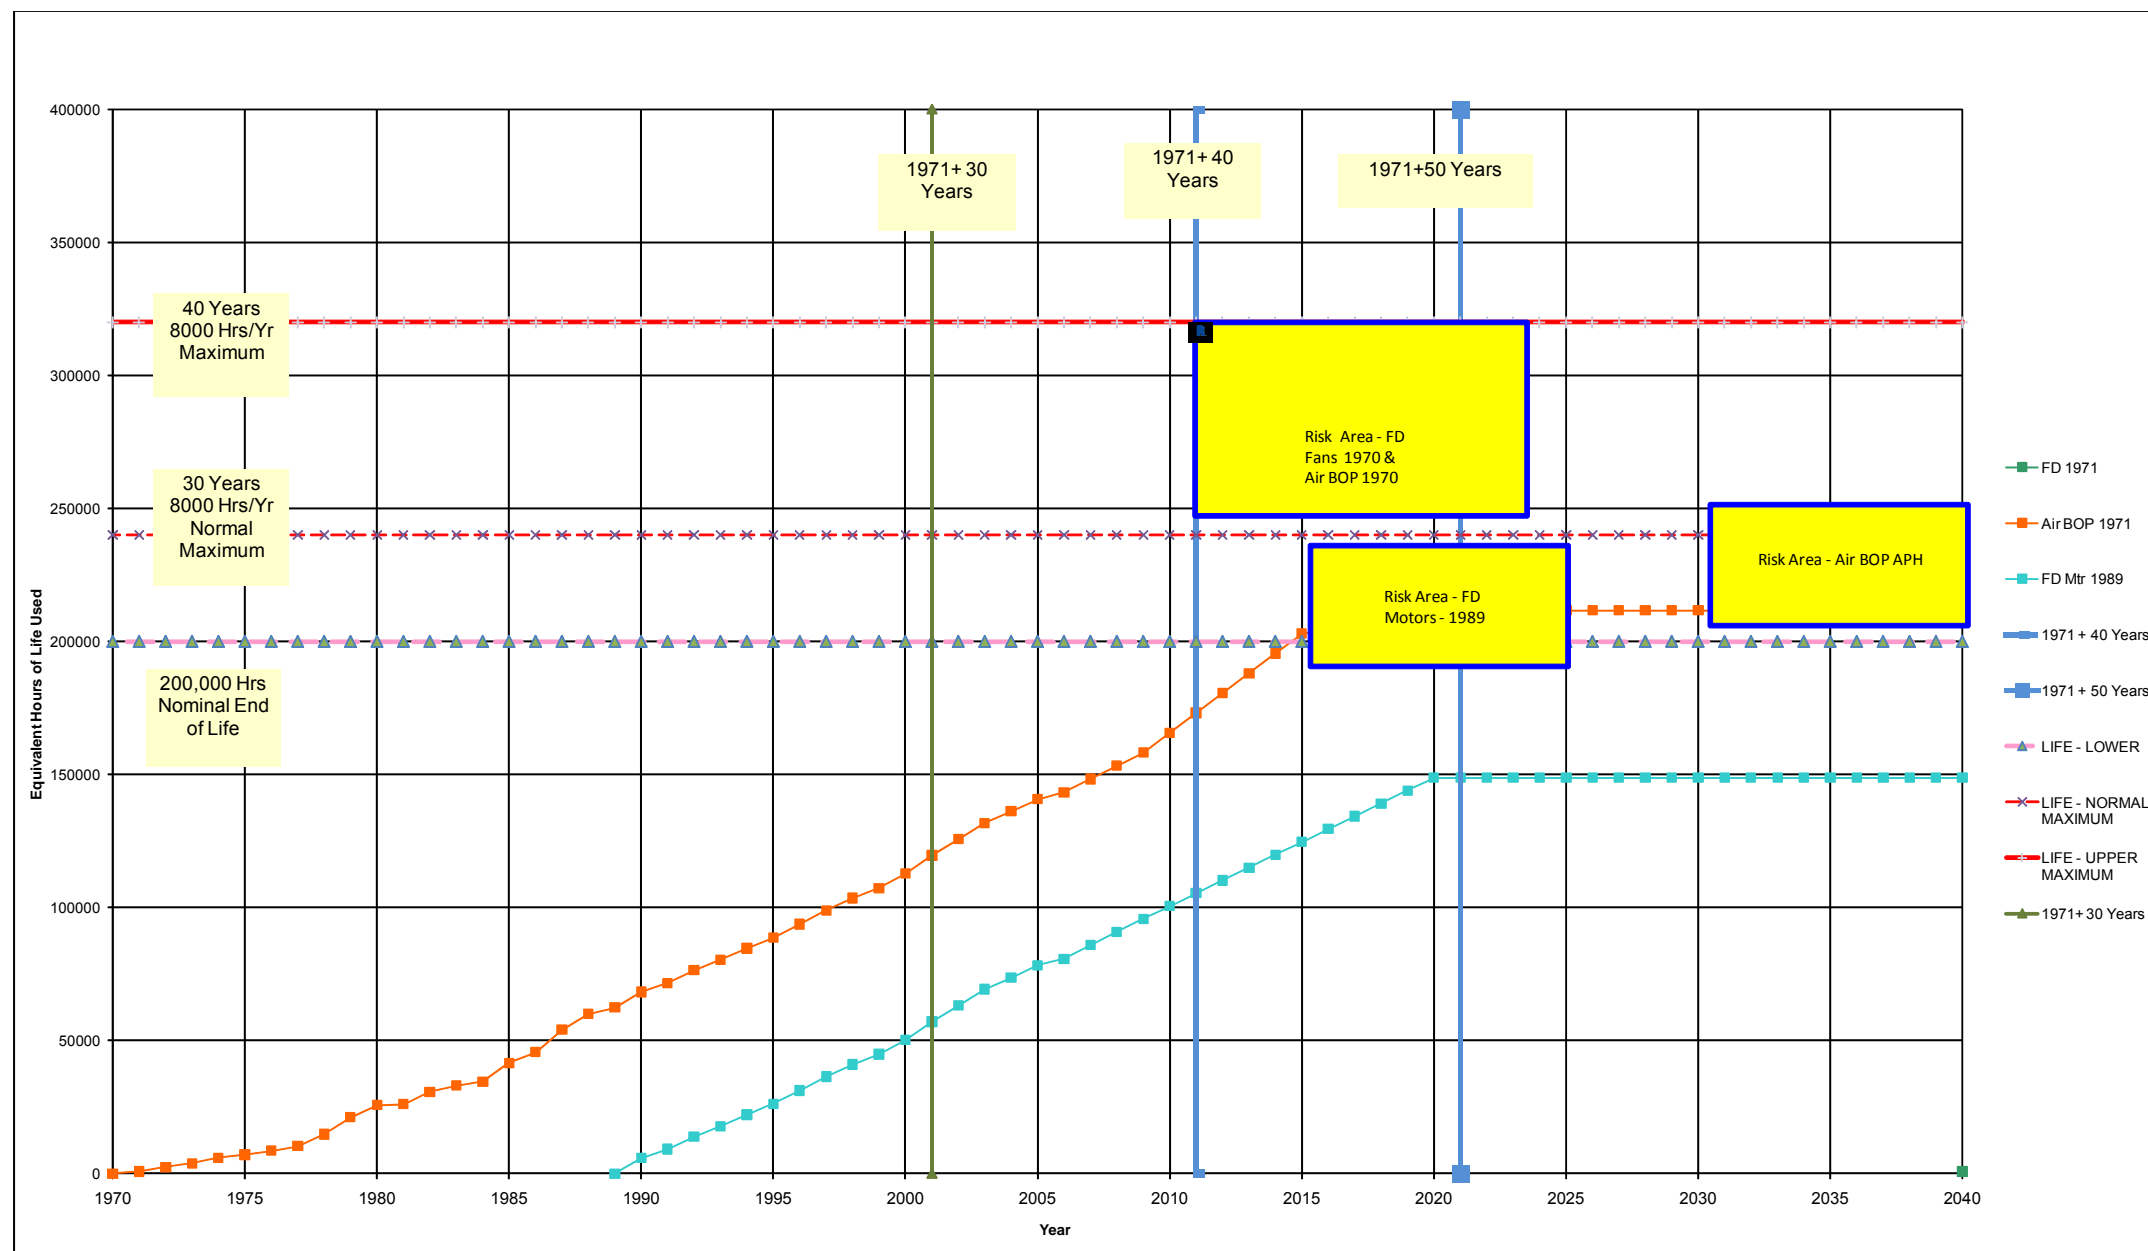
FIGURE 9-19 LIFE CYCLE CURVE – UNIT 2 FD FANS (AND SYSTEM)

The curves indicate that the remaining life (RL) of the Unit 2 FD fans (and system) is expected to meet or exceed the desired life (DL) 2020 end date for generation. The age of the large 4 kV motors makes them a logical cost-effective candidate for sparing to ensure reliability, although plant testing/monitoring programs are effectively monitoring their status.

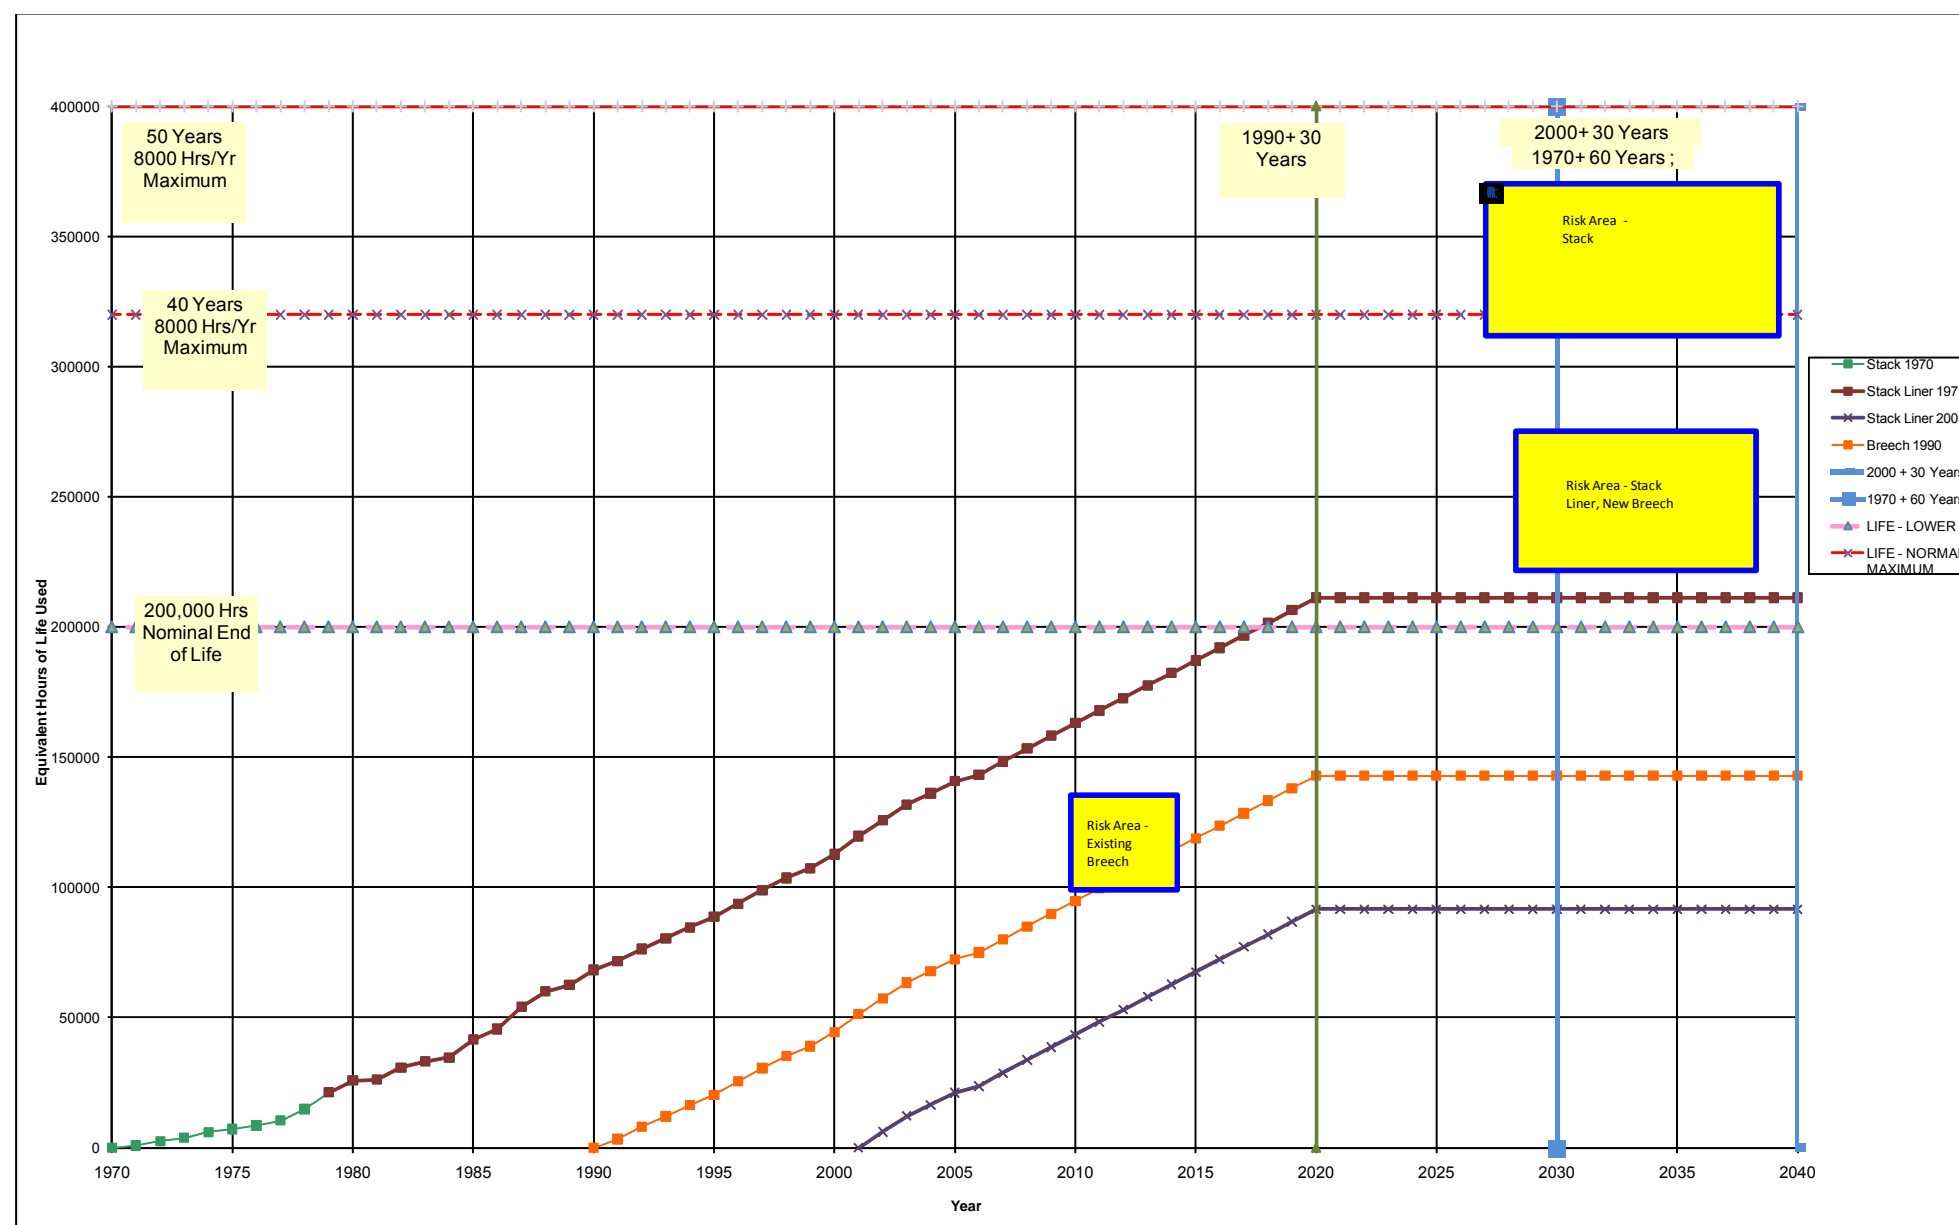
FIGURE 9-20 LIFE CYCLE CURVE – UNIT 2 STACK AND BREECHING

The curves indicate that the remaining life (RL) of the Unit 2 stack is able to reach the desired life (DL) 2020 end date for generation, as well as the end date of 2040 for synchronous condensing/plant life. It does show that the stack breaching is in need of immediate repair. The breaching requirement is not a normal life issue, but one of poor design. Other elements can achieve the 2020 end date for generation with the ongoing plant maintenance program.

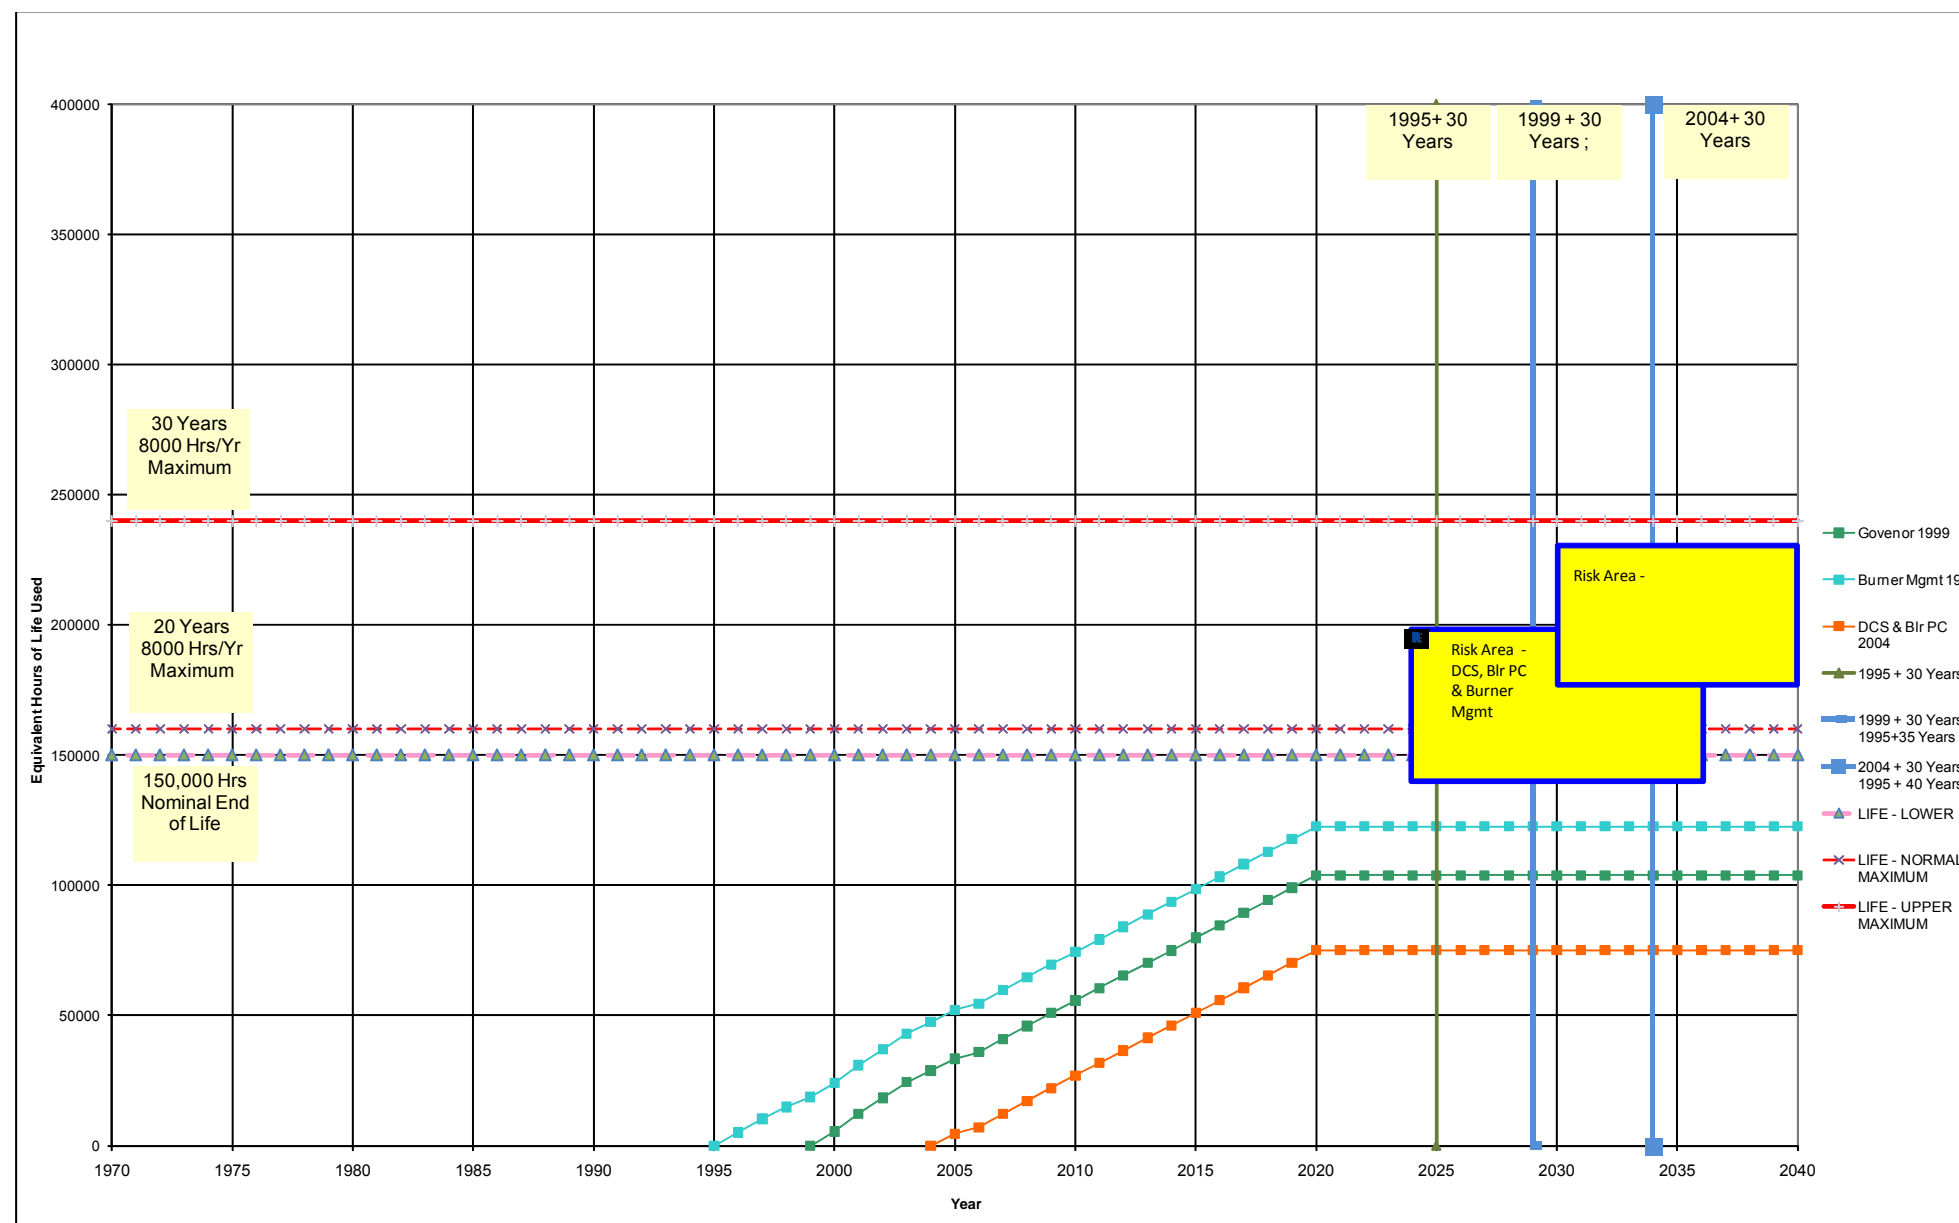
FIGURE 9-21 LIFE CYCLE CURVE – UNIT 2 ELECTRICAL AND CONTROL SYSTEMS (INCLUDING DCS) ASSOCIATED WITH STEAM SYSTEMS

The curves indicate that the remaining life (RL) of the Unit 2 control systems (including DCS) associated with steam systems can readily reach the desired life (DL) 2020 end date for generation, provided regular inspection and service per the station PM plan is maintained. The electrical systems, particularly breakers and motor controls are addressed in more detail as part of Section 9.1.3. It is clear that in order to meet the end date for generation service, some of these systems must be replaced or in some cases refurbished.
