Holyrood Thermal Generating Station (Holyrood) Condition Assessment & Life Extension Study, - Final Report

**Holyrood Thermal
 Generating Station
 Condition Assessment &
 Life Extension Study**

January 28, 2011

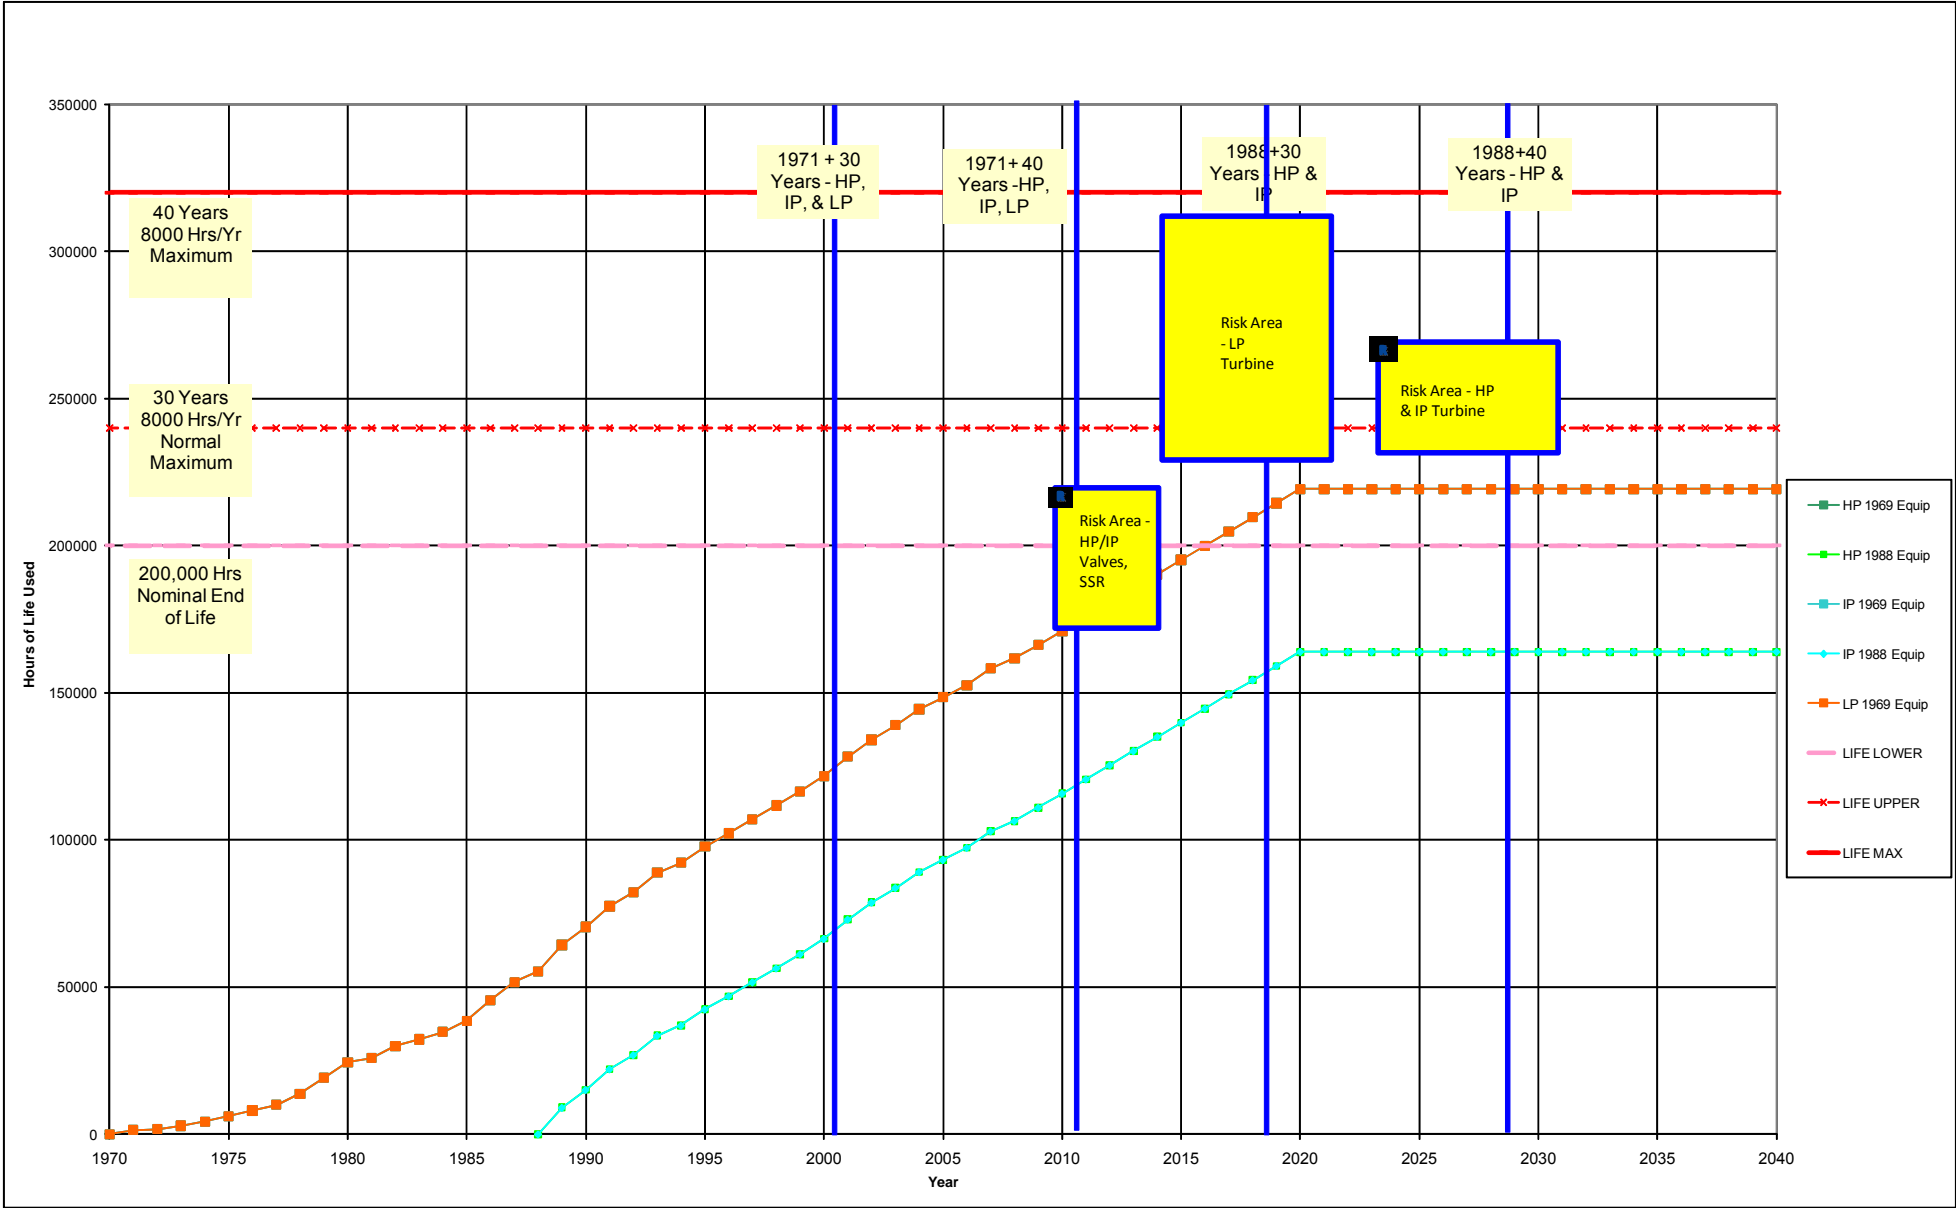
FIGURE 9-22 LIFE CYCLE CURVE – UNIT 2 STEAM TURBINE

The curves indicate that the remaining life (RL) of the various elements of the Unit 2 steam turbine exceeds the desired life (DL) which is the lesser of the time to its next major planned overhaul/inspection (2014) or to the desired End of Life (EOL) date of 2020. In fact, the 2020 end date should be readily achievable. Hence, no specific dedicated Level 2 is required, but sufficient inspection and testing will be required in the 2014 overhaul to confirm the ability to meet the 2020 EOL date. The exception to that are the HP and IP valves which continue to have reliability and life issues, the steam seal regulator, as well potentially as high temperature stud bolts. It is clear that the current inspection schedule seems suitable.

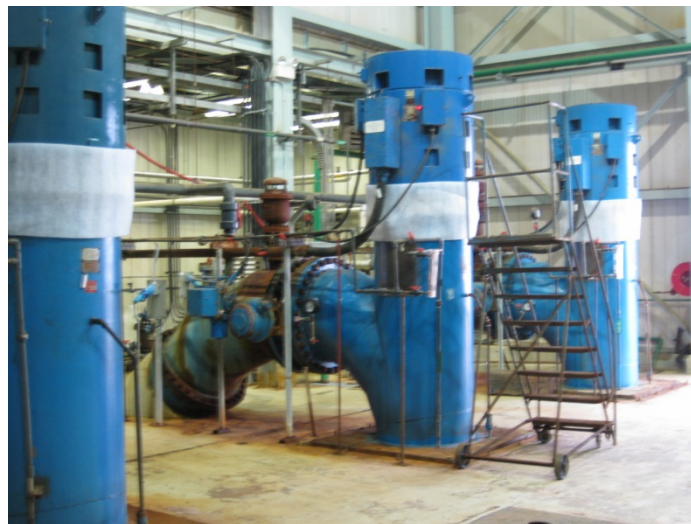
FIGURE 9-24 UNIT 1 & 2 CIRCULATING WATER PUMPS

CW Pumps: CW pumps on all units are performing fairly well. No reports were available on the condition of the pumps, but interviews suggest that regular maintenance has been kept up and the units should be able to meet 2015 and 2020 timelines with satisfactory maintenance. Major pump overhauls are scheduled on a twelve year cycle.

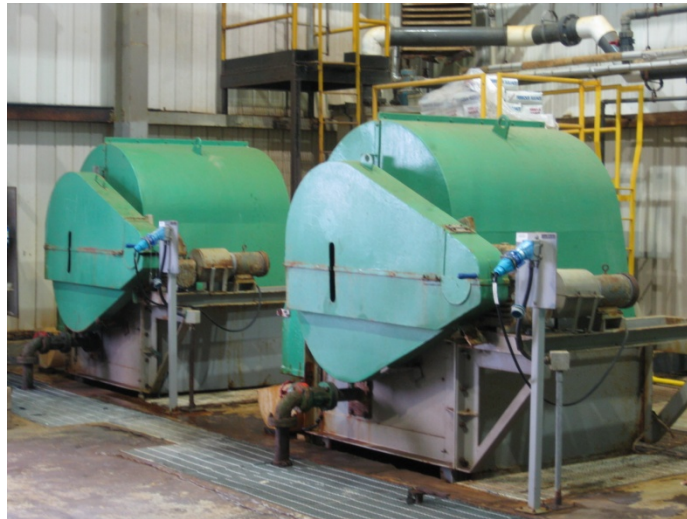
FIGURE 9-25 UNIT 1 & 2 CIRCULATING WATER TRAVELLING SCREENS

CW Travelling Screens: The travelling screen internals have been replaced on Unit 2 in the last 5 to 10 years. Interviews suggest that no recent issues have been experienced with these units. Visual examination confirmed that the Unit 2 screens generally appear to be in good condition.

The external casings are in differing states, with some parts more corroded than others. None appears to impair current or short term performance.

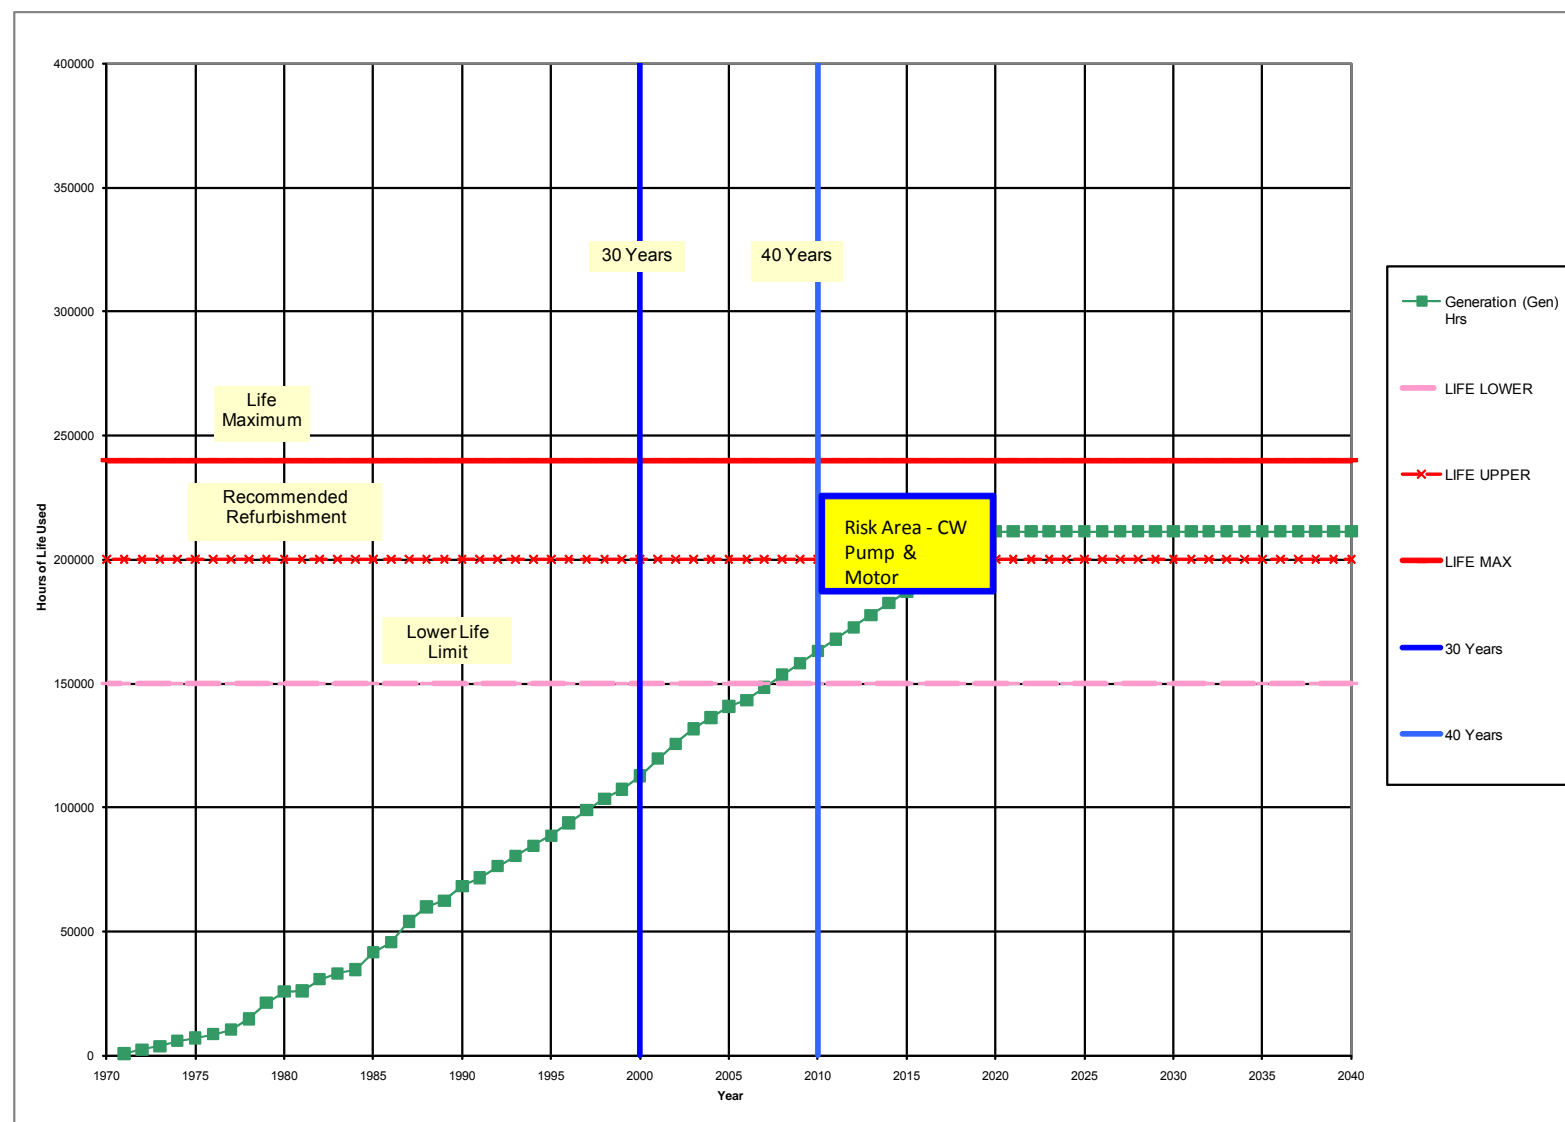
FIGURE 9-26 LIFE CYCLE CURVE – UNIT 2 COOLING WATER SYSTEM - ASSOCIATED WITH STEAM SYSTEMS

The curves indicate that the remaining life (RL) of the Unit 2 cooling water system - associated with steam systems can likely reach the desired life (DL) end date for generation of 2020, but with some reliability risk, particularly as it pertains to the 4 kV motors. It is recommended that a spare motor shared between units would be a reasonable precaution. Corrosion of the steel pipe, valves, and fittings was also evident suggesting that some maintenance on these issues is required.

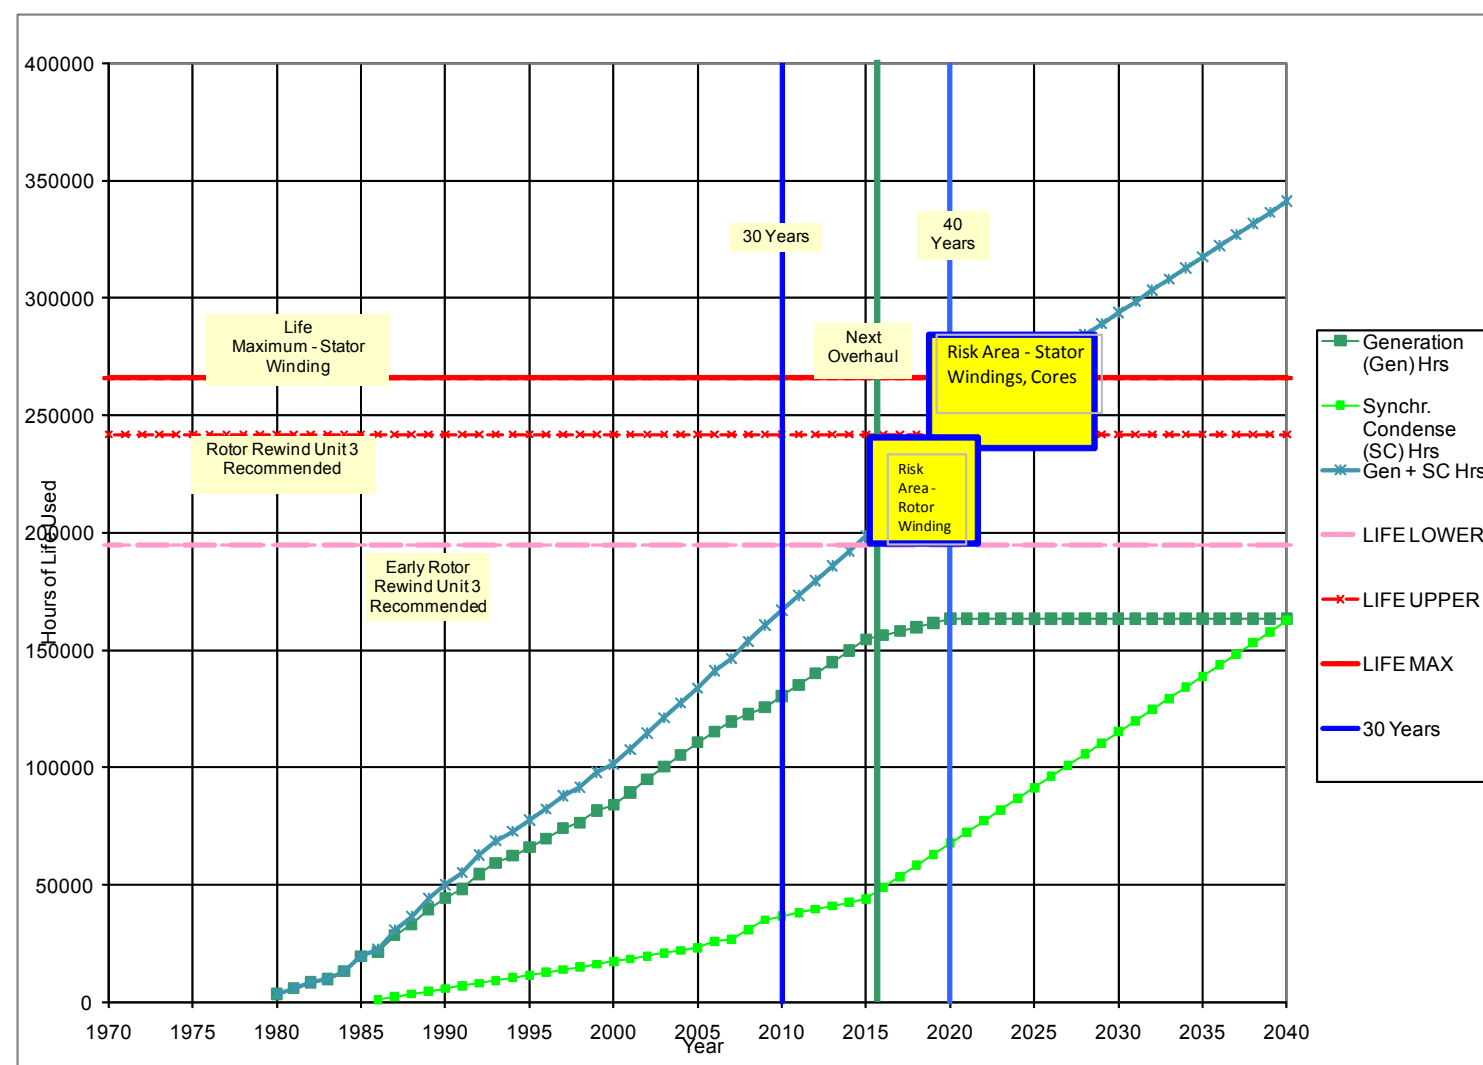
FIGURE 10-4 LIFE CYCLE CURVE – UNIT 3 GENERATOR

The generator figure below shows the operating hours as an electricity generator, in synchronous condensing mode, as well as the sum of the two. Only one set of curves is required, given that the major elements of the generator (stator and rotor windings and core) and the hydrogen system are the same age. One vertical line illustrates the timing of the next generator overhaul in 2016. The lowest two horizontal lines represent the ranges of expected generator life (primarily the rotor winding) for Holyrood Unit 3 based on current and historical information and expert opinion. The “Early Rotor Rewind Unit 3 Recommended” line is based on an estimated minimum remaining reliable rotor winding life of seven years at current generation levels. The other two represent longer rotor winding lives that may be achievable with decreasing reliability and higher failure risk, as well as a maximum 20 years likely for the stator and rotor cores.

The “Rewind Unit 3 Recommended” line is based on the estimated remaining reliable rotor and stator winding life of five years at current generation levels. The other two represent longer lives that may be achievable with decreasing reliability and higher failure risk. The two upper lines also represent a longer assessment of the remaining life of the rotor winding and maximum 20 years likely for the stator and rotor cores. The same curves apply as no major changes in equipment have taken place to date.

The curves indicate that the remaining life (RL) of the Unit 3 generator exceeds the desired life (DL) of 2016, which is the lesser of the time to its next major planned overhaul/inspection (2016) or to the desired End of Life (EOL) date of 2041. Thus no specific dedicated Level 2 is required, but sufficient inspection and testing will be required in the 2016 overhaul to assess key issues with the rotor windings, rotor core, and stator windings. The primary issue will be whether a rotor rewind is necessary in or about 2020. The remaining life (RL) of the Unit 3 generator exciter does not exceed the desired life (DL) and in fact has exceeded its normal expected life and should be replaced as soon as practical to meet the desired life of 2041. The highlighted near term risk areas include the rotor winding, exciter, the rectifying transformer, and BOP equipment. The curve also suggests that a nine year time between generator overhauls is impractical at this time in the generator's life and should be a six year cycle.

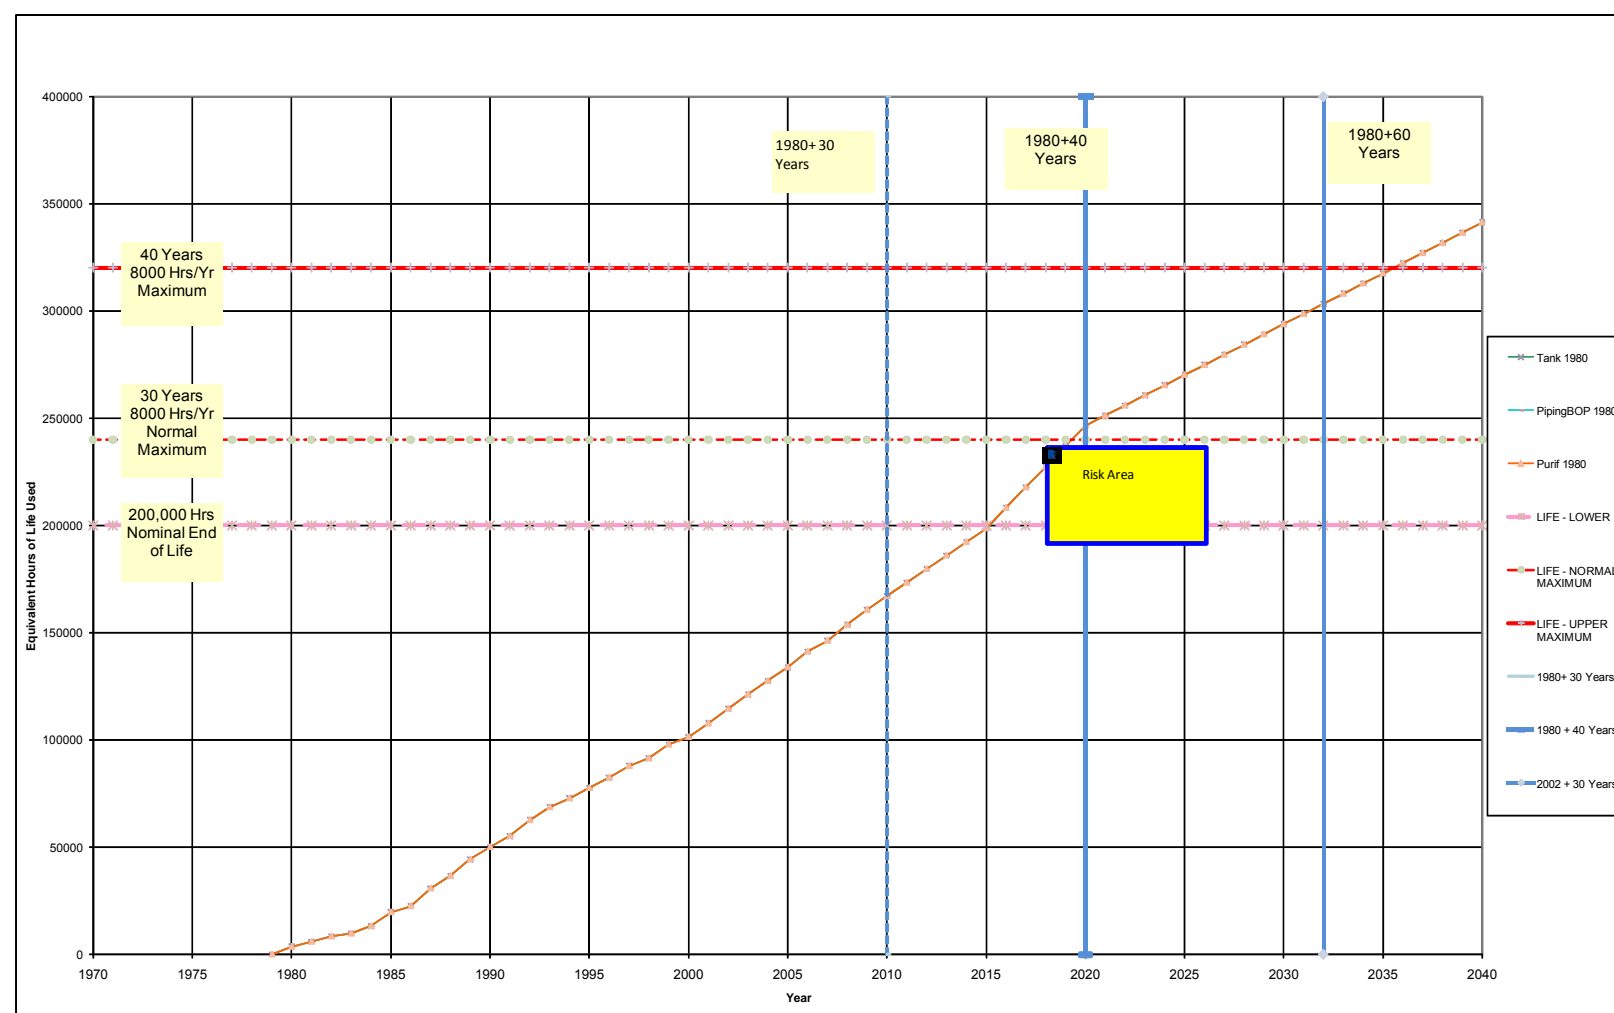
FIGURE 10-6 LIFE CYCLE CURVE – UNIT 3 GENERATOR LUBE OIL SYSTEM

The curves indicate that the remaining life (RL) of the Unit 3 generator lube oil system exceeds the desired life (DL) which is the lesser of the time to its next major planned overhaul/inspection (2016) or to the desired End of Life (EOL) date of 2041. Thus no specific dedicated Level 2 is required of the system as a whole, but sufficient inspection and testing will be required in 2013 steam turbine valve overhaul or the 2016 steam turbine generator overhaul to demonstrate the ability to meet the EOL date. The exception is the storage tank for which information was considered inadequate to form a firm conclusion and level 2 testing is recommended in 2011. The figure's highlighted risk areas is primarily operating hours driven and likely to shift further out in time after the 2016 turbine generator overhaul. The 2013 steam turbine valve overhaul and the 2016 overhaul/inspection are fundamental elements in changing the current assessment.

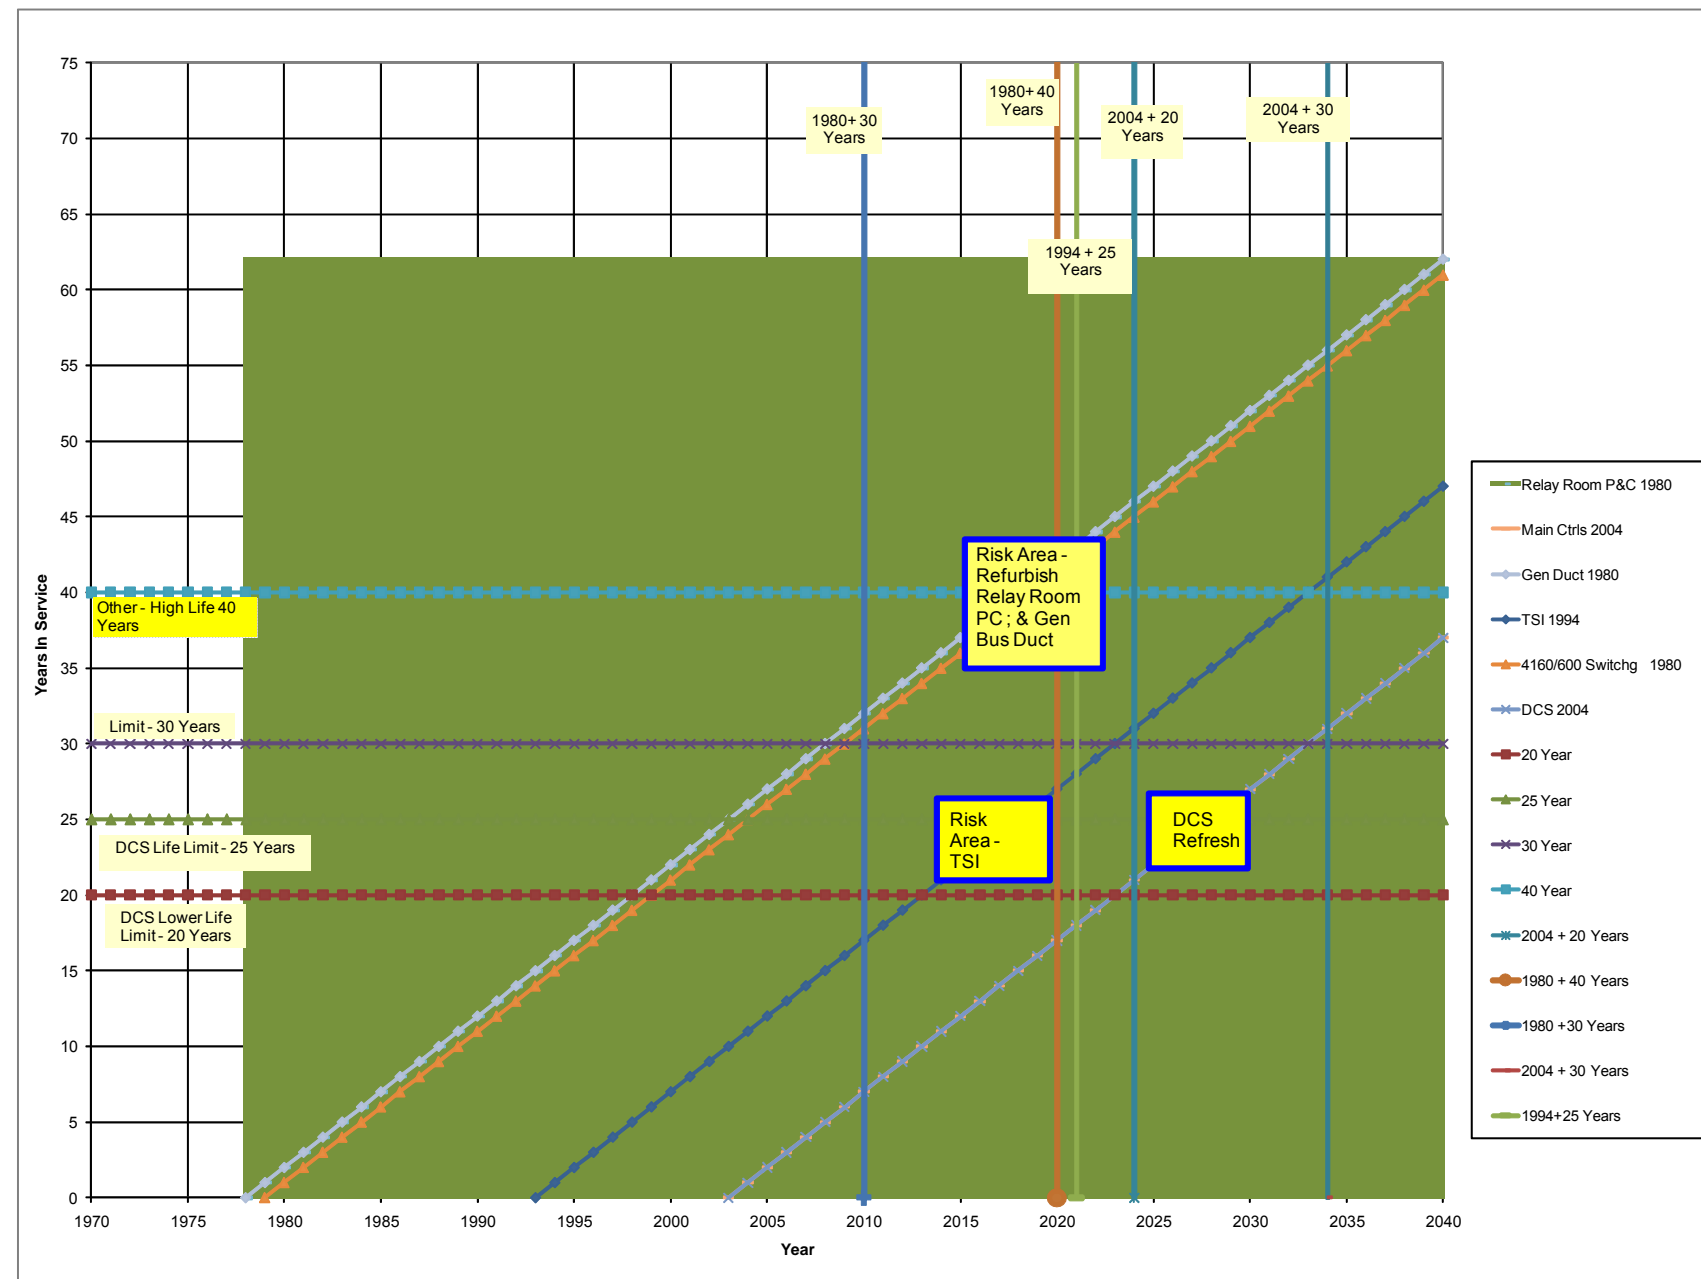
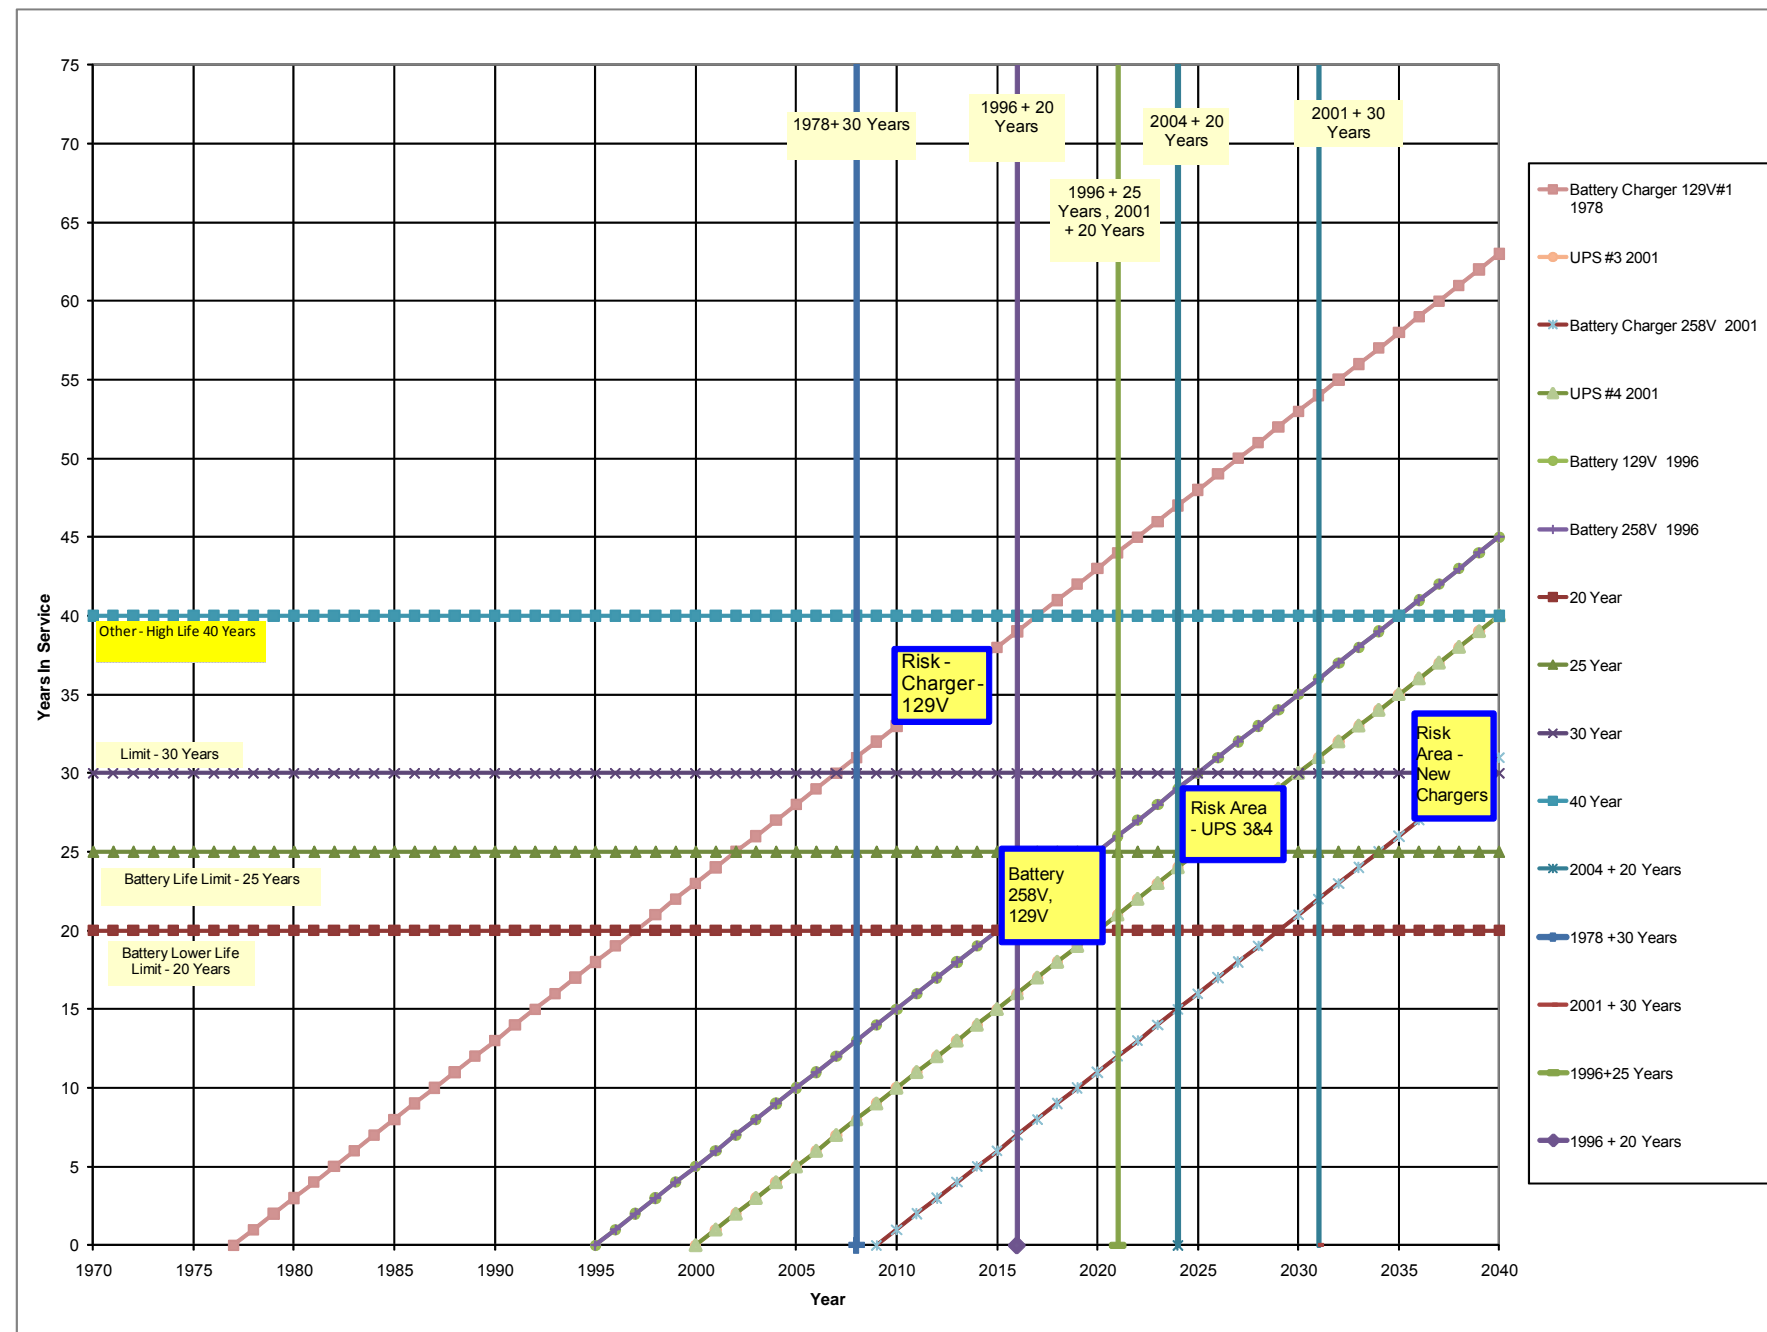
The curves indicate that the remaining life (RL) of much of the equipment does not exceed the desired life (DL) for generation of 2020 and for synchronous condensing of 2041, without extensive refurbishment or replacement. This is well illustrated by the highlighted risk areas which highlights that many original MCC's and relays as well as the TSI are in need or replacement or extensive refurbishment in the very near term. The risk figures also illustrate that some equipment (DCS, batteries, and chargers) will require replacement or refurbishment in the 2020+ period.

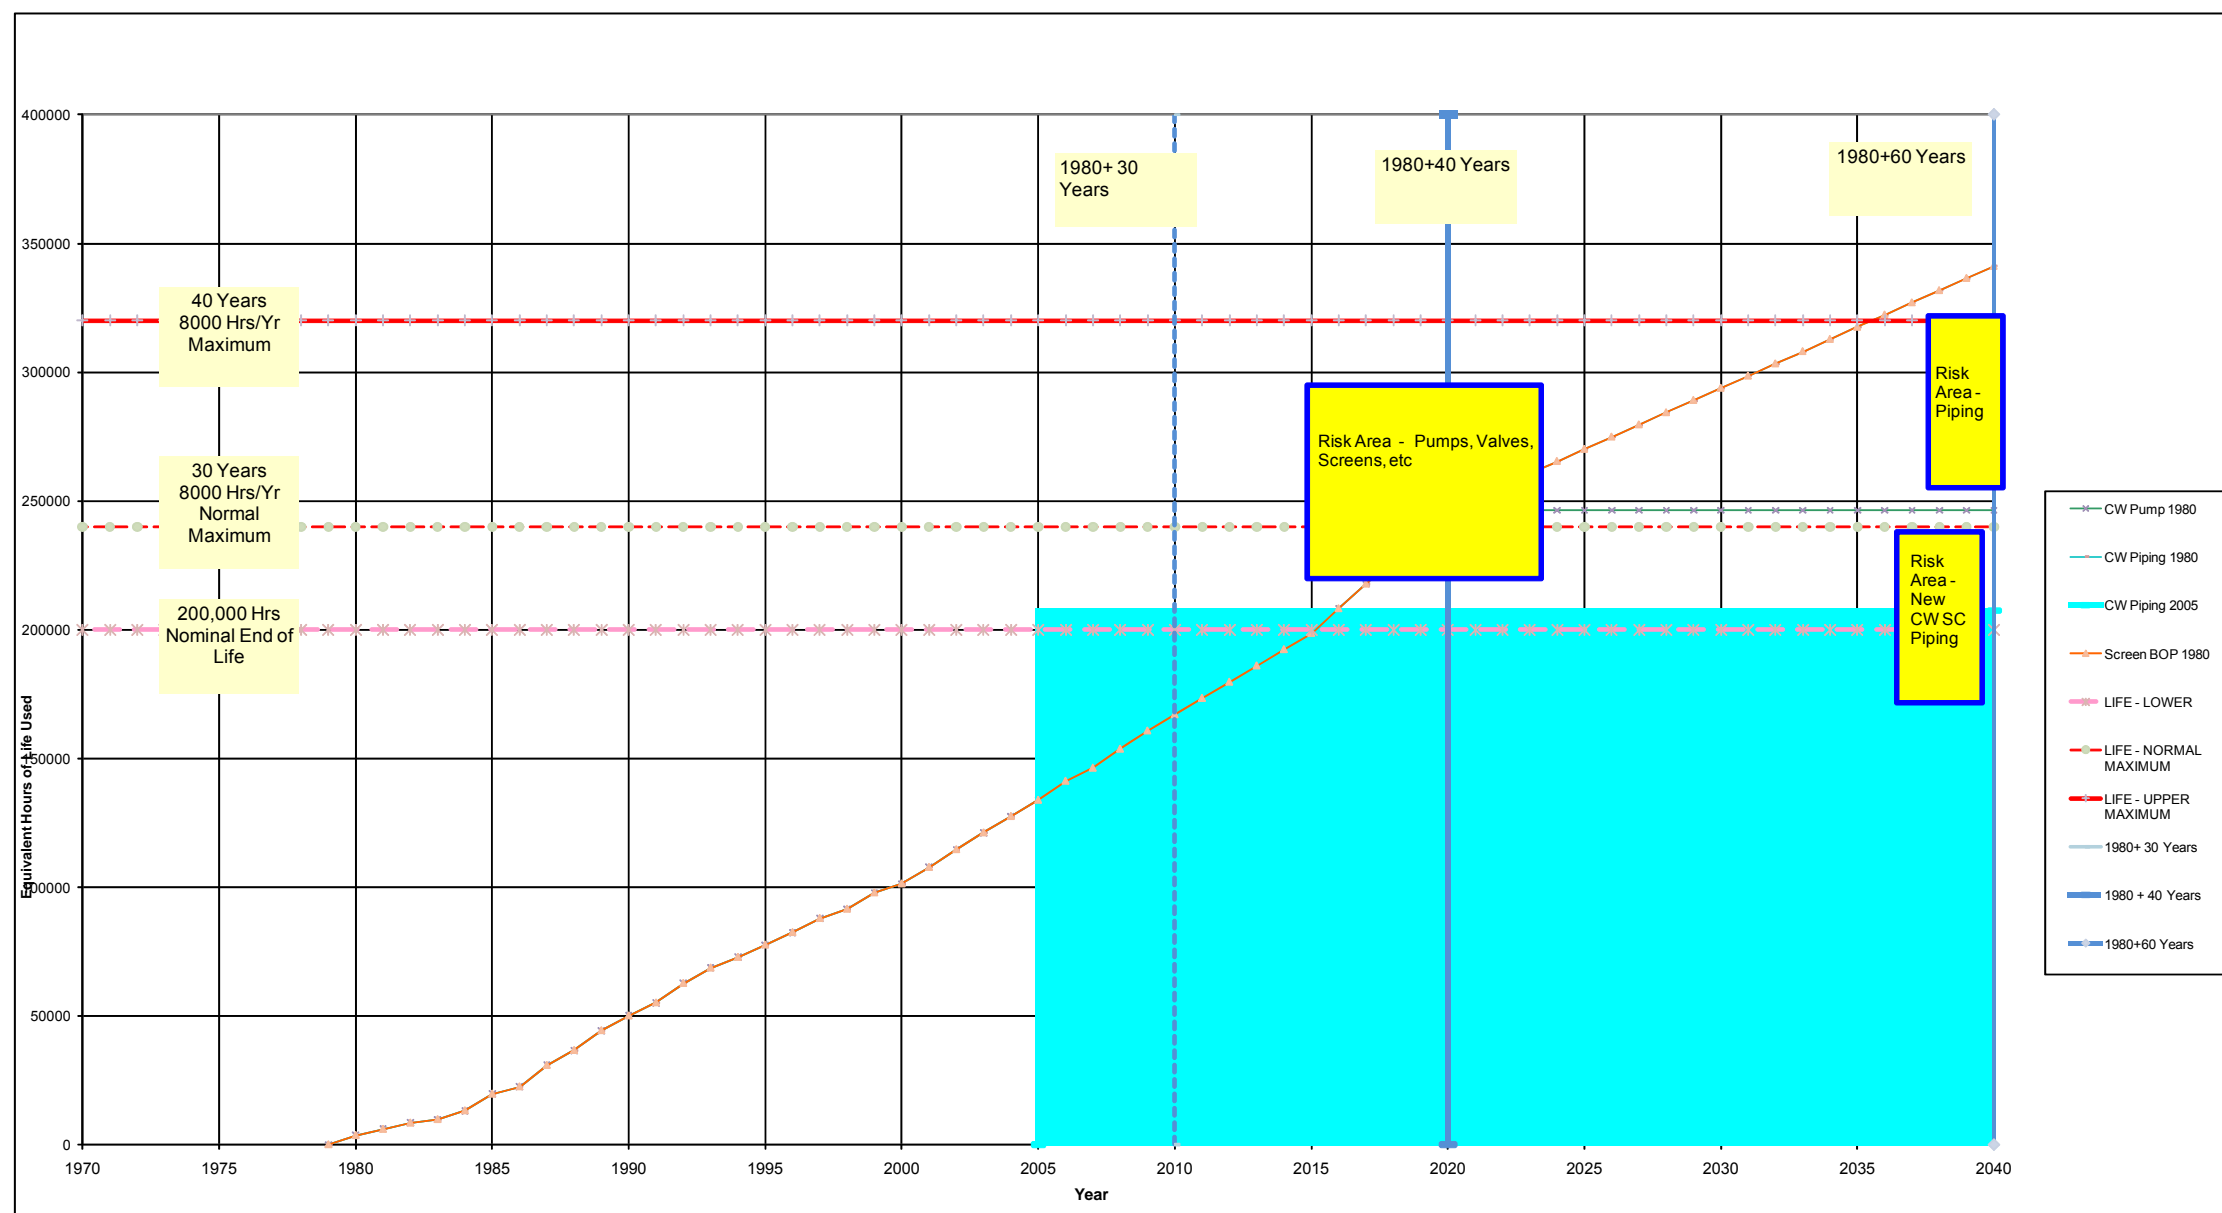
FIGURE 10-12 LIFE CYCLE CURVE – UNIT 3 WATER SYSTEMS ASSOCIATED WITH GENERATORS

The curve indicates that the remaining life (RL) of most elements of the Unit 3 cooling water systems associated with generators is sufficient to reach the end date of 2020 for generation, but not the 2041 desired life (DL) end date for synchronous condensing. The CW pumps and associated equipment are the primary nearer term issues highlighted by the risk boxes. The actual end date and remaining life will become clearer through the series of ongoing routine inspections that forms part of the plant's PM program and the Level 2 inspections recommended in the report. The intake and outfall structures and associated sub-components should be added as a result of a Level 2 inspection.

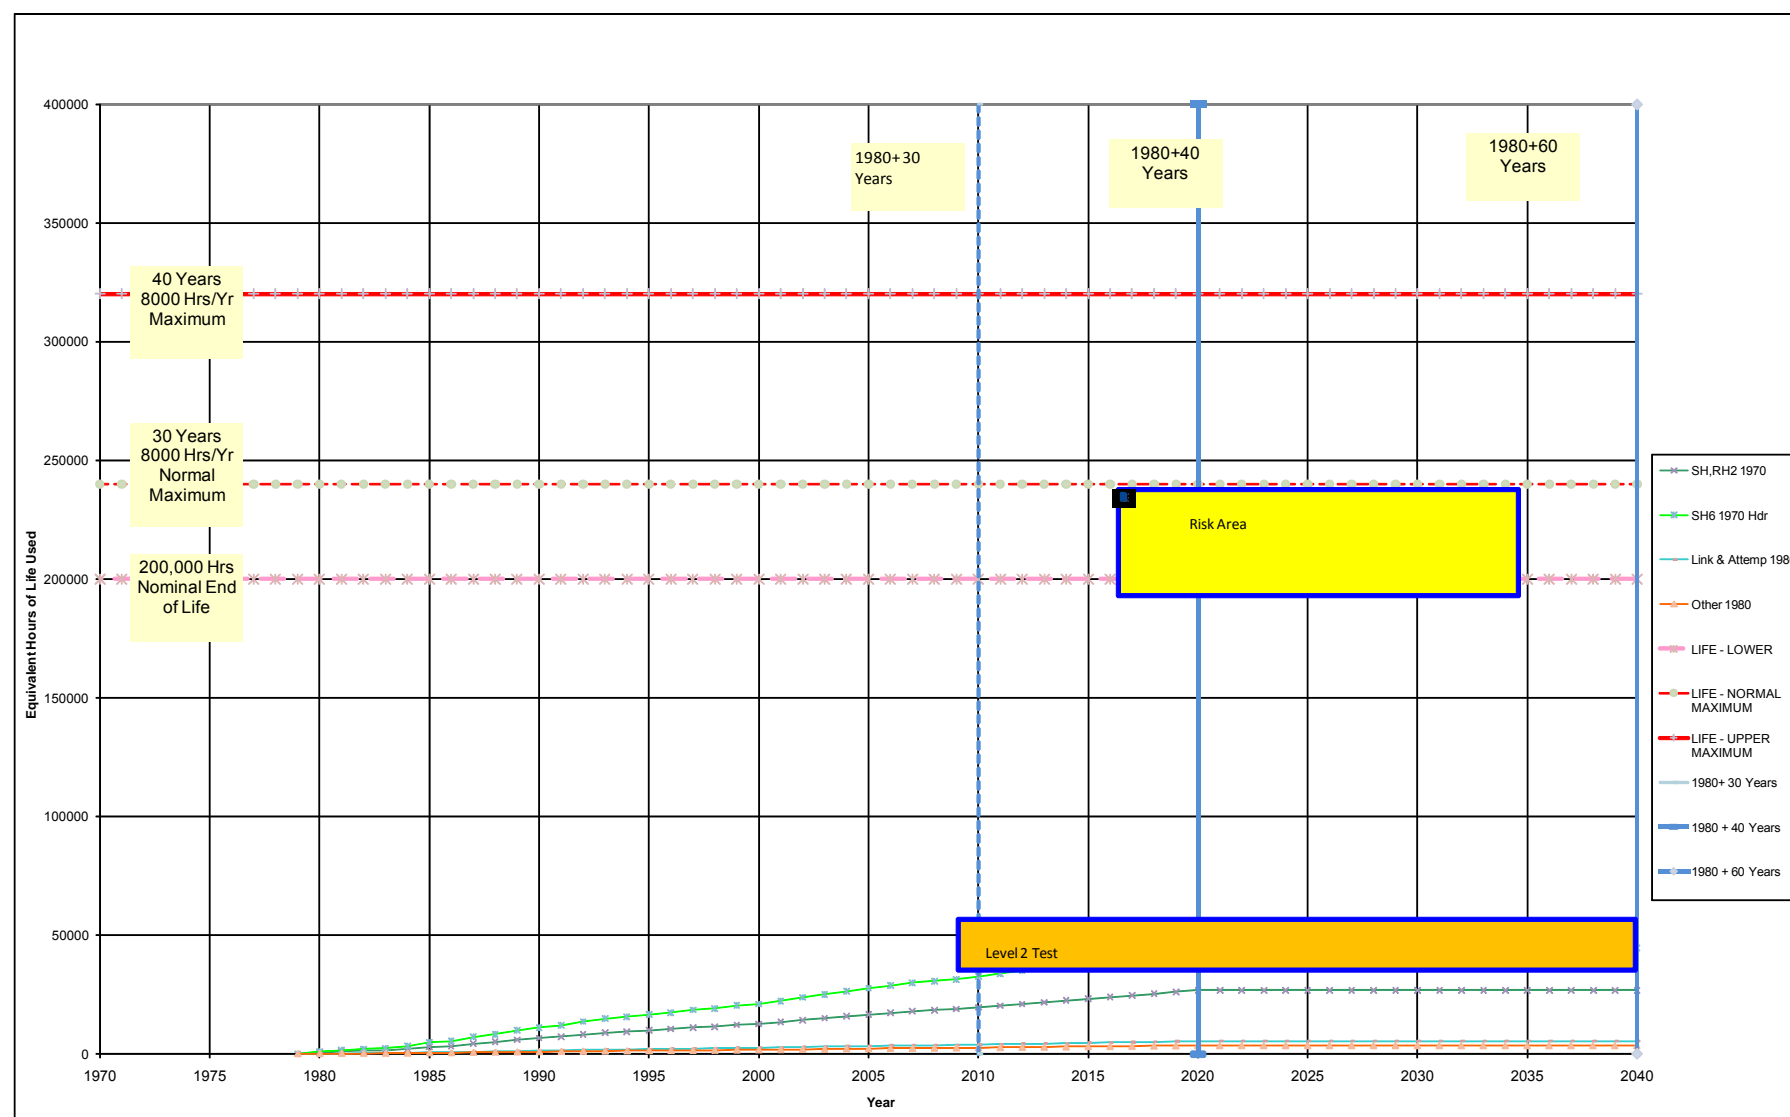
FIGURE 10-13 LIFE CYCLE CURVE – UNIT 3 BOILERS (HEADERS AND COMPONENTS)

The header life curves indicate that the remaining life (RL) of the Unit 3 boiler headers and associated components is expected to exceed the desired life (DL) which is the generation end of life in 2020. Nevertheless, it also identifies that some of higher temperature components should undergo a Level 2 inspection (identified later in this section of the report) if not already planned or undertaken.

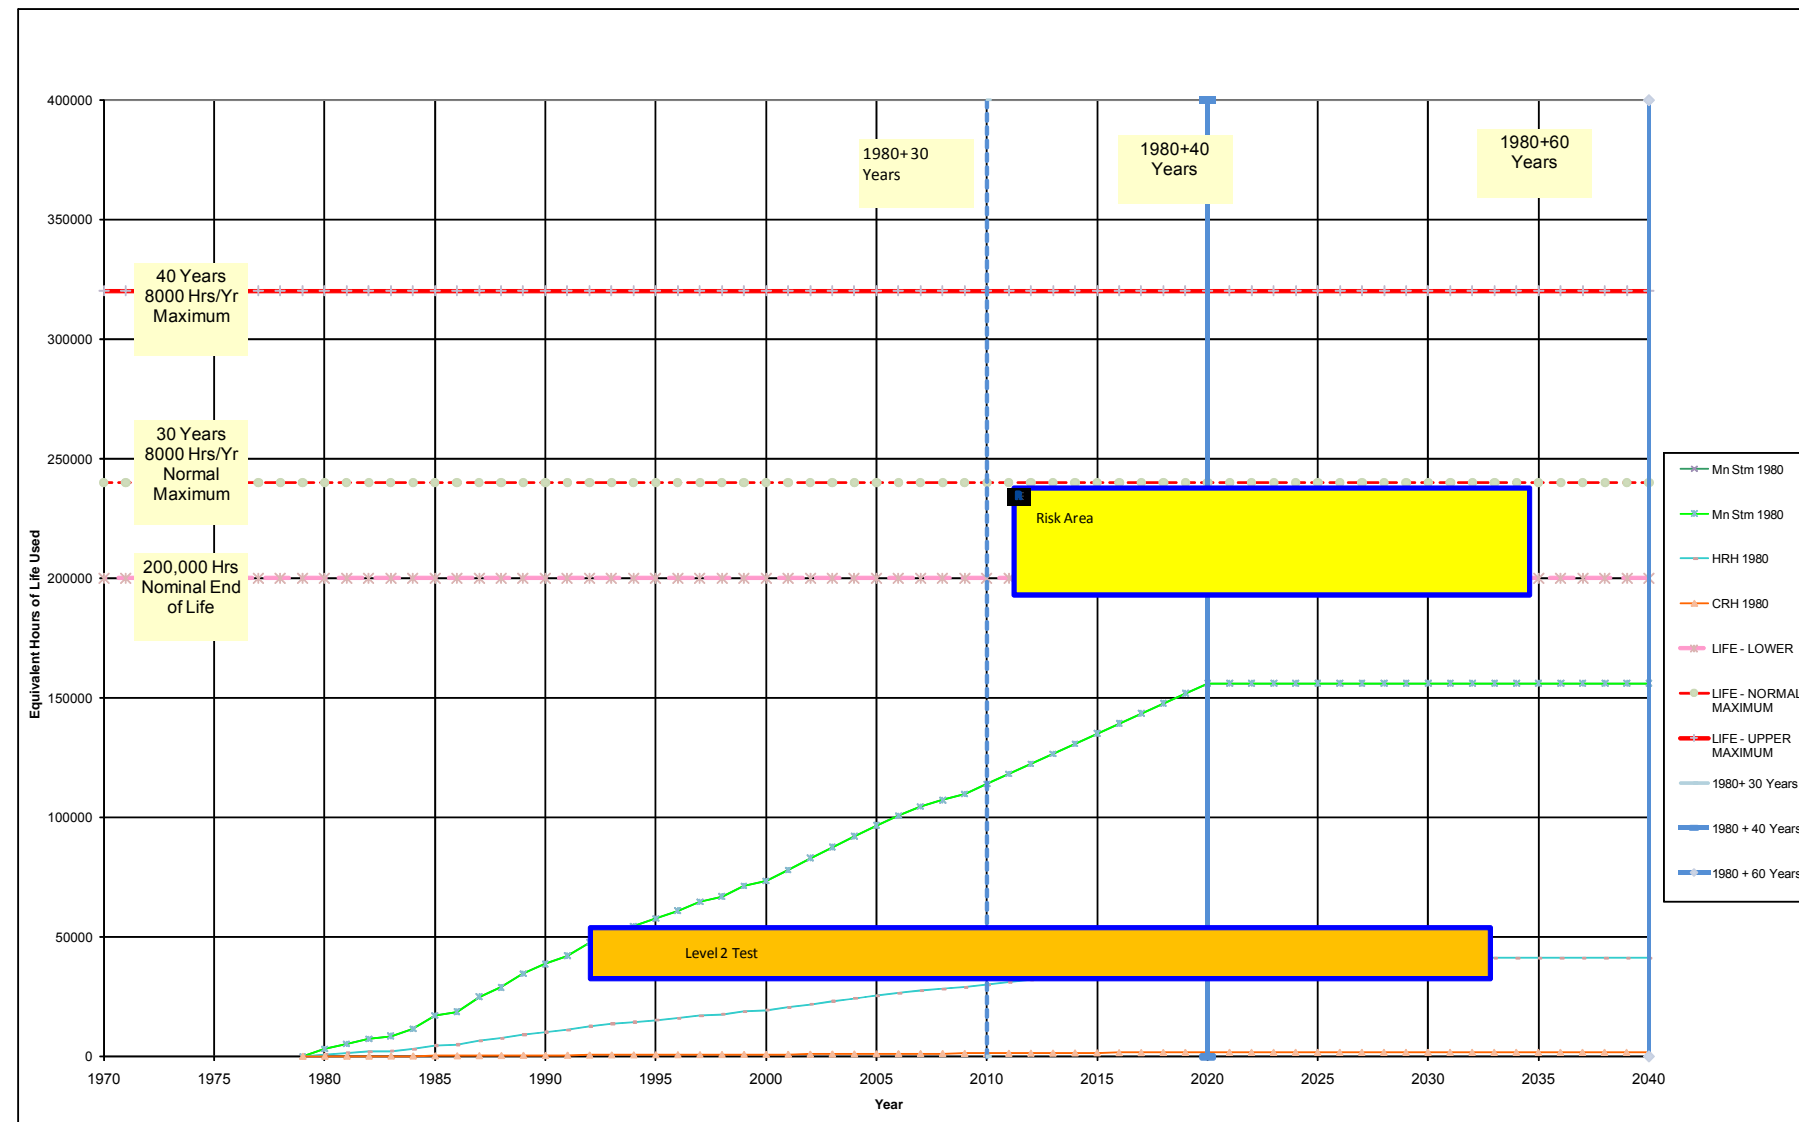
FIGURE 10-14 LIFE CYCLE CURVE – UNIT 3 BOILERS (HIGH PRESSURE AND TEMPERATURE STEAM LINES)

The high pressure steam line life curves indicate that the remaining life (RL) of the Unit 3 steam lines and their associated components are expected to exceed the desired life (DL) which is the generation end of life in 2020. Nevertheless it also identifies that both the main steam and hot reheat steam lines exceed EPRI's 10% consumed life guide for a Level 2 inspection of these systems. Given that they have not been tested for some time, this is considered appropriate at this time.

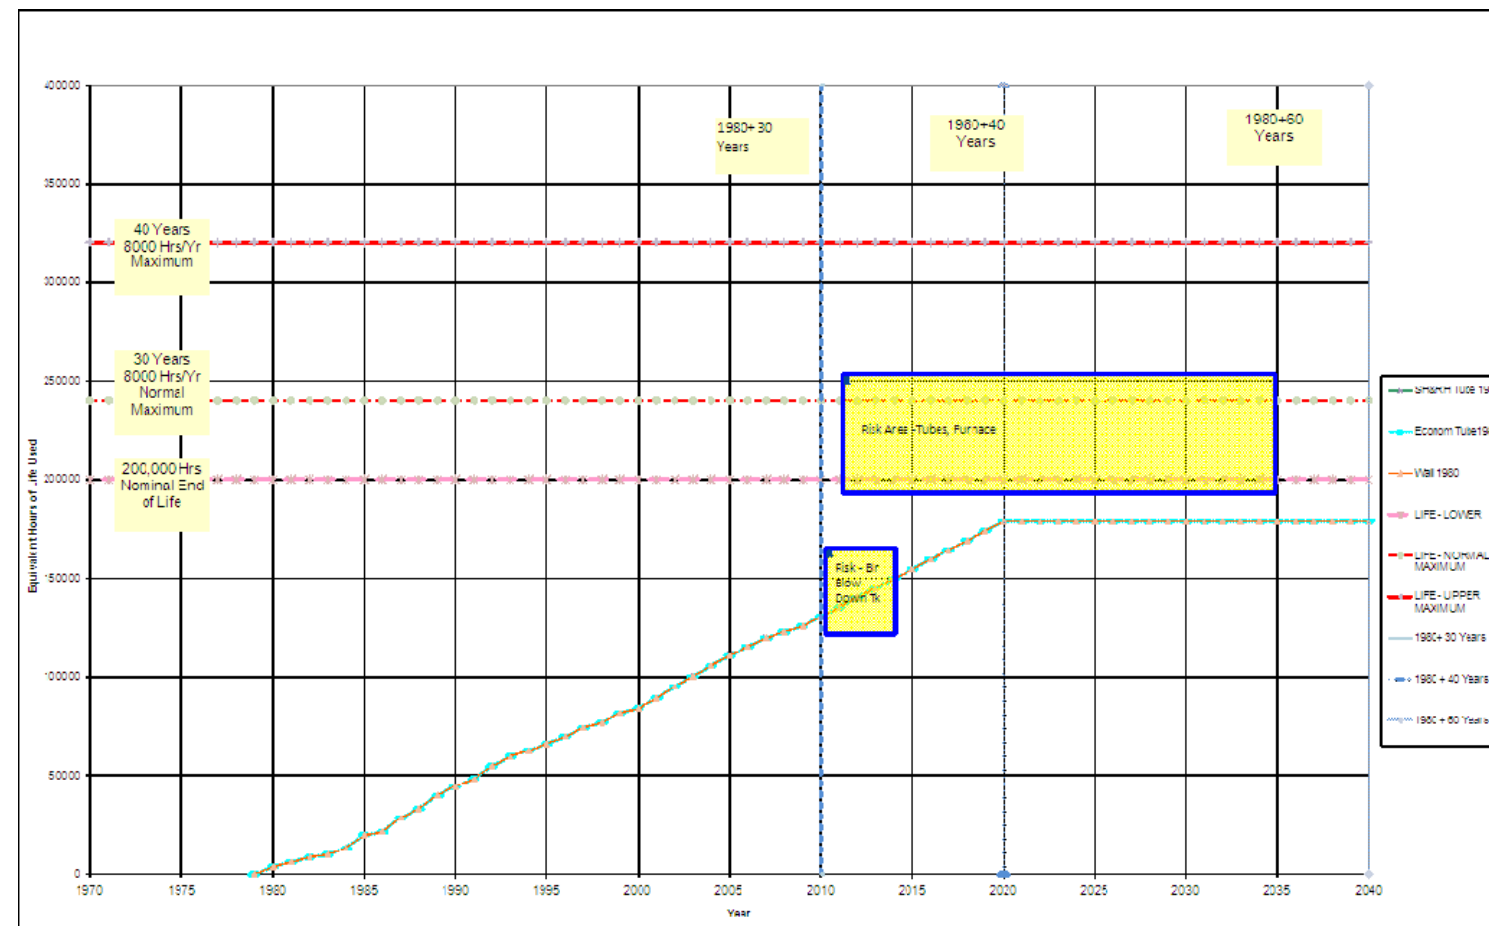
FIGURE 10-15 LIFE CYCLE CURVE – UNIT 3 BOILER SYSTEM (TUBES EXPOSED TO THE COMBUSTION PROCESS)

The curve indicates that the boiler tubes within the furnace envelope would have been expected to be seeing some end of life component concerns with original equipment. Nevertheless, it is more likely legacy impacts that will have greater effects on component replacements and refurbishments going forward to 2020. With ongoing inspections and refurbishments, 2020 is achievable with good reliability with the new fuel. It also shows that the boiler blowdown tank should be replaced.
