Holyrood Thermal Generating Station (Holyrood) Condition Assessment & Life Extension Study, - Final Report

**Holyrood Thermal
 Generating Station
 Condition Assessment &
 Life Extension Study**

January 28, 2011

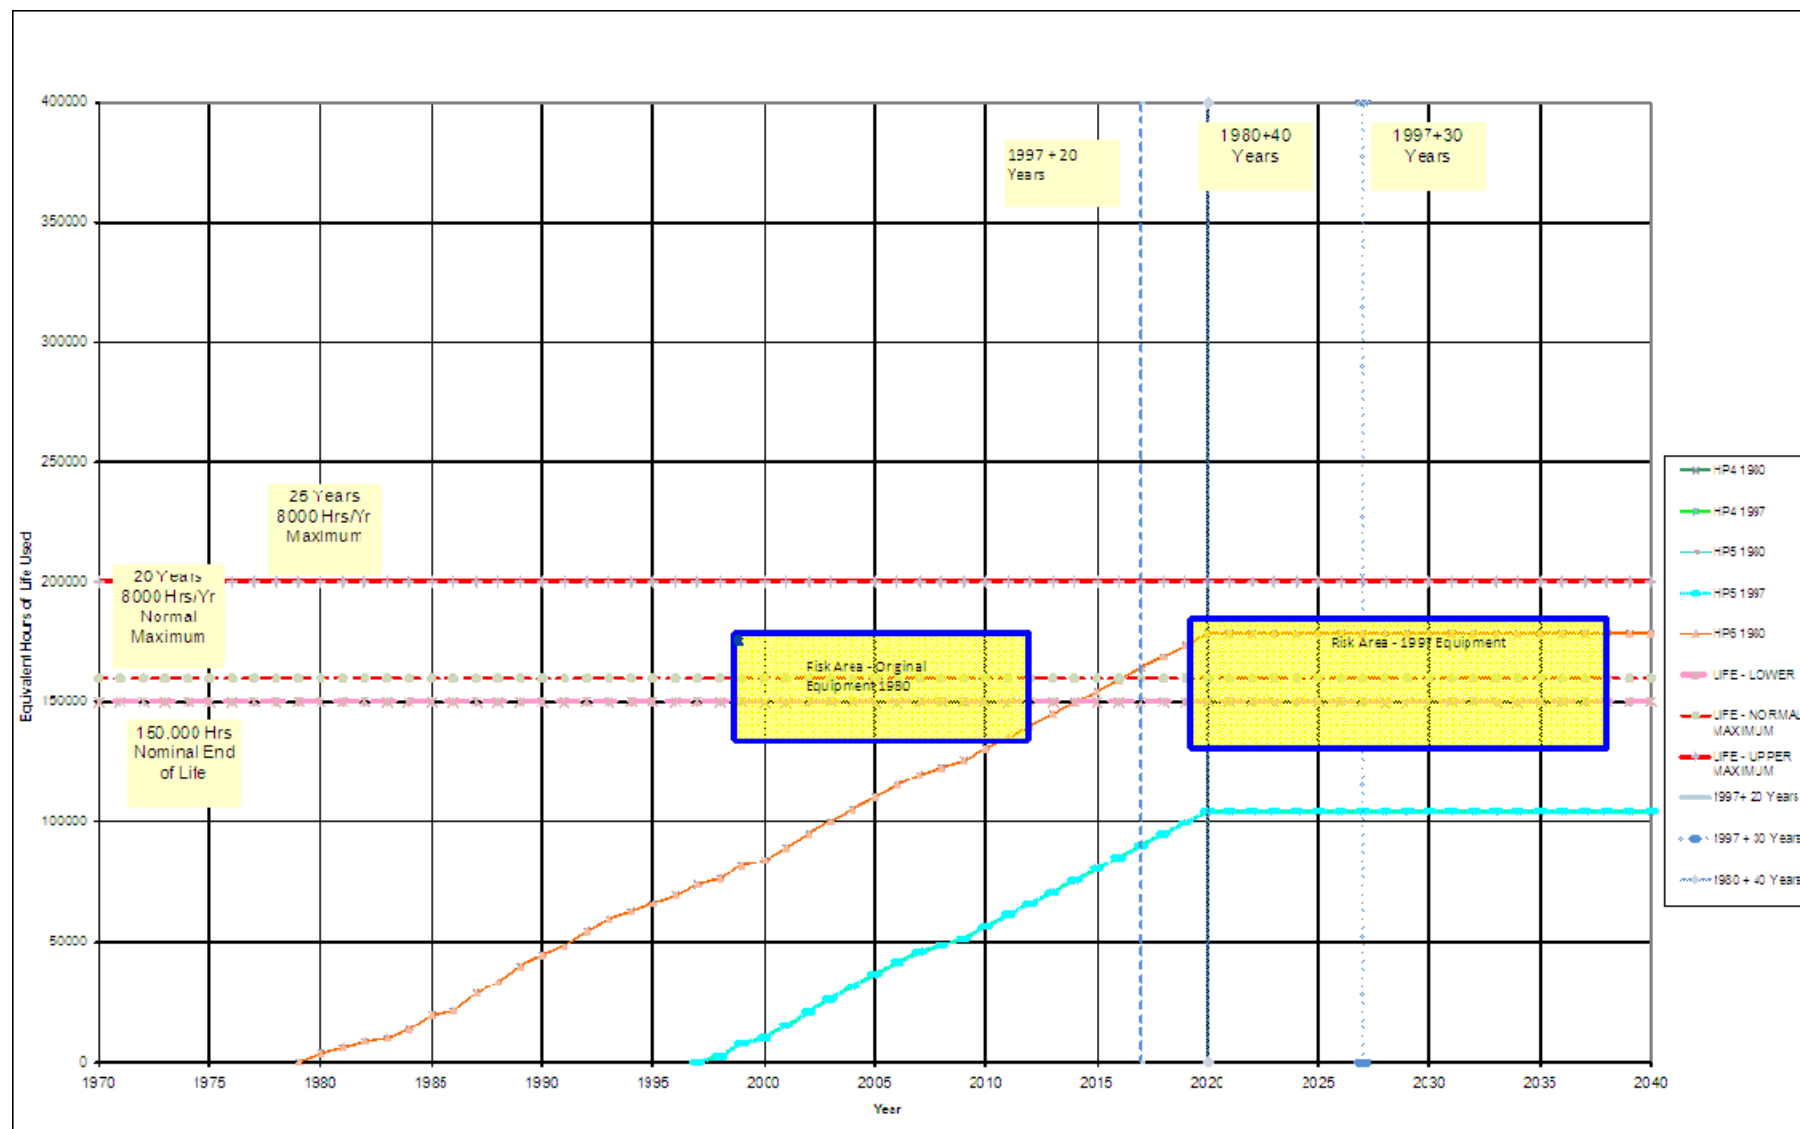
FIGURE 10-16 LIFE CYCLE CURVE – UNIT 3 FEED WATER SYSTEM HP HEAT EXCHANGERS

The curves indicate that the remaining life (RL) of the Unit 3 HP heat exchangers (and the associated feedwater systems) may be able to reach the desired life (DL) 2020 end date for generation. Nevertheless, given that no detailed NDE information has been obtained on the HP heat exchangers for some time, a detailed Level 2 inspection is recommended for 2014.

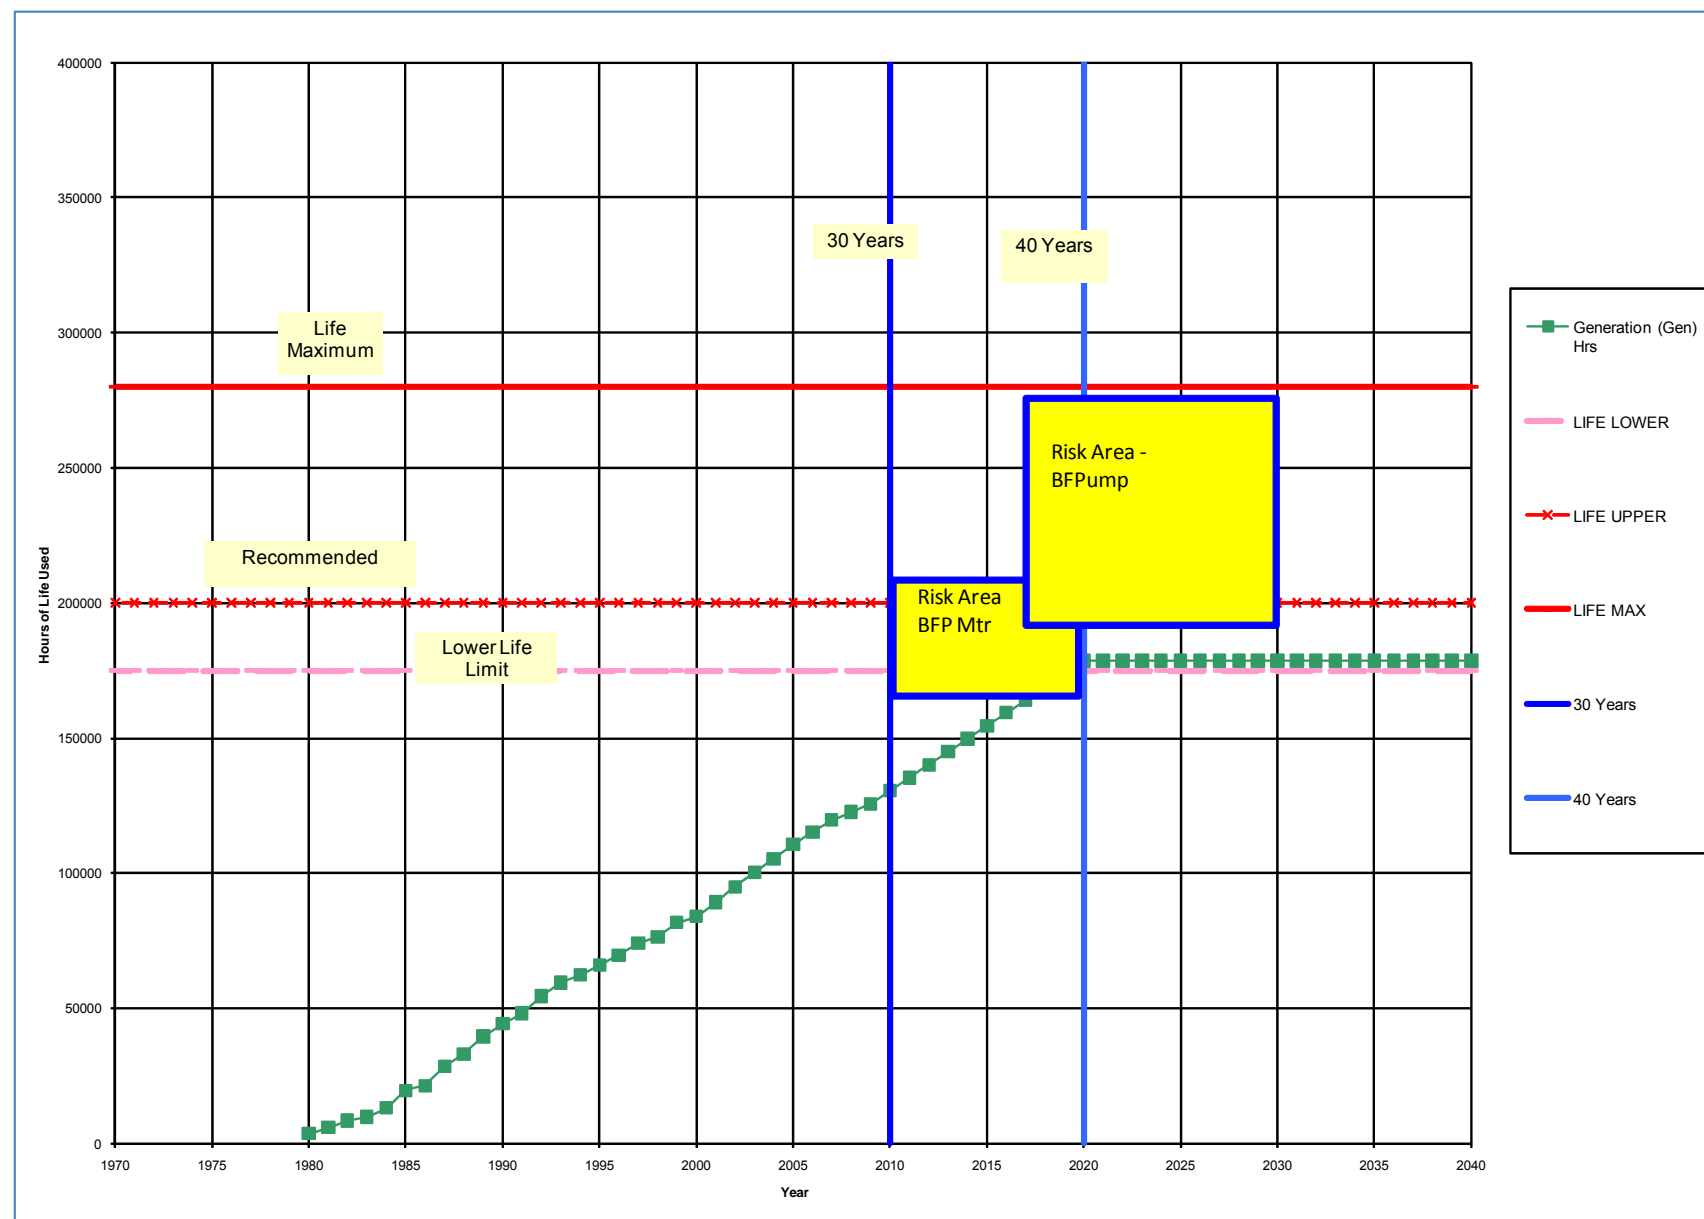
FIGURE 10-17 LIFE CYCLE CURVE – UNIT 3 FEEDWATER SYSTEM - BOILER FEED PUMPS

For the Unit 3 boiler feed pumps, a single curve represents each of the two boiler feed pumps dating back to their original installation. While indicative of expected life with good maintenance practice, the pumps have been and continue to be refurbished on a six year cycle using a spare pump section. Their actual condition is therefore substantially better than might otherwise be expected.

The curve indicates that the remaining life (RL) of the Unit 3 HP boiler feed pumps is likely able to reach desired end date which is the 2020 end date for generation. Given their six year refurbishment cycle and a spare pump section, they are expected to continue to perform reliably well past the 2020 end date for generation. The BFP motors are approaching older age and entering areas where reliability and unexpected failure may become more an issue than expected life.

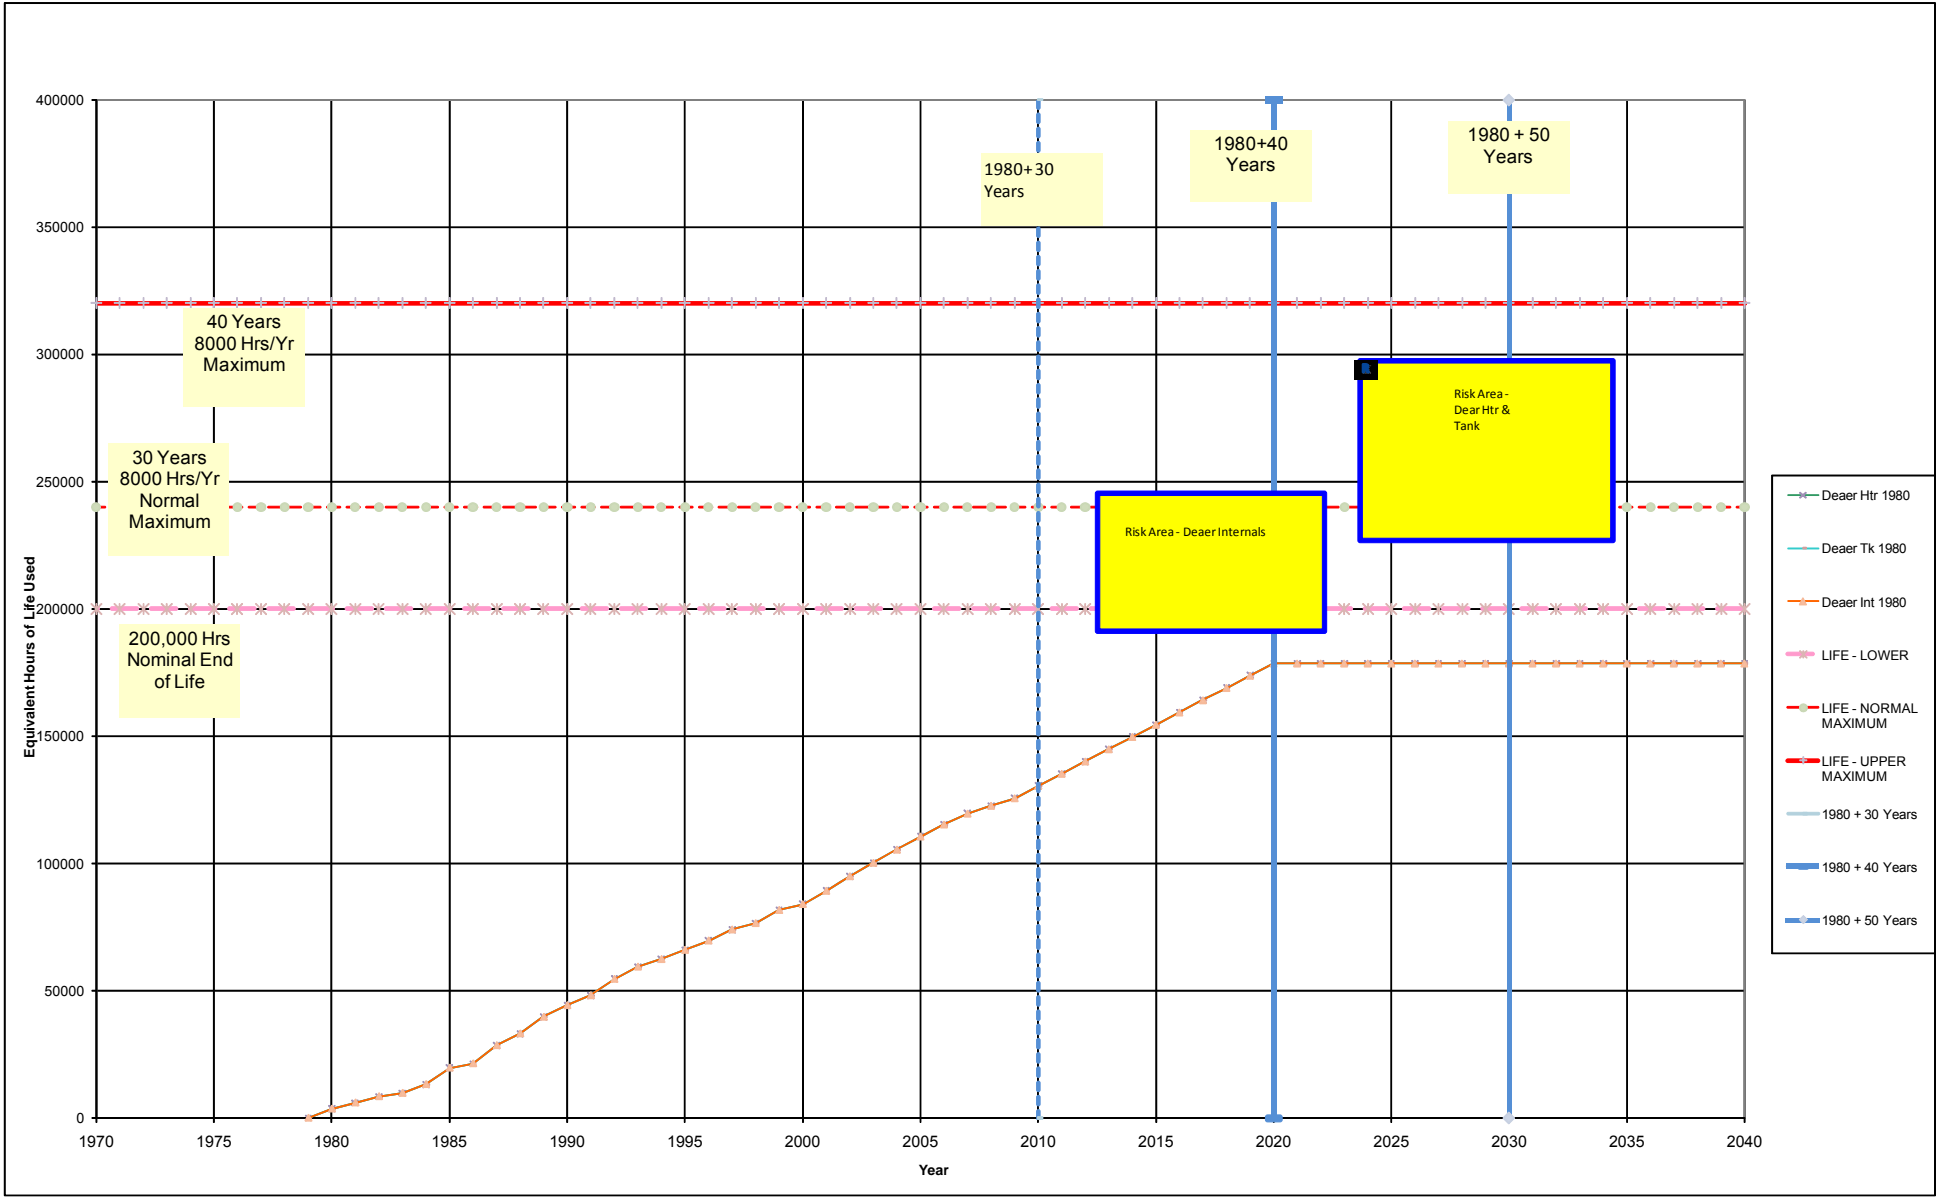
FIGURE 10-18 LIFE CYCLE CURVE – UNIT 3 FEEDWATER SYSTEM - DEAERATOR

The curve indicates that the remaining life (RL) of the Unit 3 feedwater system - deaerator exceeds the desired life (DL) which is end date for generation of 2020, with the potential though unlikely exception of some deaerator internals. The plant inspections form an excellent base of condition information supporting the ability of the deaerator as a whole to meet the EOL date. However, there is insufficient detailed inspection information of some of the internals that are difficult to access in order to fully assess their condition. A detailed Level 2 inspection is recommended in 2014.

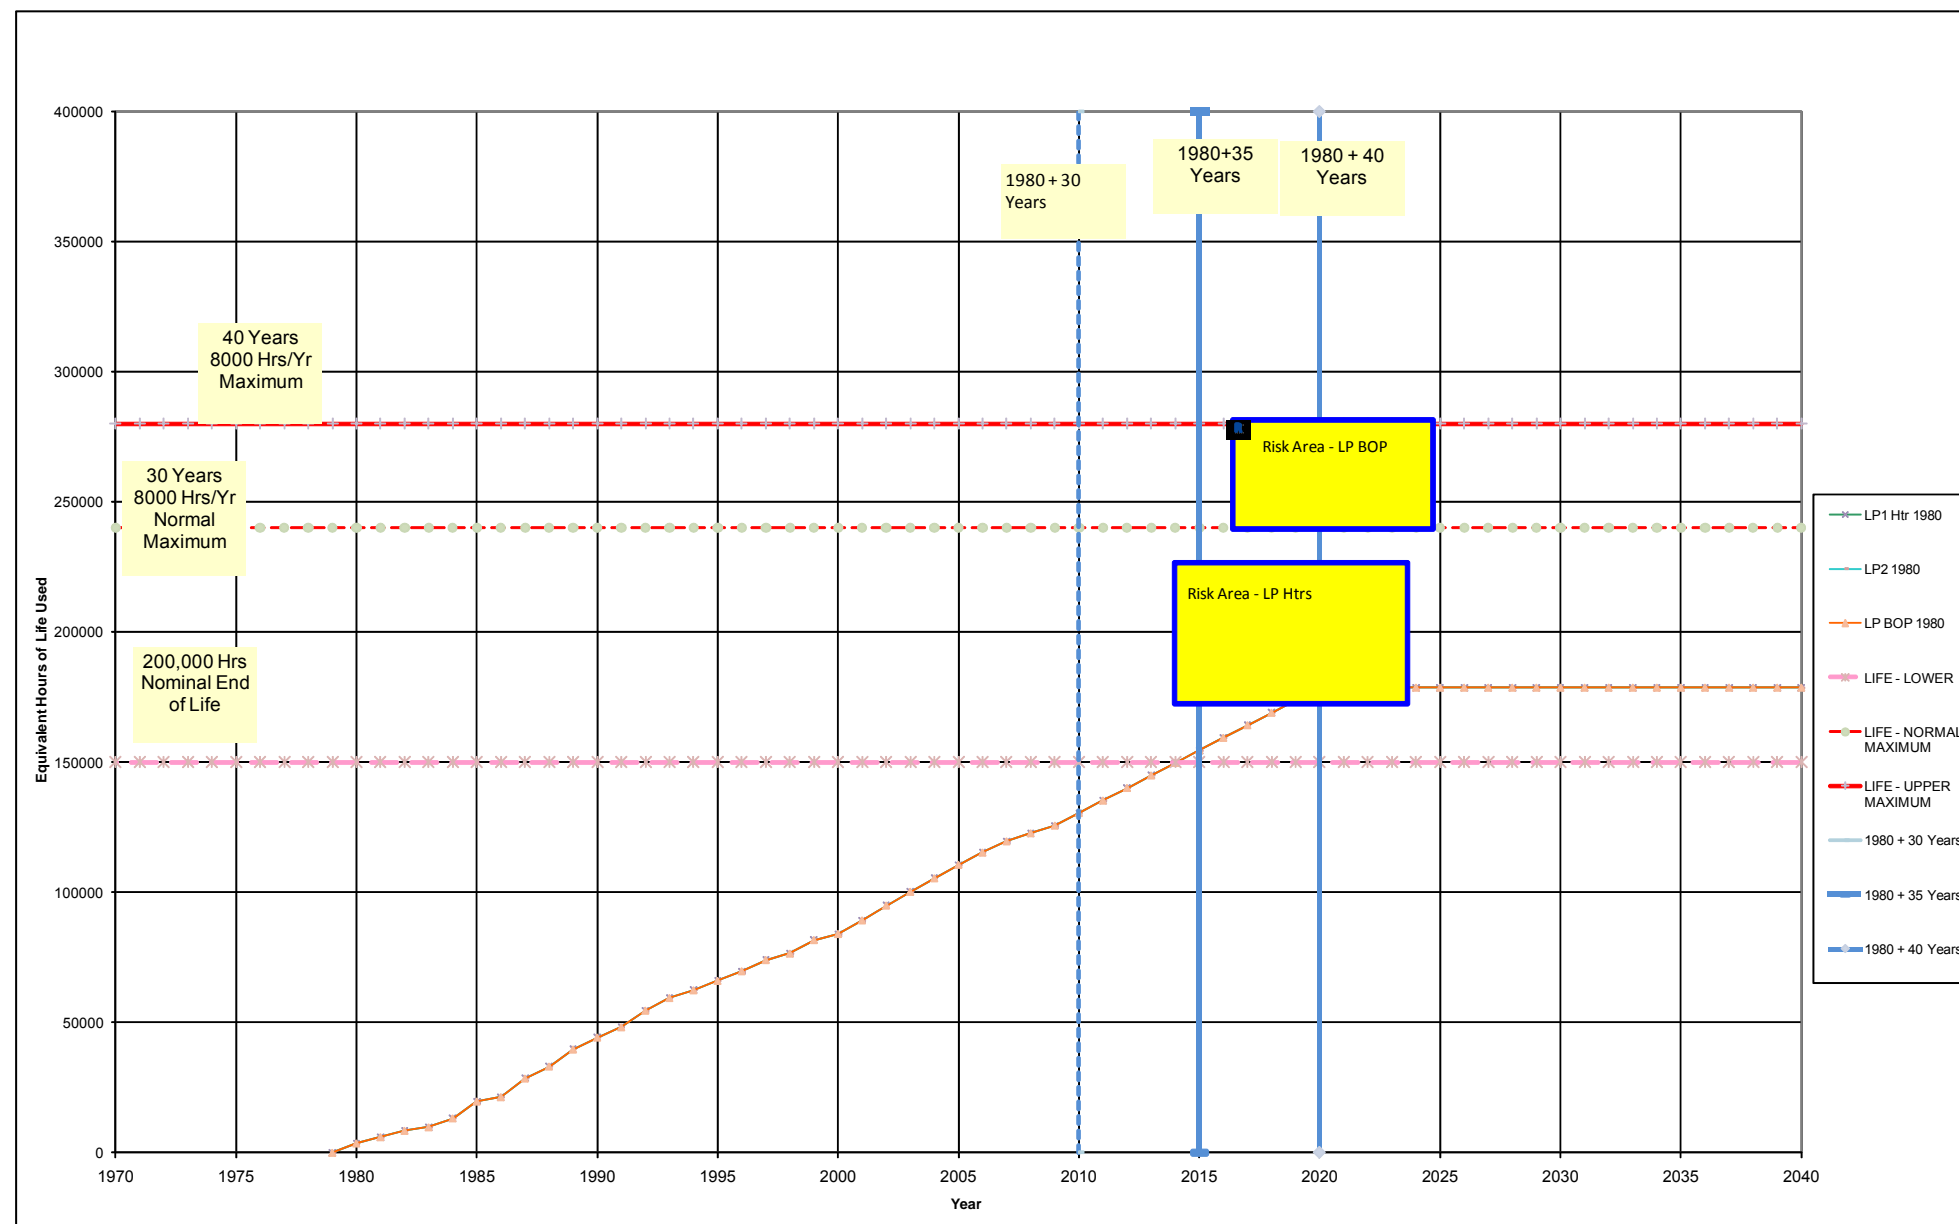
FIGURE 10-19 LIFE CYCLE CURVE – UNIT 3 FEEDWATER SYSTEM - LOW PRESSURE FEEDWATER HEAT EXCHANGERS

The curve indicates that the remaining life (RL) of the Unit 3 feed water system LP heat exchangers may not be able to reach the desired life (DL) 2020 end date for generation. Given that no detailed NDE information has been obtained on the LP heat exchangers, a detailed Level 2 inspection is recommended for 2011.

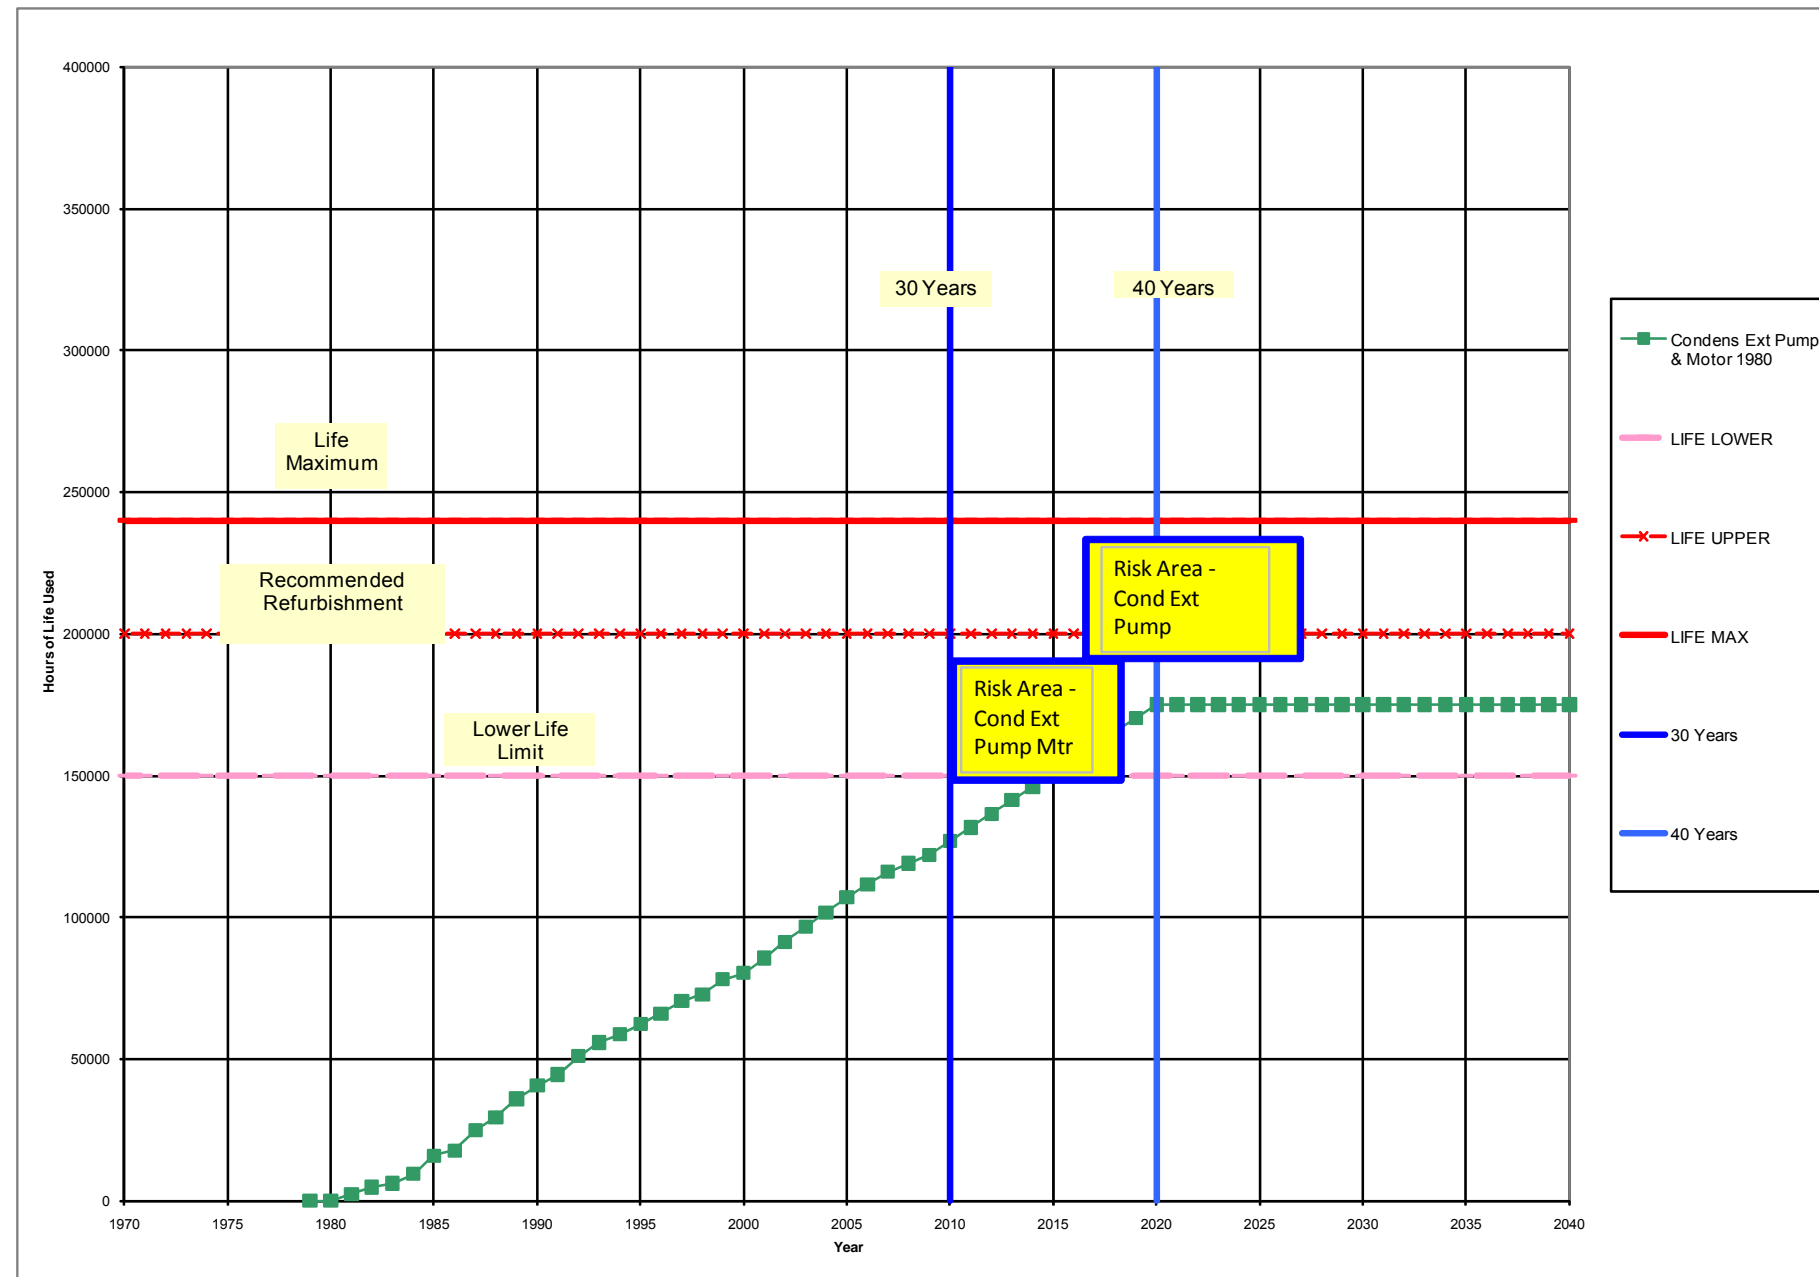
FIGURE 10-20 LIFE CYCLE CURVE – UNIT 3 FEEDWATER SYSTEM - CONDENSATE EXTRACTION SYSTEM

The curves indicate that the remaining life (RL) of the condenser condensate extraction pumps and motors can likely be able to reach the desired life (DL) 2020 end date for generation. The condensate extraction pump motors are expected however to be entering a period of higher unreliability.

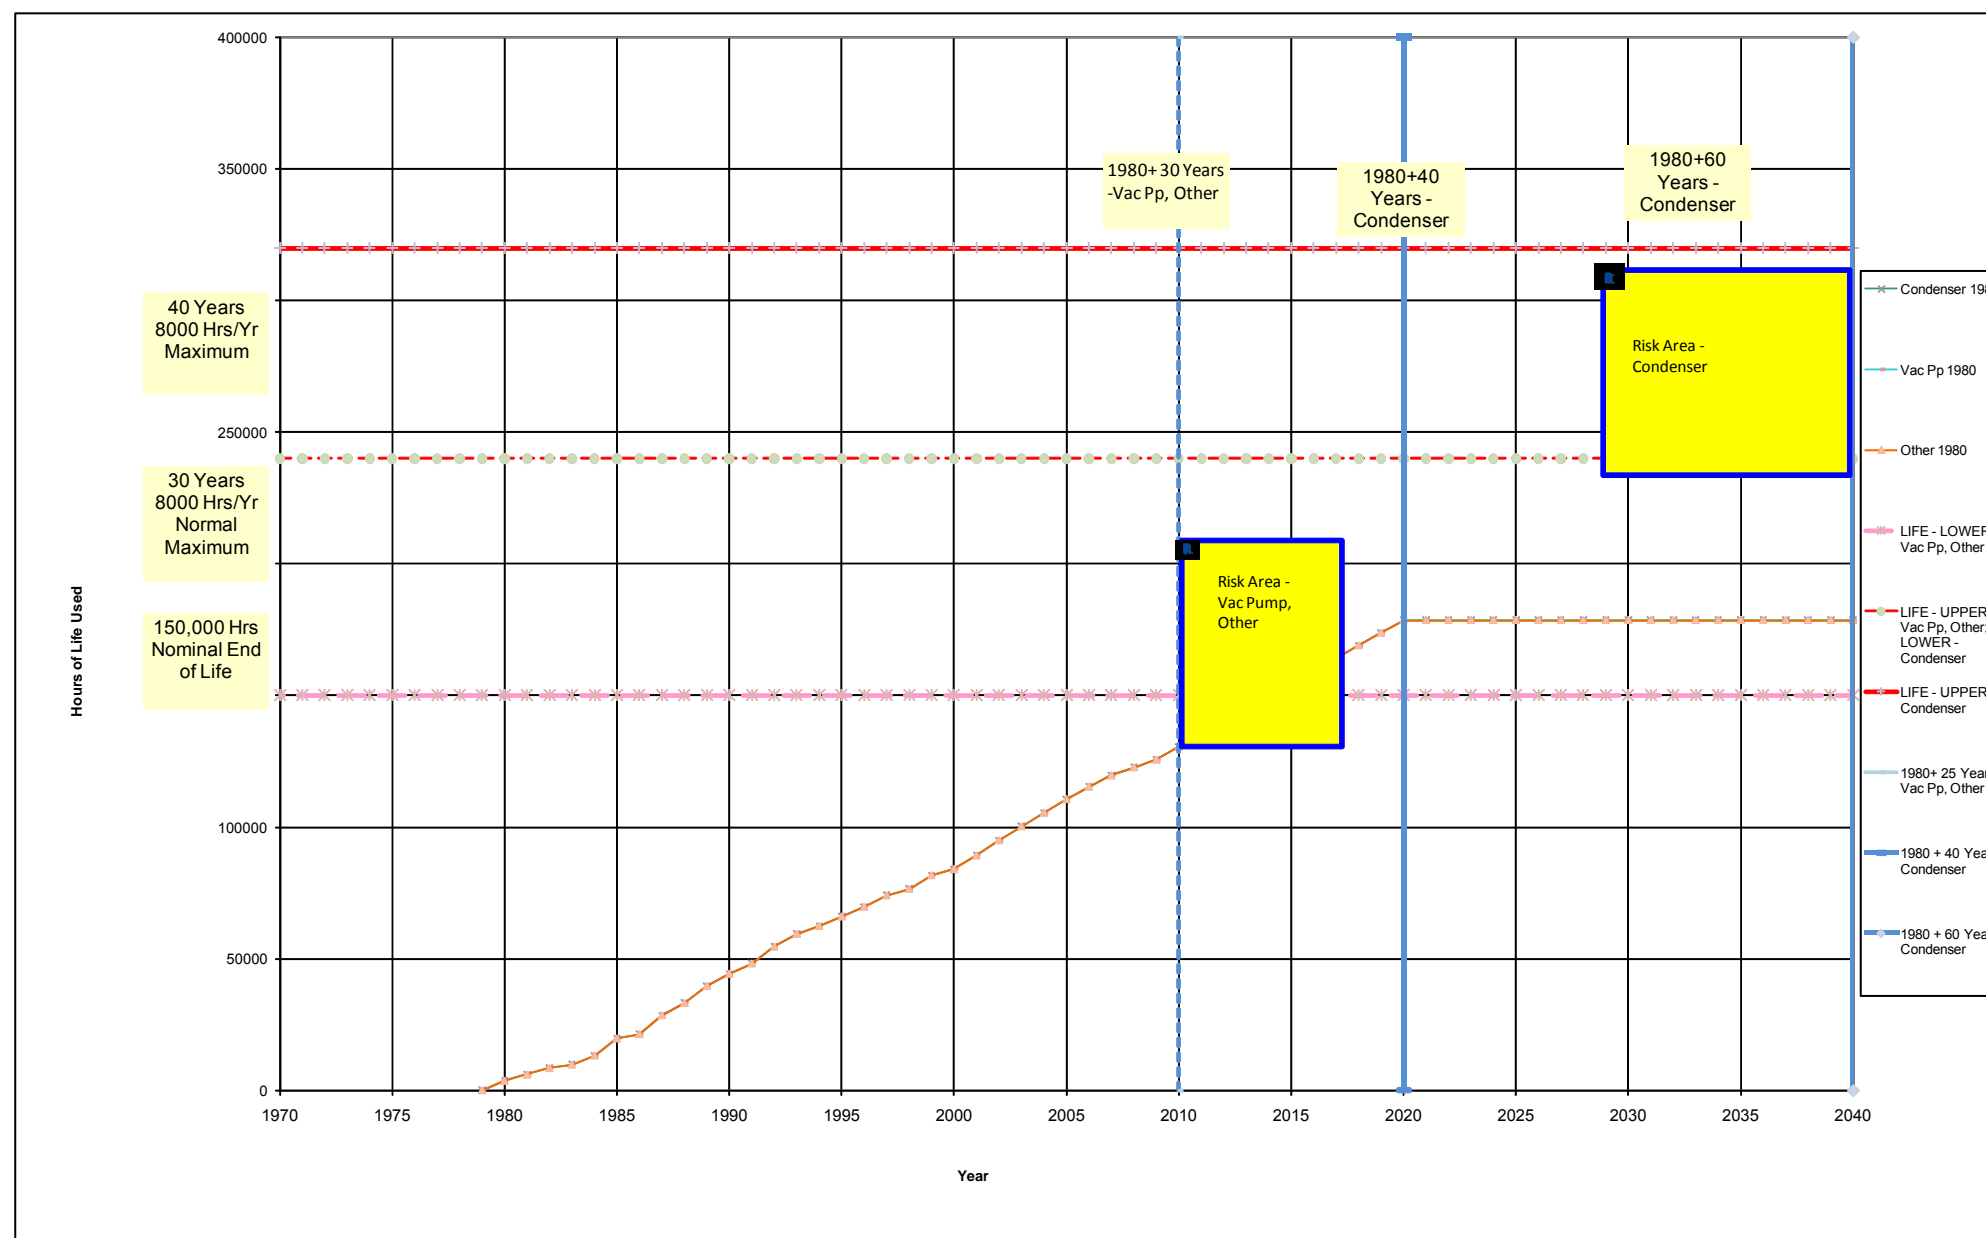
FIGURE 10-21 LIFE CYCLE CURVE – UNIT 3 CONDENSER

With the exception of the vacuum pumps, the curves indicate that the remaining life (RL) of the Unit 3 condenser can easily reach the desired life (DL) 2020 end date for generation. Additional information at the 2013 and 2016 turbine inspections should further confirm the condition. The equipment is original and is likely at or near end of life.

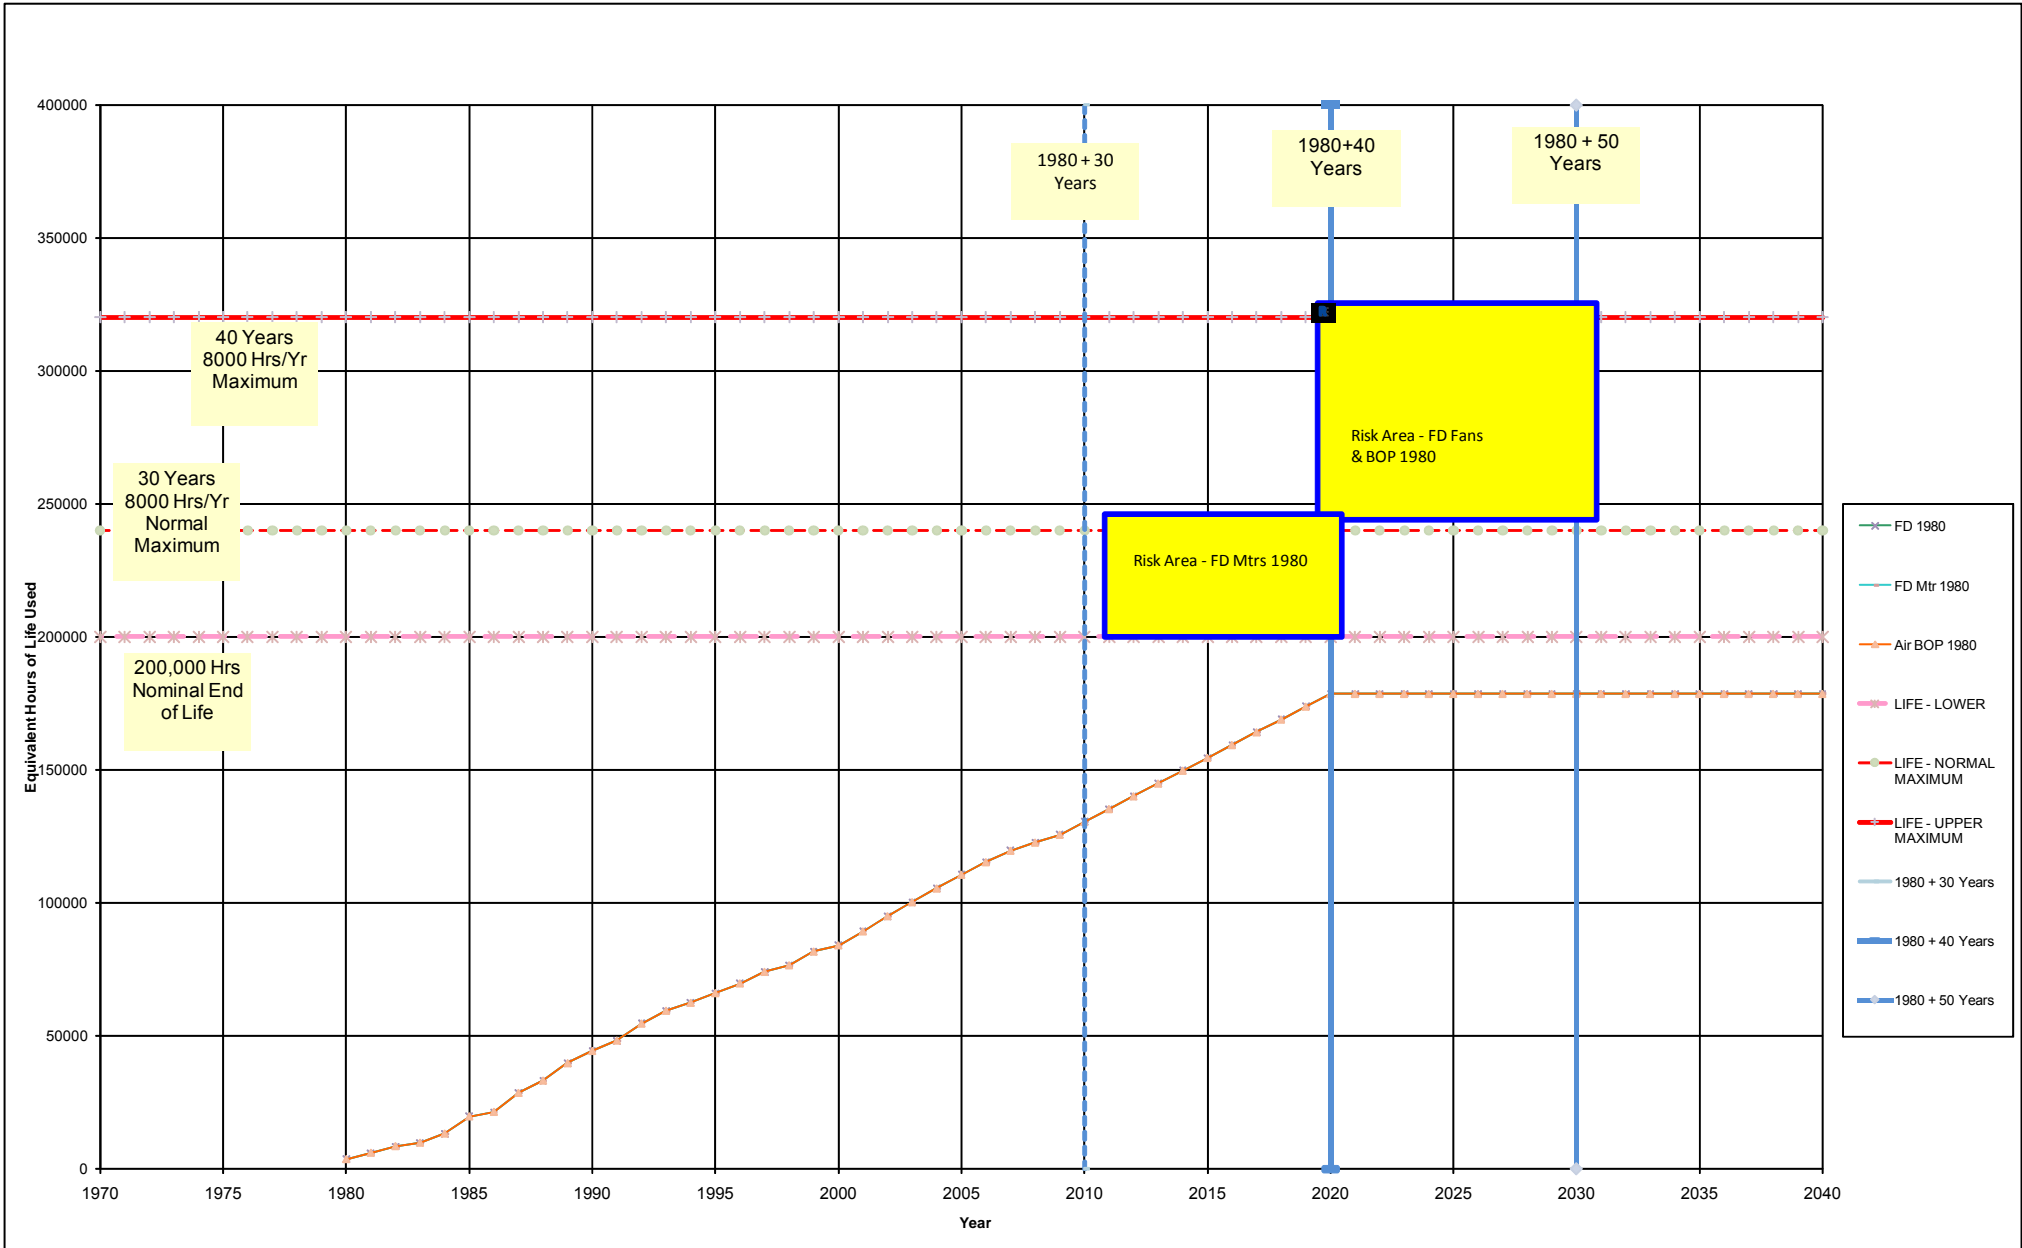
FIGURE 10-22 LIFE CYCLE CURVE – UNIT 3 FD FANS (AND SYSTEM)

The curves indicate that the remaining life (RL) of the Unit 3 FD fans (and system) are likely able to meet or exceed the desired life (DL) 2020 end date for generation. The age of the large 4 kV motors makes them a logical cost-effective candidate for sparing to ensure reliability, although plant testing/monitoring programs are effectively monitoring their status.

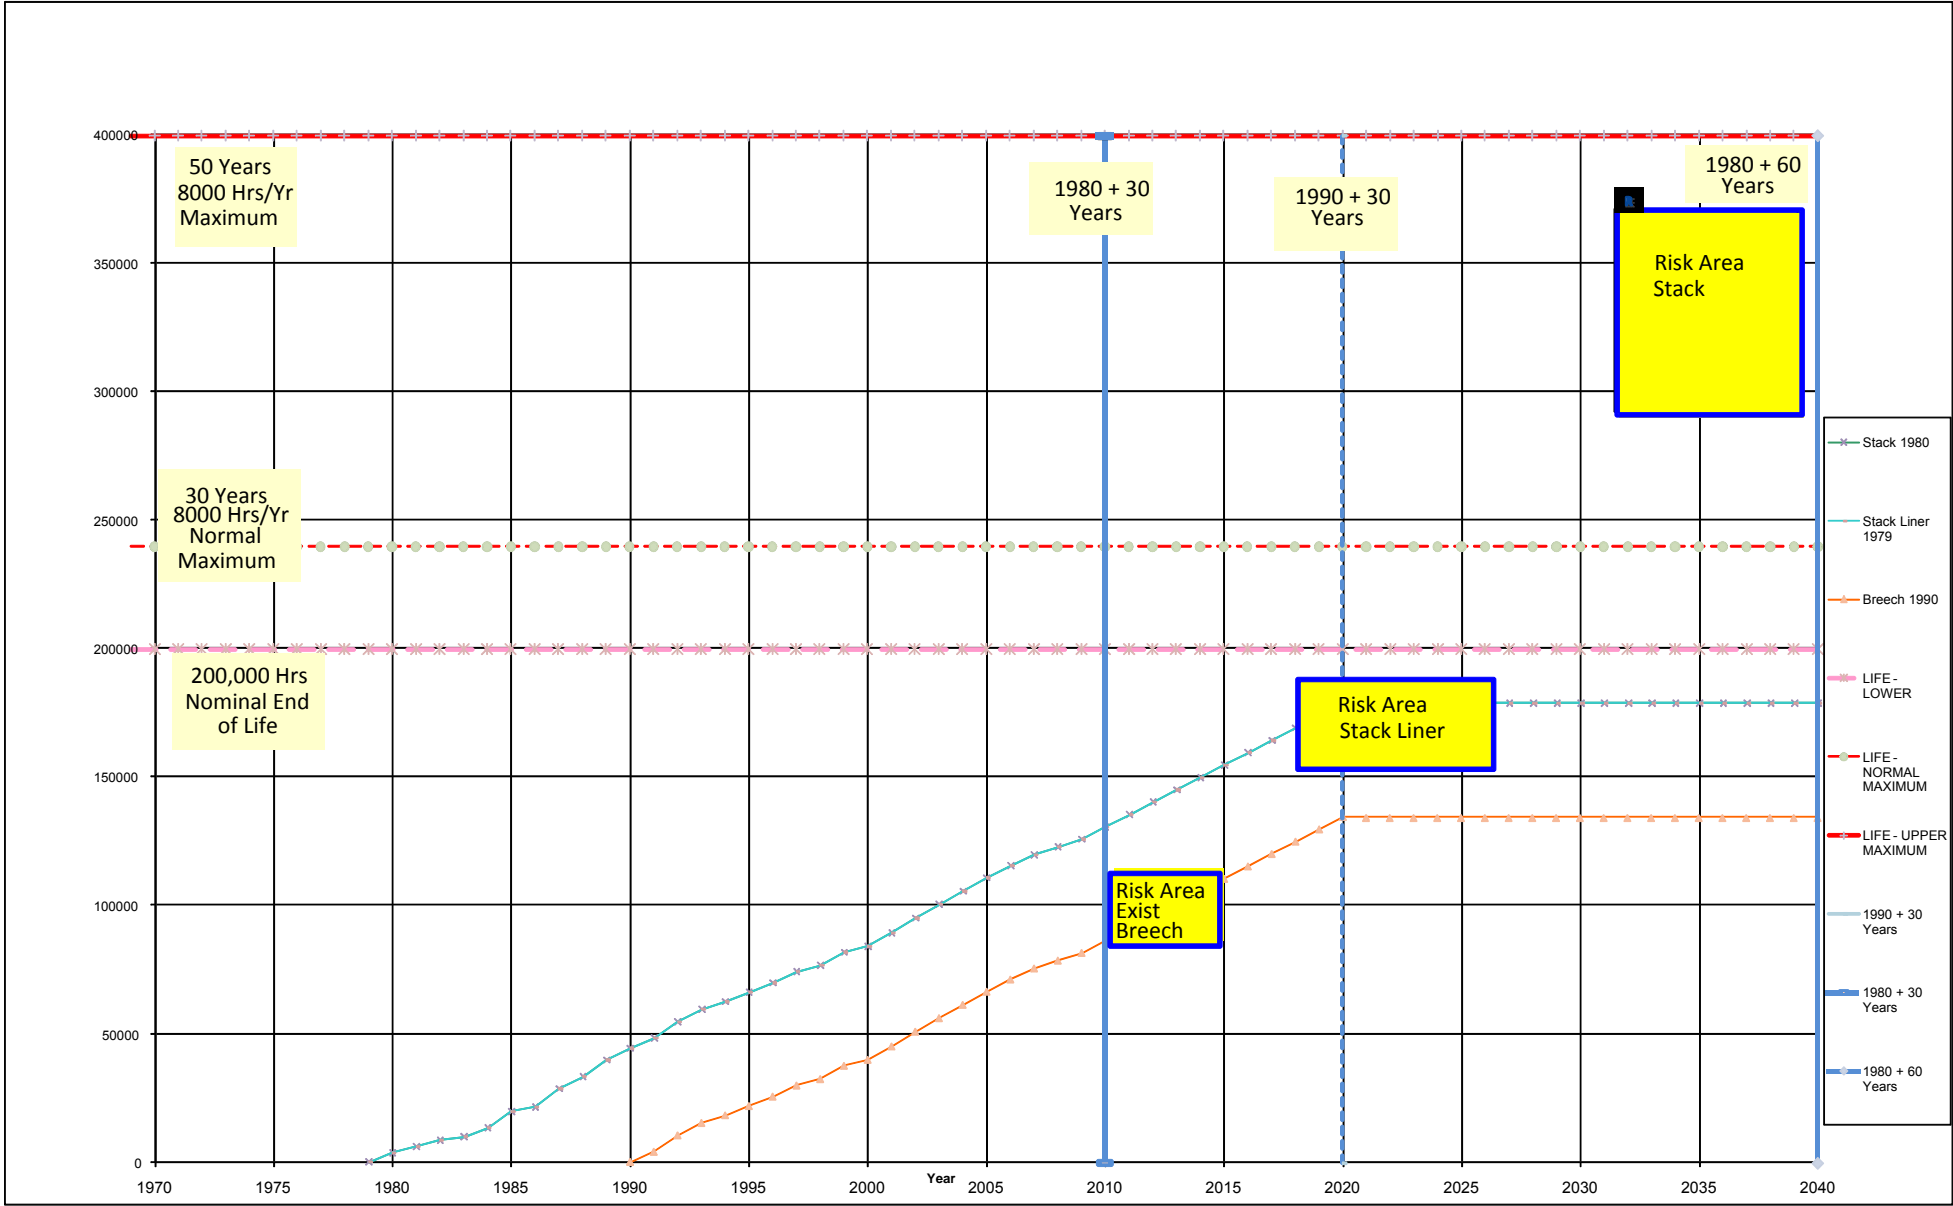
FIGURE 10-23 LIFE CYCLE CURVE – UNIT 3 STACKS AND BREACHING

The curves indicate that the remaining life (RL) of the Unit 3 stack is able to reach the desired life (DL) 2020 end date for generation, as well as the end date of 2041 for synchronous condensing/plant life. It does show that the stack breaching is in need of immediate repair. The breaching requirement is not a normal life issue, but one of design. Other elements can achieve the 2020 end date for generation with the ongoing plant maintenance program.

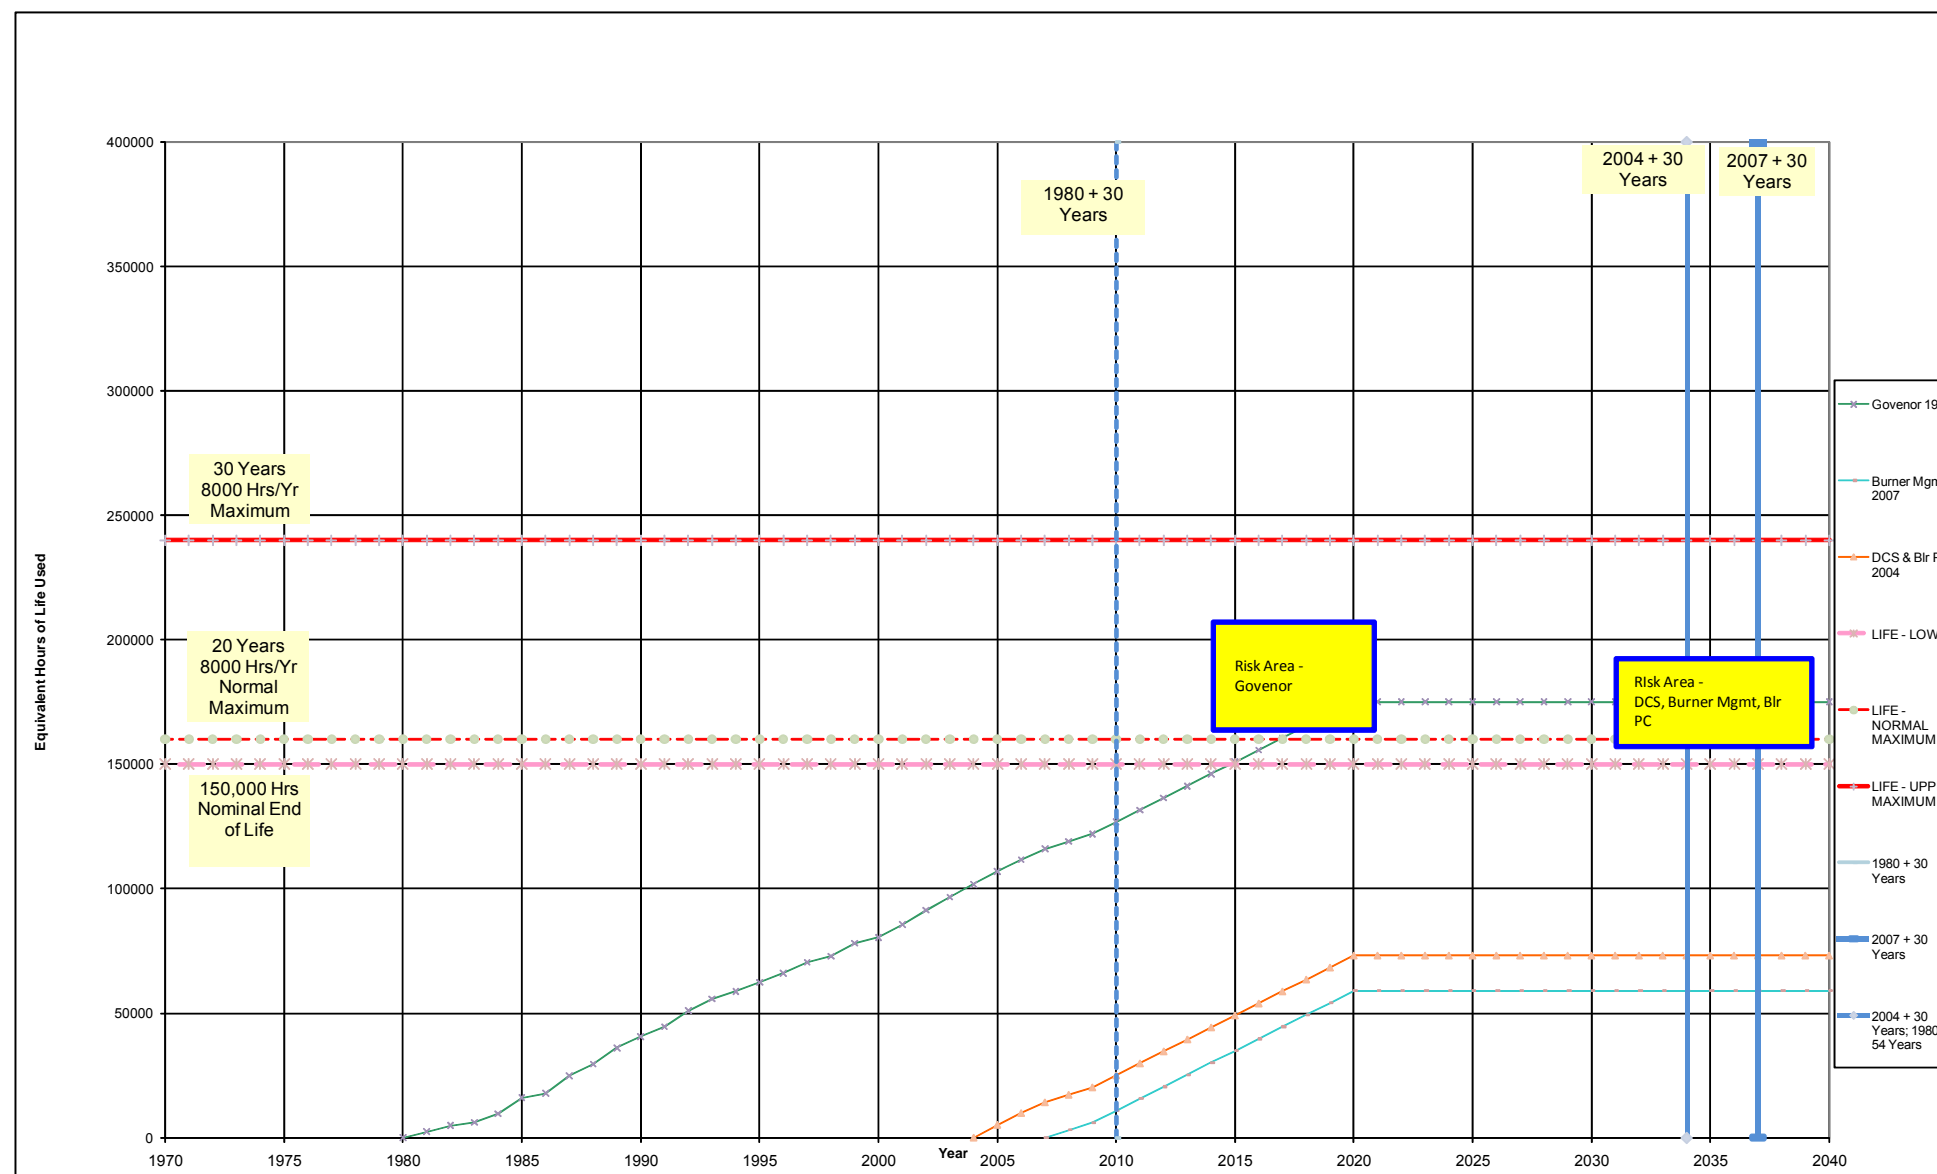
FIGURE 10-24 LIFE CYCLE CURVE – UNIT 3 ELECTRICAL AND CONTROL SYSTEMS (INCLUDING DCS) ASSOCIATED WITH STEAM SYSTEMS

The curves indicate that the remaining life (RL) of the Unit 3 control systems (including DCS) associated with steam systems can readily reach the desired life (DL) 2020 end date for generation, provided regular inspection and service per the station PM plan is maintained. The electrical systems, particularly breakers and motor controls are addressed in more detail as part of Section 10.1.3. It is clear that in order to meet the end date for generation service, some of these components must be replaced or in some cases refurbished.
