Holyrood Thermal Generating Station (Holyrood) Condition Assessment & Life Extension Study, - Final Report

**Holyrood Thermal
 Generating Station
 Condition Assessment &
 Life Extension Study**

January 28, 2011

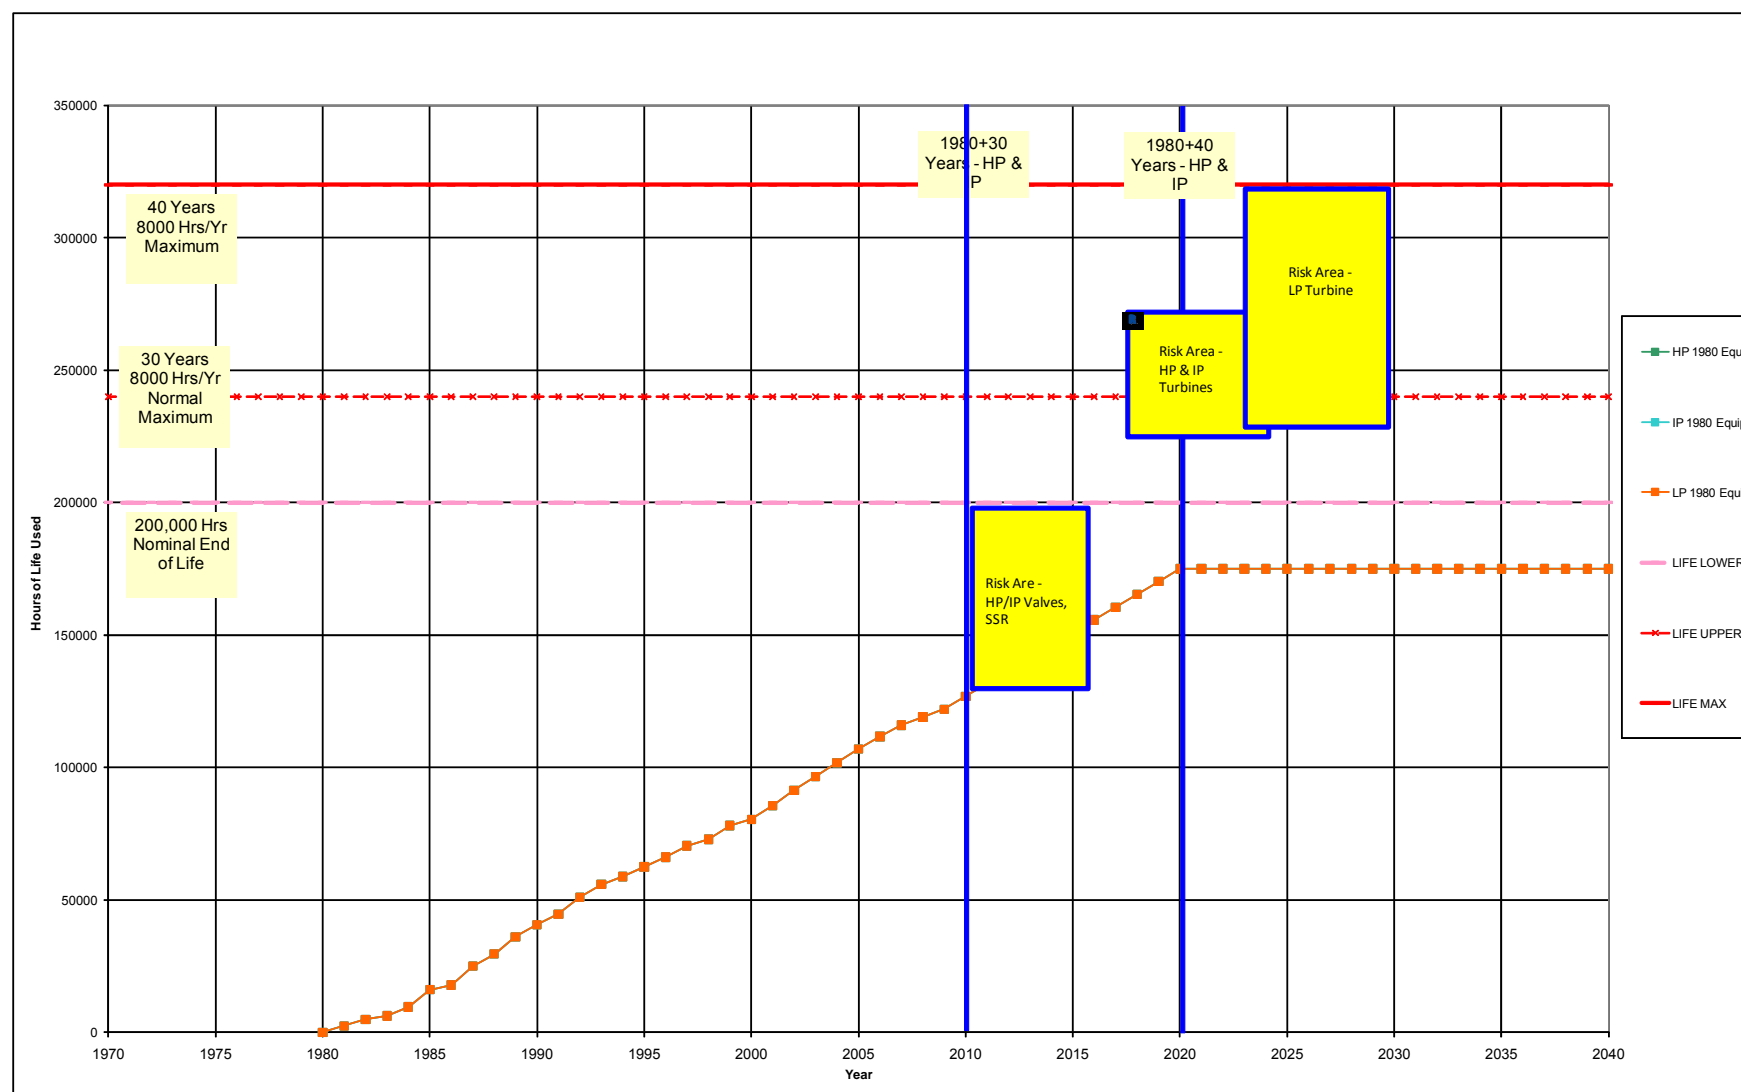
FIGURE 10-25 LIFE CYCLE CURVE – UNIT 3 STEAM TURBINE

The curves indicate that the remaining life (RL) of the various elements of the Unit 3 steam turbine exceeds the desired life (DL) which is the lesser of the time to its next major planned overhaul/inspection (2016) or to the desired End of Life (EOL) date of 2020. In fact the 2020 end date should be readily achievable. No specific dedicated Level 2 is required, but sufficient inspection and testing will be required in the 2016 overhaul to confirm the ability to meet the 2020 EOL date. The exception to this is the SSR and the high temperature stud bolts. It is clear that the current inspection schedule seems suitable.

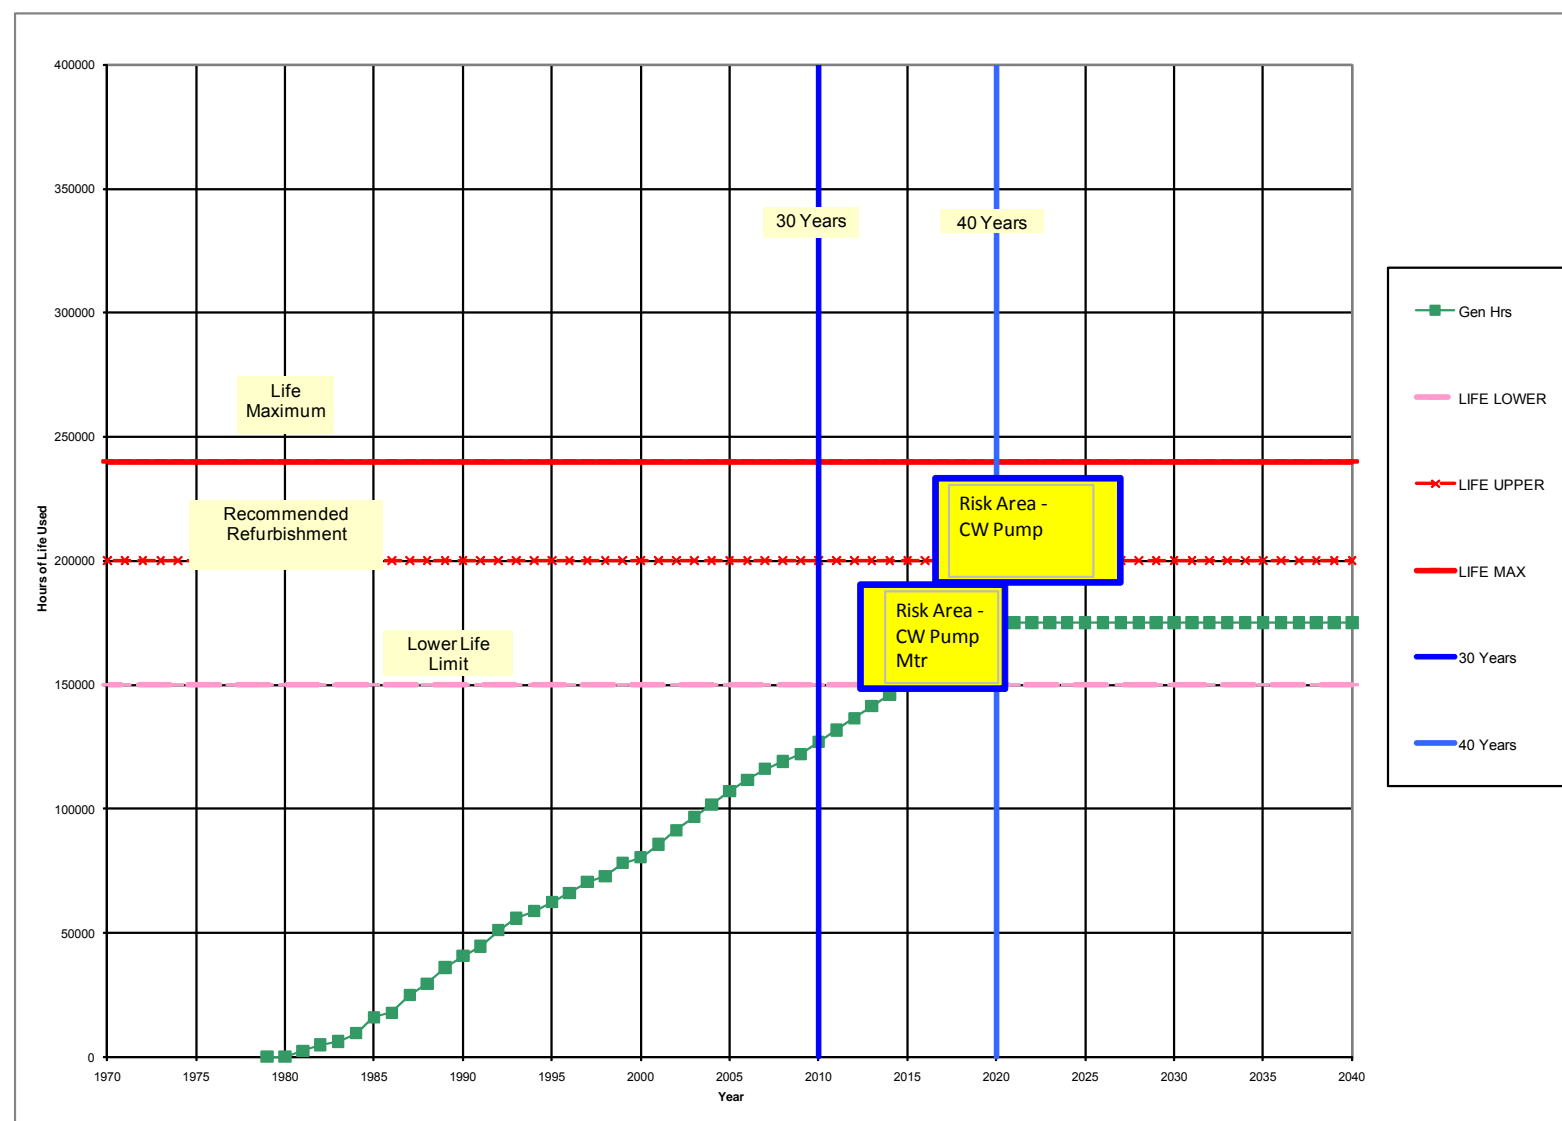
FIGURE 10-29 LIFE CYCLE CURVE – COOLING WATER SYSTEM - ASSOCIATED WITH STEAM SYSTEMS

The curves indicate that the remaining life (RL) of the Unit 3 cooling water system - associated with steam systems can likely reach the desired life (DL) end date for generation of 2020, but with some reliability risk, particularly as it pertains to the 4 kV motors. It is recommended that a spare motor shared between units would be a reasonable precaution. Corrosion of the steel pipe, valves, and fittings was also evident suggesting that some maintenance on these issues is required.

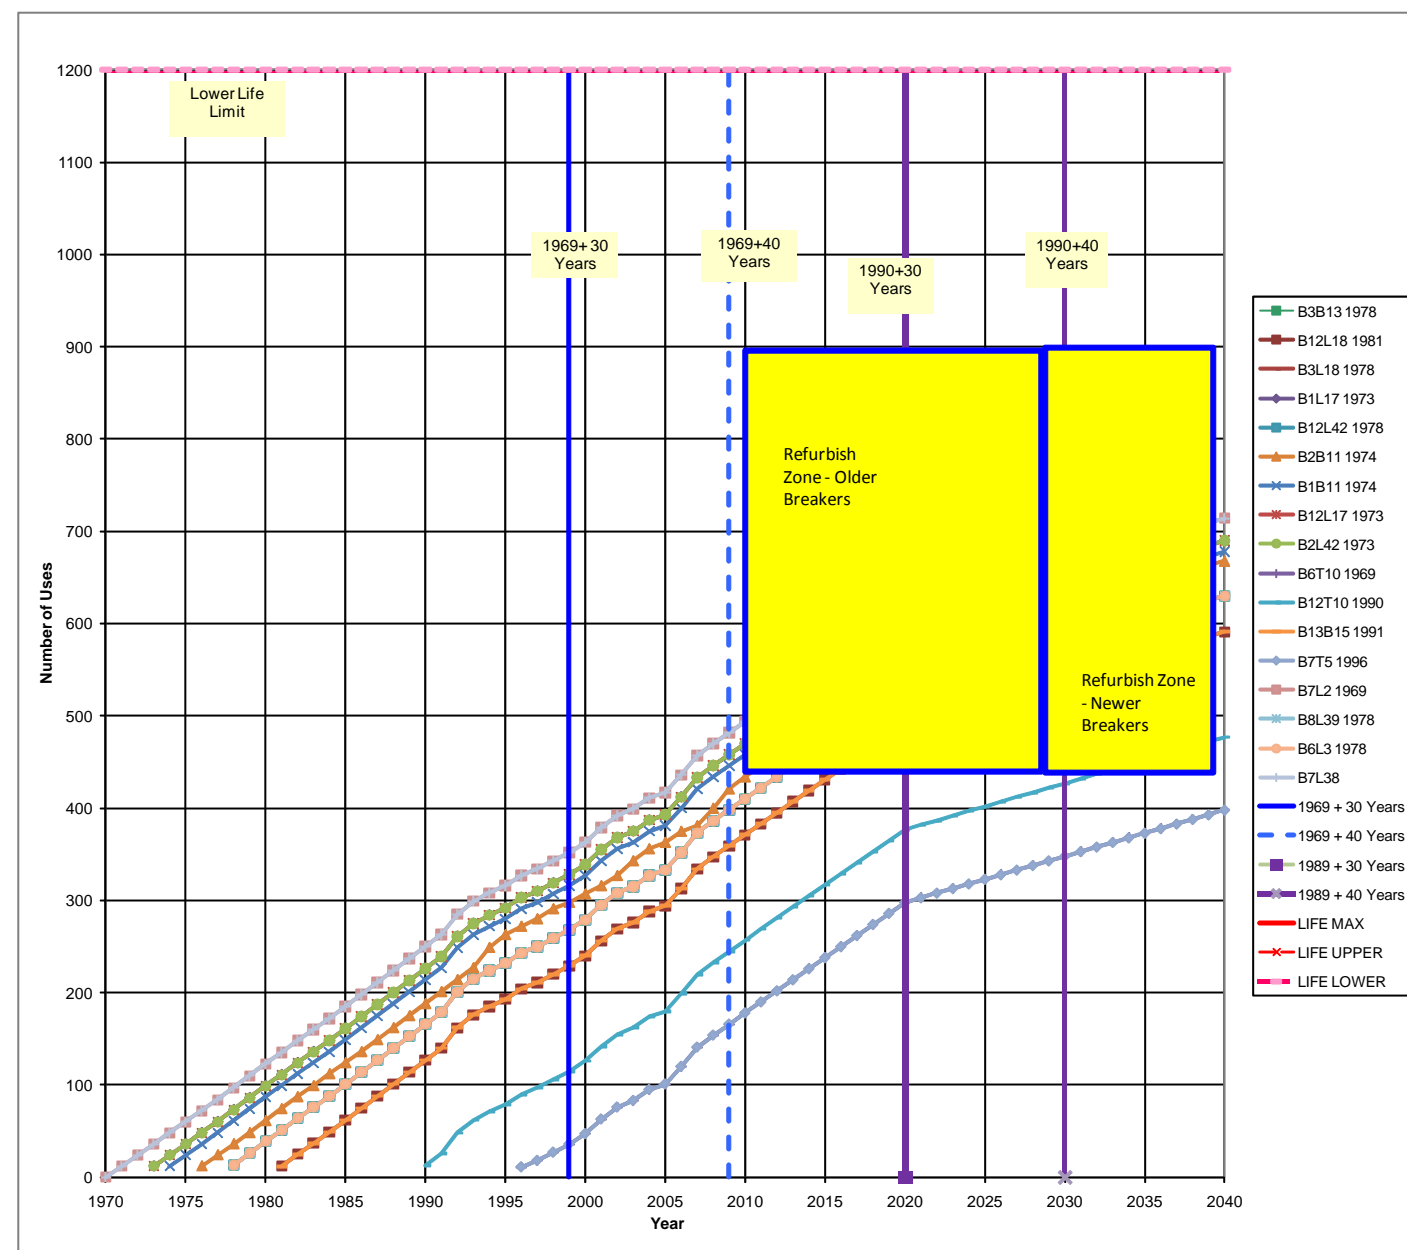
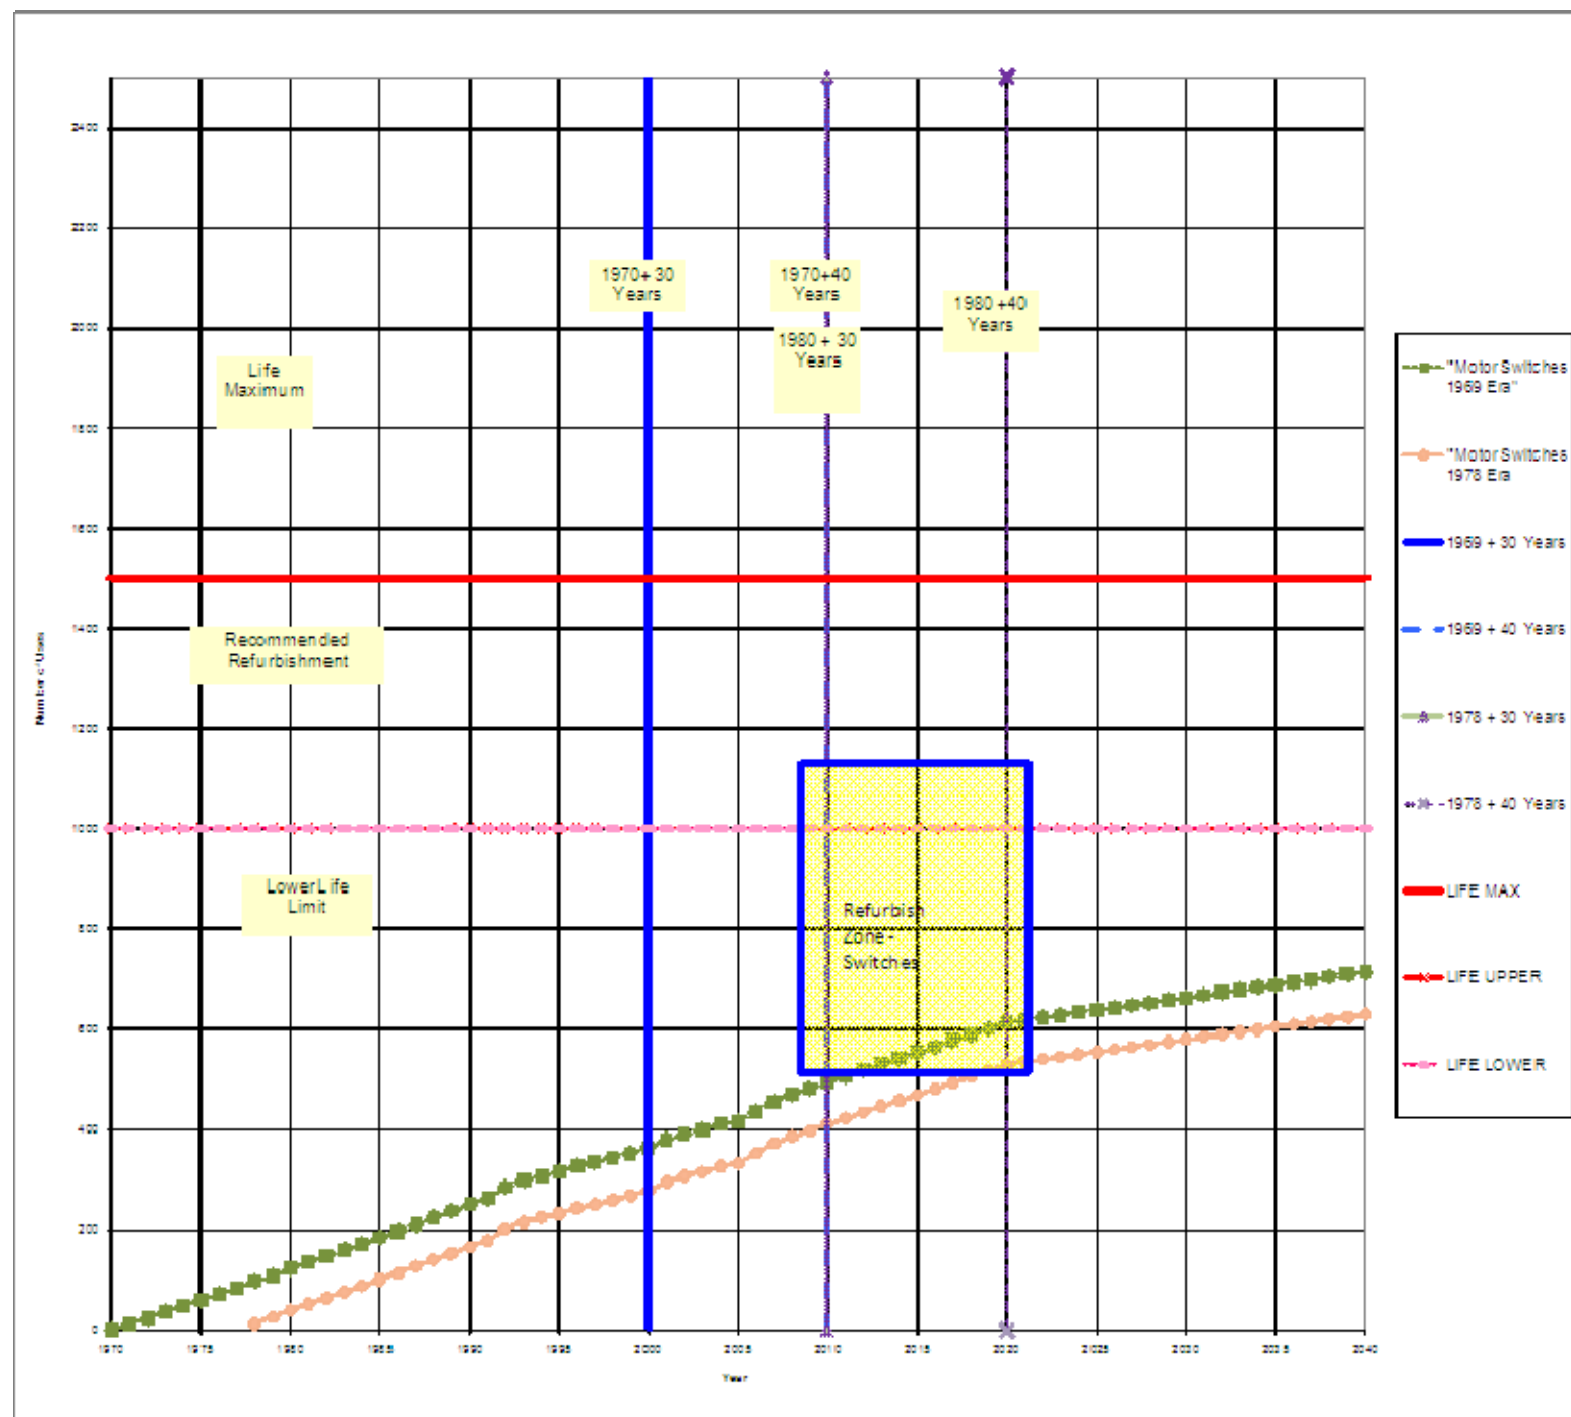
The curves indicate that the remaining life (RL) of the switchyard switchgear exceeds the end date for generation of 2020, but not the desired life (DL) of 2041 (at the end of synchronous condensing life) without refurbishment and/or replacement. The equipment has reached an age where reliability is a concern, particularly where system interruptions or lightning storm impacts play a role. Given the critical nature of the station and its switchyard to the supply of the mainland, a pro-active program of testing and refurbishment is a priority.

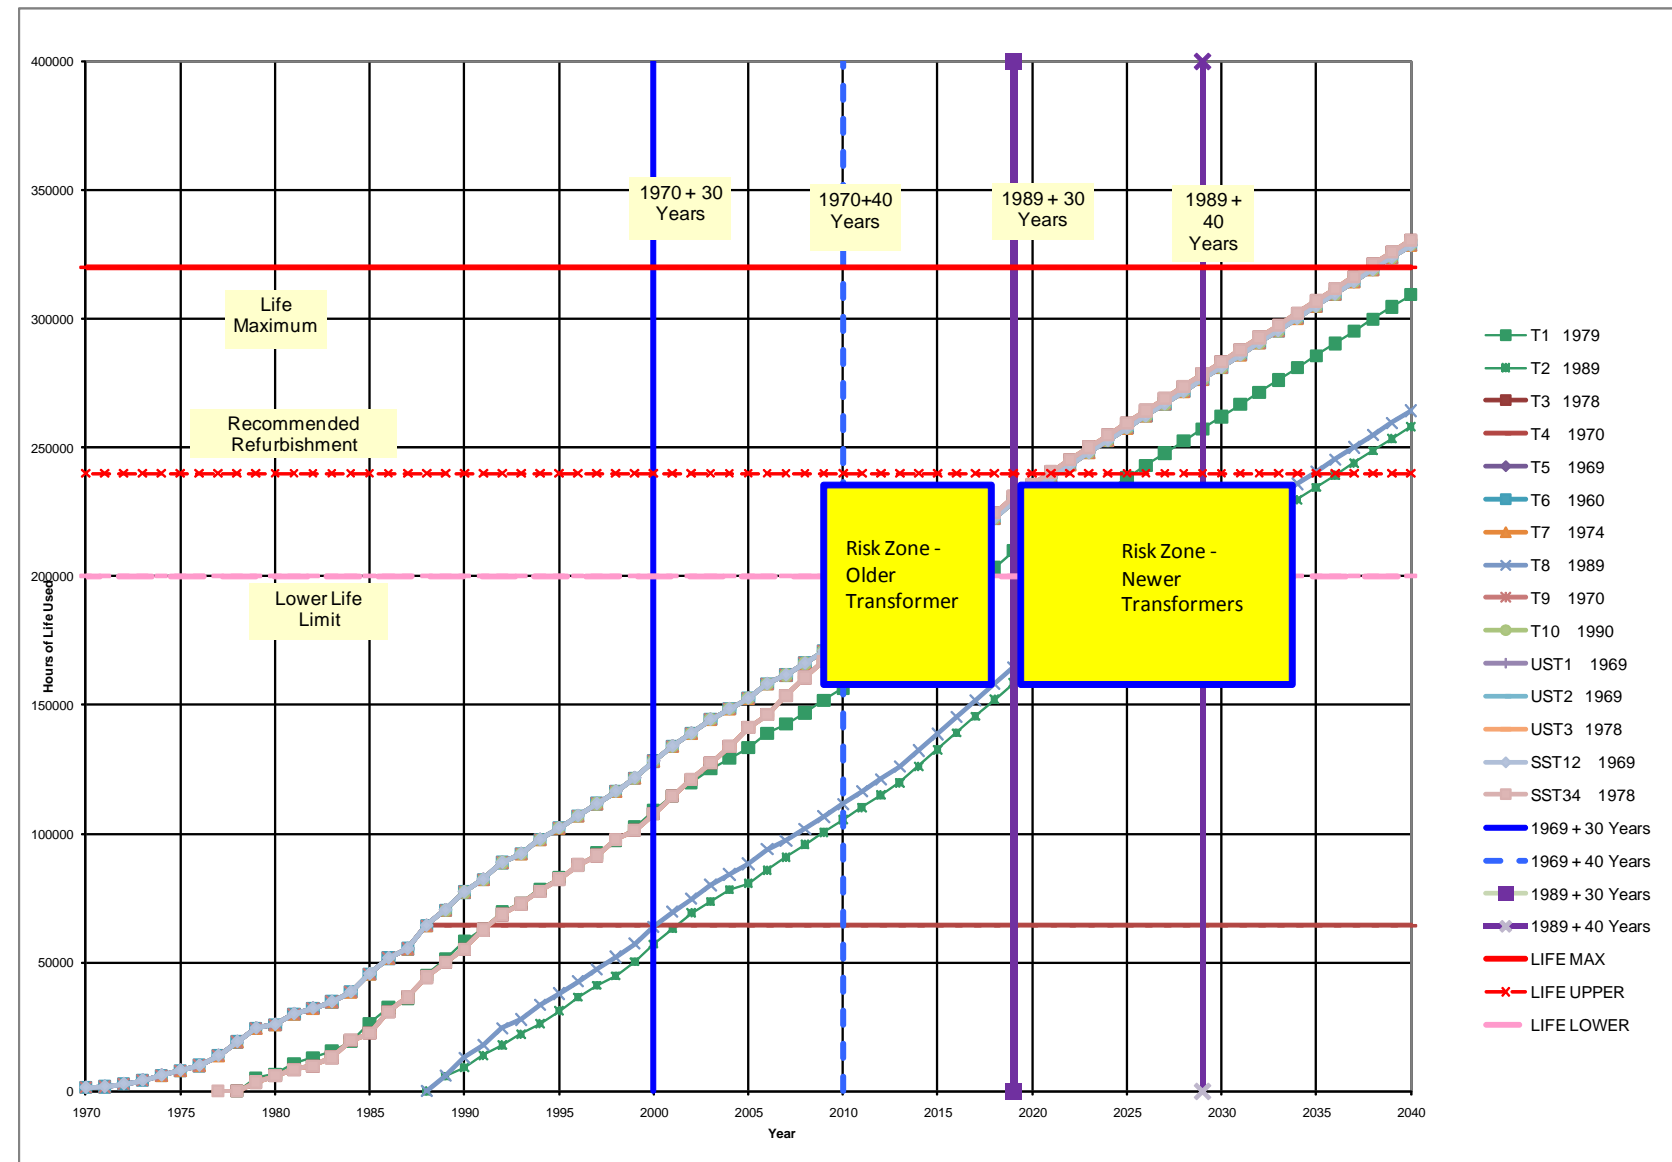
FIGURE 11-7 LIFE CYCLE CURVE – TRANSFORMERS

The curves indicate that the older transformers are in a critical period in their life where their reliability decreases and their likely susceptibility to system disturbance effects is higher. The remaining life (RL) of the transformers exceeds the end date for generation of 2020, but may not exceed the desired life (DL) of 2041 (at the end of synchronous condensing life) without refurbishment and/or replacement. The equipment has reached an age where reliability is a concern, particularly where system interruptions or lightning storm impacts play a role. Given the critical nature of the station and its switchyard to the supply of the mainland, a pro-active program of testing and refurbishment is a priority.

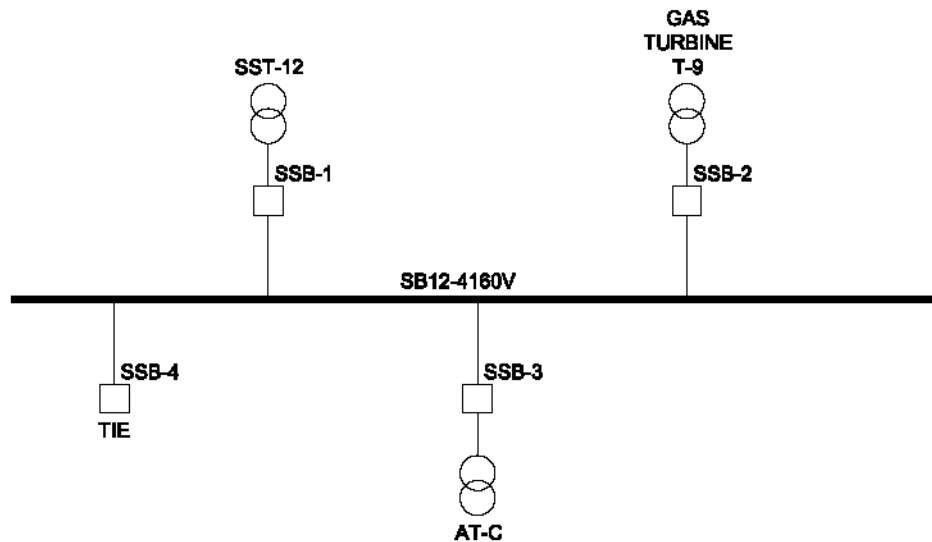
FIGURE 11-8 SB12 SWITCHGEAR

Station Board SB12 (4160V) was manufactured by ITE and installed in 1968. The 4160V switchgear utilizes original ITE type 5HK draw-out power breakers, 1200A and 2000A. Some feeders have Schweitzer 701 motor protection relays added. All other loads utilize original P&B Golds relays. All power breakers are original. All protection, synch, and control relays are original CGE electro-mechanical.

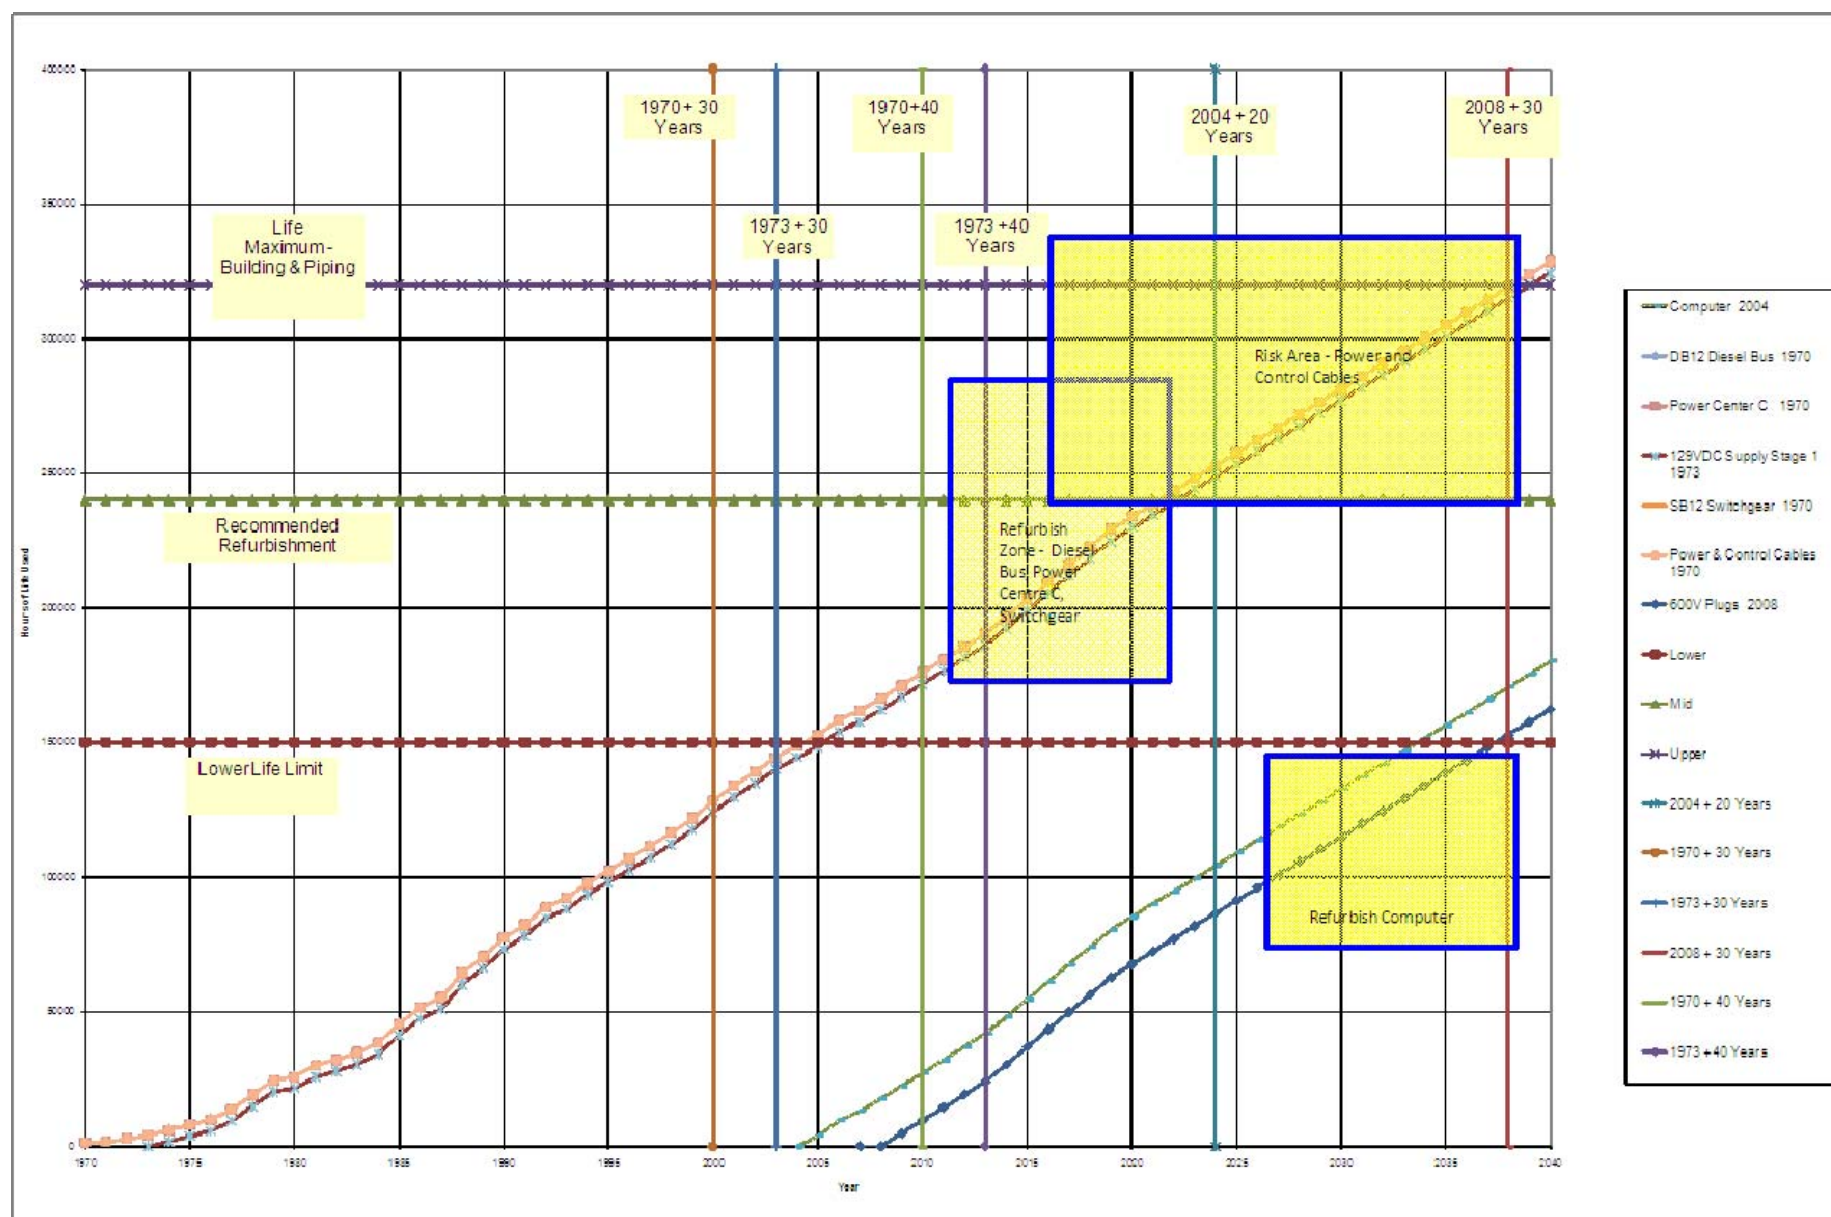
FIGURE 11-9 LIFE CYCLE CURVE – COMMON ELECTRICAL AND CONTROL ASSETS

The curves indicate that the remaining life (RL) of most of the common electrical and control assets exceeds the end date for generation of 2020, but not the desired life (DL) which is the end date for synchronous condensing of 2041. Further, any older switchgear such as breakers or motor control centres will need to be replaced (some possibly refurbished) within the next five years or risk increasing rates of failure.

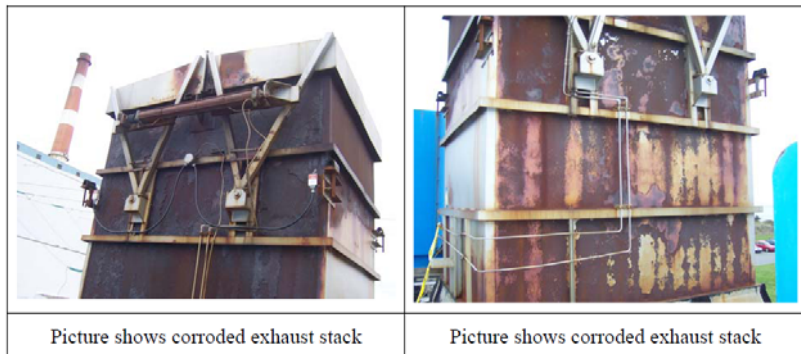
FIGURE 11-10 CORRODED EXHAUST STACK (GAS TURBINE PLANT)

Roofs & Siding: The siding and roof of the gas turbine building, specifically in the area around the stack, at the roofliner, and at the base of the building, show evidence of significant corrosion.

Exhaust Stack: The exhaust stack is extensively corroded with leaks into the building and into the turbine, and should be replaced.

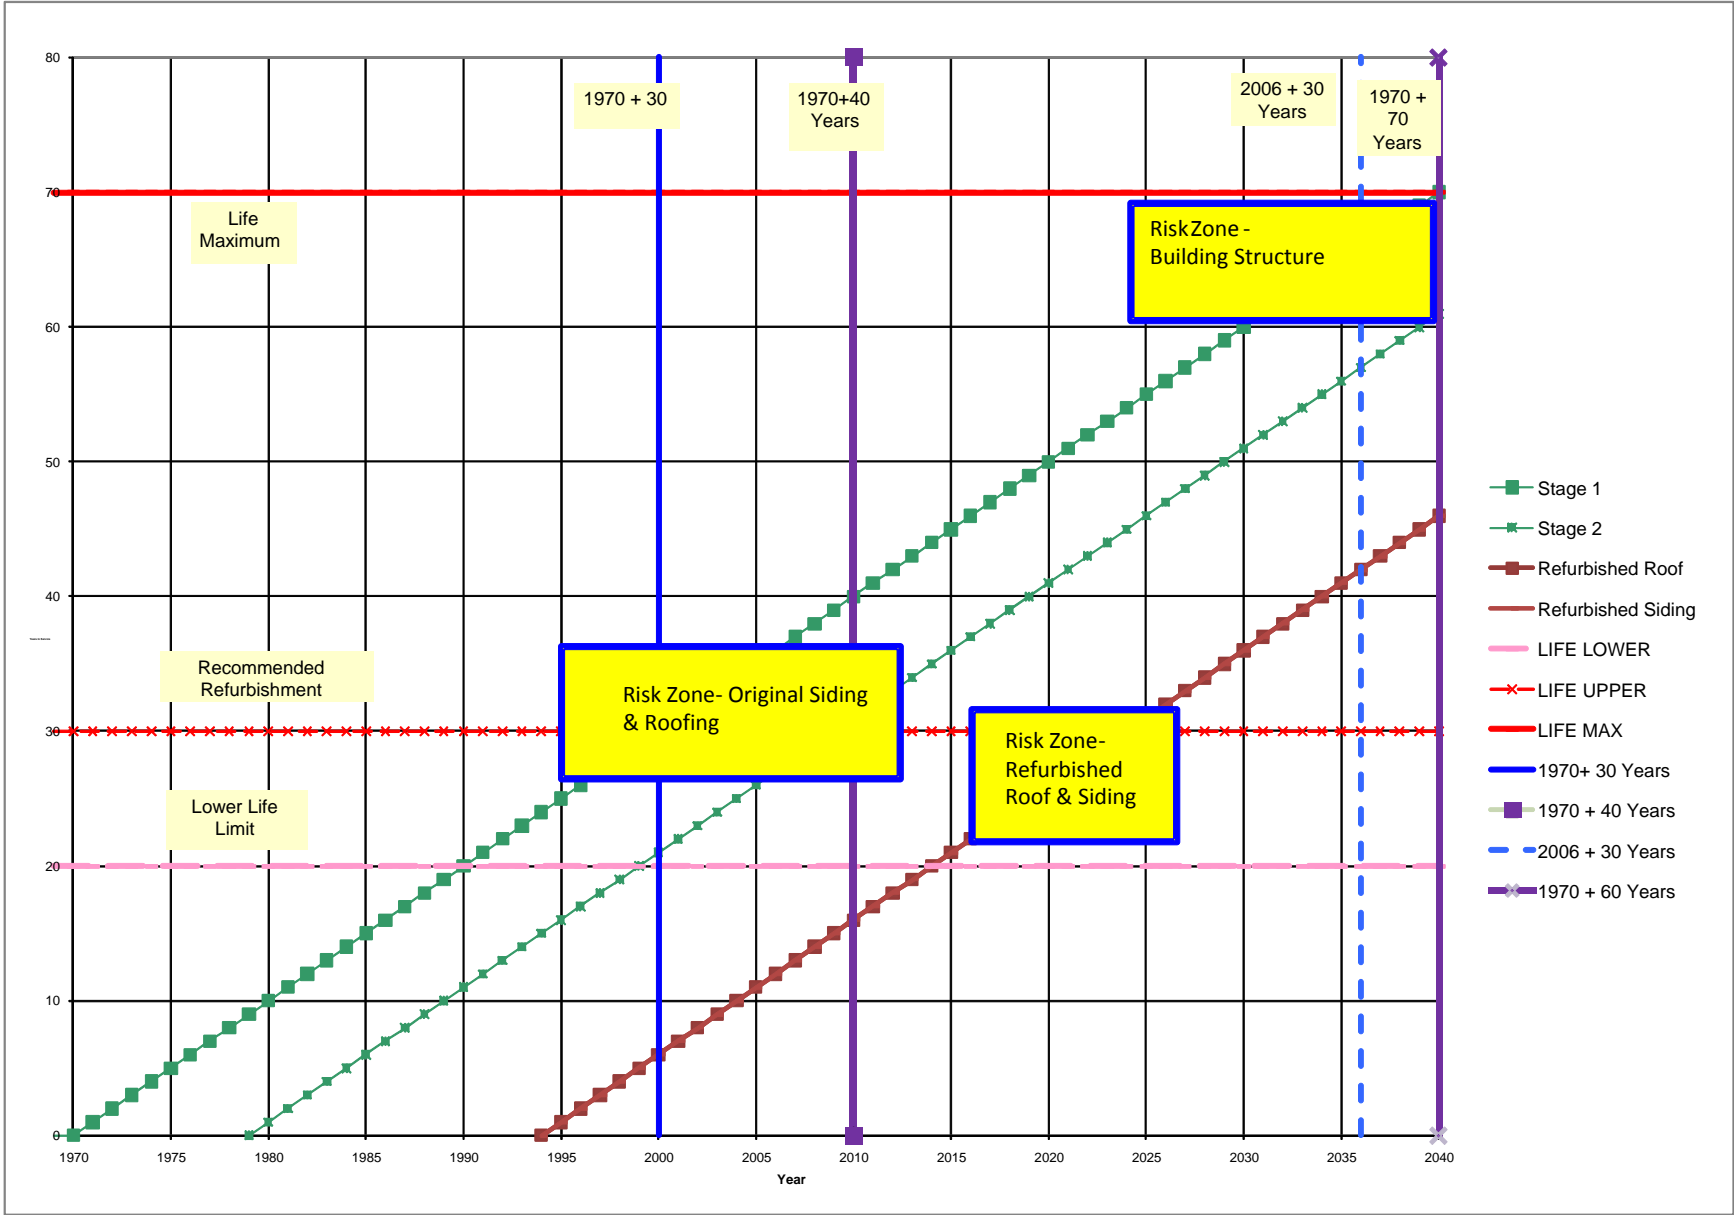
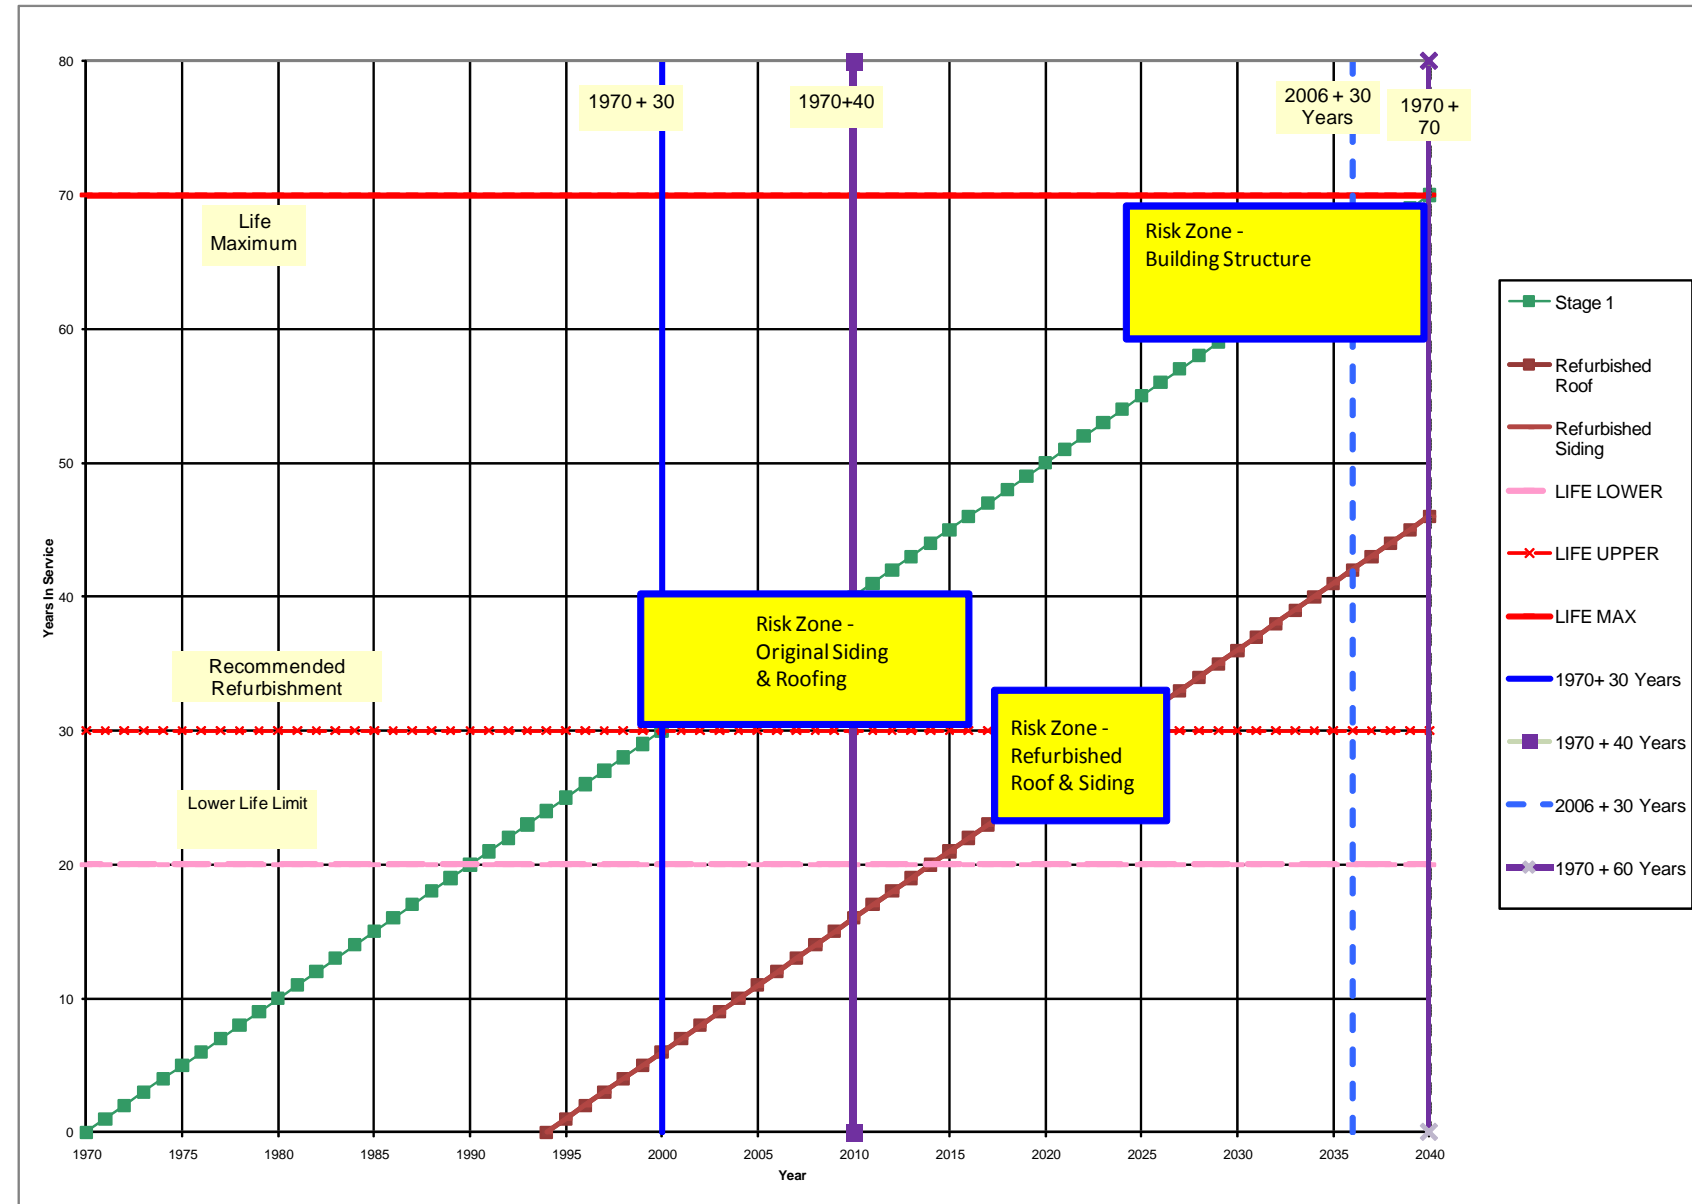
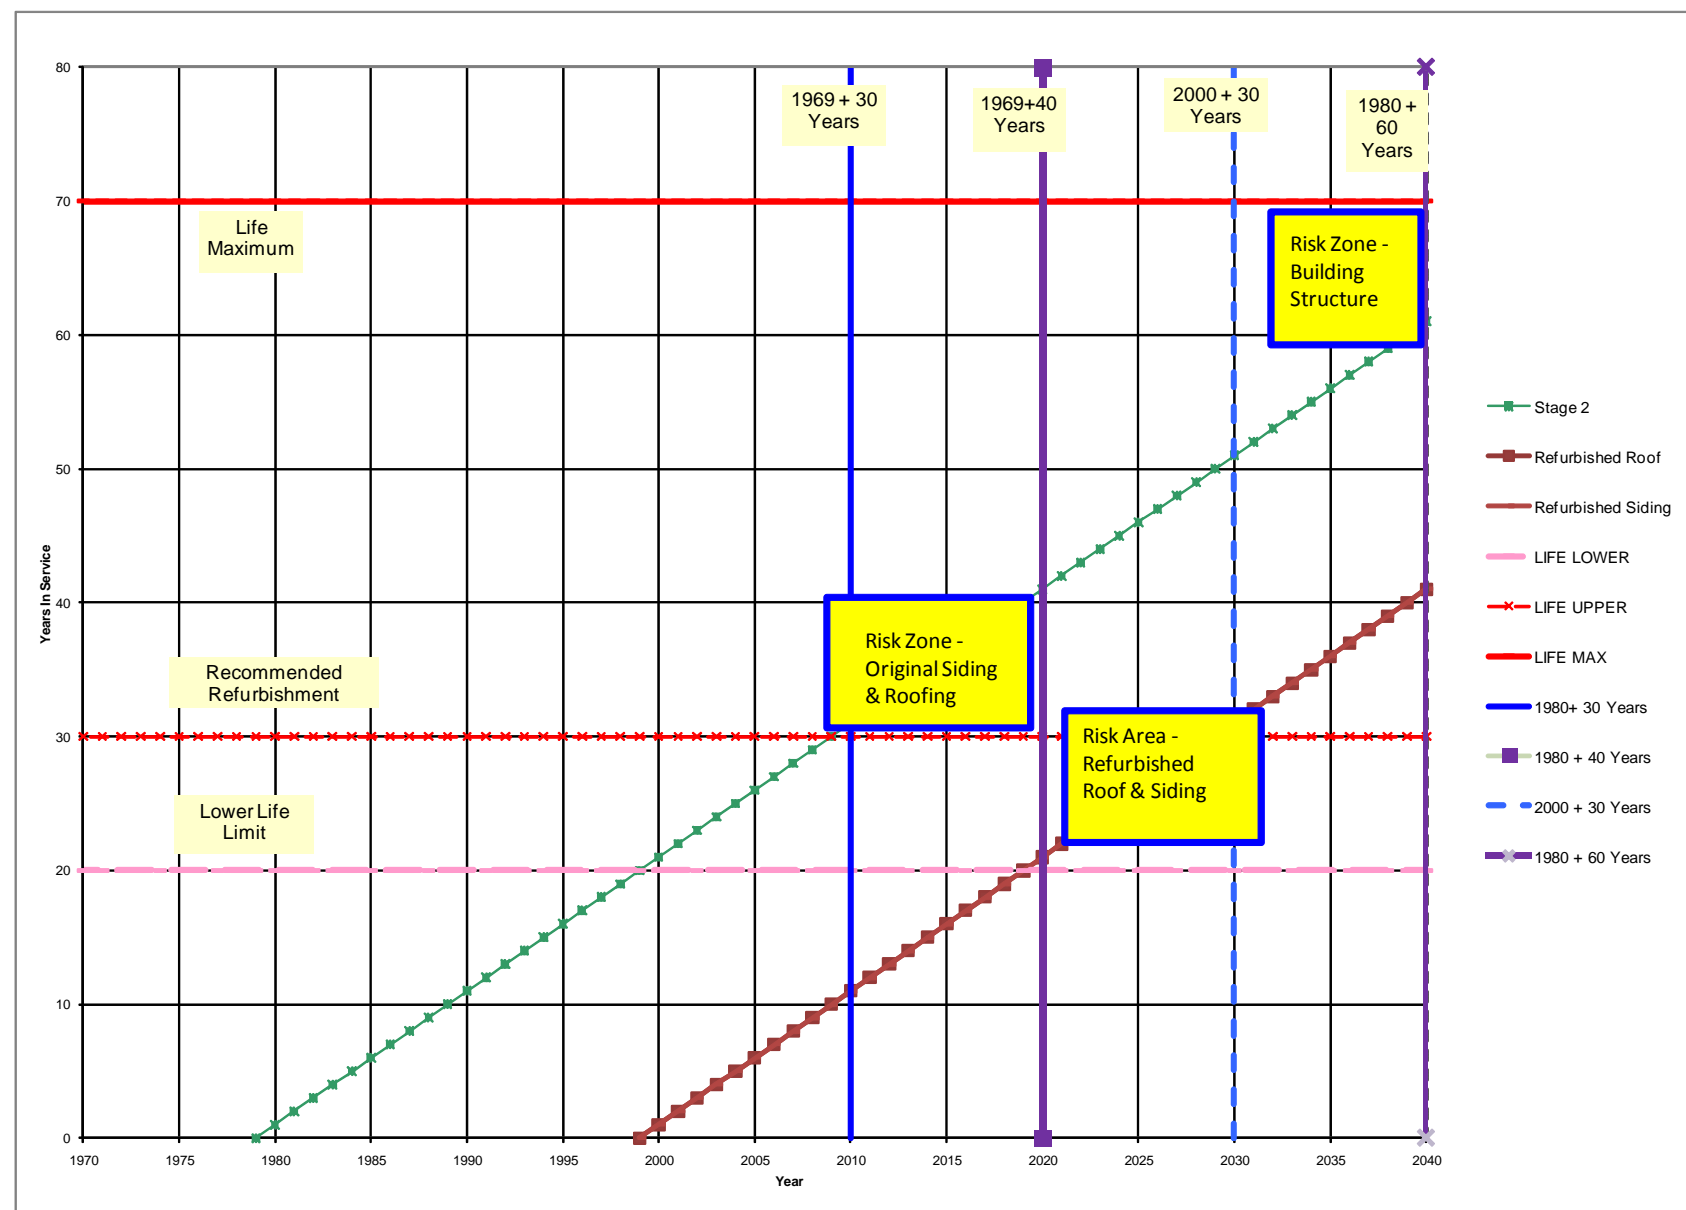
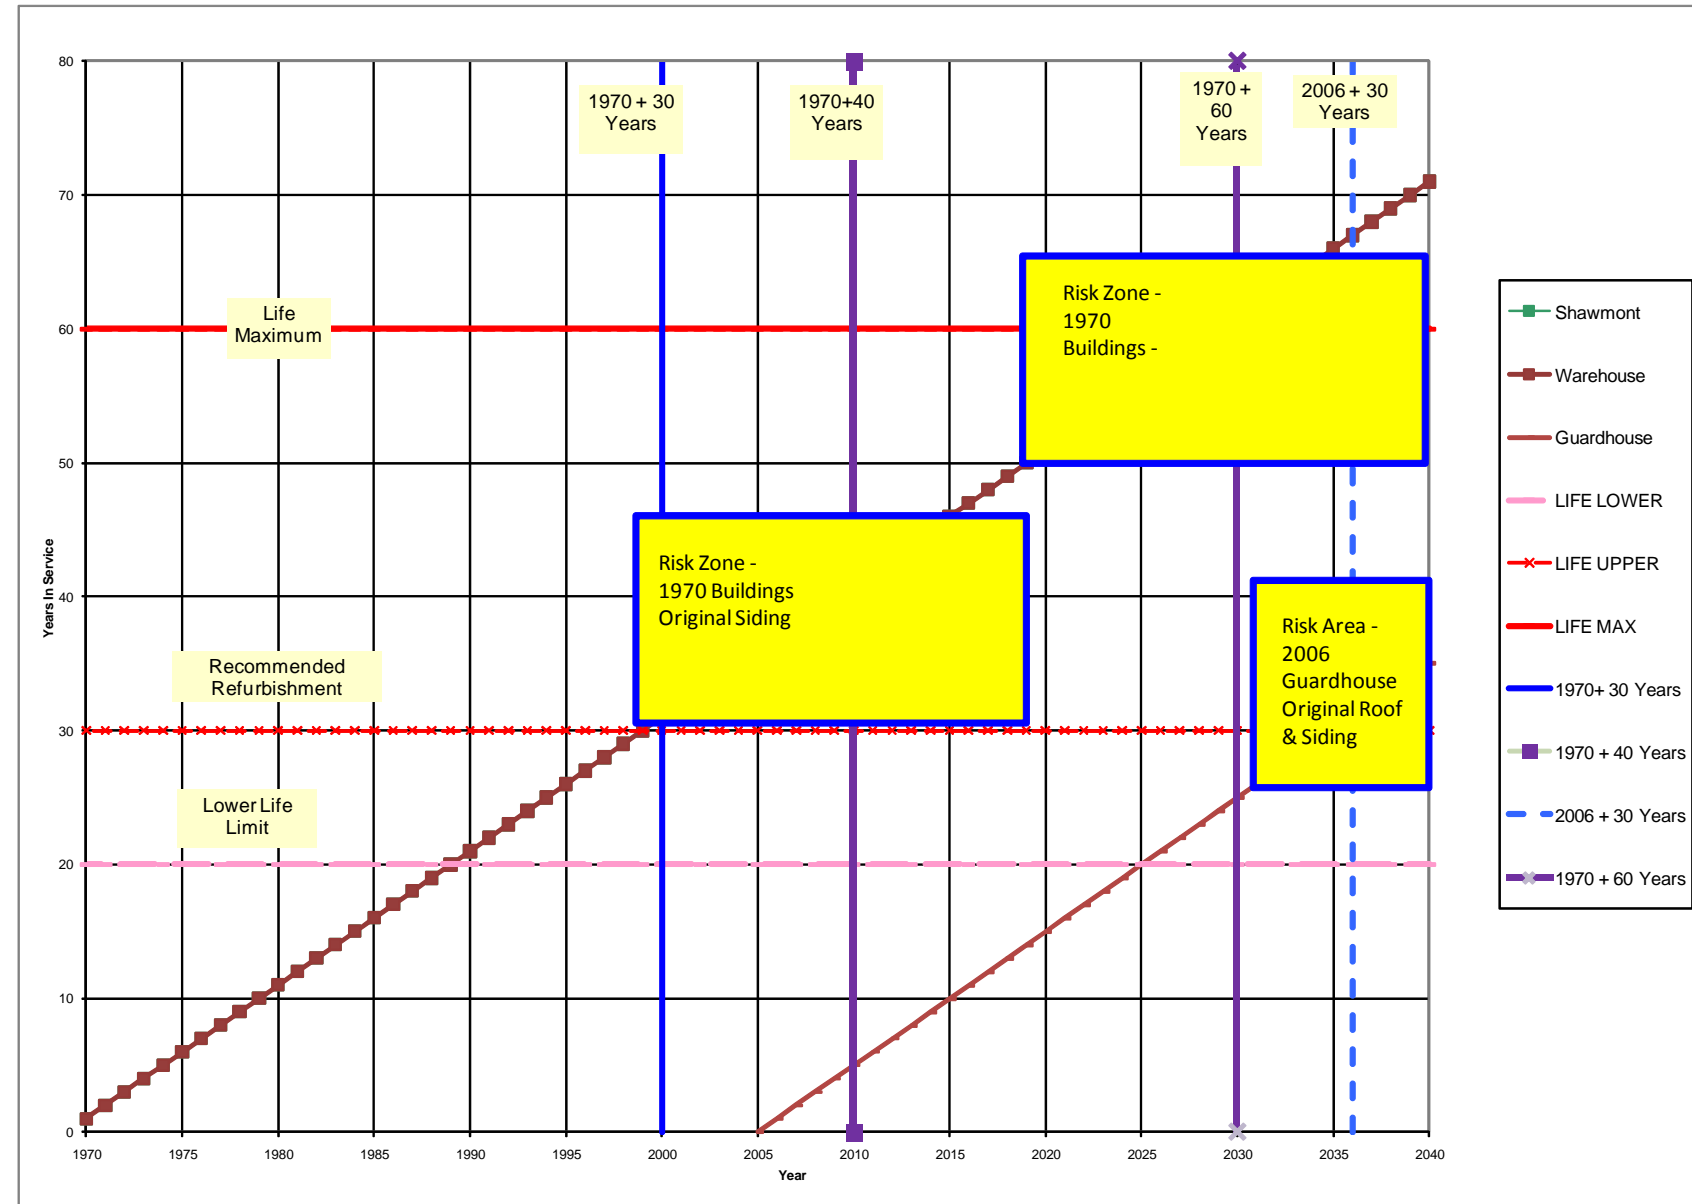
The curves indicate that the remaining life (RL) of most buildings exceeds the generation end date of 2020 and likely the desired life (DL) which is the end date for synchronous generation of 2041. The implementation of a roofing and siding refurbishment program will be necessary between the 2015 to 2025 period, and later for newer buildings or parts of buildings (WTP, guardhouse). The basic structure of most buildings is considered sound, but with limited data available. The primary M and E system of concern (not shown) are the powerhouse house elevators which are likely nearing the end of their reliable service life and should have a major refurbishment or be replaced. Cranes are an issue to continue regular testing, but no specific life issues were identified. Other aspects such as HVAC also will come into play (i.e. condenser vacuum venting, upper roof vent wind protection) in the short term, but nothing major beyond these in the immediate future.
