Holyrood Thermal Generating Station (Holyrood) Condition Assessment & Life Extension Study, - Final Report

**Holyrood Thermal
 Generating Station
 Condition Assessment &
 Life Extension Study**

January 28, 2011

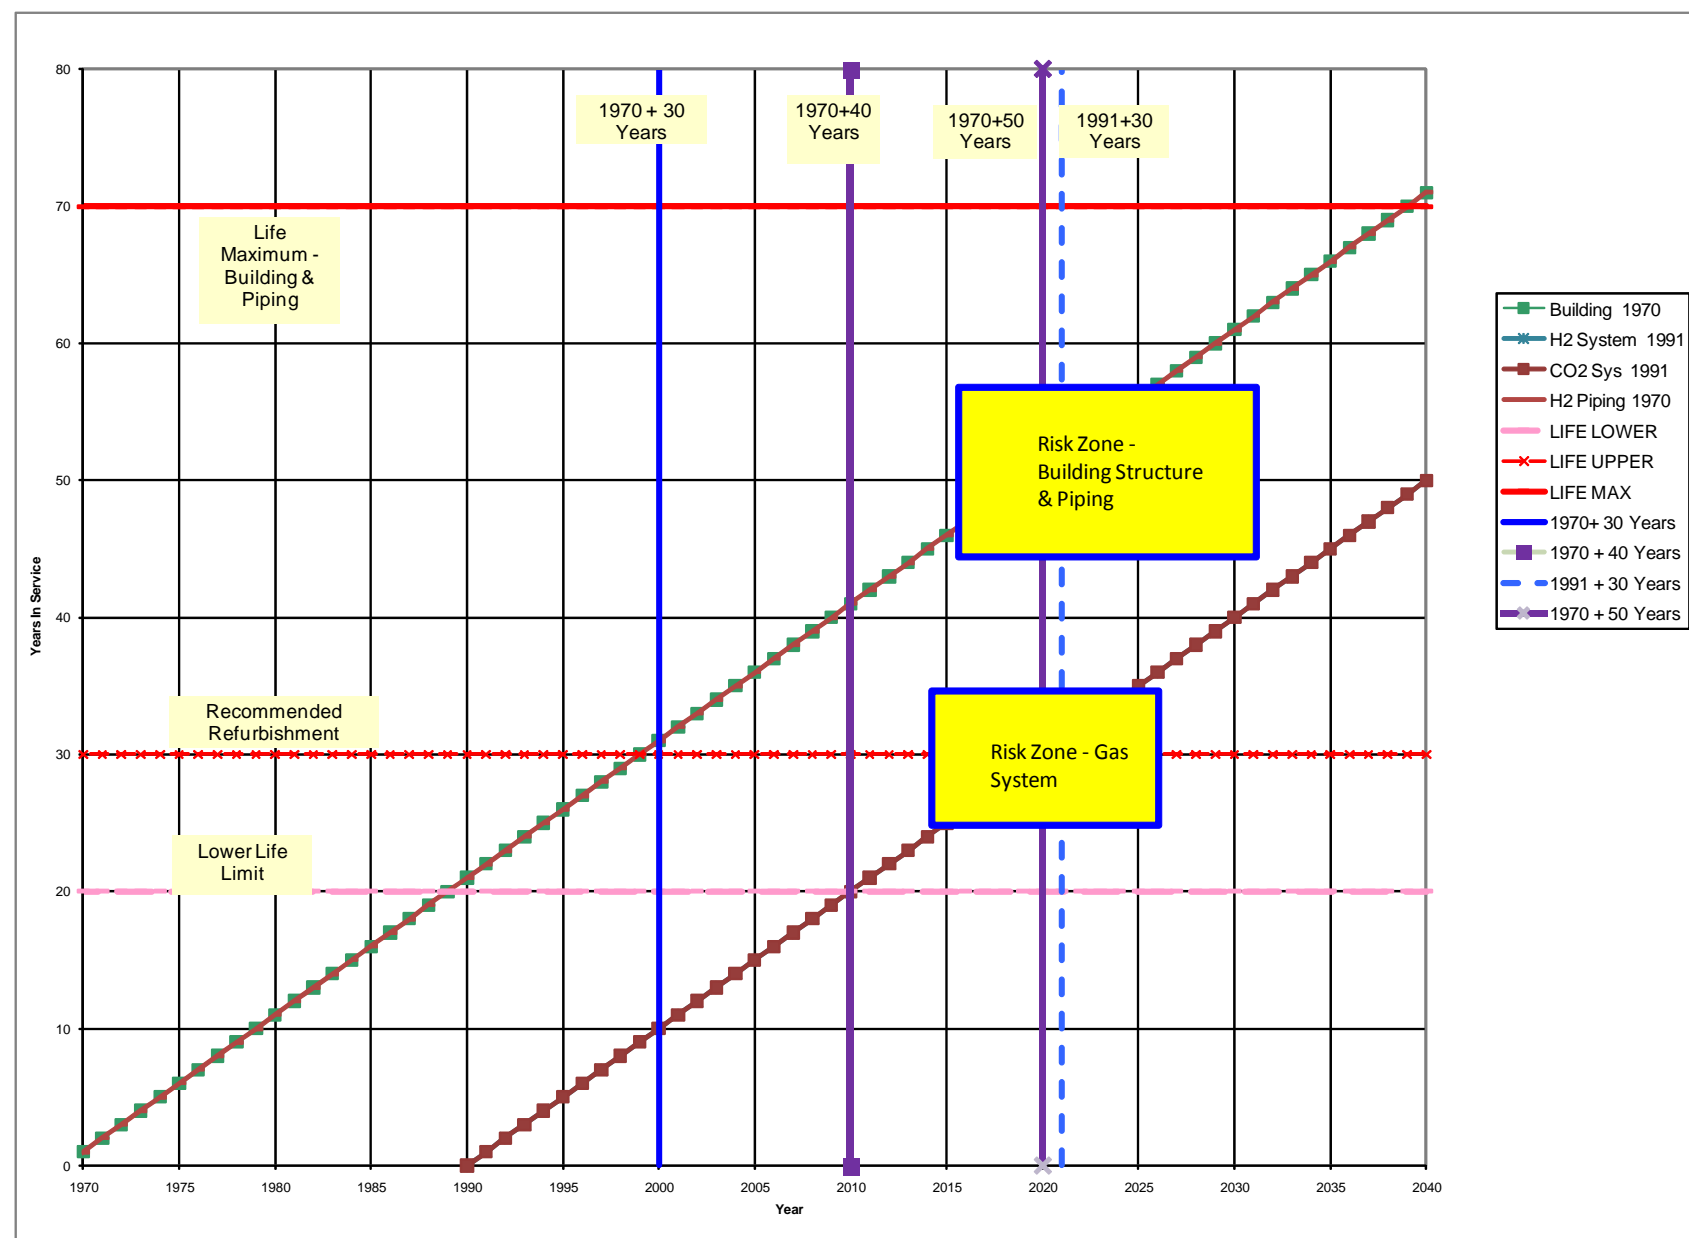
FIGURE 11-19 LIFE CYCLE CURVE – HYDROGEN, NITROGEN, AND CARBON DIOXIDE SUPPLY SYSTEMS

The curves indicates the remaining life (RL) of the hydrogen, nitrogen, and carbon dioxide supply systems exceeds the end date for generation of 2020 but not likely the desired life (DL) which is the end date for synchronous generation of 2041. It is clear that the system generally has considerable technical life remaining. Three concerns not reflected are i) the condition of the distribution piping for which no test information was reviewed, ii) the restricted supply capability of the carbon dioxide delivery system; and iii) the limited supply infrastructure for hydrogen on the mainland.

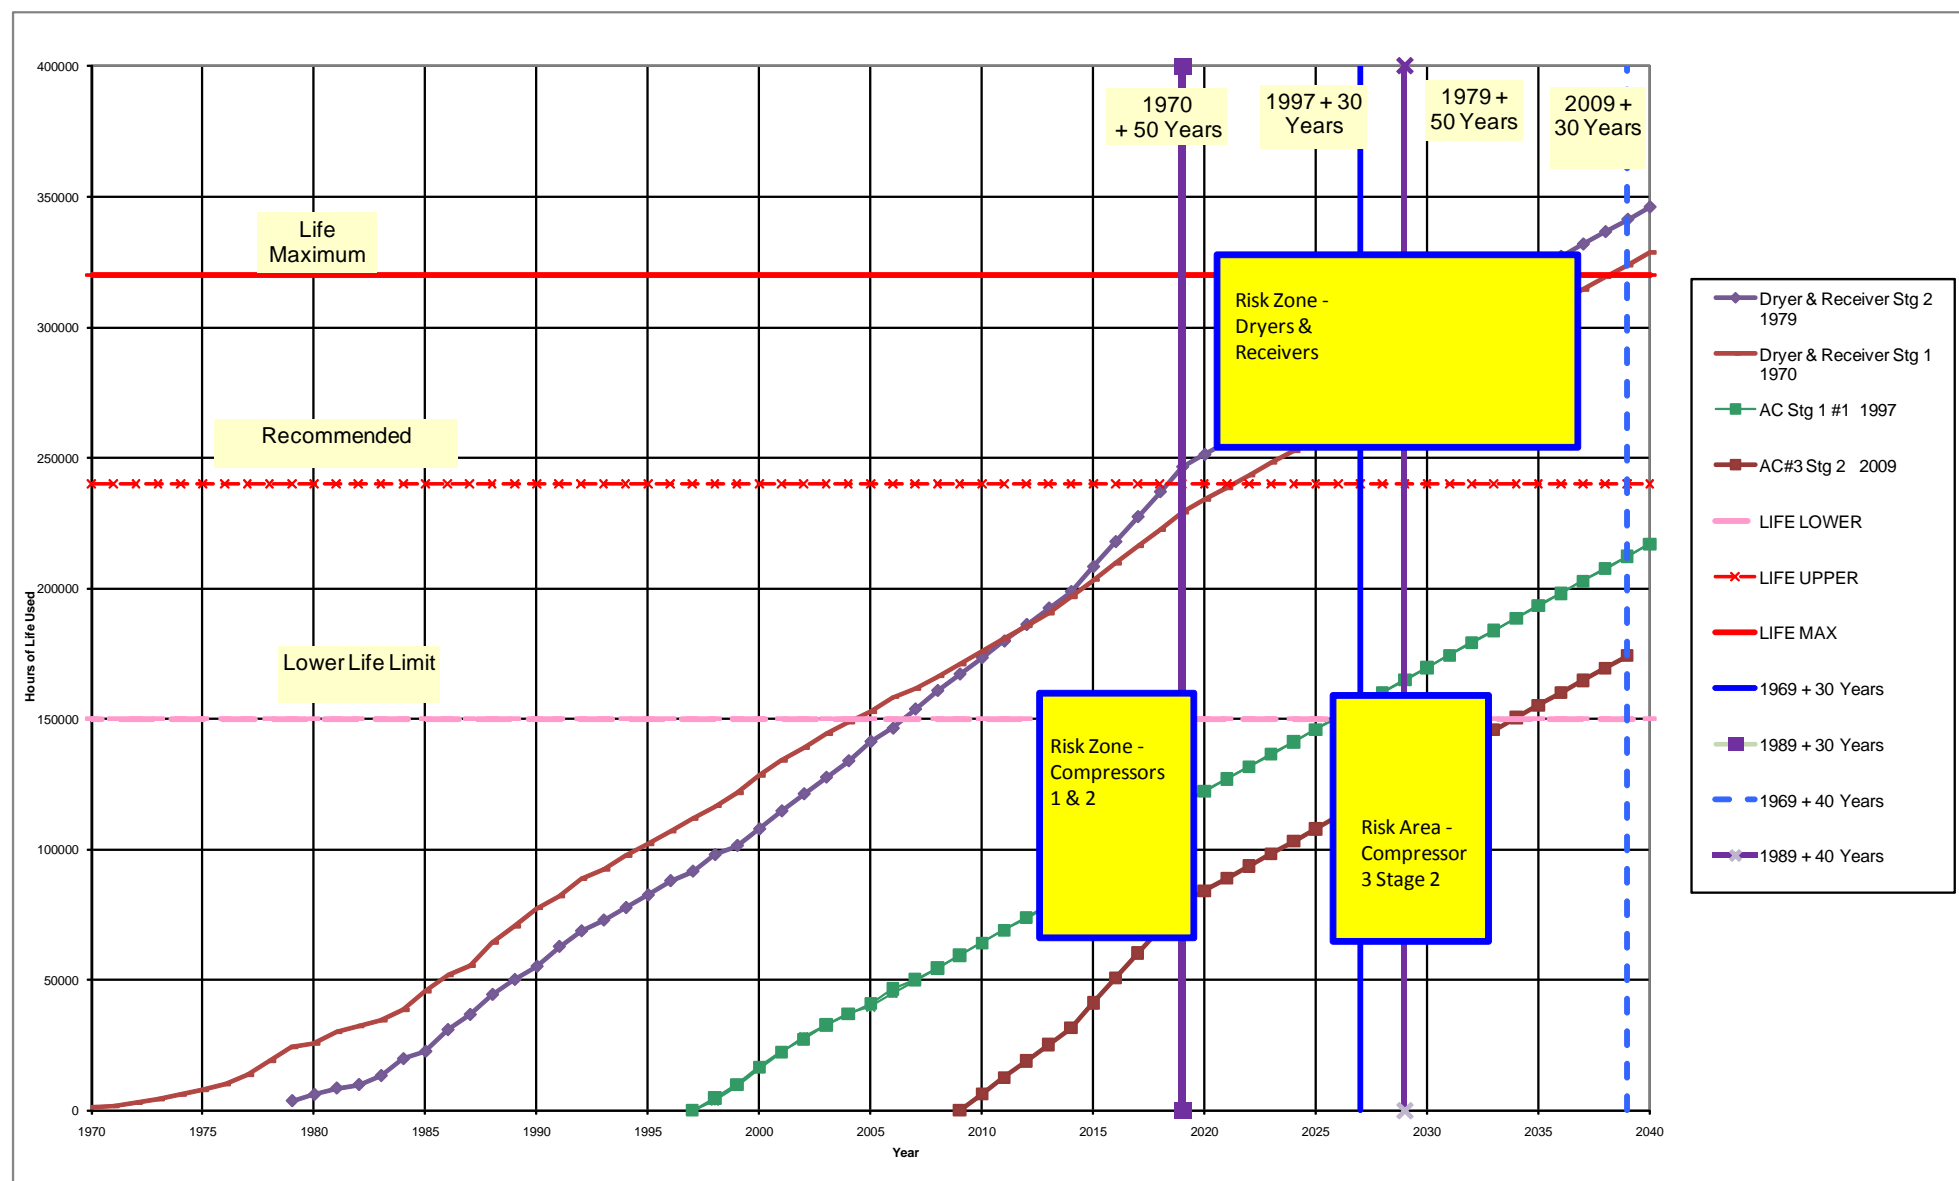
FIGURE 11-21 LIFE CYCLE CURVE – COMPRESSED AIR

The curves indicate that the remaining life (RL) of the compressed air system exceeds the end date for generation of 2020, but maybe not the desired life (DL) of 2041 (at the end of synchronous condensing life) without refurbishment and/or replacement. The exception is the current stage 1 compressors which are in need of replacement in the next few years and the newer Stage 2 compressors which will likely need replacement in the period after 2020.

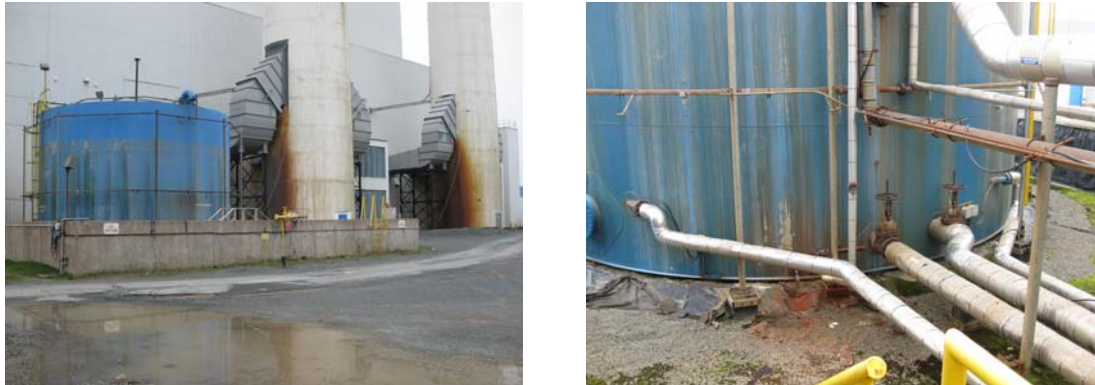
FIGURE 11-24 HEAVY OIL DAY TANK AND PIPING TO POWERHOUSE

Heavy Oil Day Tanks: The heavy oil day tank is approximately 12 to 15 years old. It has a rubber lined floor. The capacity was increased from 57 to 114 million litres (2000 to 4000 bbls) in 1980's. The piping layout for Unit 3 heavy oil system includes the use of a "short" recirculation valve which is piped back to the fuel oil day tank allowing the heavy oil pumps to be in service with the main oil trip valve closed. A "main fuel oil recirculation valve" and line is provided just upstream of the main oil trip valve and is used to re-circulate the oil back to the day tank.

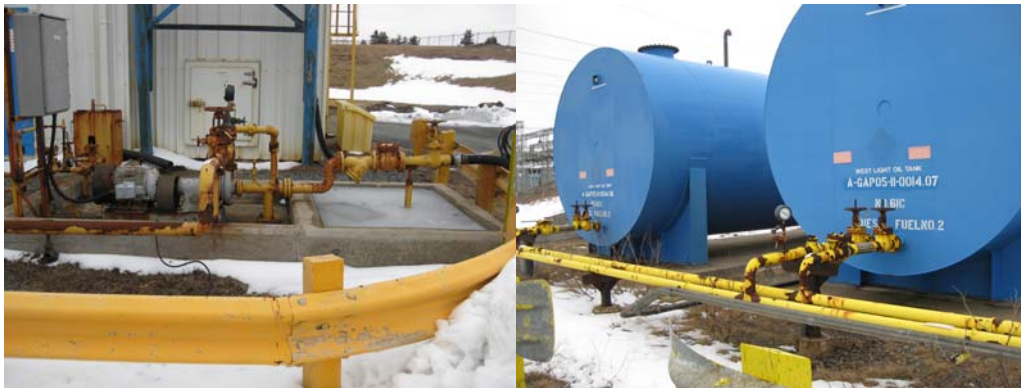
FIGURE 11-26 LIGHT OIL RECEIVING SYSTEM AND STORAGE TANKS

Oil is received at the side of the black start diesel building and transferred to two 100,000 litre light oil tanks. There is very obvious corrosion pitting of the receiving lines and valves. The light oil pressure at the main units is maintained through constant recirculation back to the light oil storage tanks through a pressure control valve and piping arrangement.

The tanks themselves are relatively new (5 to 6 years). The lines under the roadway have been replaced as part of road repair work carried out in 2007.

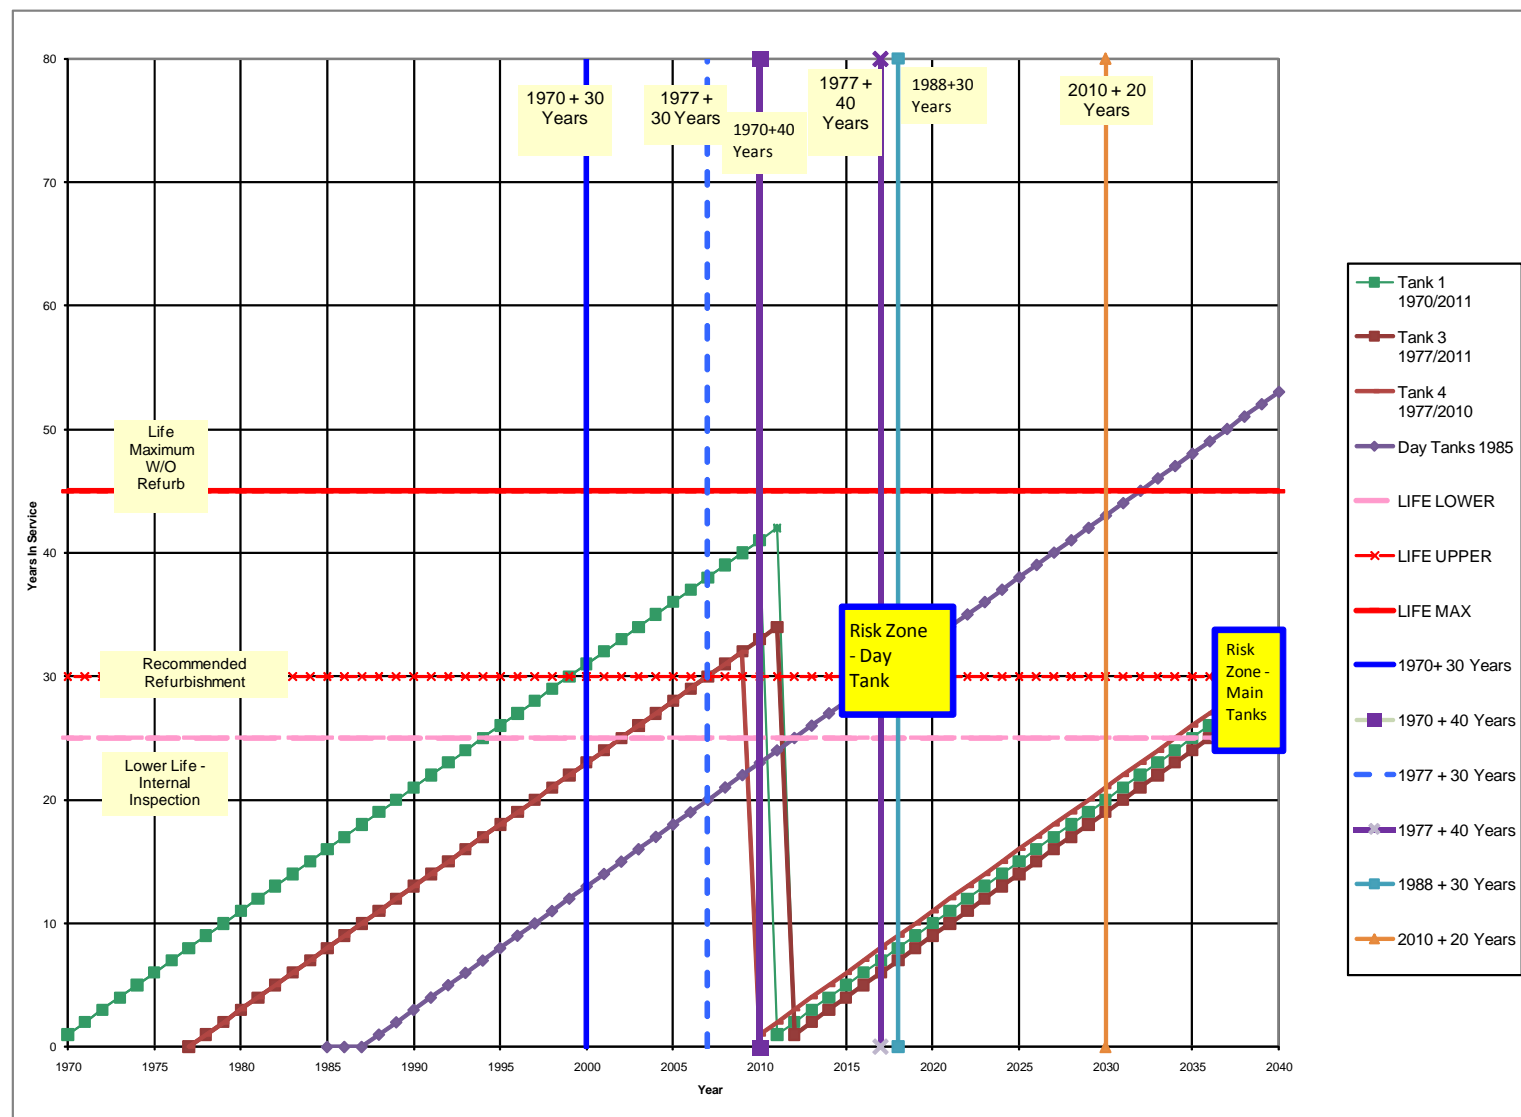
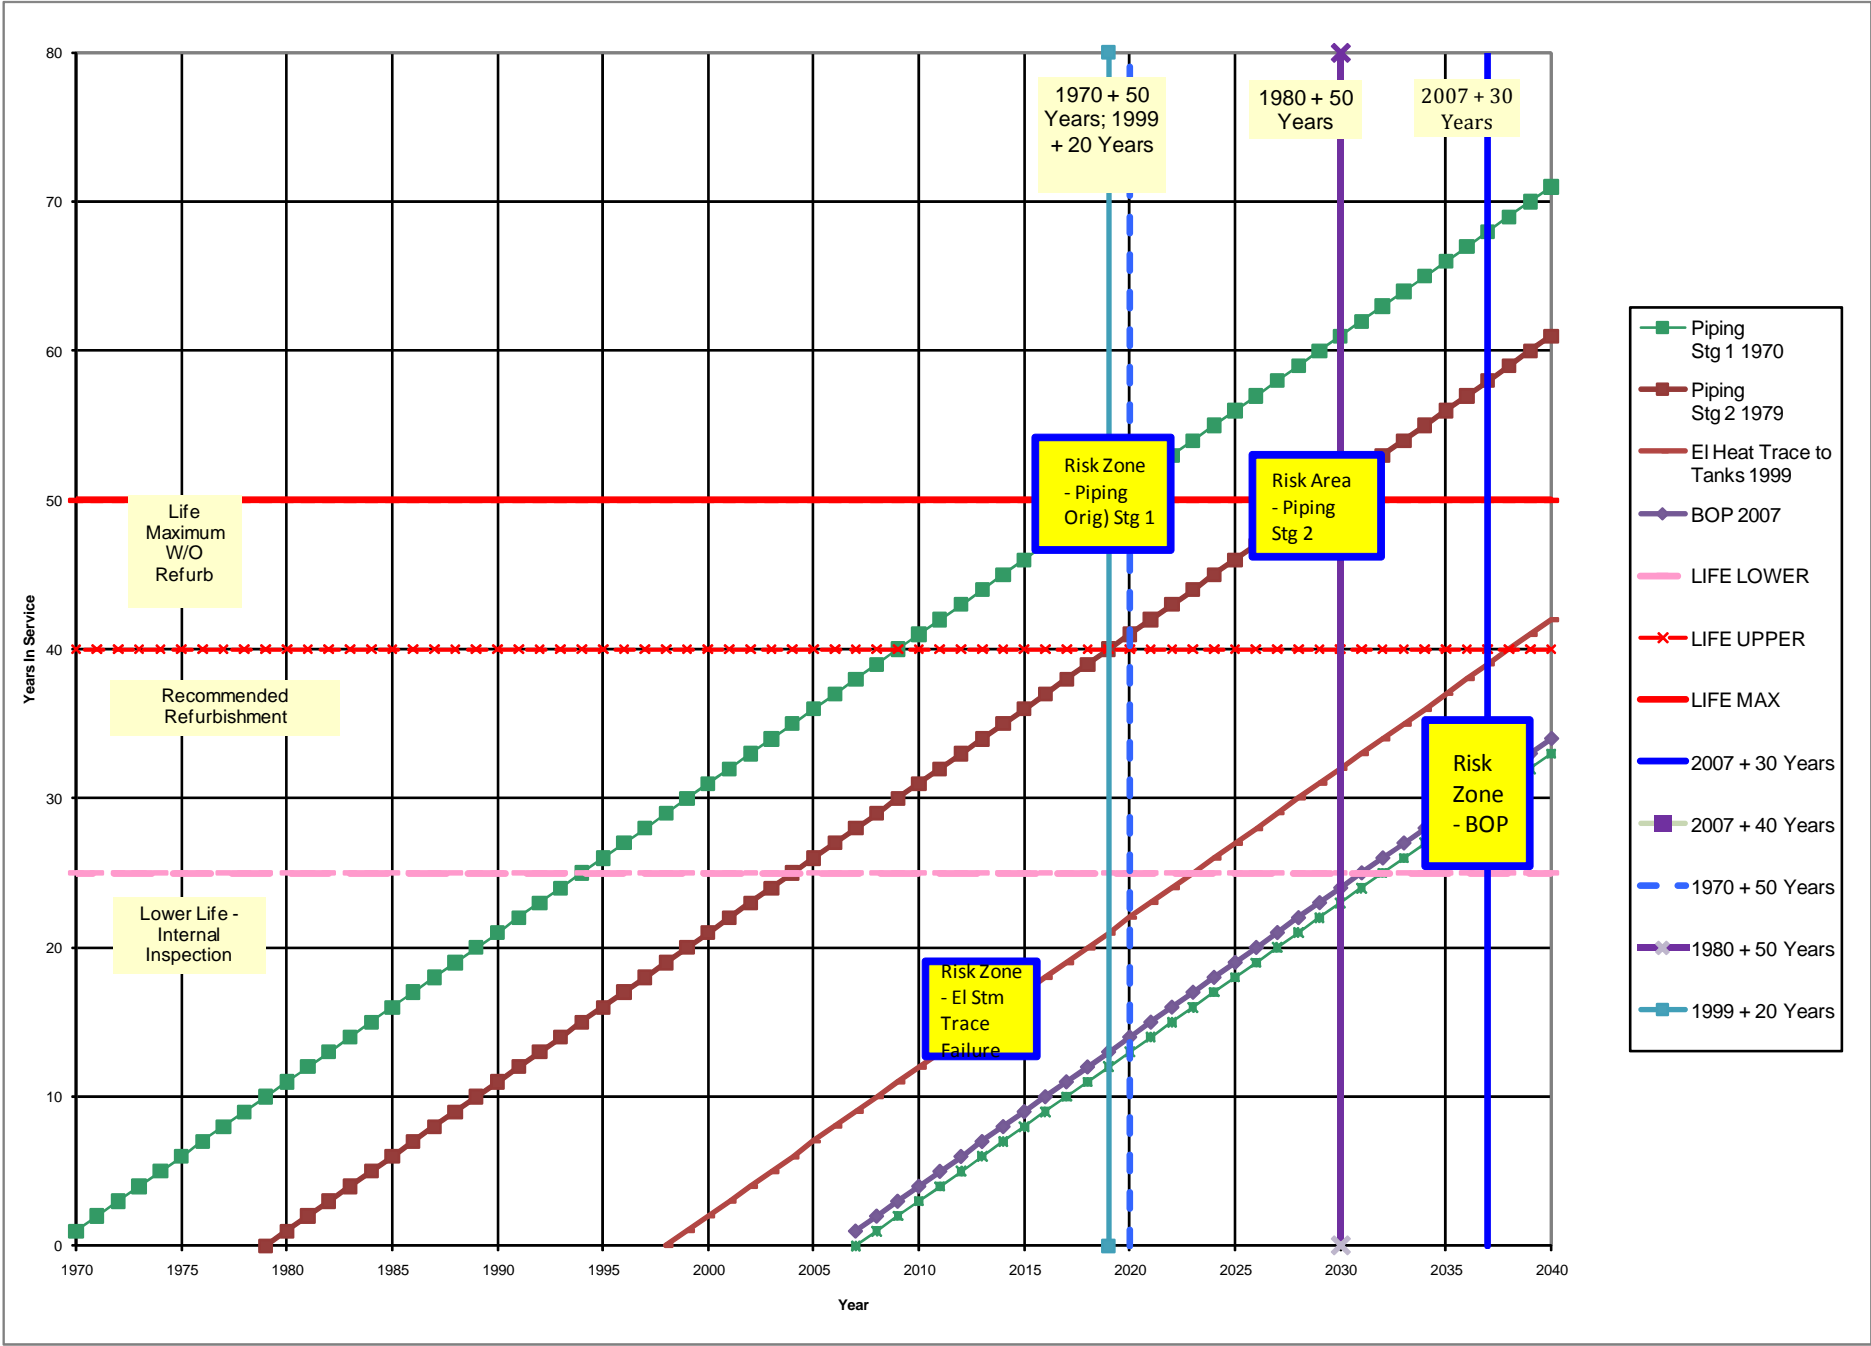
The curves indicate that the remaining life (RL) of the light oil and heavy oil tanks can reach the desired life (DL) of the end date for generation of 2020 once the current heavy oil tank refurbishment is completed. It does identify a need for the heavy oil day tank to be inspected and refurbished in the near future. It also identified the immediate and critical problem of the electric heat tracing on the oil delivery line to the heavy oil tank farm.

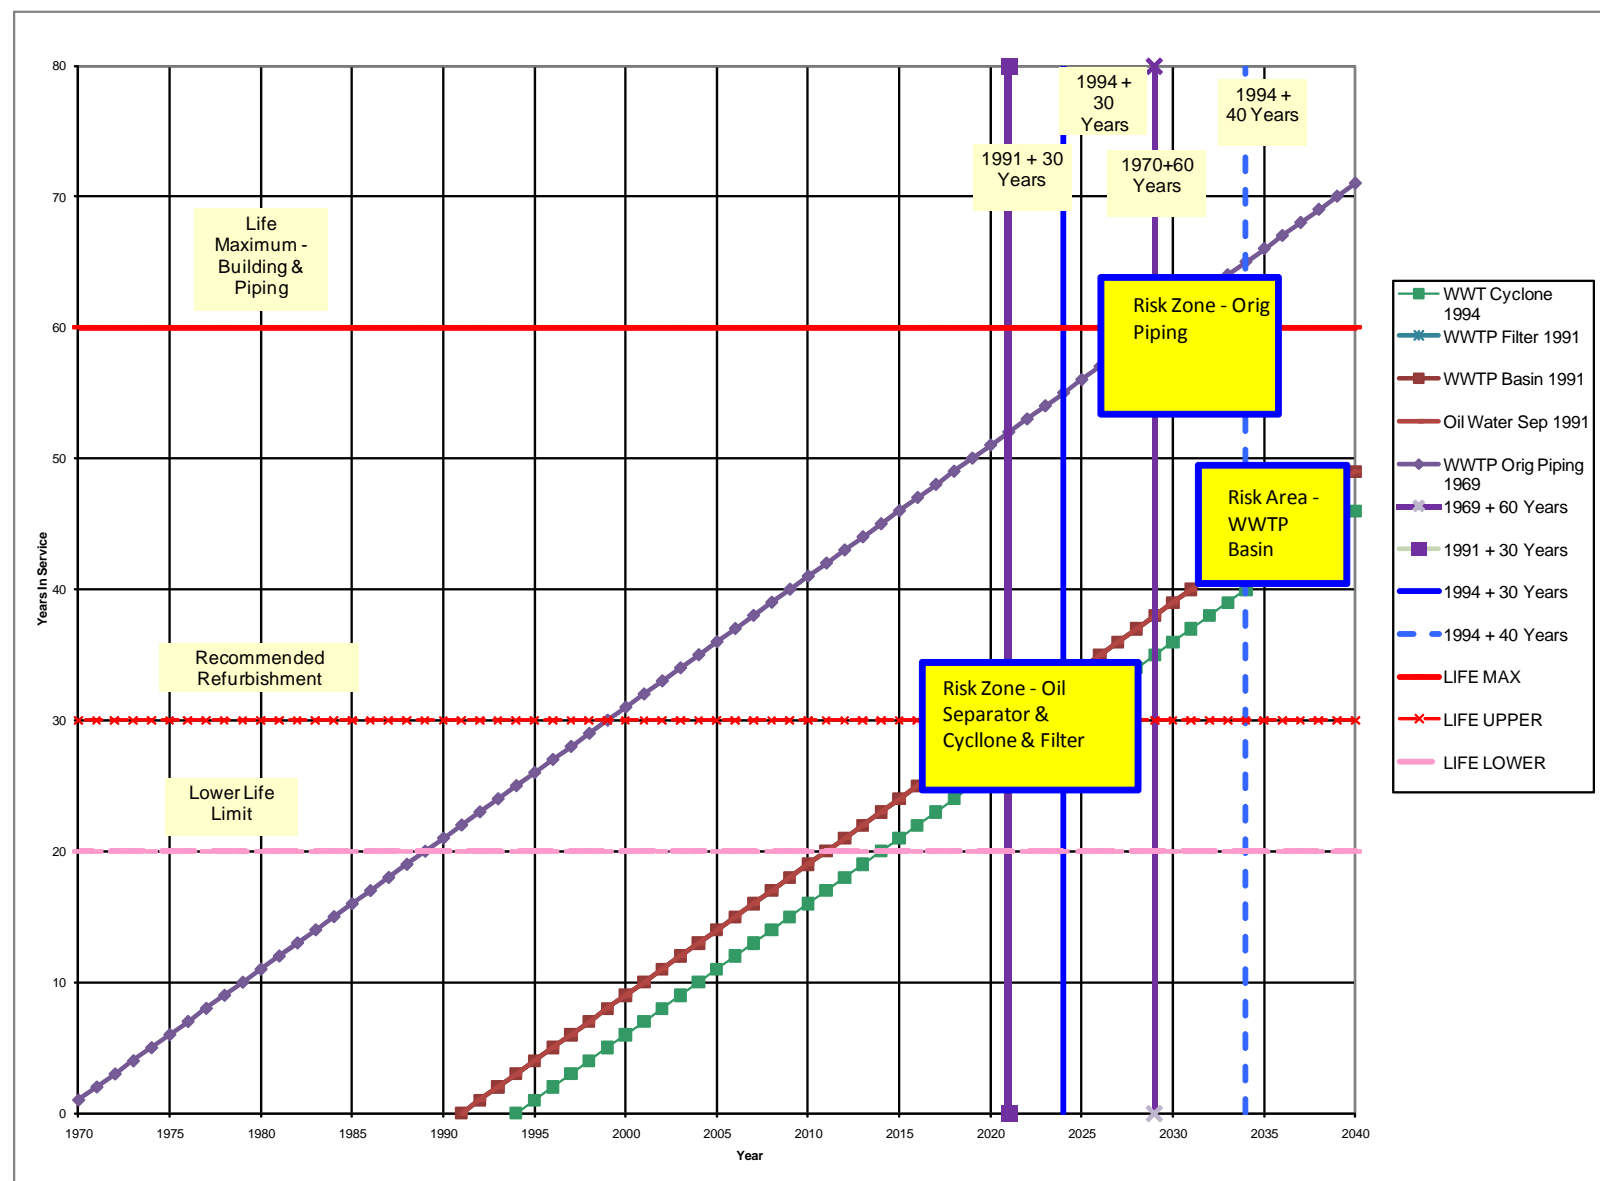
FIGURE 11-29 LIFE CYCLE CURVE – WASTE WATER TREATMENT PLANT (WWTP)

The curves indicate that the remaining life (RL) of most of the waste water treatment plant (WWTP) system exceeds the desired life (DL) which is the end date for generation of 2020. The exception is the WWTP basin building which requires refurbishment/replacement. The dates for the oil separation and piping and basin tanks are subject to inspection information required.

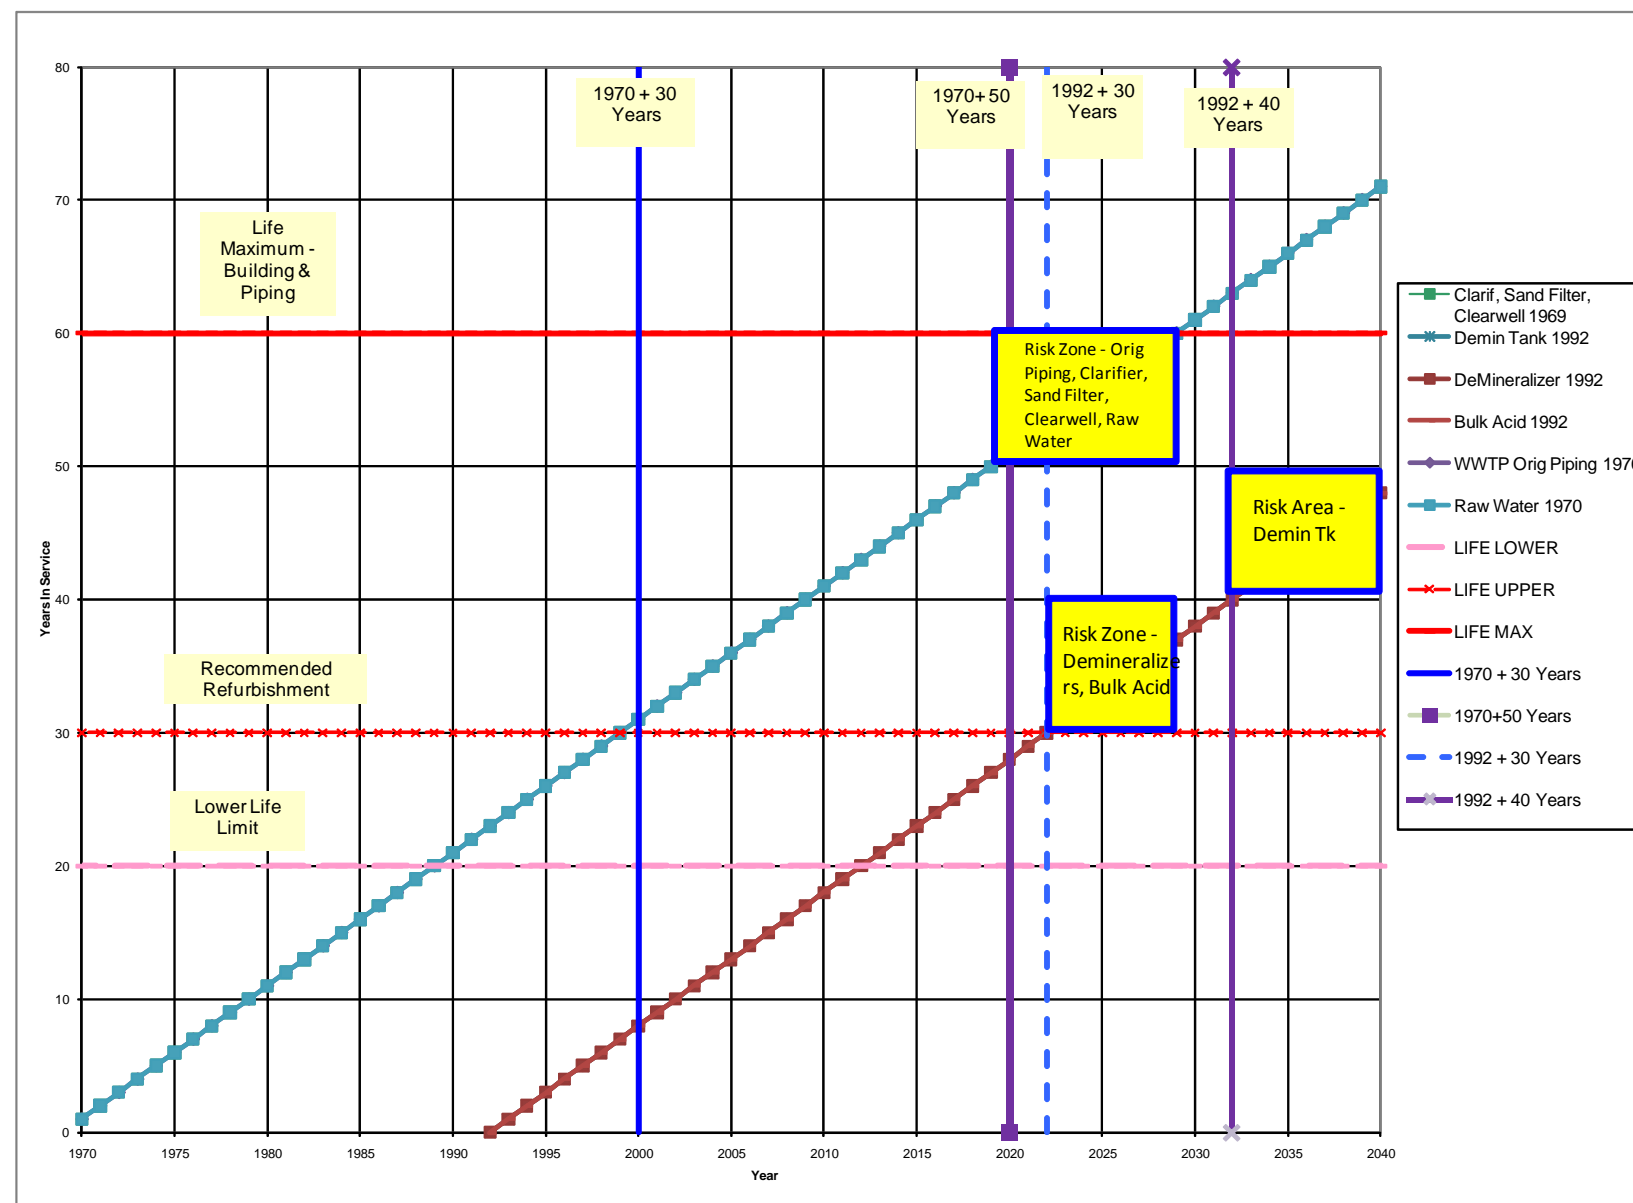
FIGURE 11-33 LIFE CYCLE CURVE – WATER TREATMENT PLANT (WTP) SYSTEM

The curves indicate that the remaining life (RL) of the water treatment plant (WTP) system exceeds the desired life (DL) which is the end date for generation of 2020. This is dependent on the condition primarily of the original equipment. Given they represent a single contingency failure mode, an assessment of their condition is critical to firming this assessment. Similarly, their importance as a single contingency failure mode makes an understanding of the condition of the raw water line from the storage pond and the dam at the storage pond a critical task.

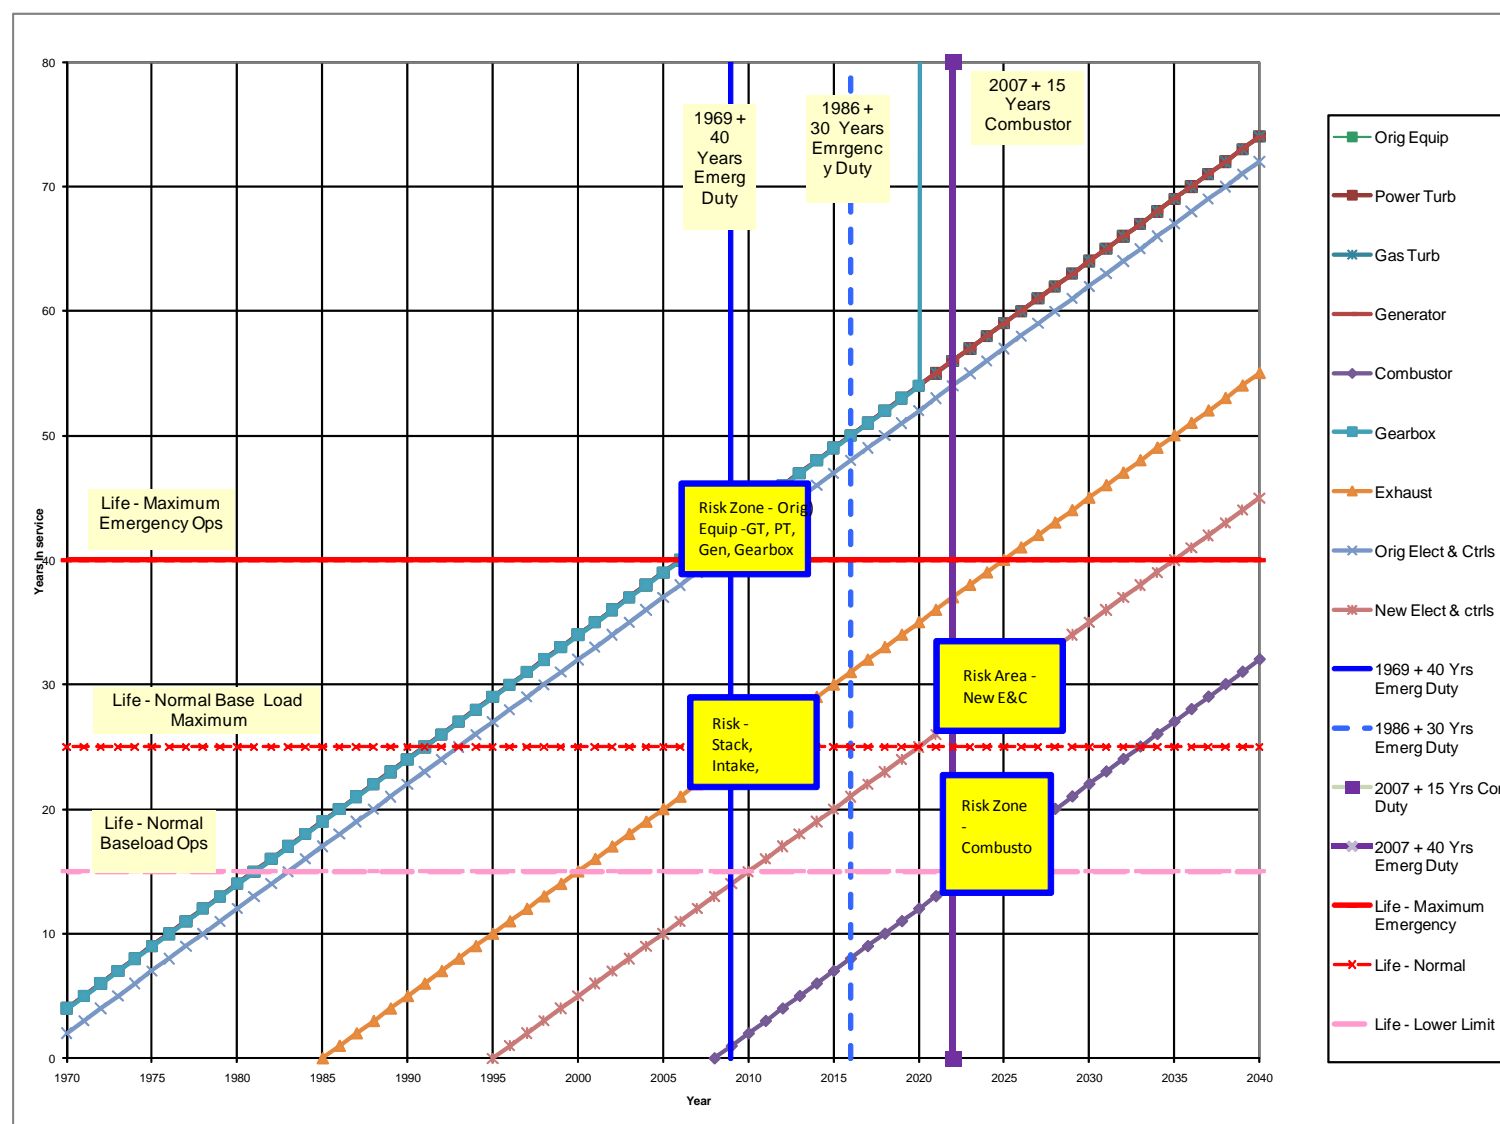
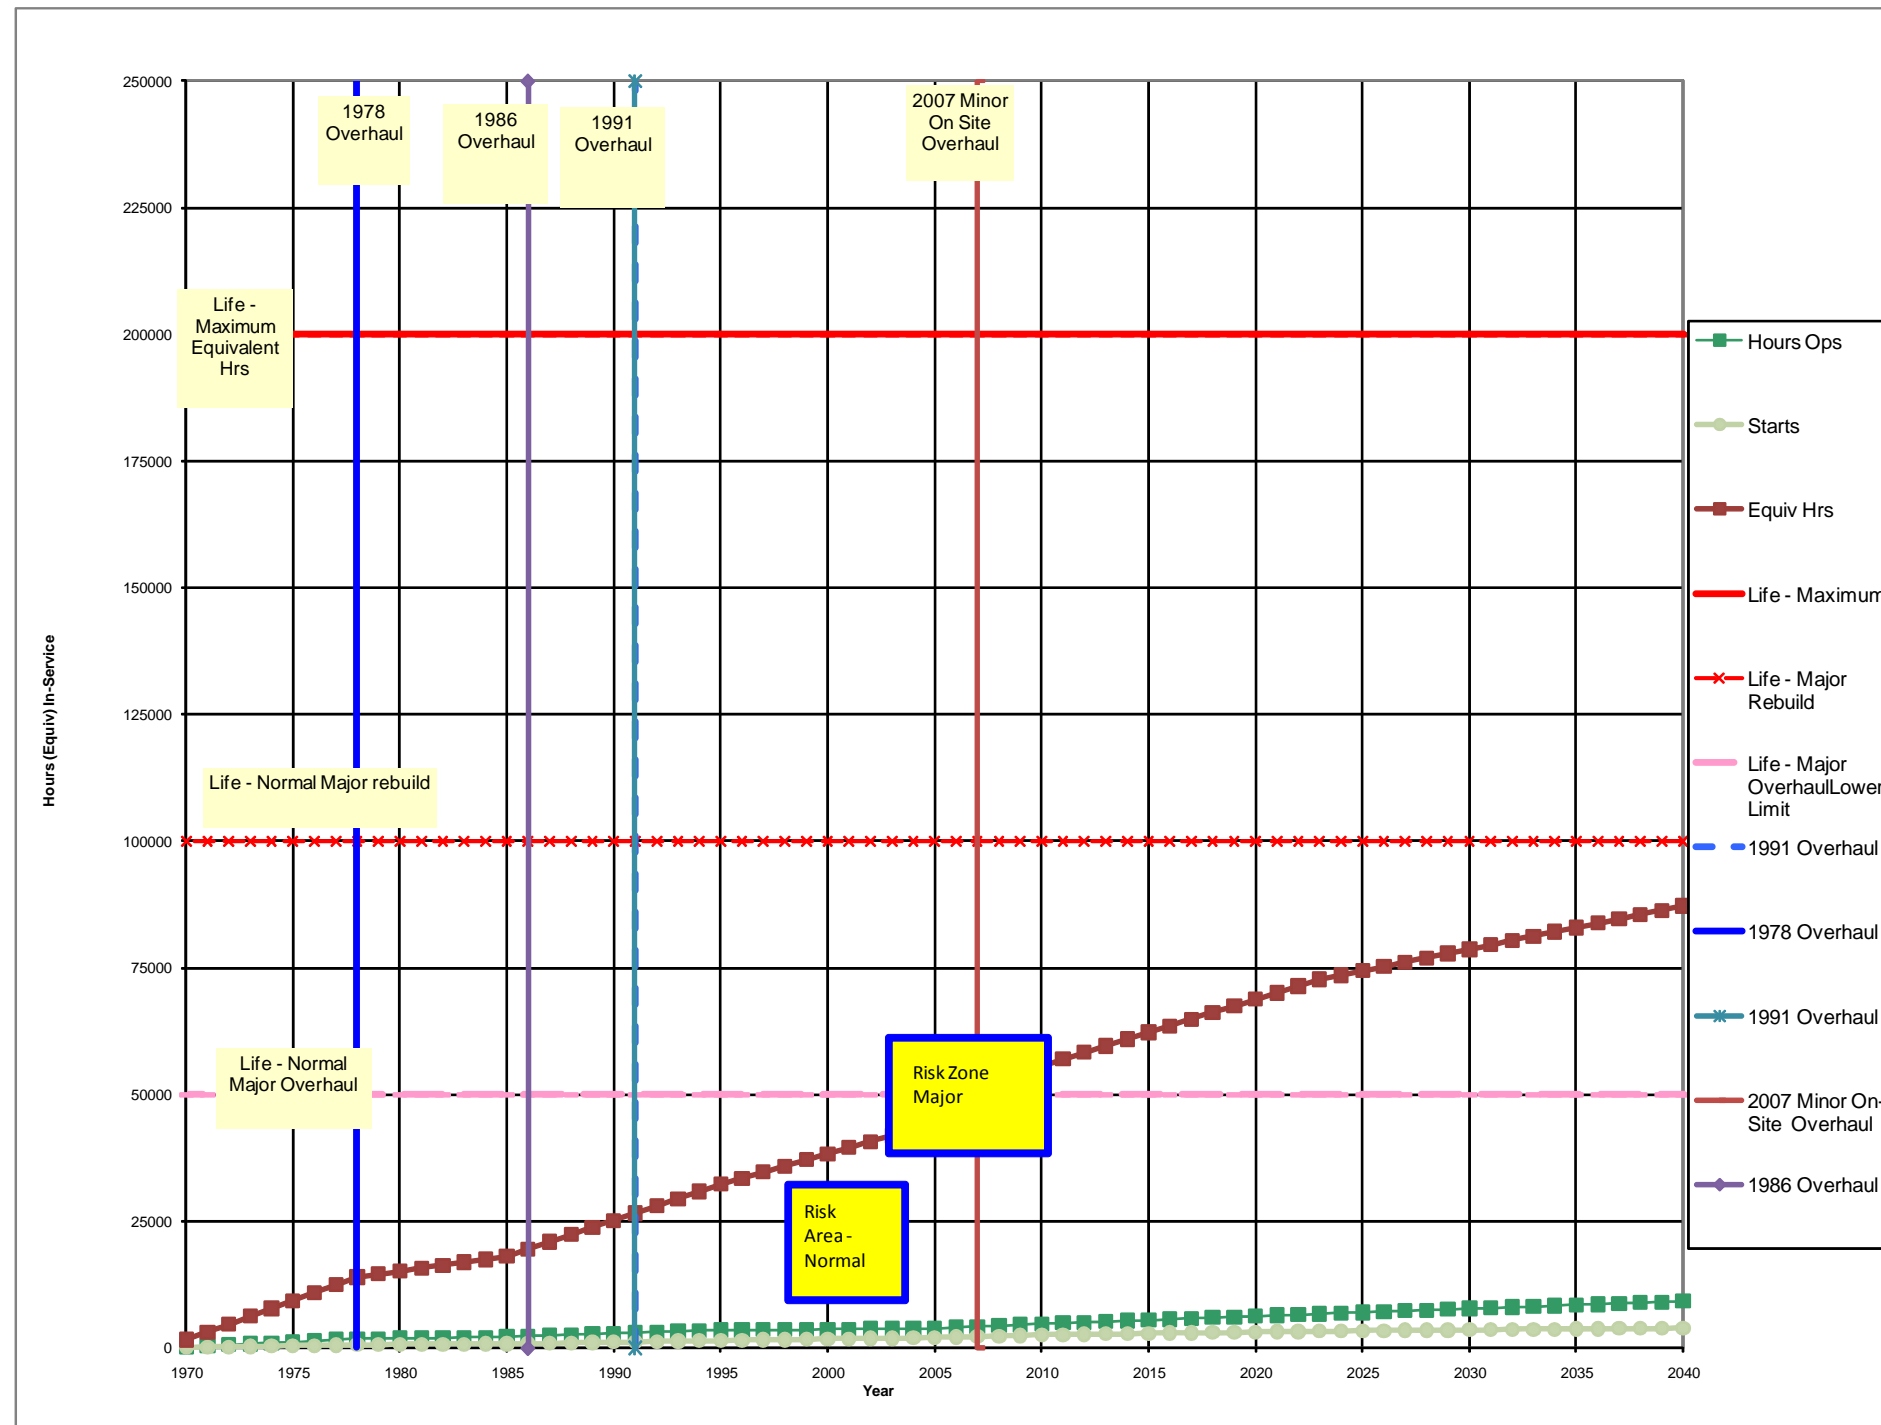
FIGURE 11-39 LIFE CYCLE CURVE – GAS TURBINE GENSET (PHYSICAL AGE BASIS)

FIGURE 11-40 LIFE CYCLE CURVE – GAS TURBINE GENSET (EQUIVALENT OPERATING HOURS BASIS)

The curves, as well as the condition assessment, indicate the unit is in need of a significant and immediate overhaul and refurbishment or replacement. Its remaining life (RL) is less than the desired life (DL) which is 2020. The importance of a near term overhaul or replacement is highlighted by the critical system role that the unit needs to play in black starting the Holyrood units in the event of a system failure. The stack is physically in need of refurbishment or replacement. The intake likely needs a better filter media. The fuel system and coolers need repairs and better ambient protection. The gearbox seals continue to be an issue and a fire safety hazard. The gas turbine has not been overhauled for a considerable period, and recent inspections as well as the life cycle curve for a marine environment suggest that this necessary.

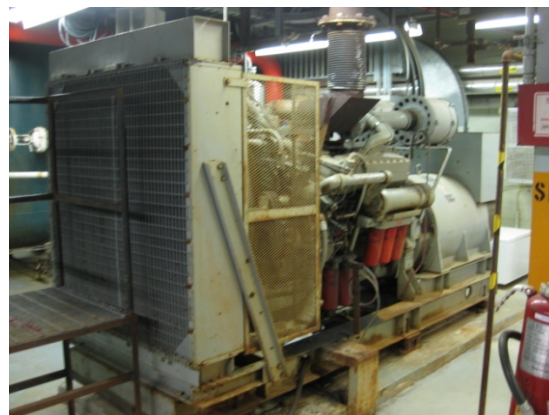
Stage 2 Diesel

The Stage 2 emergency diesel was installed in 1980. It is at the end of its normal useful life. It should be replaced between 2012 and 2015 and would then be expected to last to 2041.

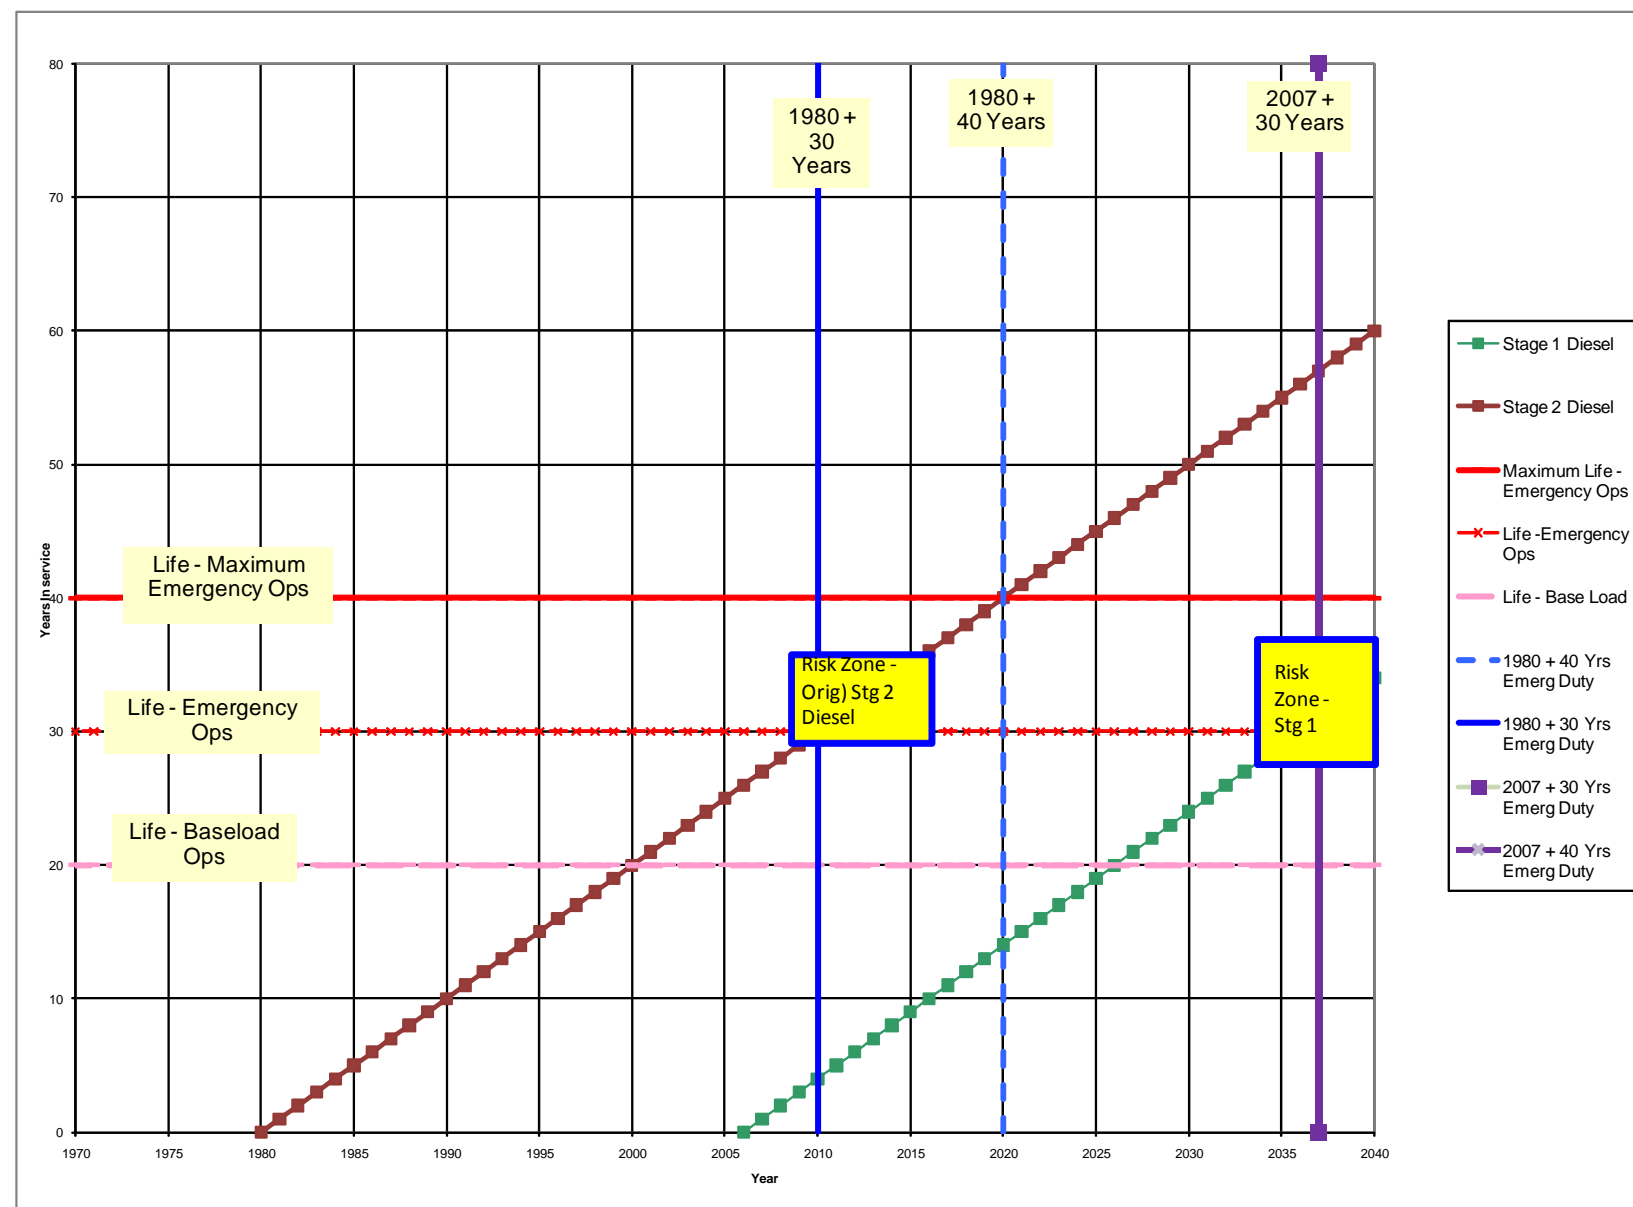
FIGURE 11-42 LIFE CYCLE CURVE – DIESEL GENSETS

The curves indicate that the remaining life (RL) of the newer Stage 1 diesel genset exceeds the end date for generation of 2020, and likely the desired life (DL) of 2041 (at the end of synchronous condensing life). It also indicates that the original Stage 2 diesel genset is at or very near its end of life and should be replaced. Given the critical role these units play in emergency safe shutdown, the replacement should be a high priority.
