THE Lower Churchill PROJECT

April 2008

GI1190 - Dam Break Study Volume 1

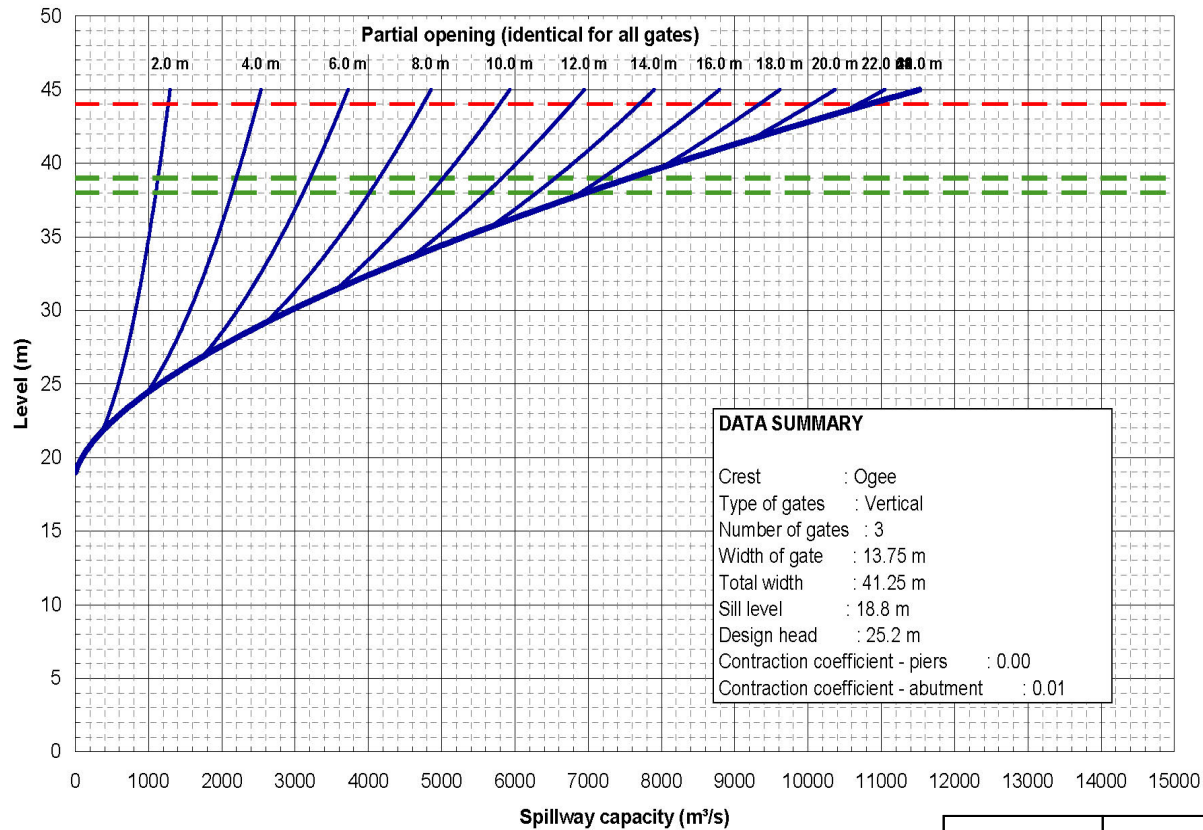
**Muskrat Falls - Variant 10 - Three gates
Spillway capacity**

HATCH LIMITED
	NEWFOUNDLAND AND LABRADOR HYDRO
	GI1190 – DAM BREAK STUDY
PROJECT H-325967	MUSKRAT FALLS PROJECT SPILLWAY RATING CURVE
SCALE NTS	
DATE JAN 2008	FIGURE 2.6

Spillway rating curves were provided by Hydro and are shown in Figures 2.6, 2.7, and 2.8. A speed-no-load discharge for the generating station was estimated to be approximately 405 m³/s, using methodologies presented by Gordon [Ref 1], and was used for the dam breach modeling.

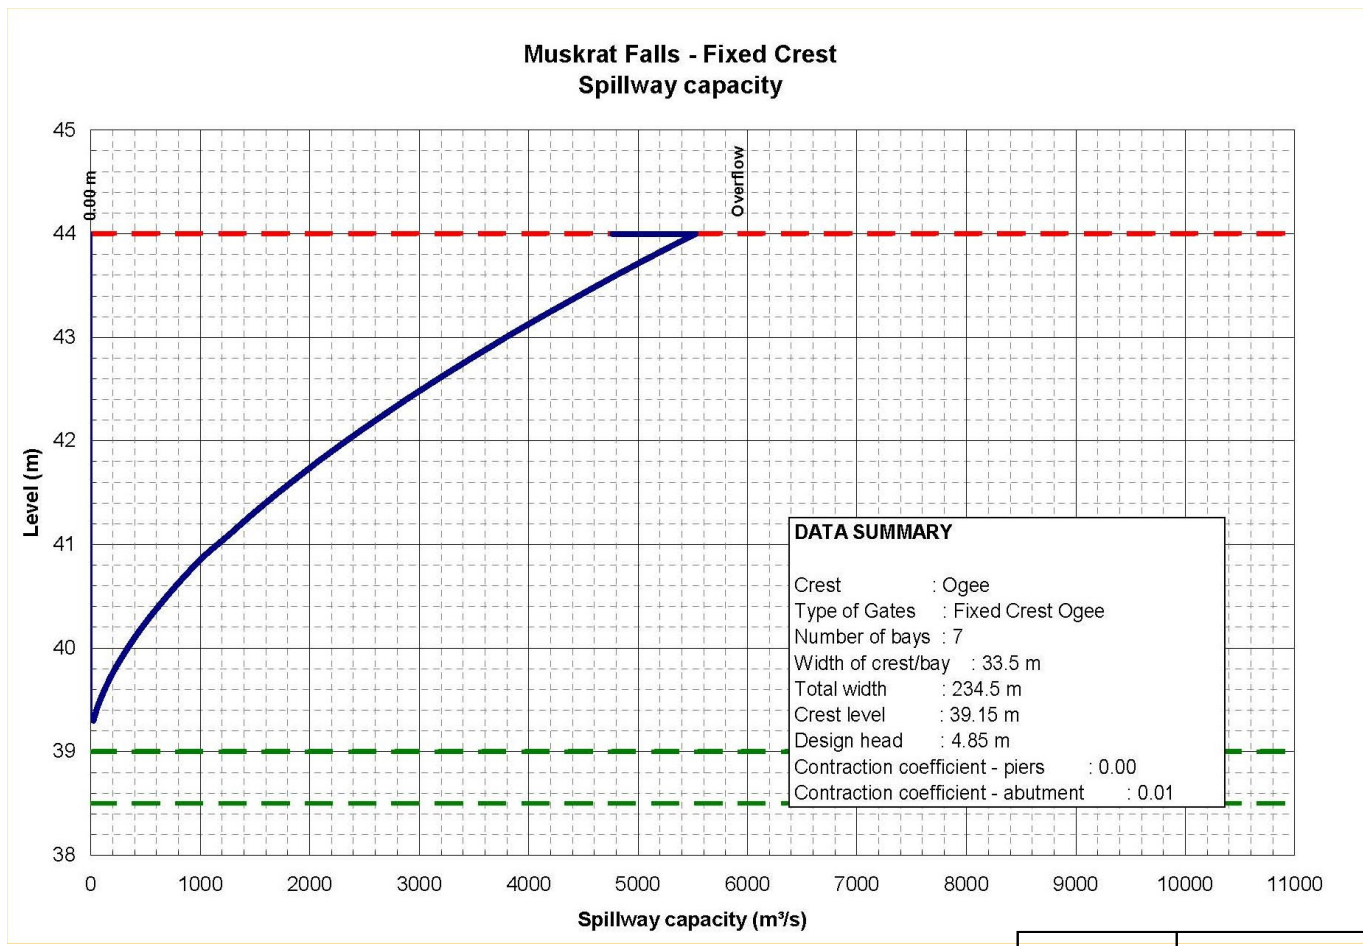
HATCH LIMITED
	NEWFOUNDLAND AND LABRADOR HYDRO
	GI1190 – DAM BREAK STUDY
PROJECT H-325967	MUSKRAT FALLS PROJECT
SCALE NTS	RCC OVERFLOW RATING CURVE
DATE JAN 2008	FIGURE 2.7

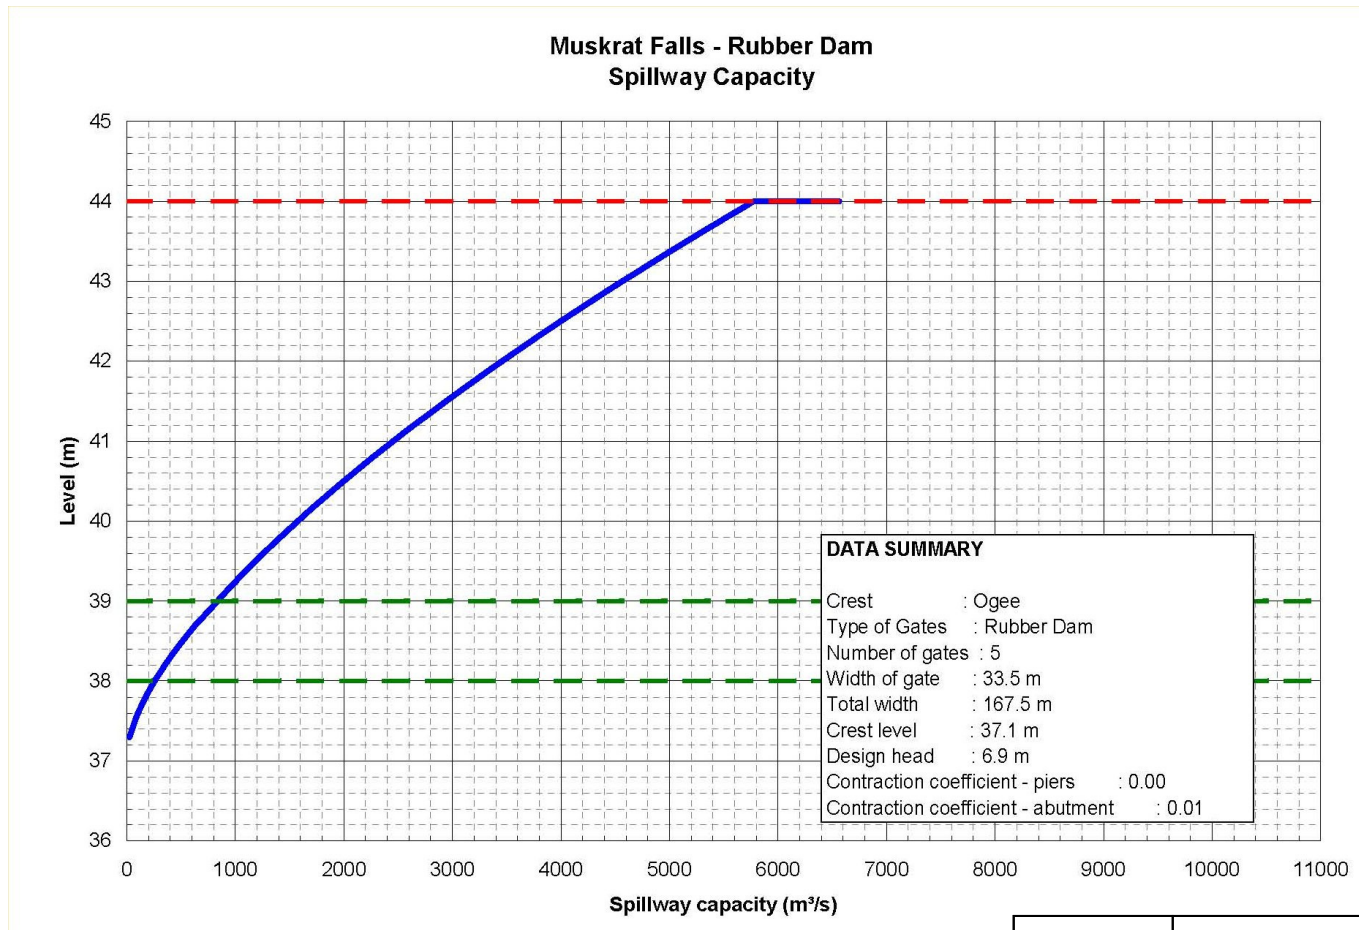
HATCH LIMITED
	NEWFOUNDLAND AND LABRADOR HYDRO
	GI1190 – DAM BREAK STUDY
PROJECT H-325967	MUSKRAT FALLS PROJECT
SCALE NTS	RCC RUBBER DAM RATING CURVE
DATE JAN 2008	FIGURE 2.8

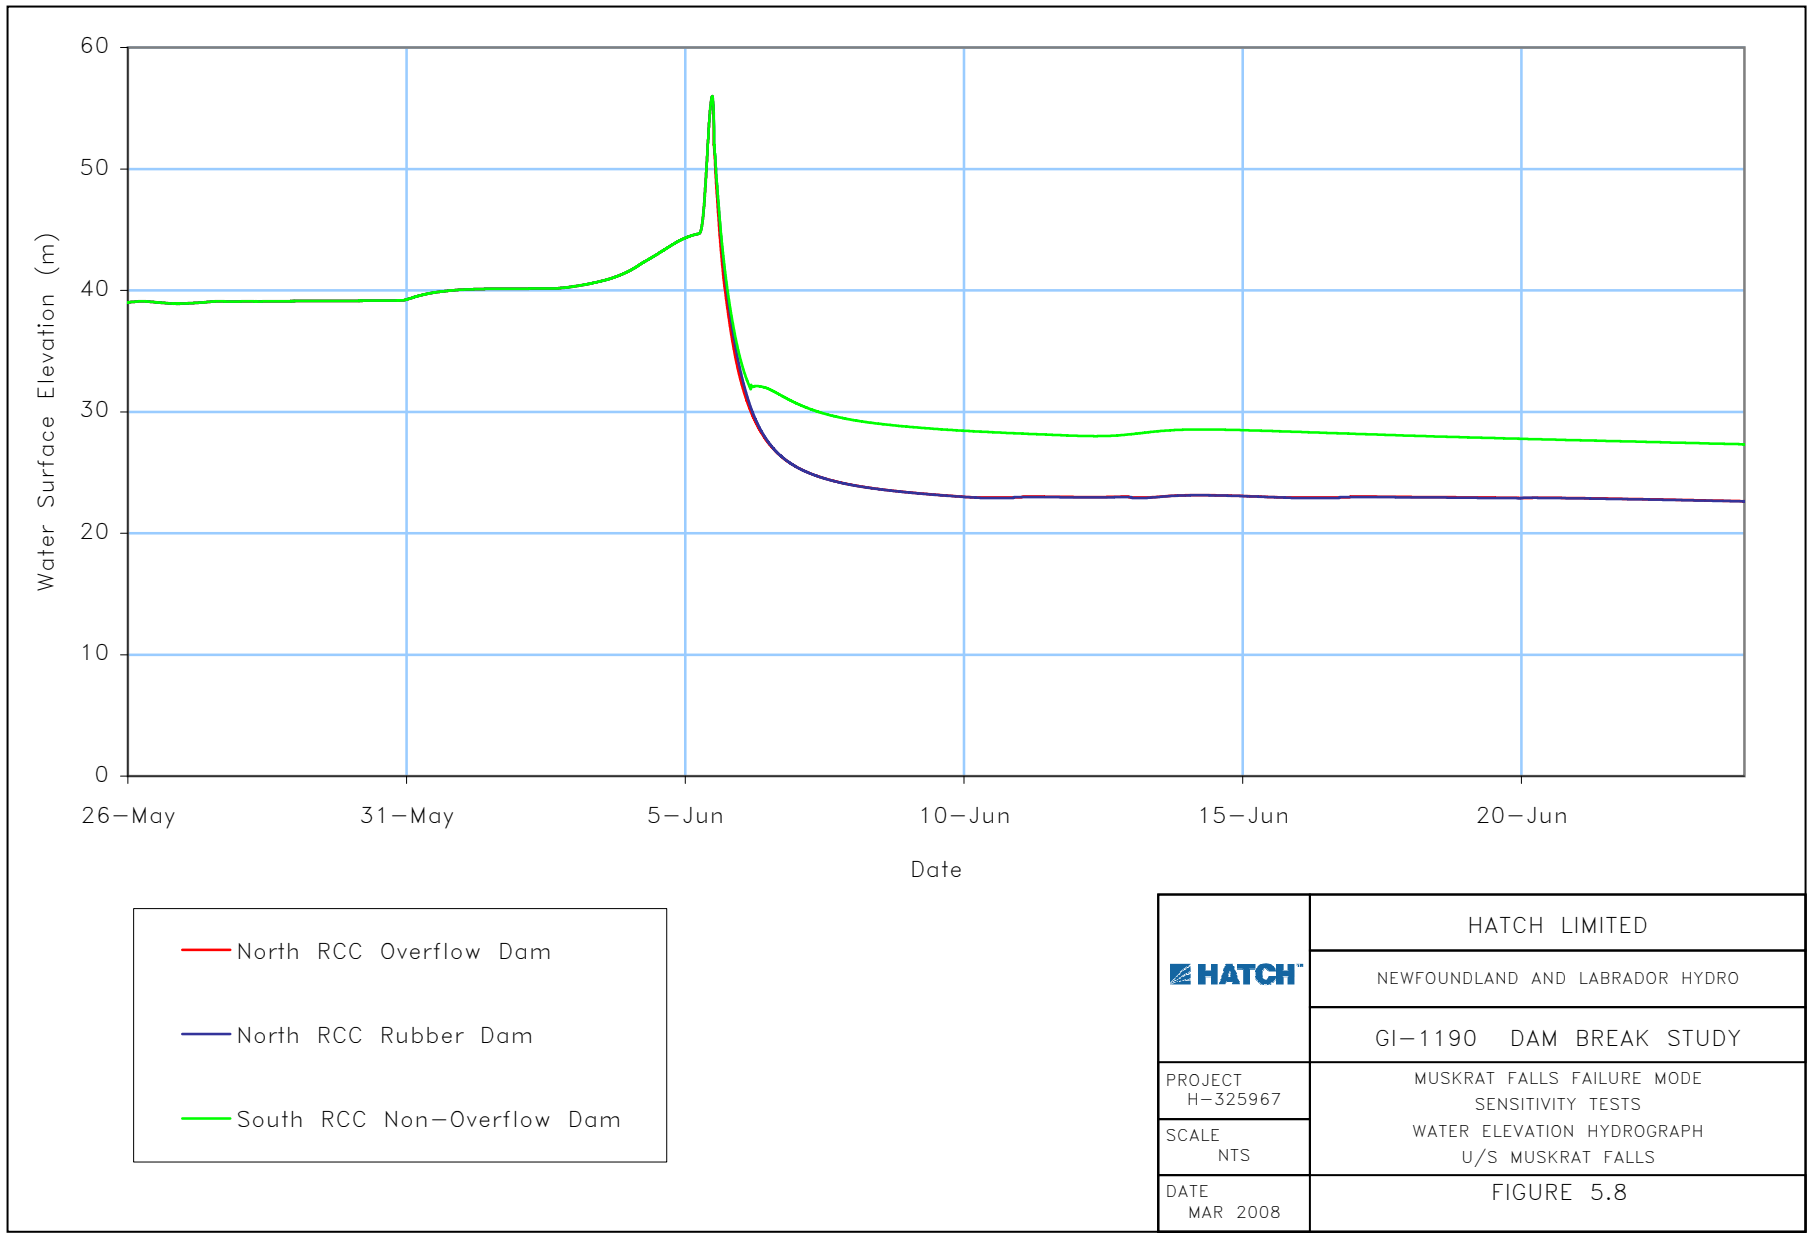
HATCH LIMITED
	NEWFOUNDLAND AND LABRADOR HYDRO
	GI-1190 DAM BREAK STUDY
PROJECT H-325967	MUSKRAT FALLS FAILURE MODE SENSITIVITY TESTS
SCALE NTS	WATER ELEVATION HYDROGRAPH U/S MUSKRAT FALLS
DATE MAR 2008	FIGURE 5.8

Because it is not immediately apparent which RCC structure will produce the worst downstream flooding each was breached in turn and the downstream effects were observed. Figures 5.7 to 5.12 compare the effects of the various dam breach scenarios on the water levels at six downstream locations of interest. As can be seen in these figures, there is very little difference in water level between the three failures. Of the three; however, the failure of the North RCC overflow dam produces the highest levels in the vicinity of Happy Valley - Goose Bay. For this reason, this structure was adopted as the critical failure for the remainder of this study.

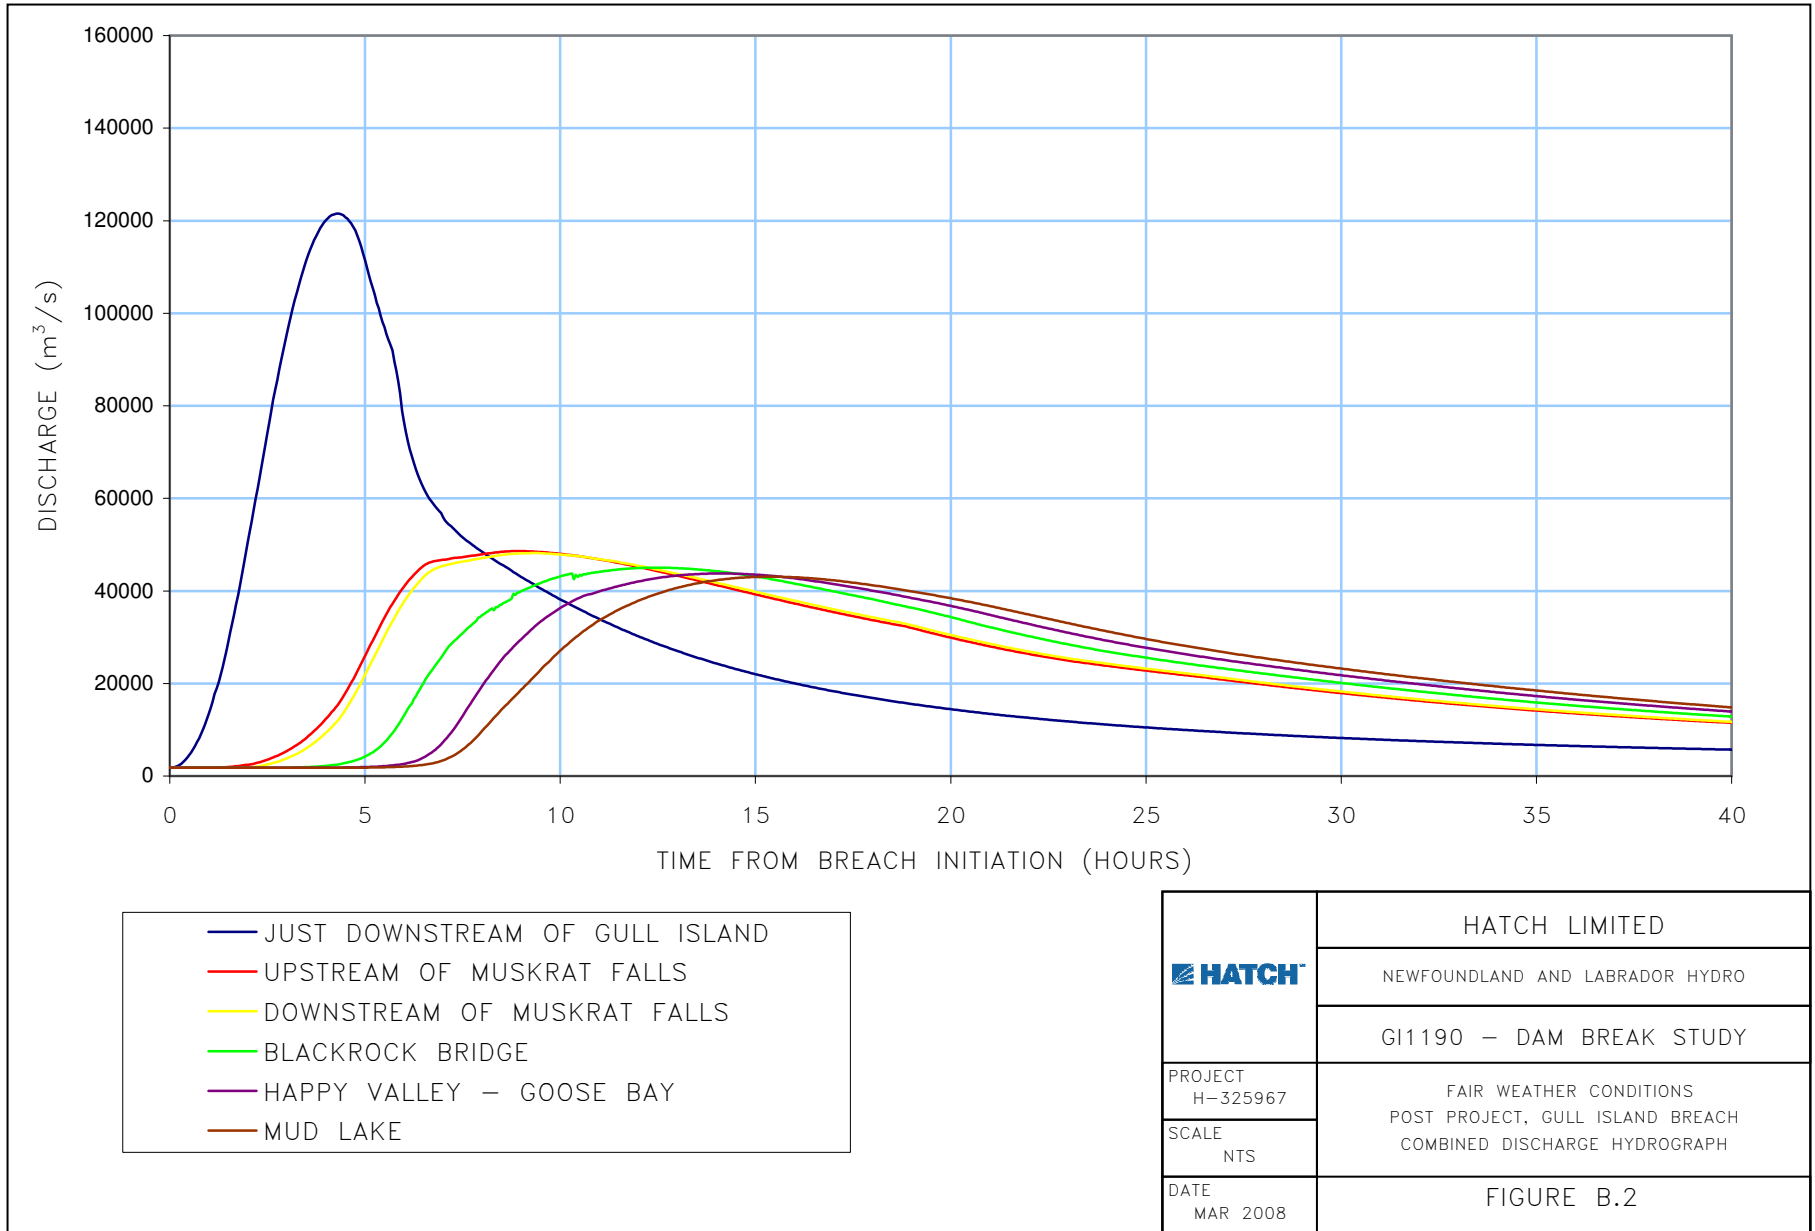
- JUST DOWNSTREAM OF GULL ISLAND
- UPSTREAM OF MUSKRAT FALLS
- DOWNSTREAM OF MUSKRAT FALLS
- BLACKROCK BRIDGE
- HAPPY VALLEY - GOOSE BAY
- MUD LAKE

HATCH LIMITED
	NEWFOUNDLAND AND LABRADOR HYDRO
	GI1190 - DAM BREAK STUDY
PROJECT H-325967	FAIR WEATHER CONDITIONS POST PROJECT, GULL ISLAND BREACH COMBINED DISCHARGE HYDROGRAPH
SCALE NTS	
DATE MAR 2008	FIGURE B.2

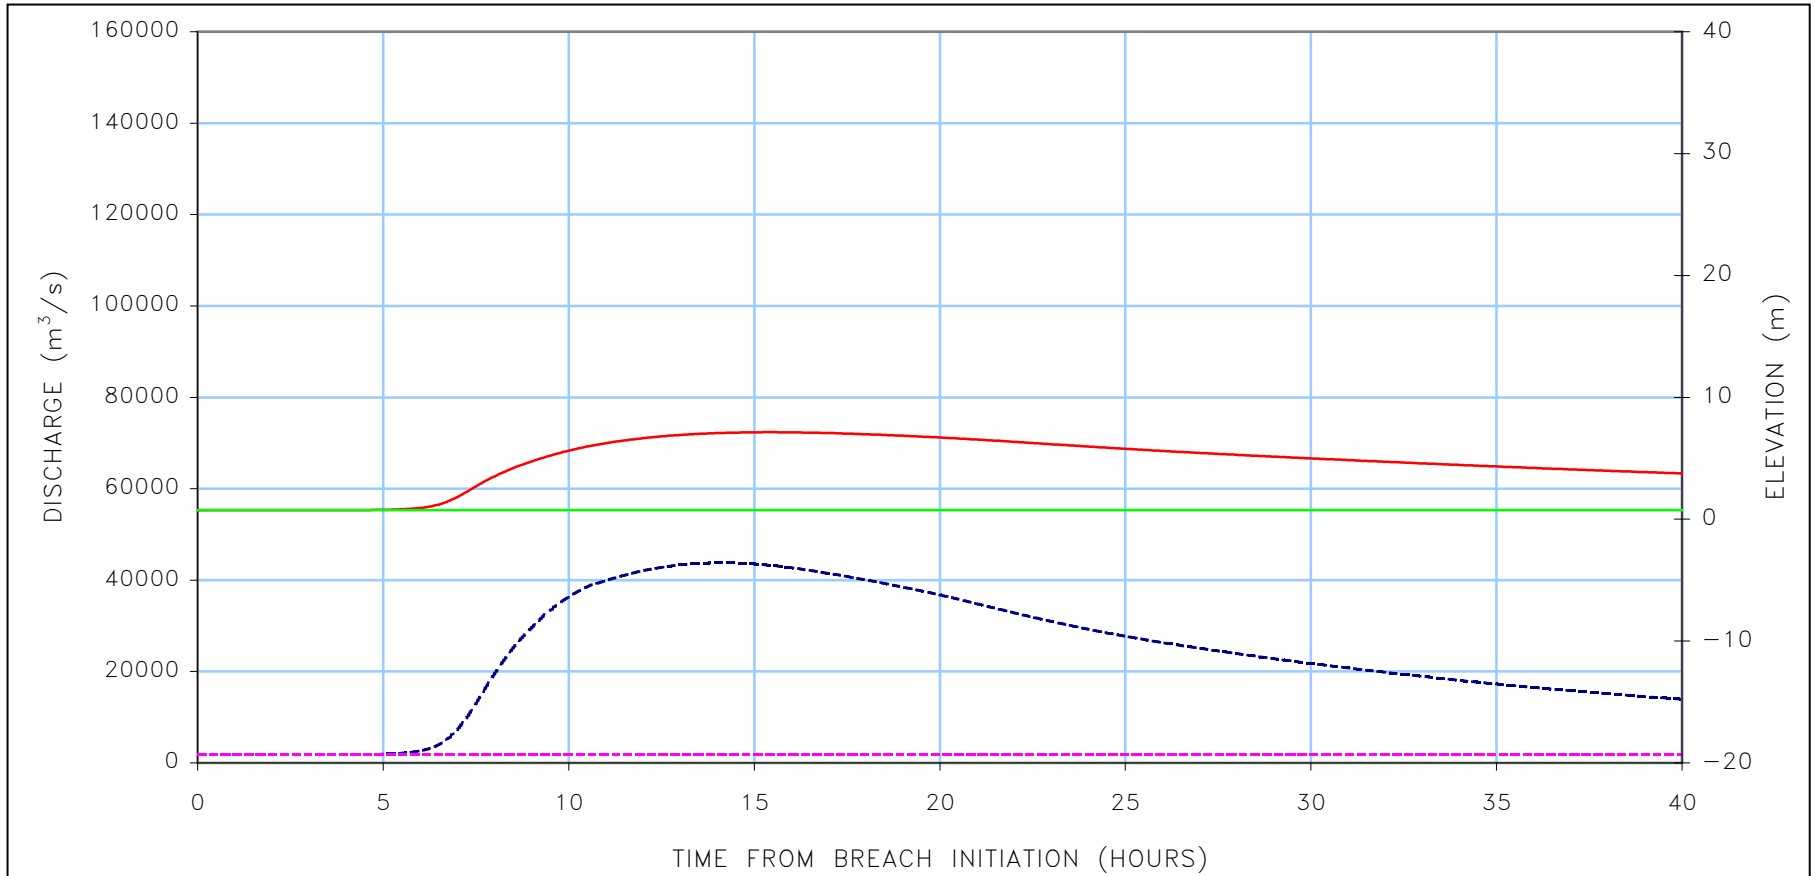
- DISCHARGE WITH BREACH
- - - DISCHARGE WITHOUT BREACH
- WATER ELEVATION WITH BREACH
- WATER ELEVATION WITHOUT BREACH

HATCH LIMITED
	NEWFOUNDLAND AND LABRADOR HYDRO
	G11190 – DAM BREAK STUDY
PROJECT H-325967	FAIR WEATHER CONDITIONS POST PROJECT, GULL ISLAND BREACH DISCHARGE AND WATER LEVEL HYDROGRAPH HAPPY VALLEY-GOOSE BAY
SCALE NTS	
DATE MAR 2008	FIGURE B.7

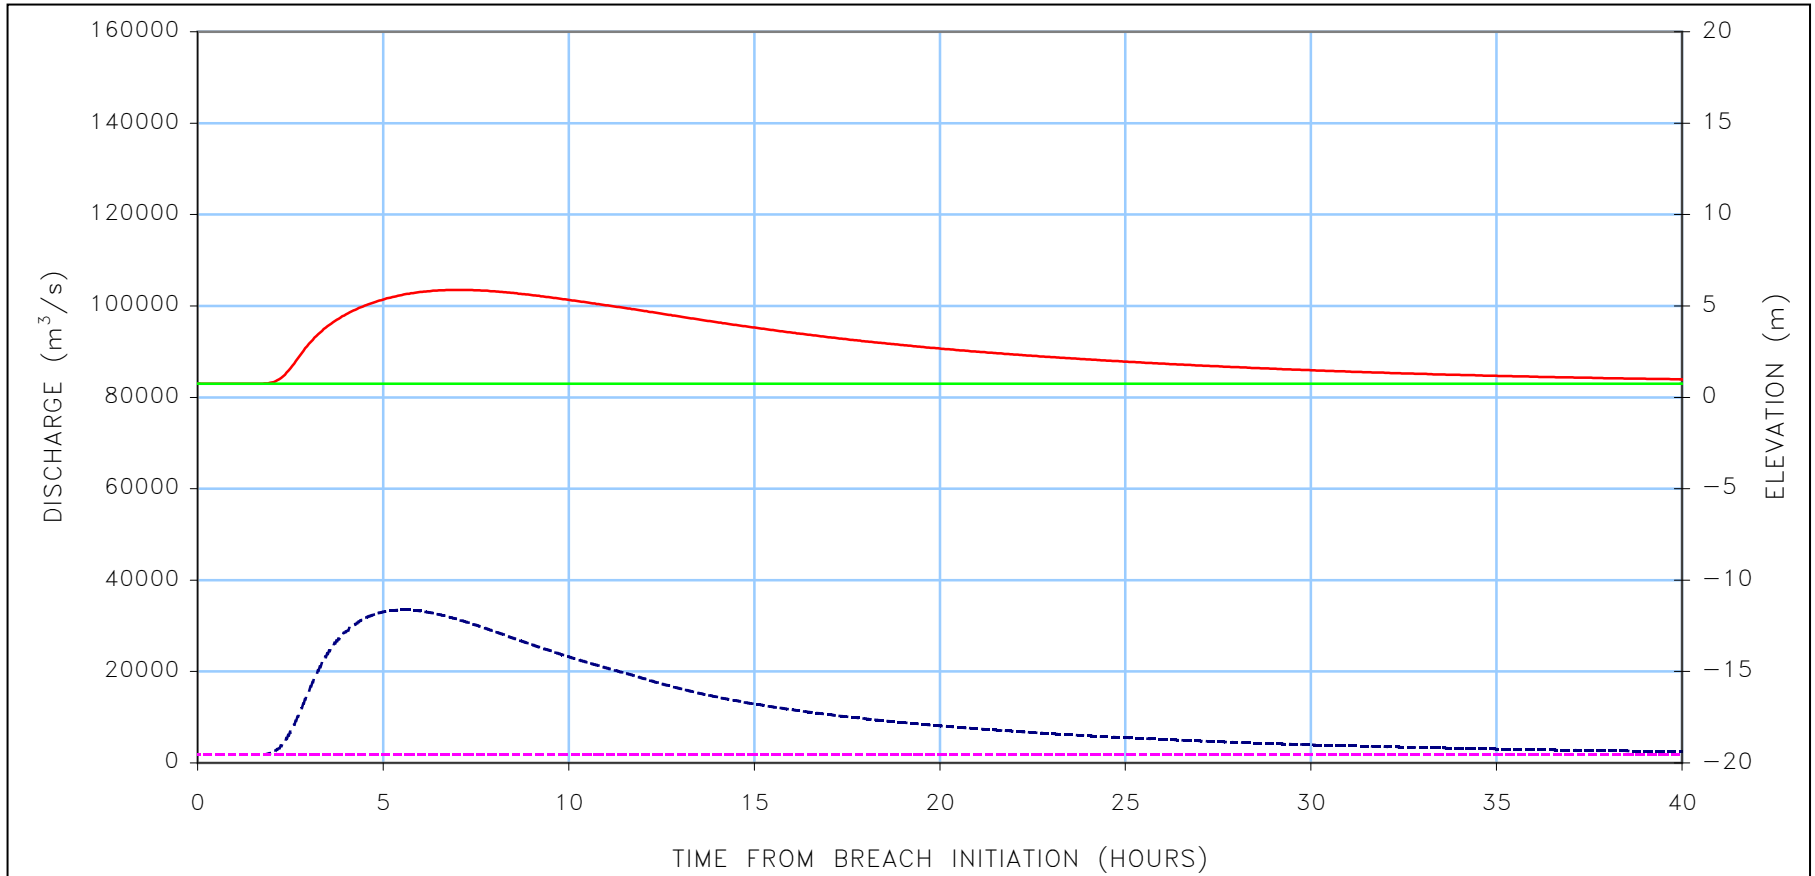
- DISCHARGE WITH BREACH
- DISCHARGE WITHOUT BREACH
- WATER ELEVATION WITH BREACH
- WATER ELEVATION WITHOUT BREACH

HATCH LIMITED
	NEWFOUNDLAND AND LABRADOR HYDRO
G11190 – DAM BREAK STUDY	
PROJECT H-325967	FAIR WEATHER CONDITIONS POST PROJECT, MUSKRAT FALLS BREACH DISCHARGE AND WATER LEVEL HYDROGRAPH HAPPY VALLEY-GOOSE BAY
SCALE NTS	
DATE MAR 2008	FIGURE C.7

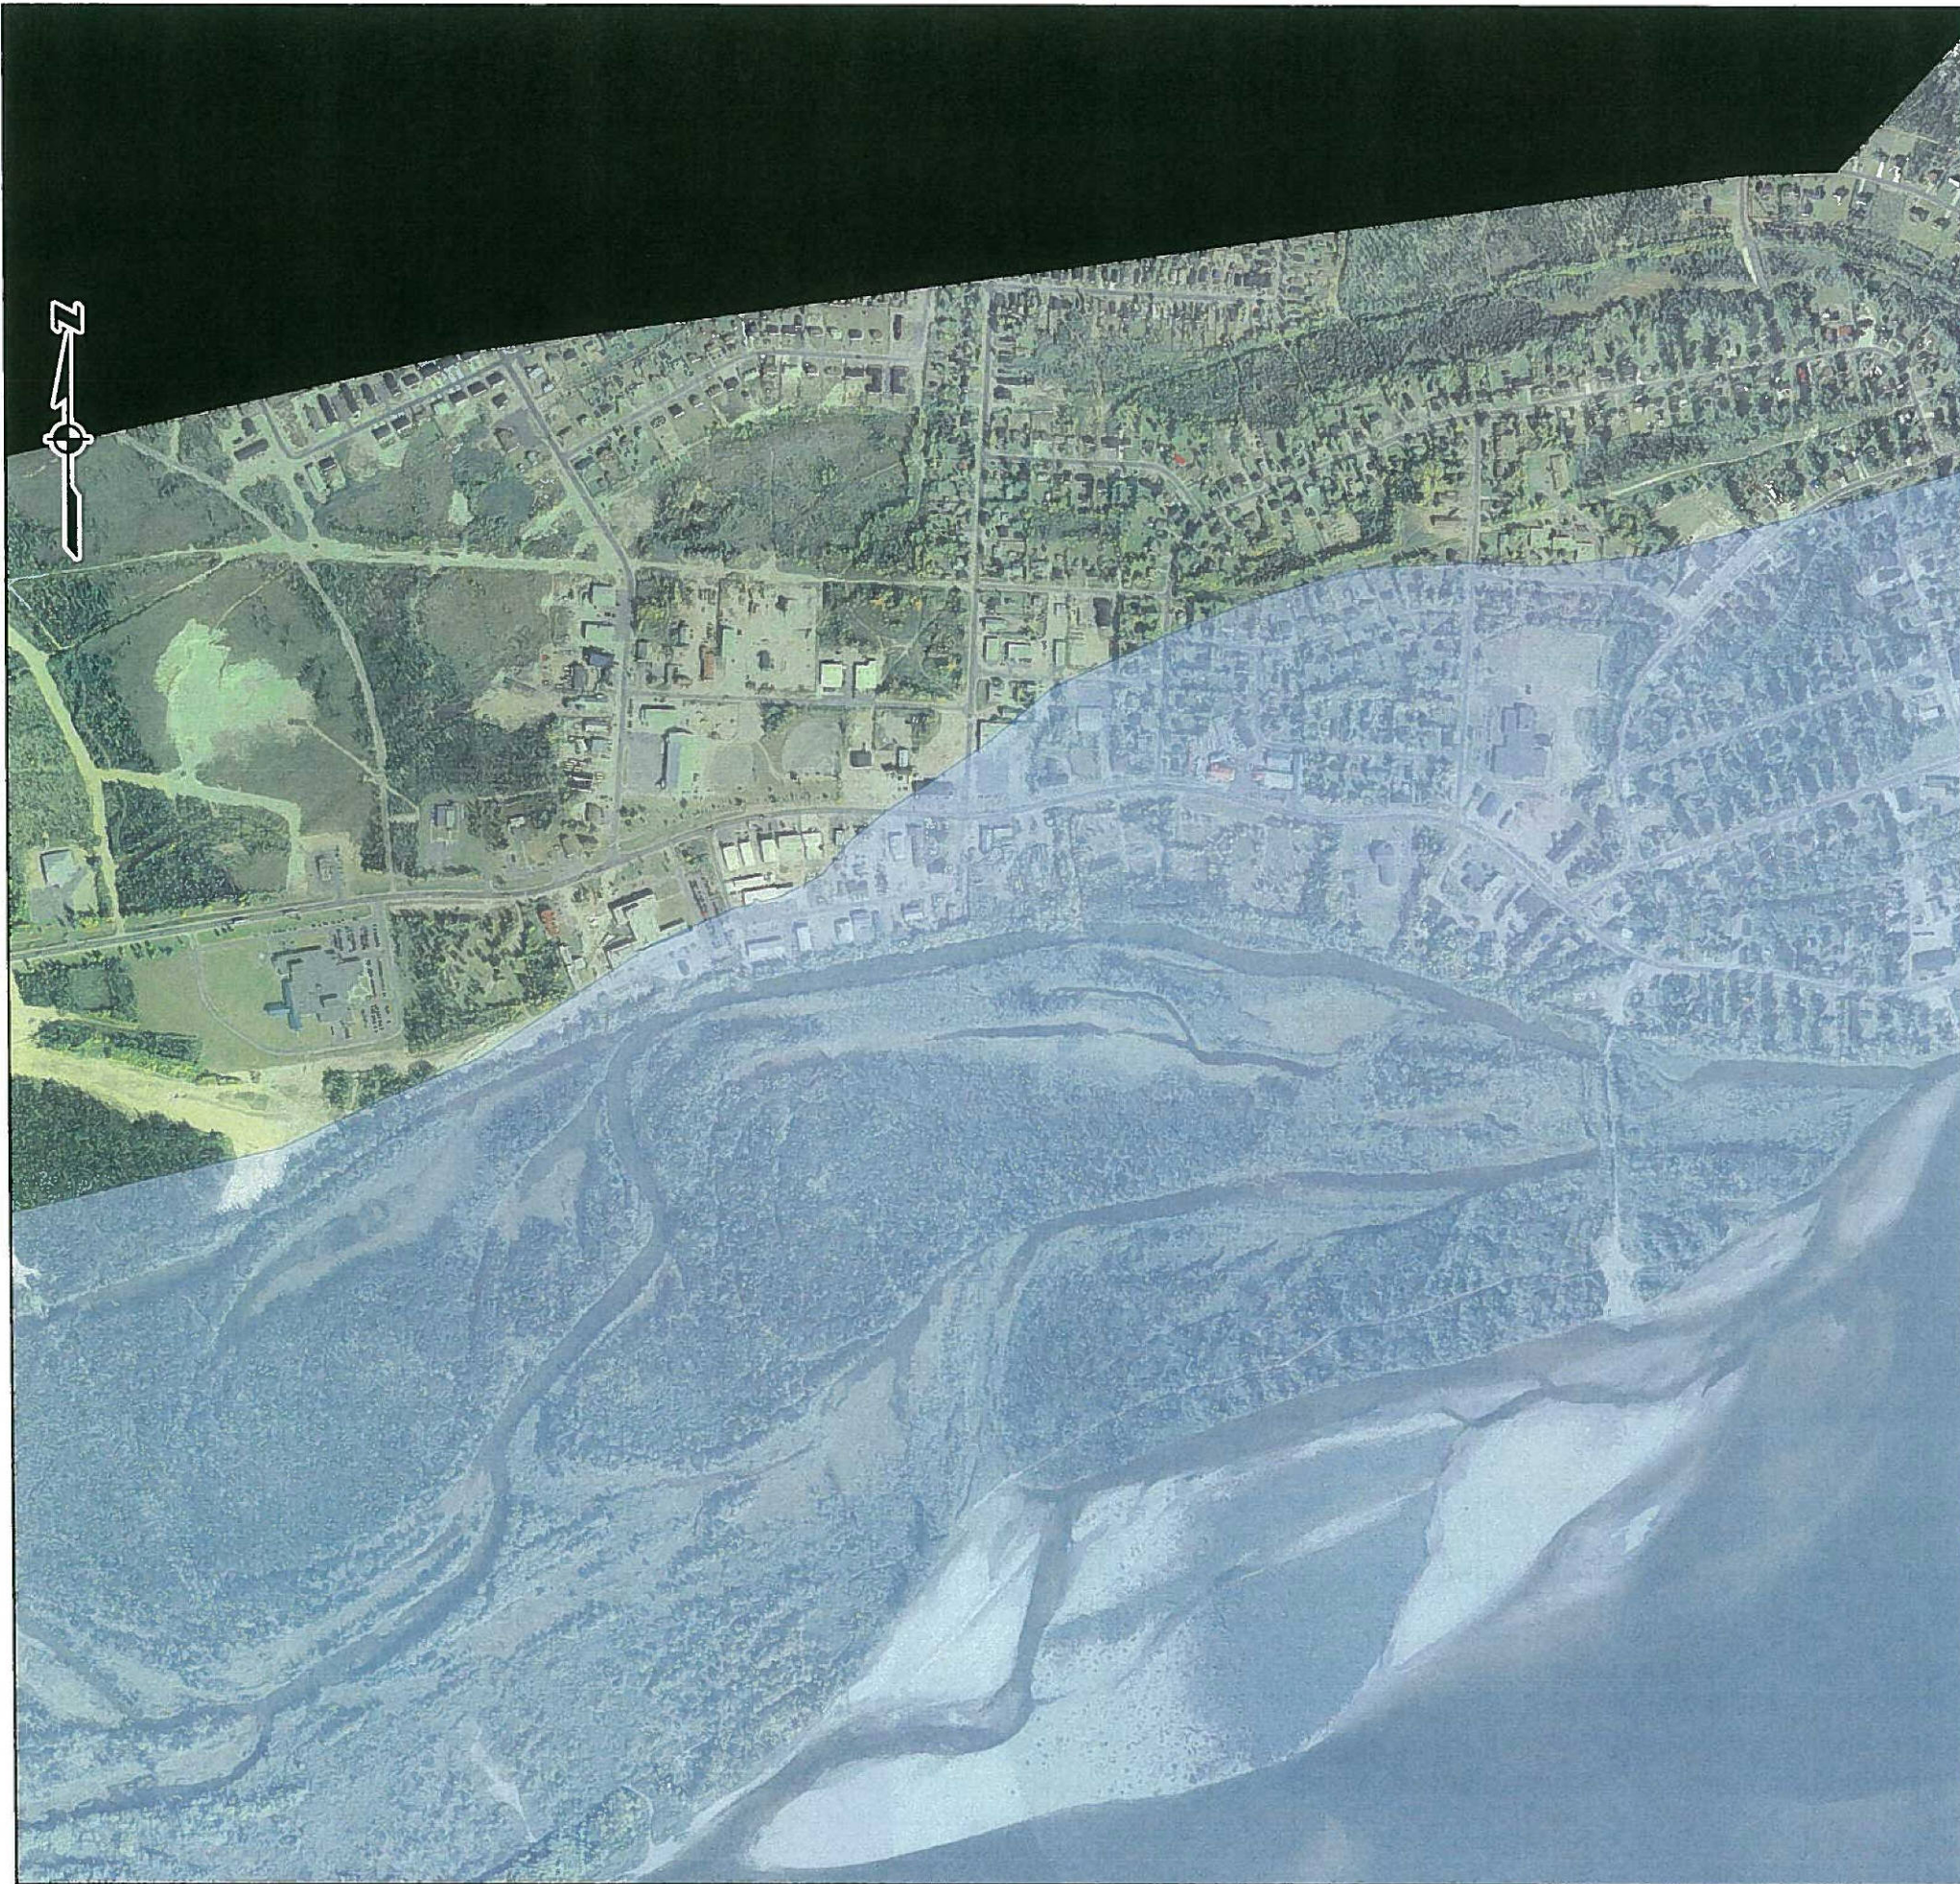
“Fair Weather” Inundation Mapping Series – Happy Valley- Goose Bay and Mud Lake

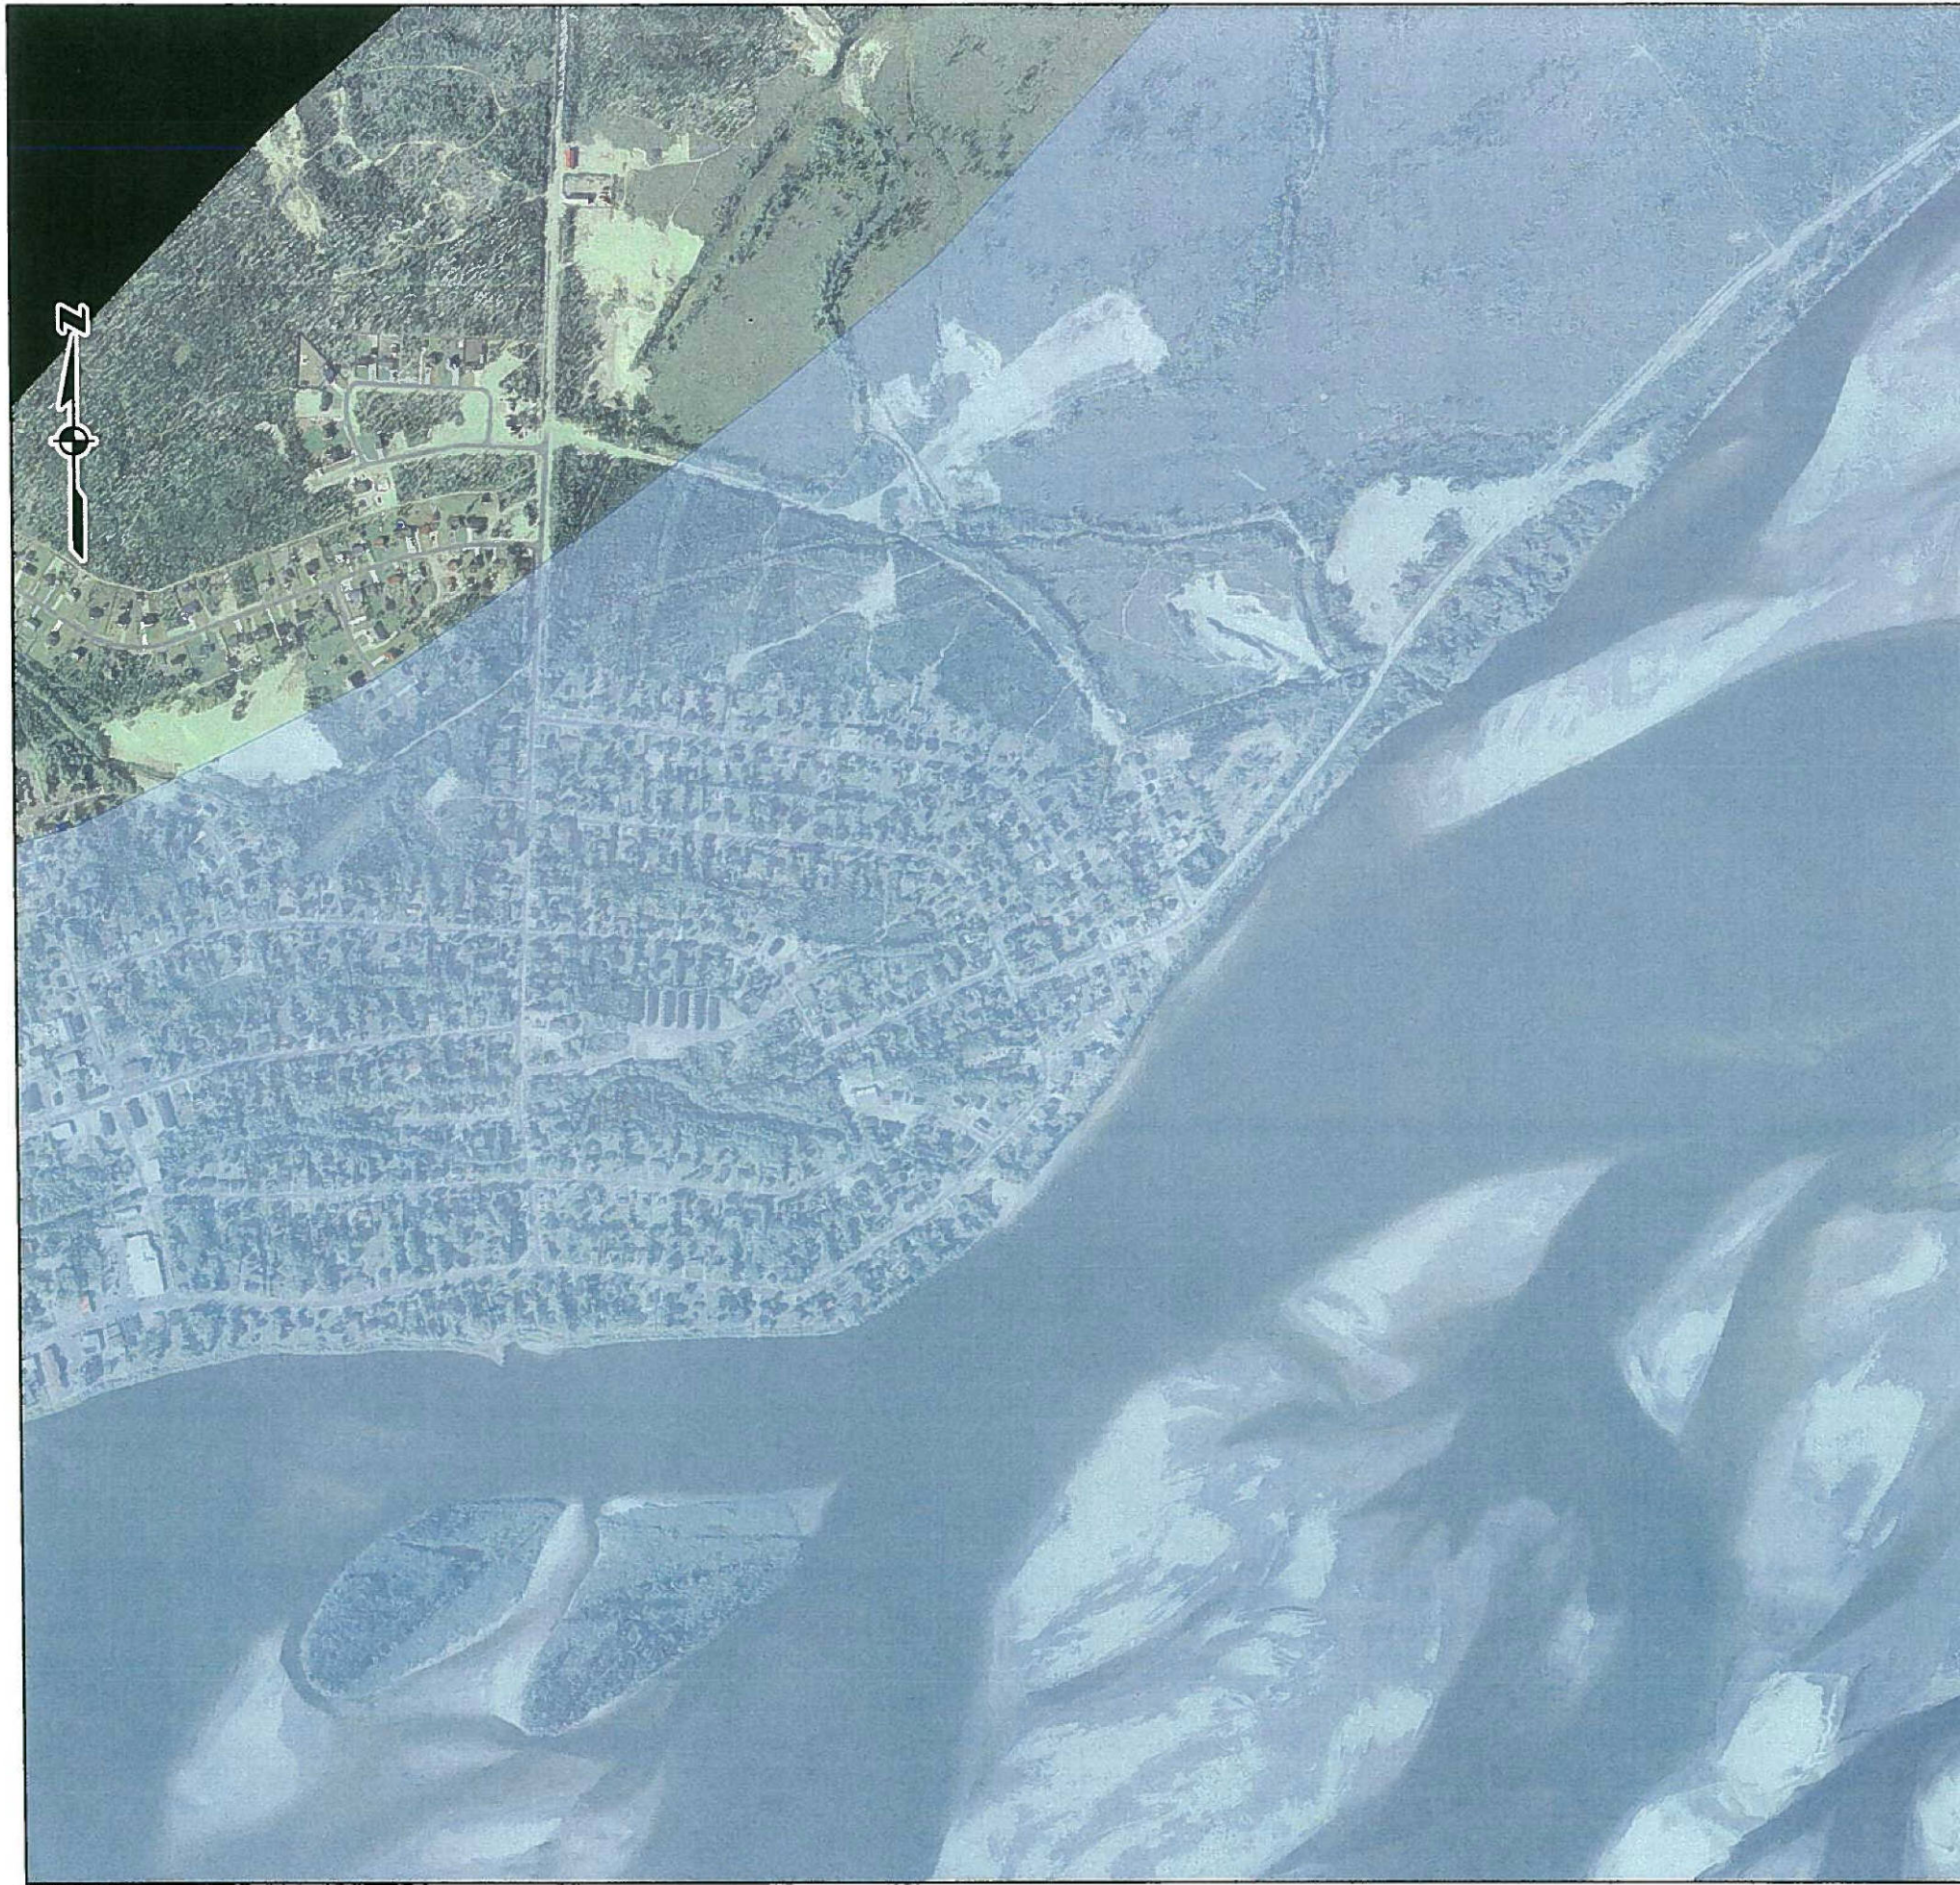
DRAWING NO. FIGURE C1-1

FAIR WEATHER CONDITIONS
 POST GULL ISLAND
 FAILURE OF GULL ISLAND MAIN DAM

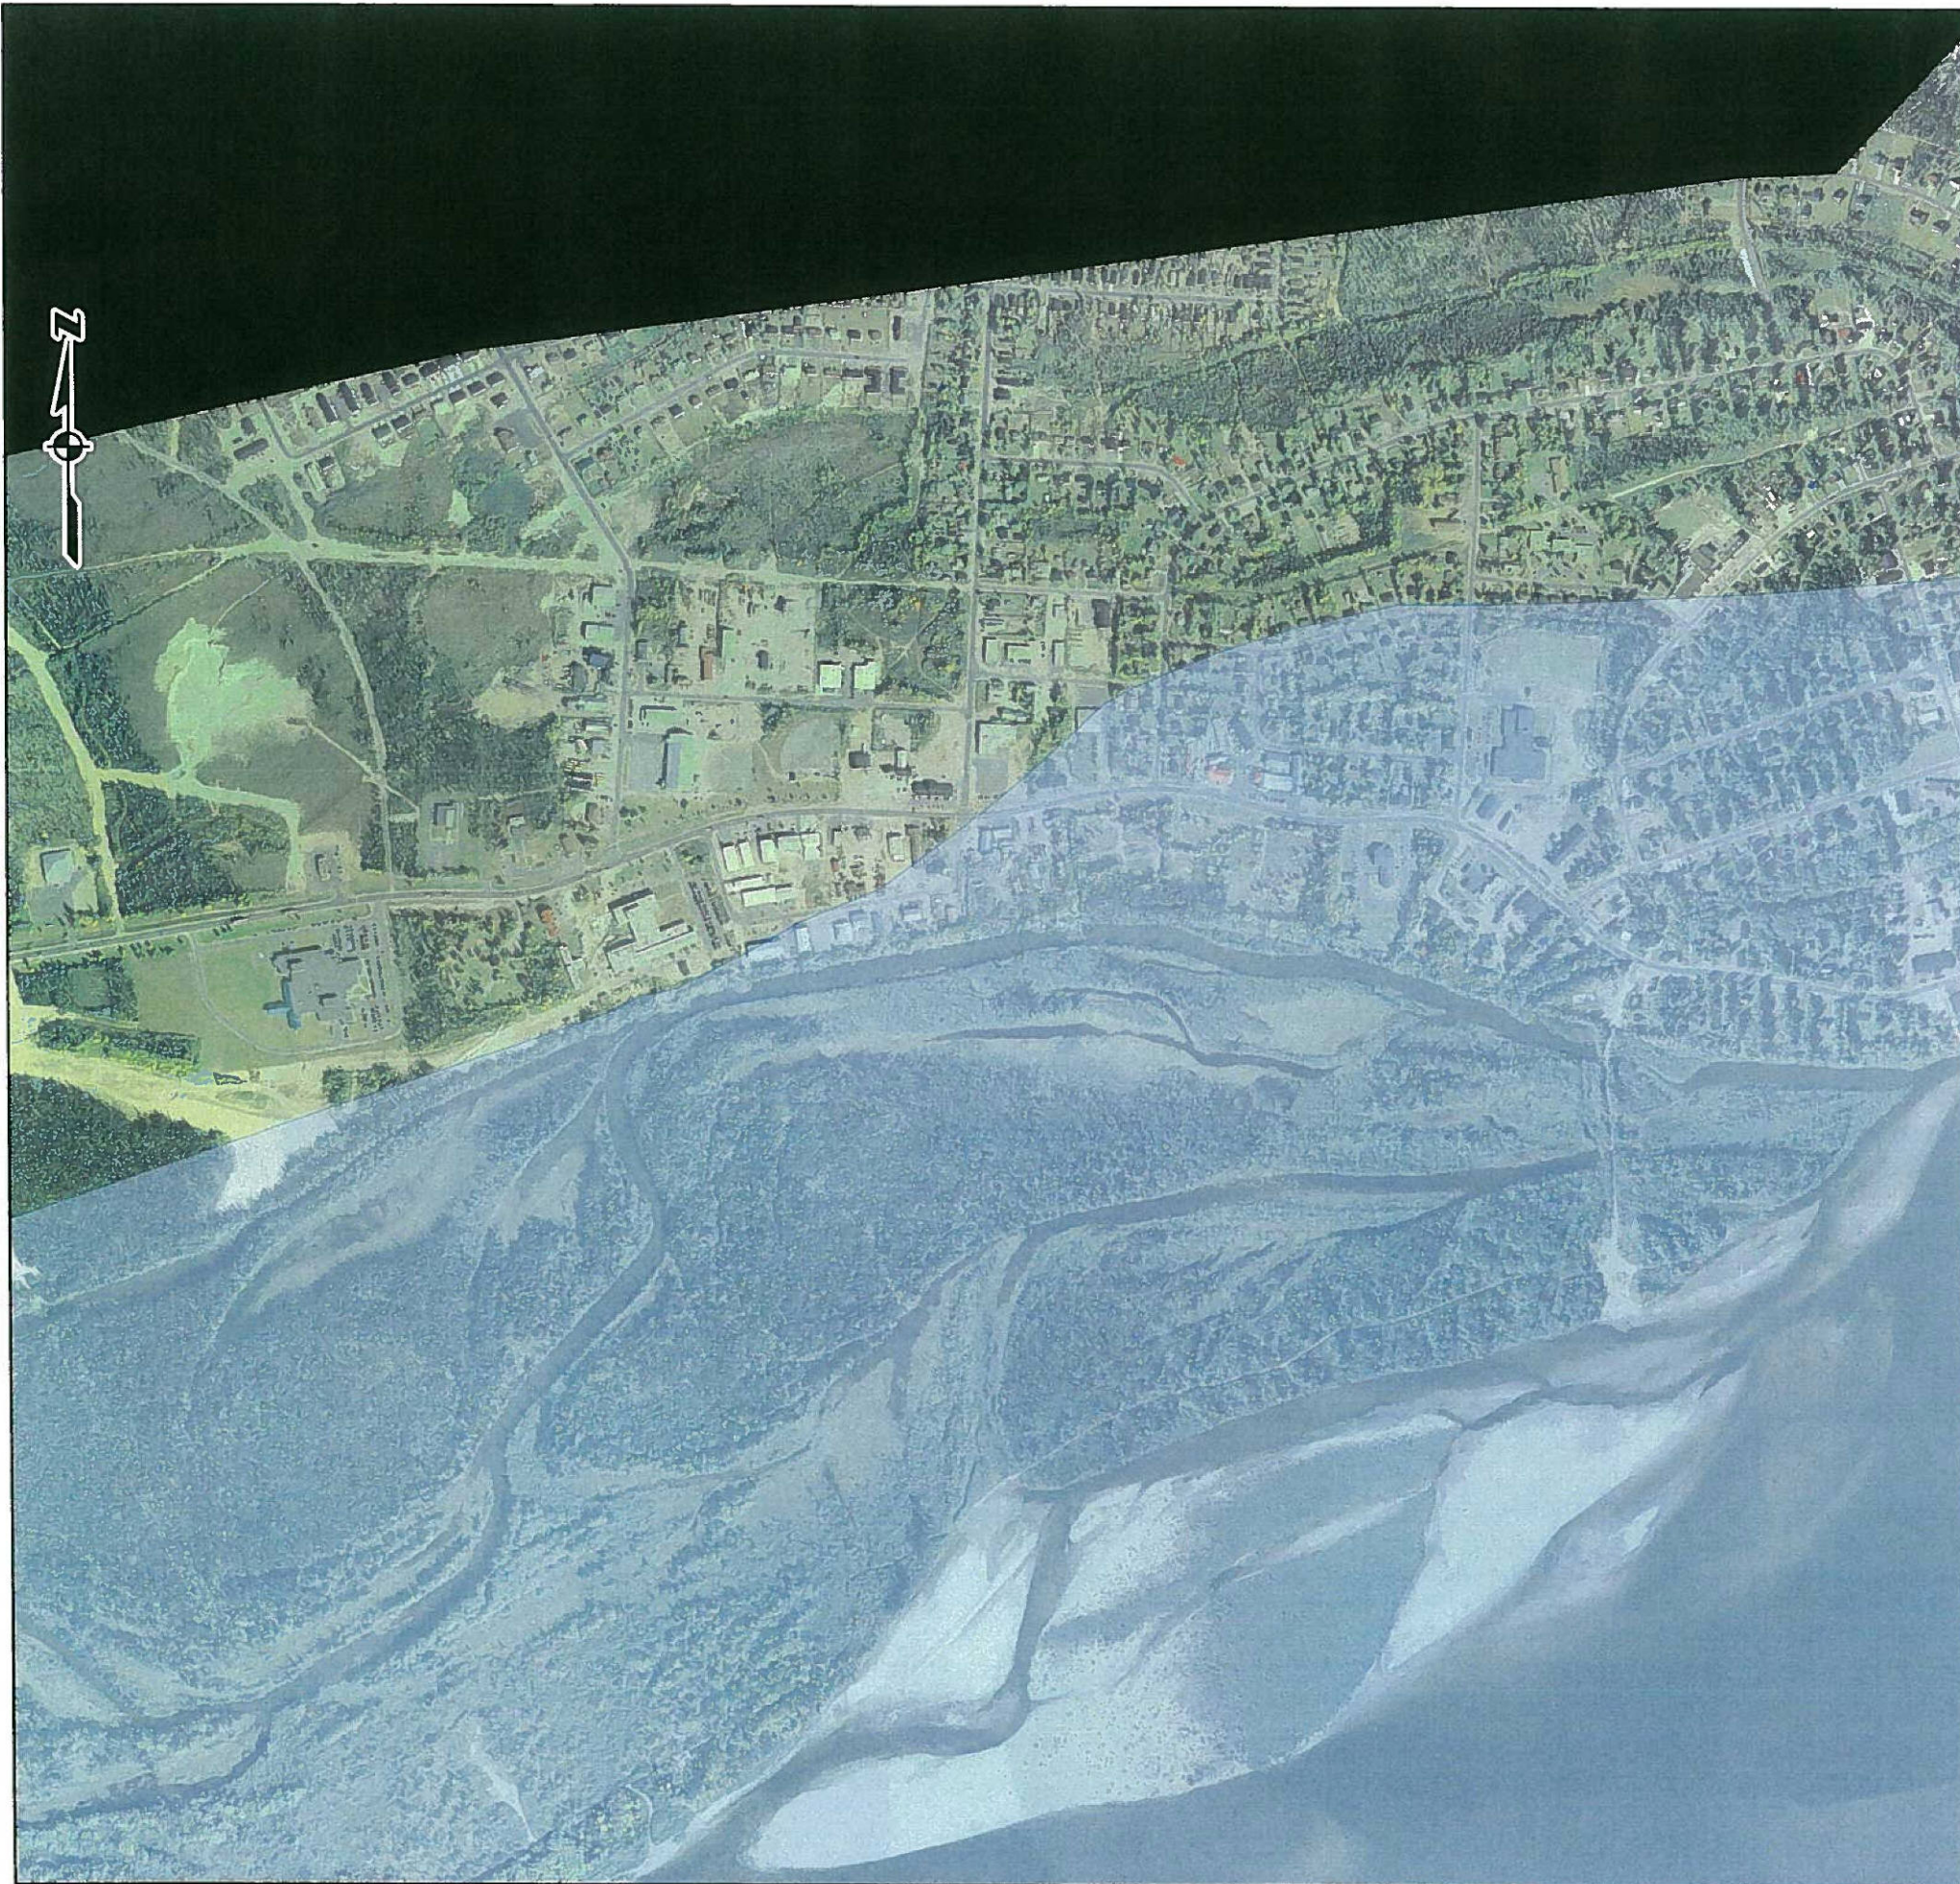
FAIR WEATHER CONDITIONS
POST GULL ISLAND
FAILURE OF GULL ISLAND MAIN DAM
