THE Lower Churchill PROJECT

April 2008

GI1190 - Dam Break Study Volume 1

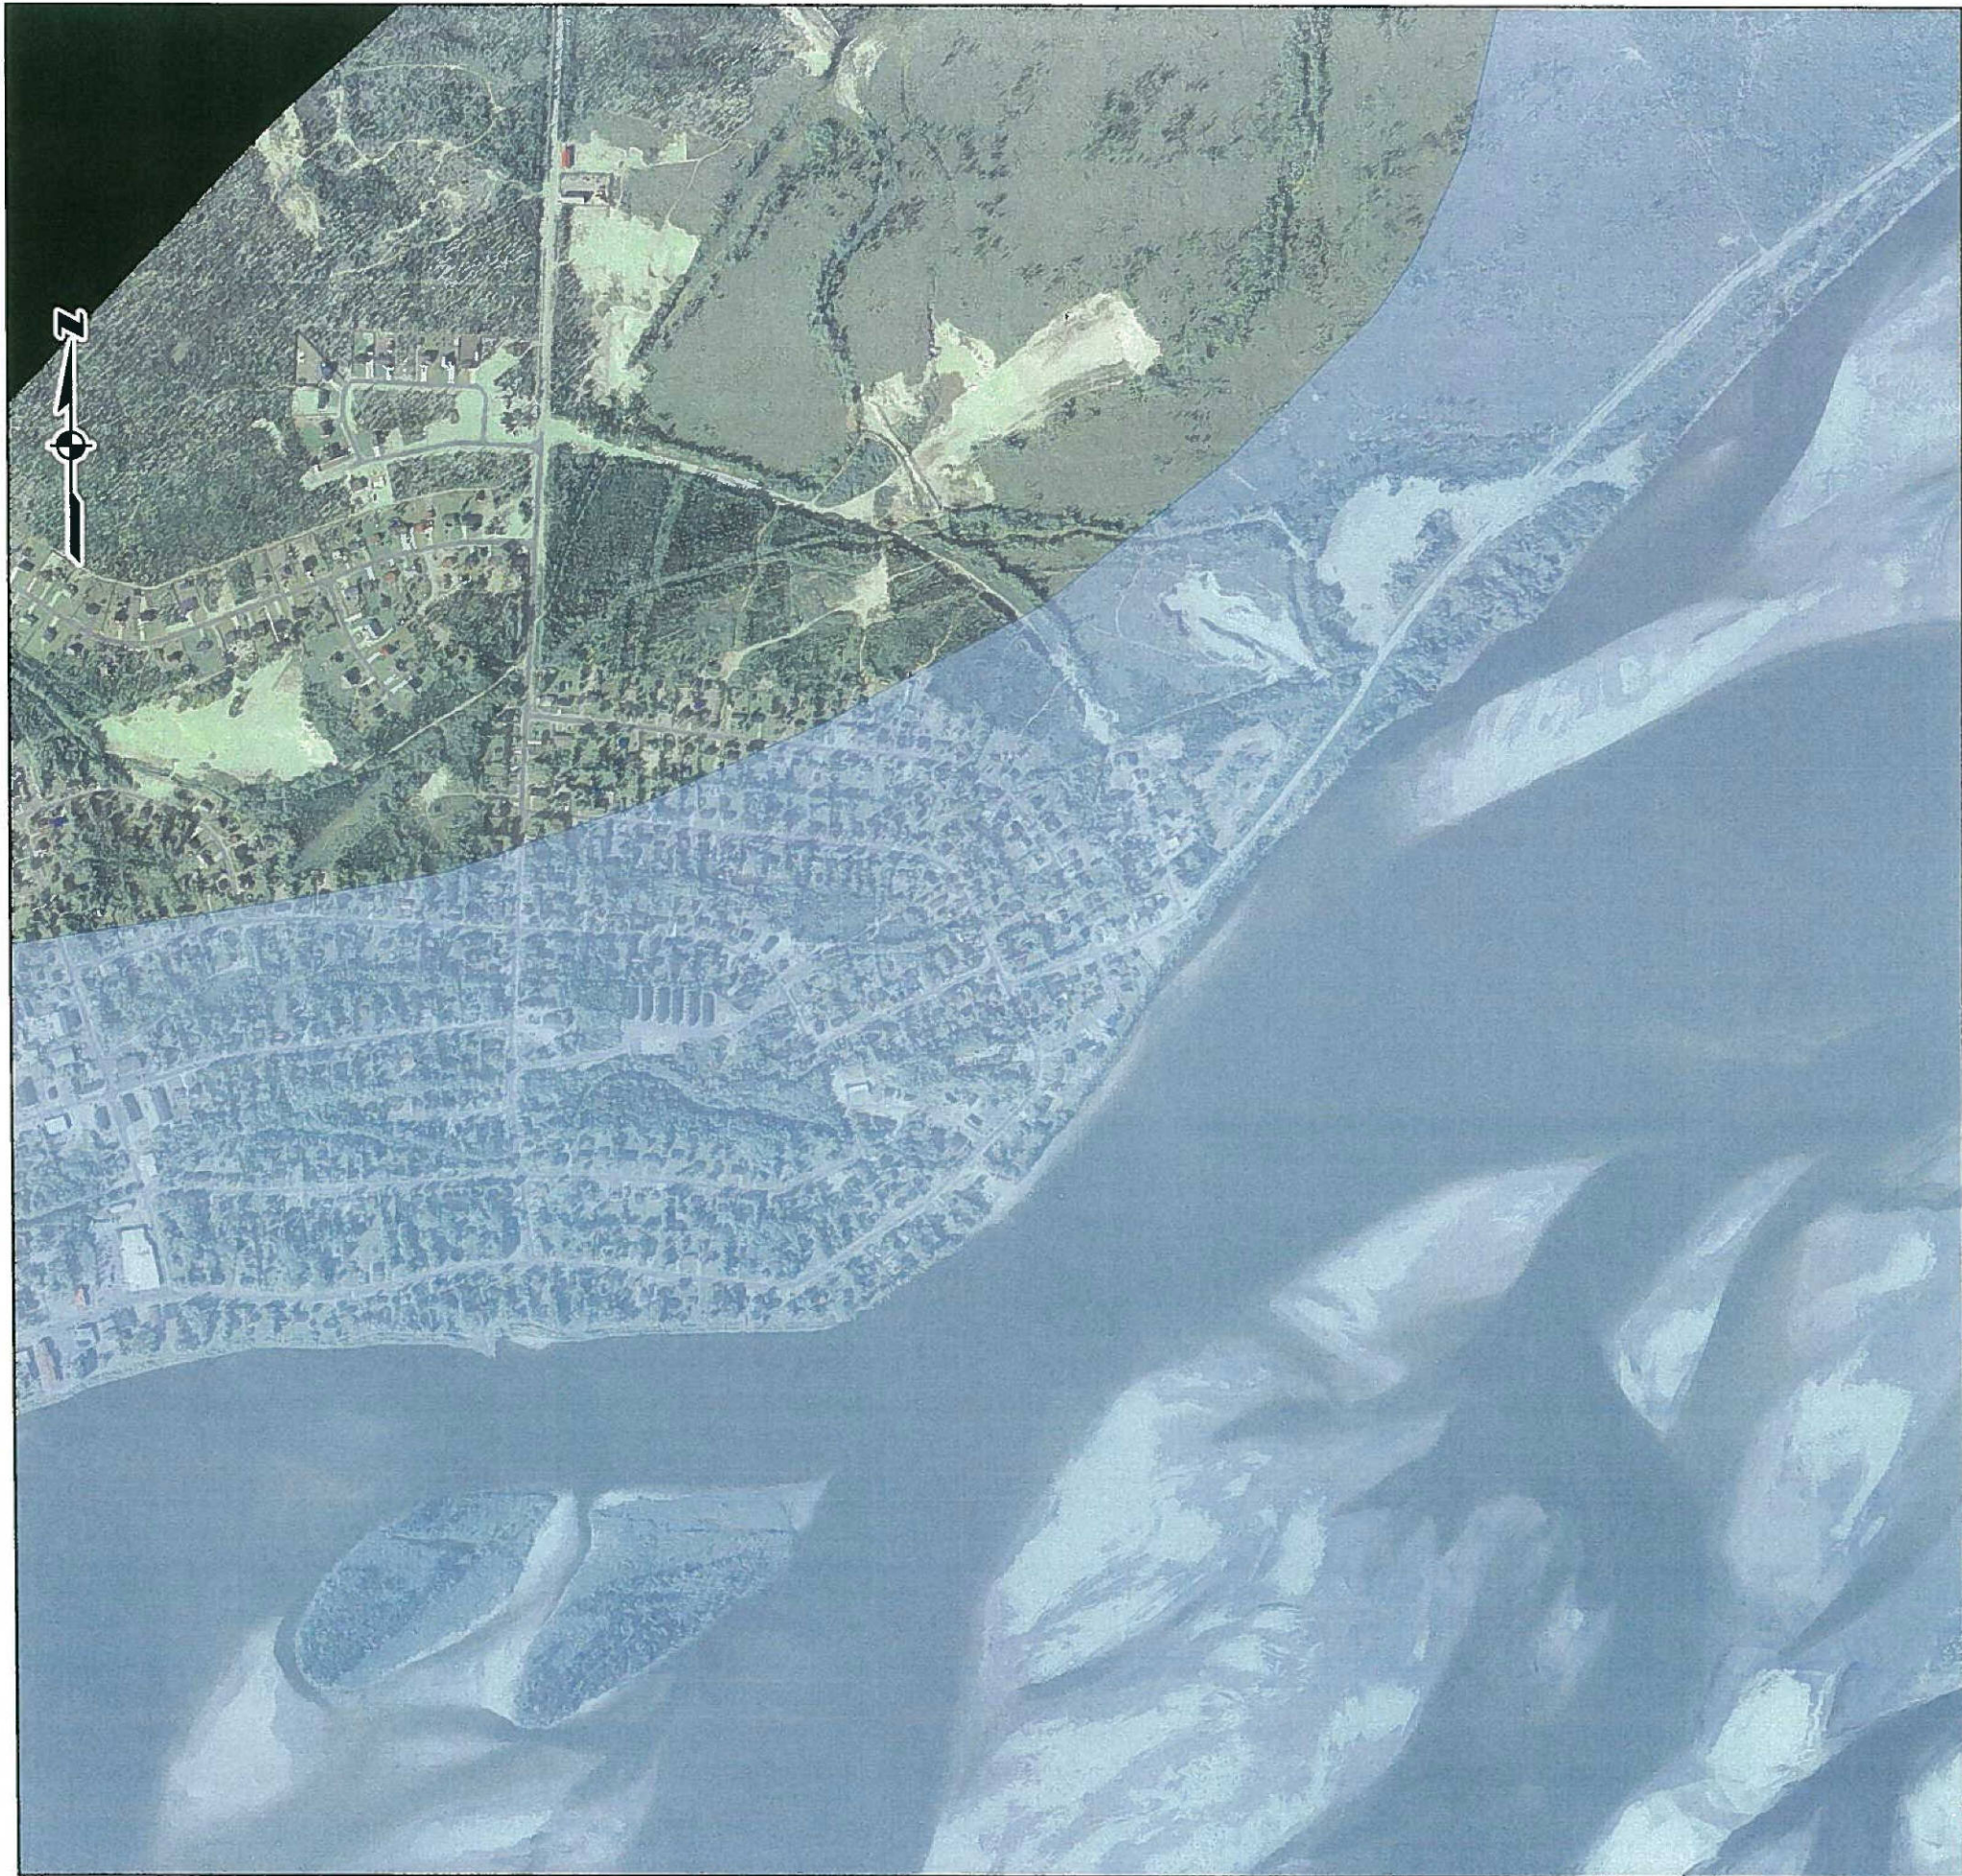
SCALE 1:10000	DRAWING NO. FIGURE C2-1
HATCH PROJECT NO. H-325967

FAIR WEATHER CONDITIONS
 POST GULL ISLAND AND MUSKRAT FALLS
 FAILURE OF GULL ISLAND MAIN DAM

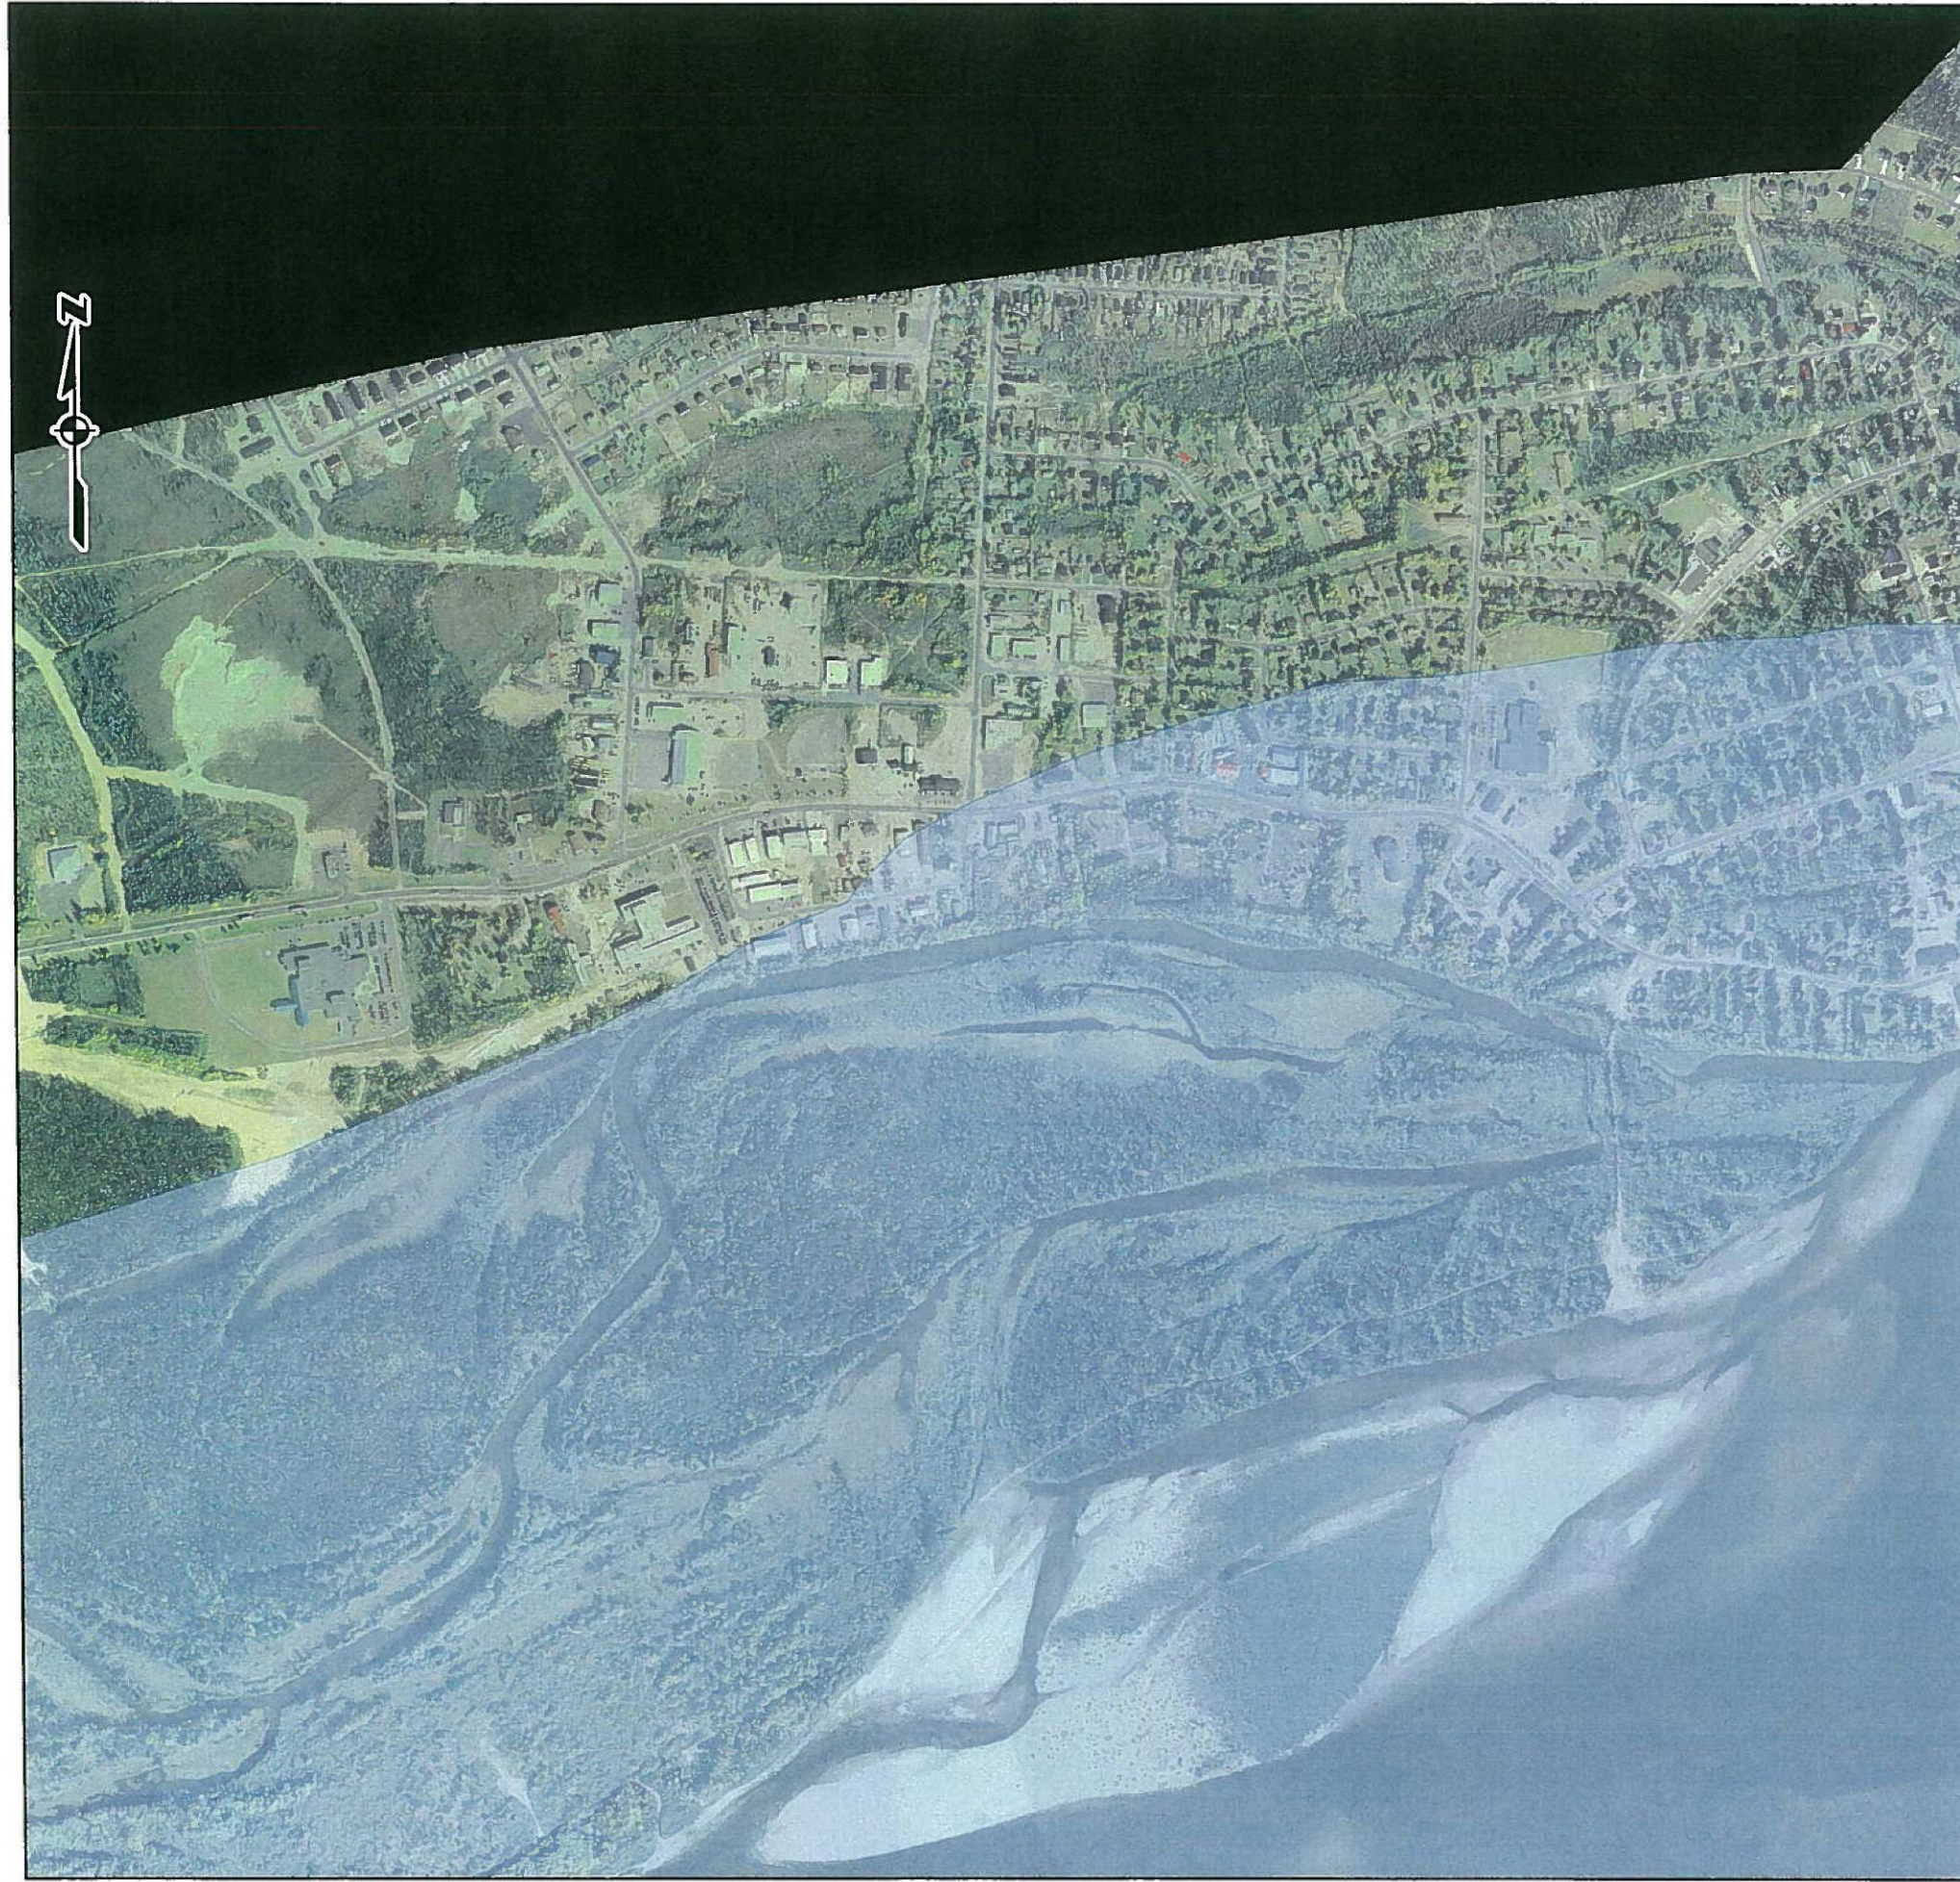
DRAWING NO. FIGURE C2-3

FAIR WEATHER CONDITIONS
 POST GULL ISLAND AND MUSKRAT FALLS
 FAILURE OF GULL ISLAND MAIN DAM

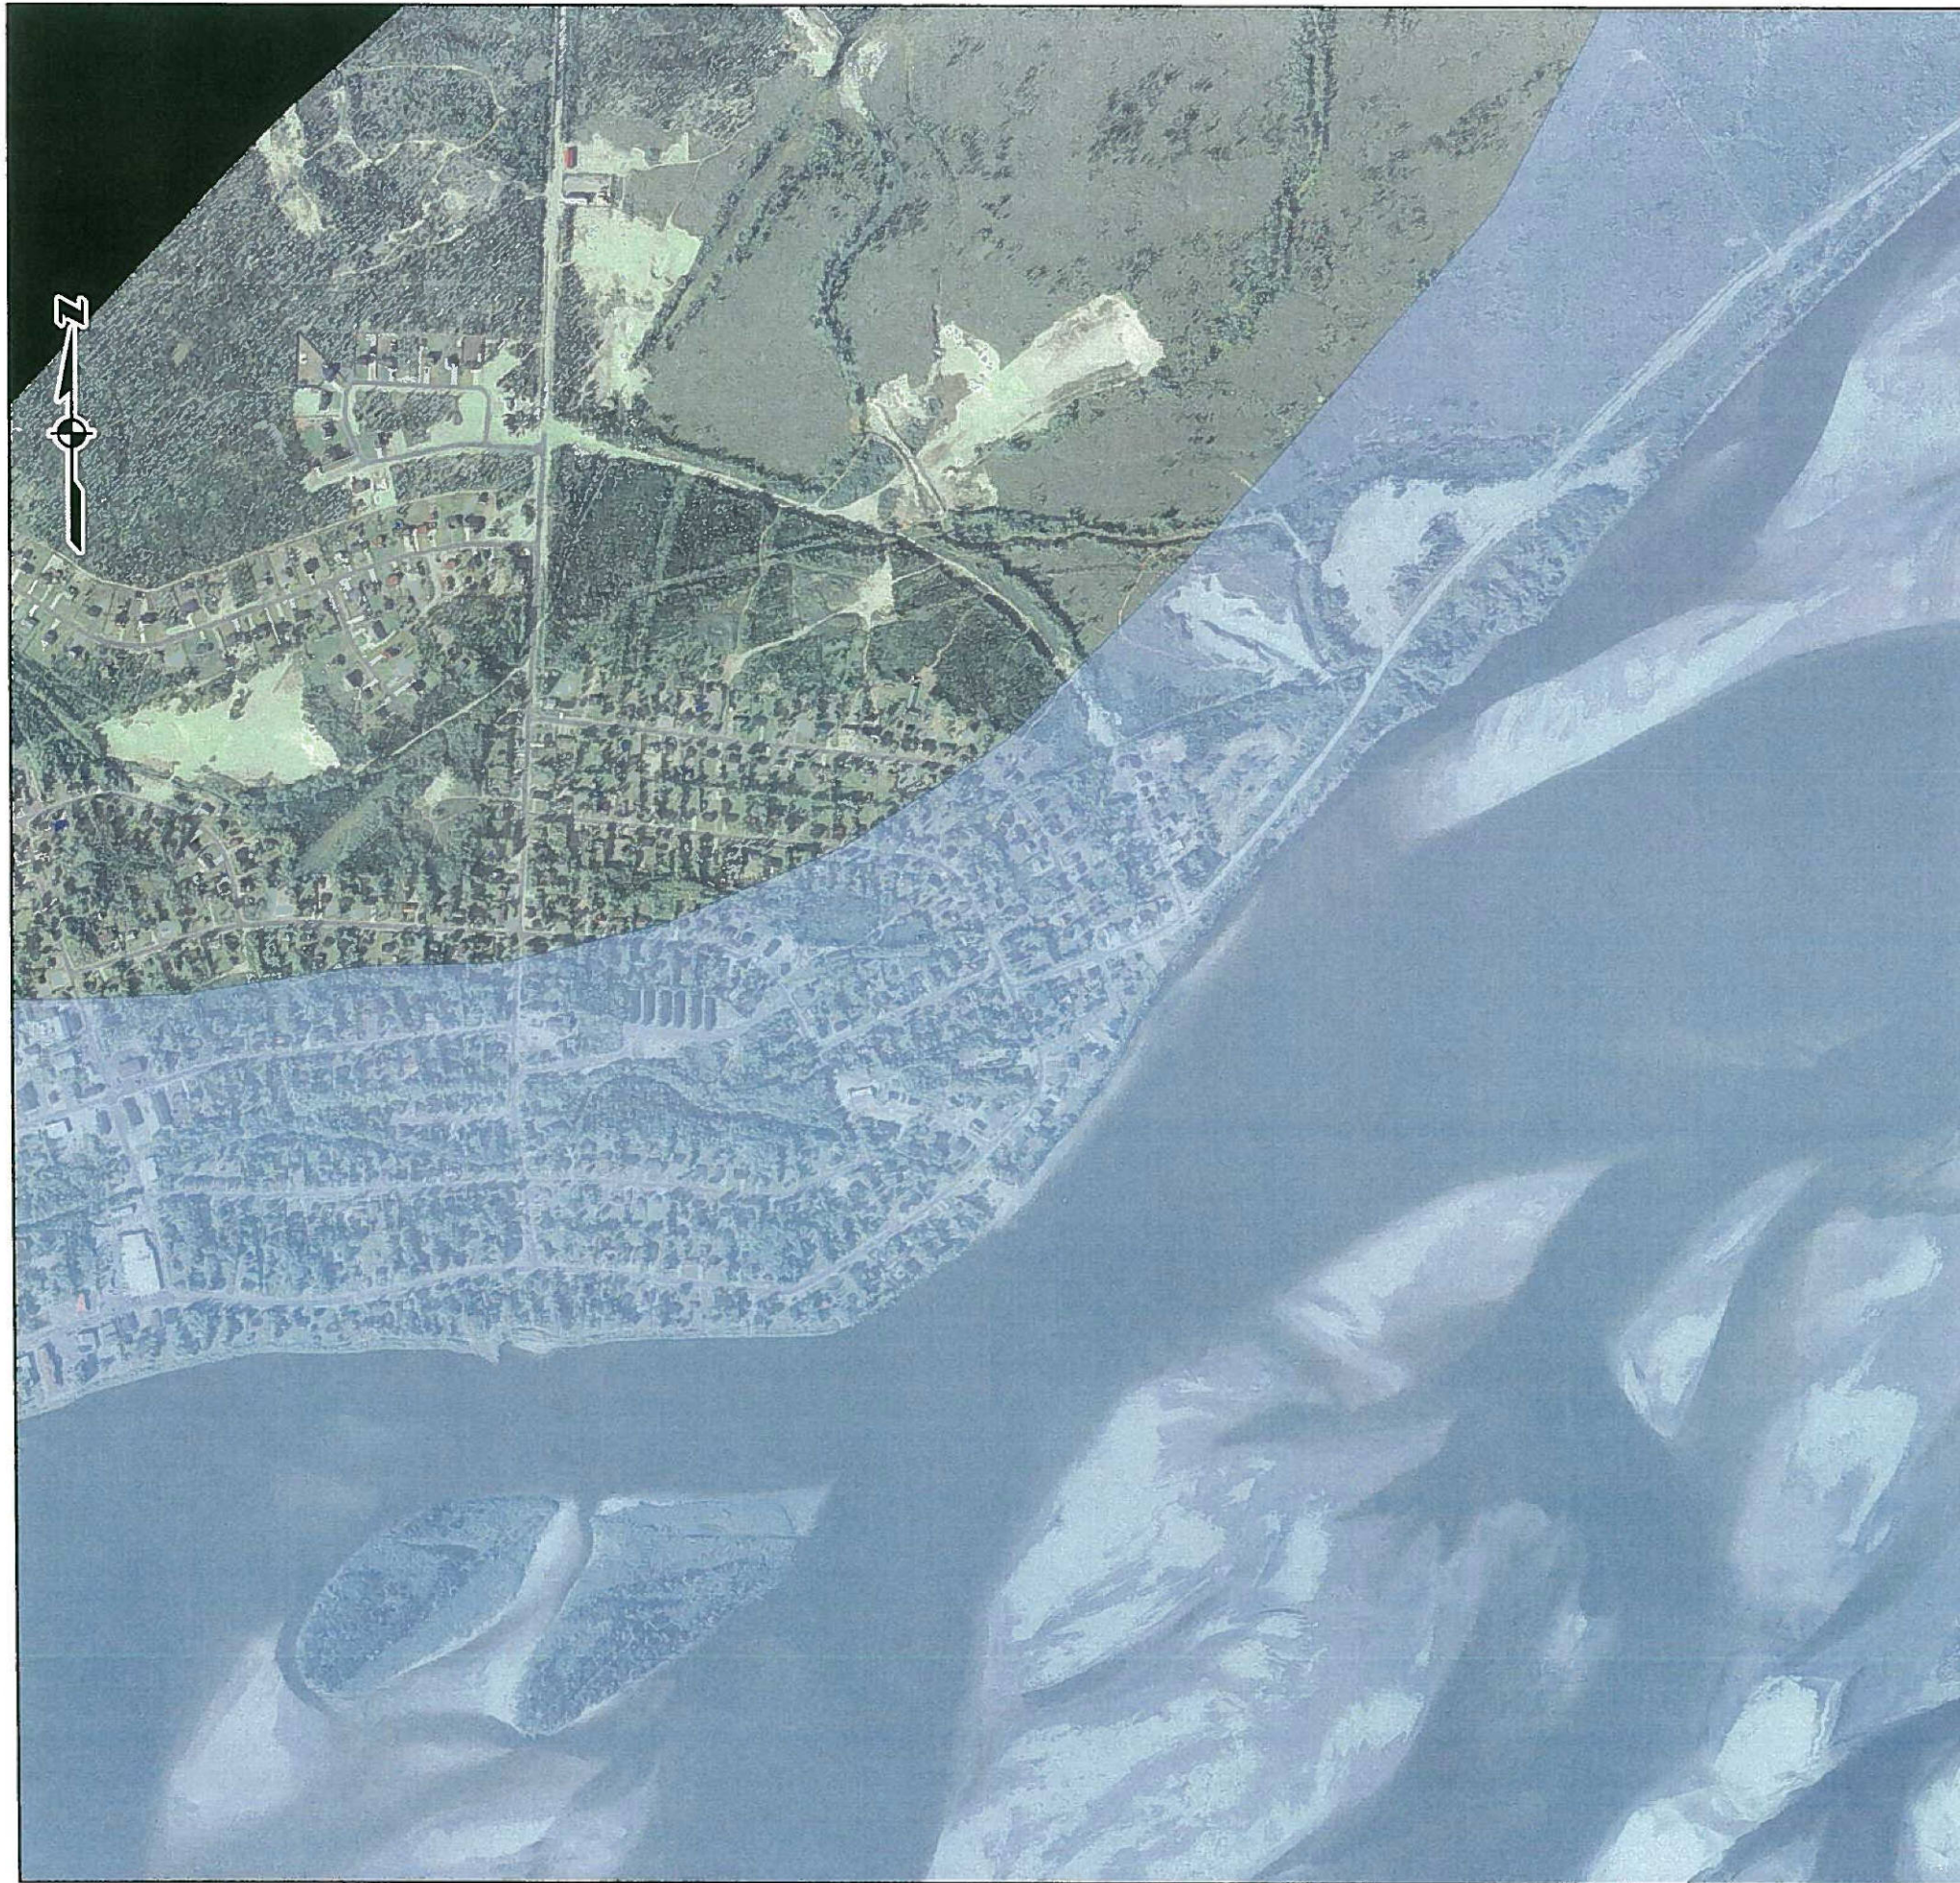
DRAWING NO. FIGURE C3-1

FAIR WEATHER CONDITIONS
 POST GULL ISLAND AND MUSKRAT FALLS
 FAILURE OF MUSKRAT FALLS NORTH RCC DAM

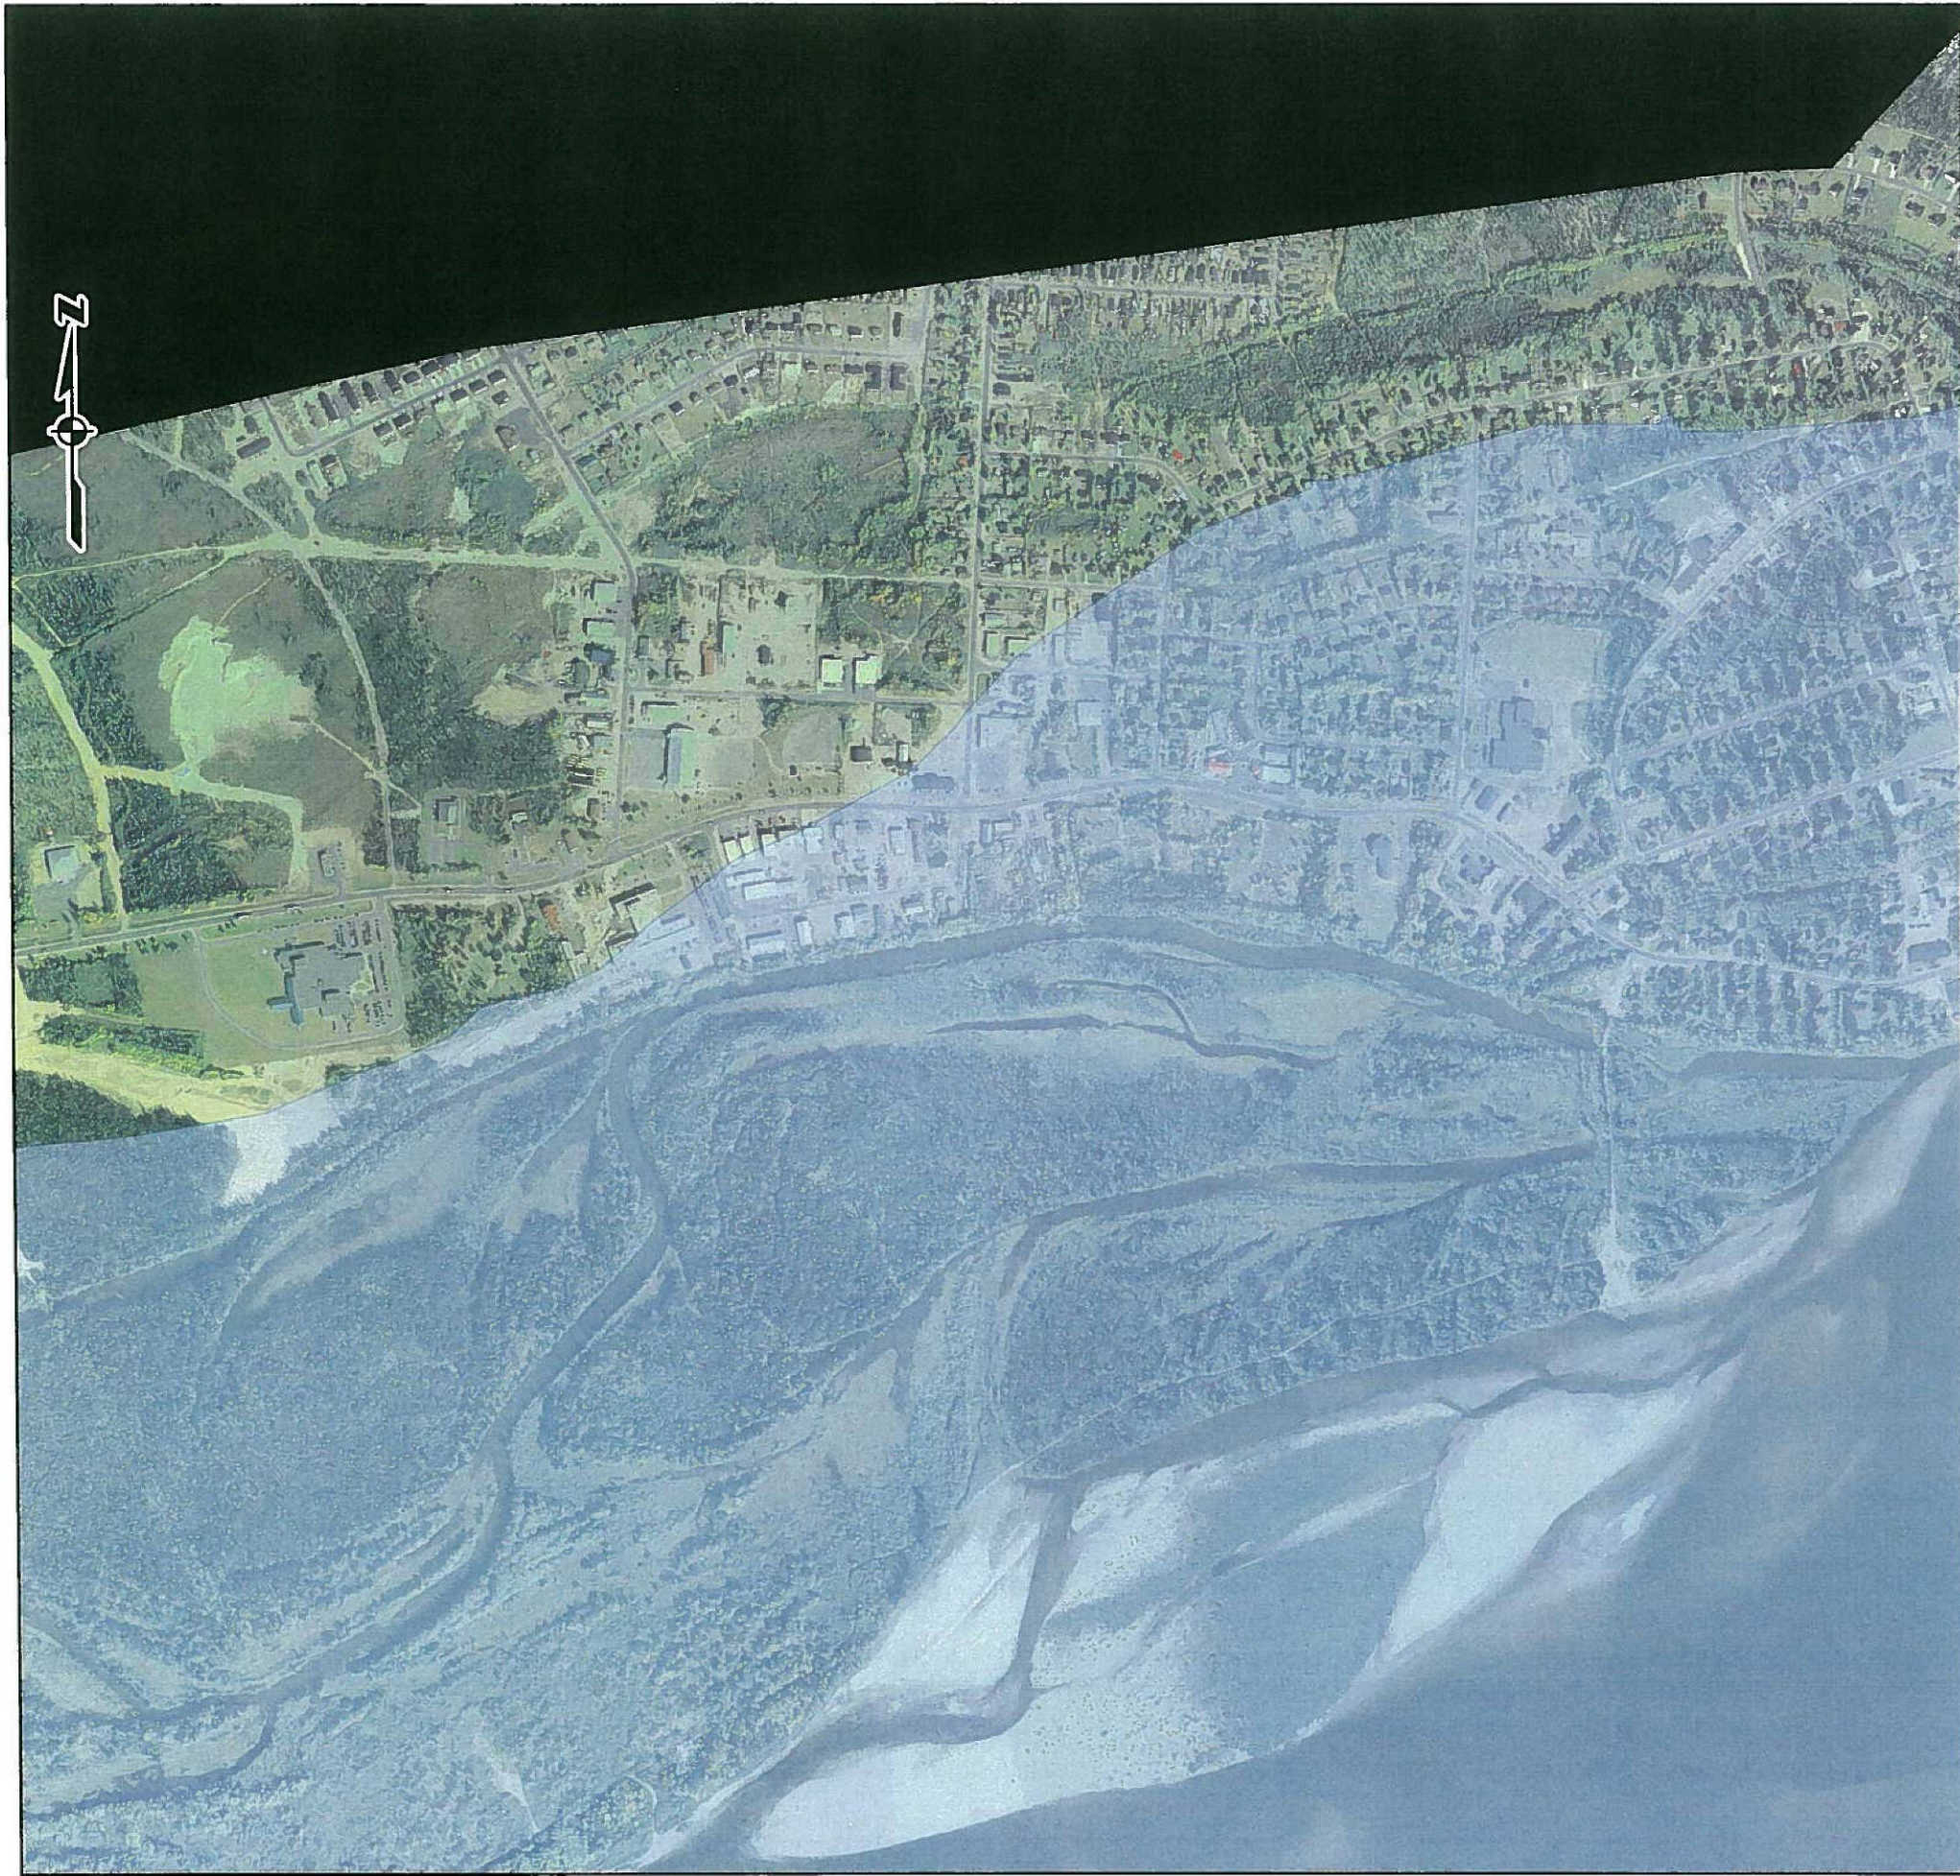
SCALE 1:10000	DRAWING NO. FIGURE C3-3
HATCH PROJECT NO. H-325967

FAIR WEATHER CONDITIONS
 POST GULL ISLAND AND MUSKRAT FALLS
 FAILURE OF MUSKRAT FALLS NORTH RCC DAM

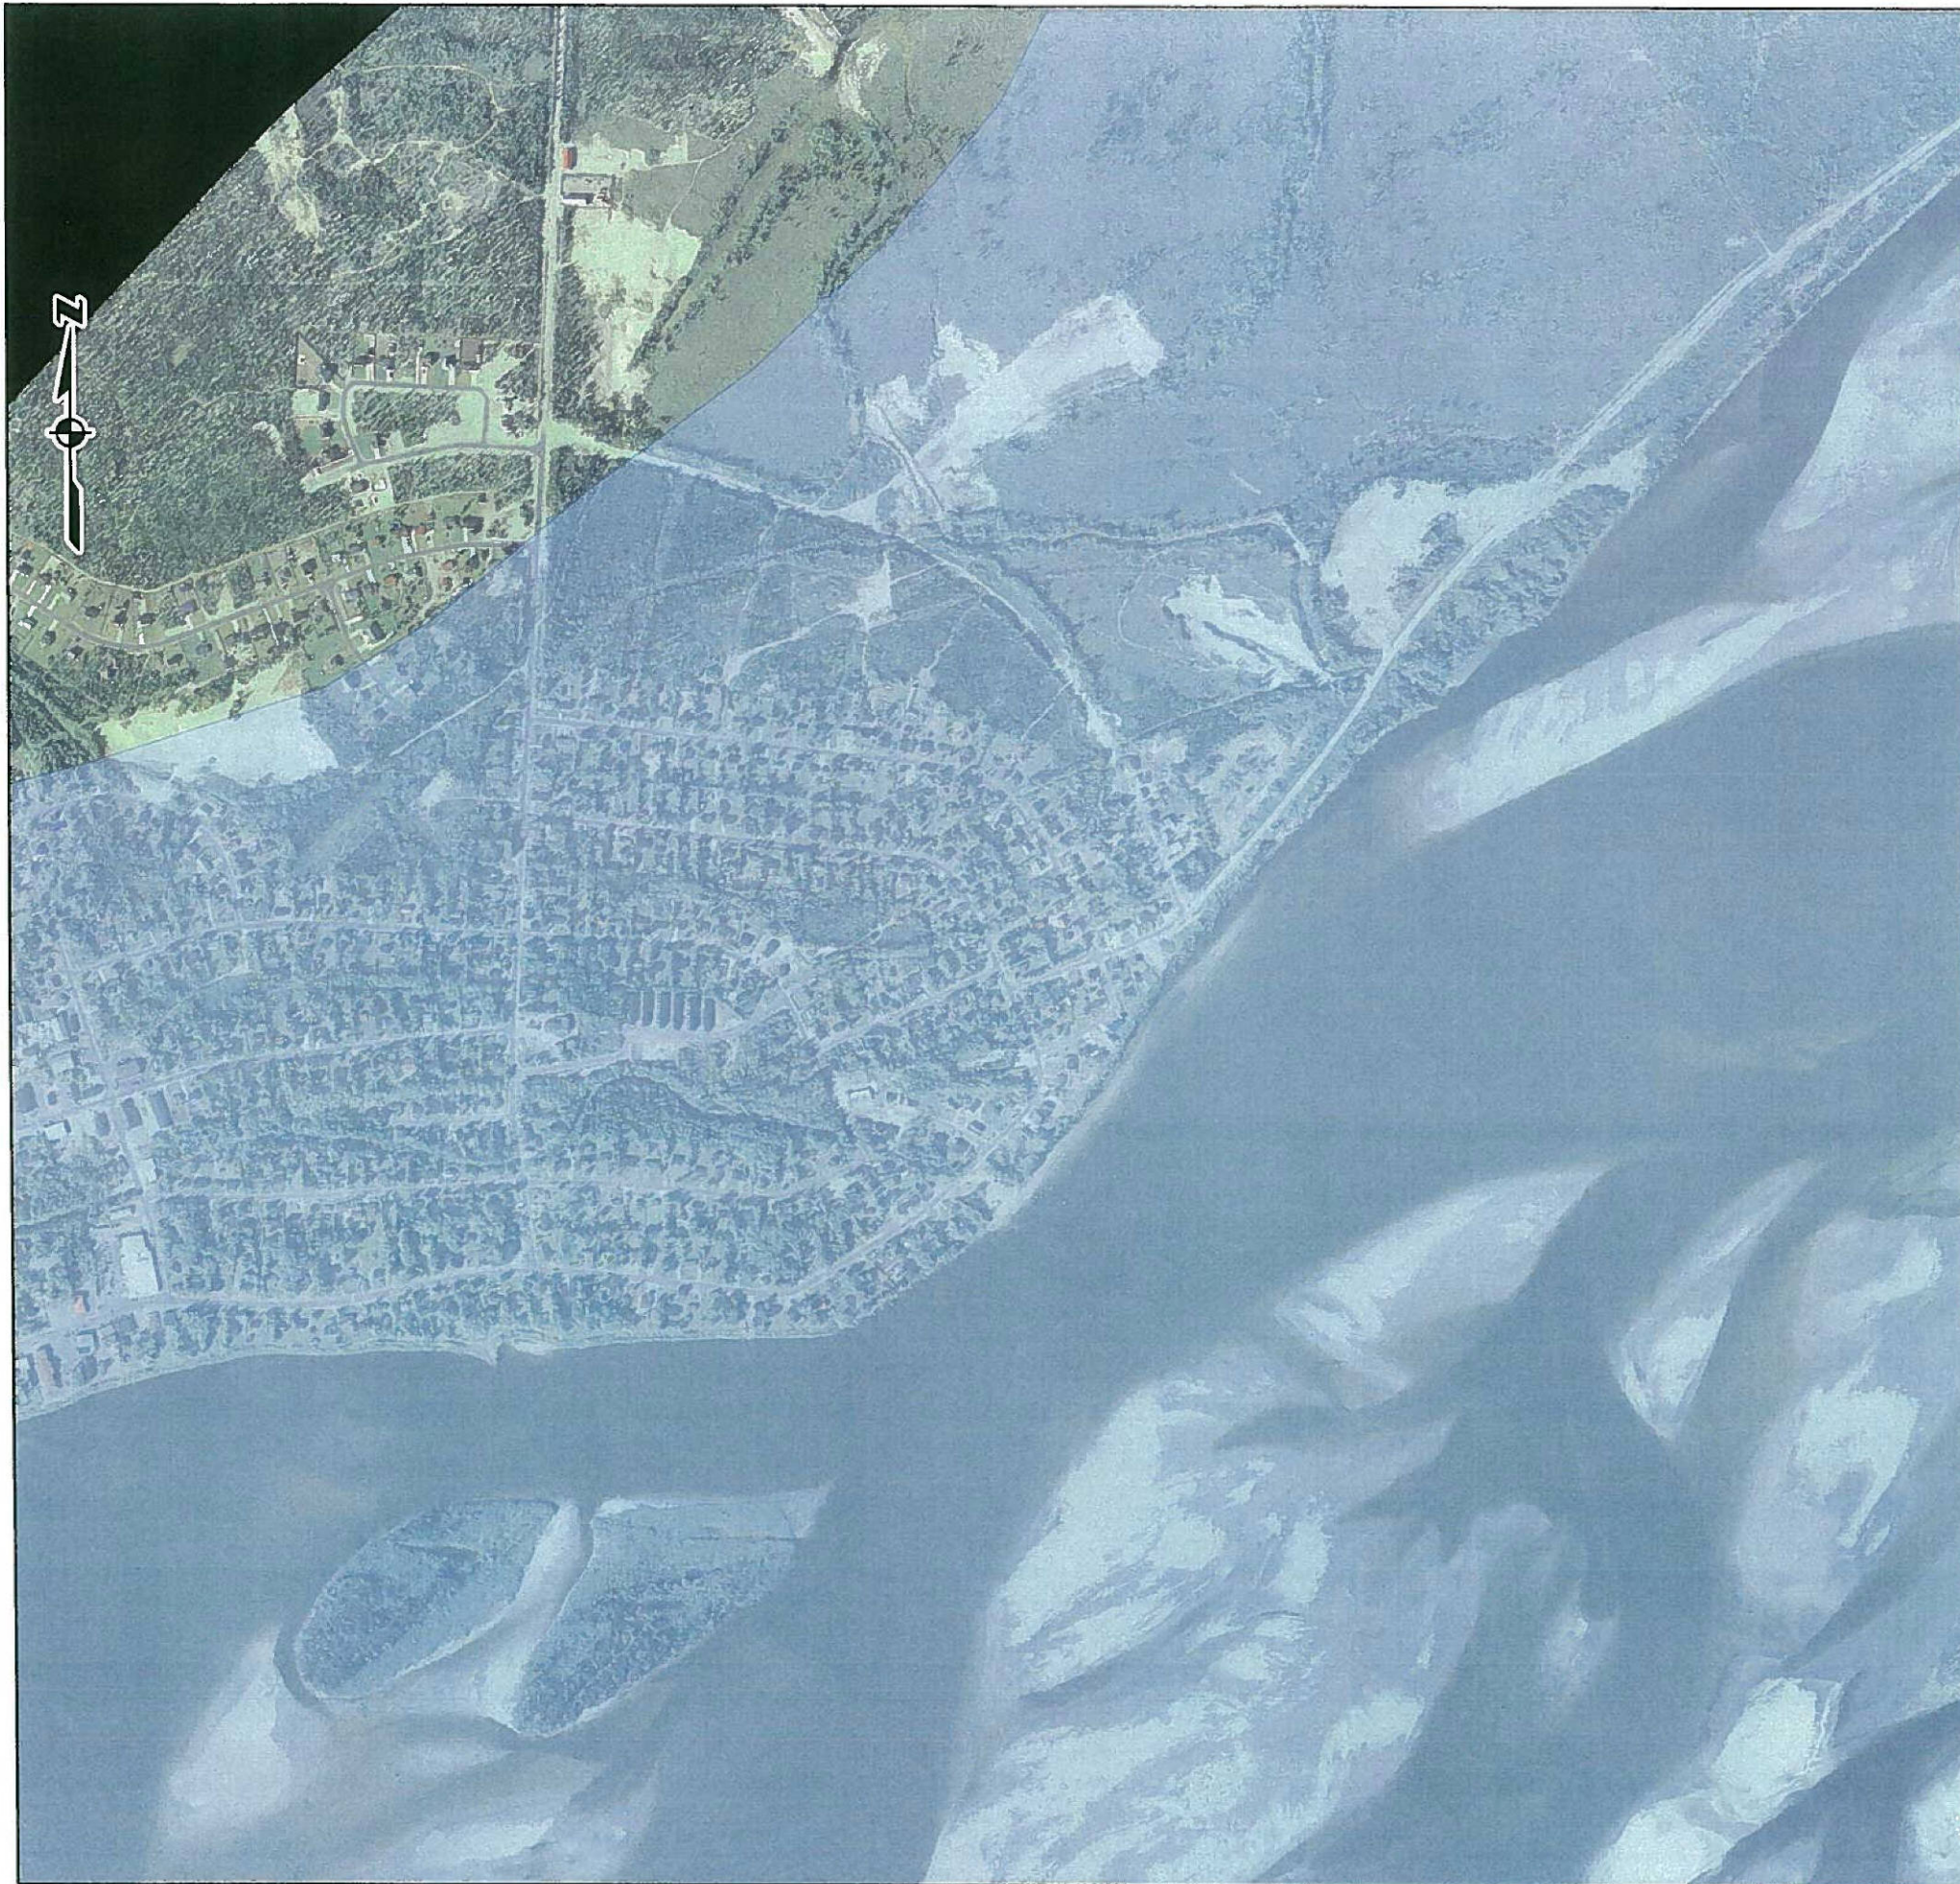
SCALE 1:10000 DRAWING NO. HATCH PROJECT NO. H-325967 **FIGURE C4-1**

FAIR WEATHER CONDITIONS
 POST GULL ISLAND AND MUSKRAT FALLS
 FAILURE OF GULL ISLAND MAIN DAM AND MUSKRAT
 FALLS NORTH RCC DAM

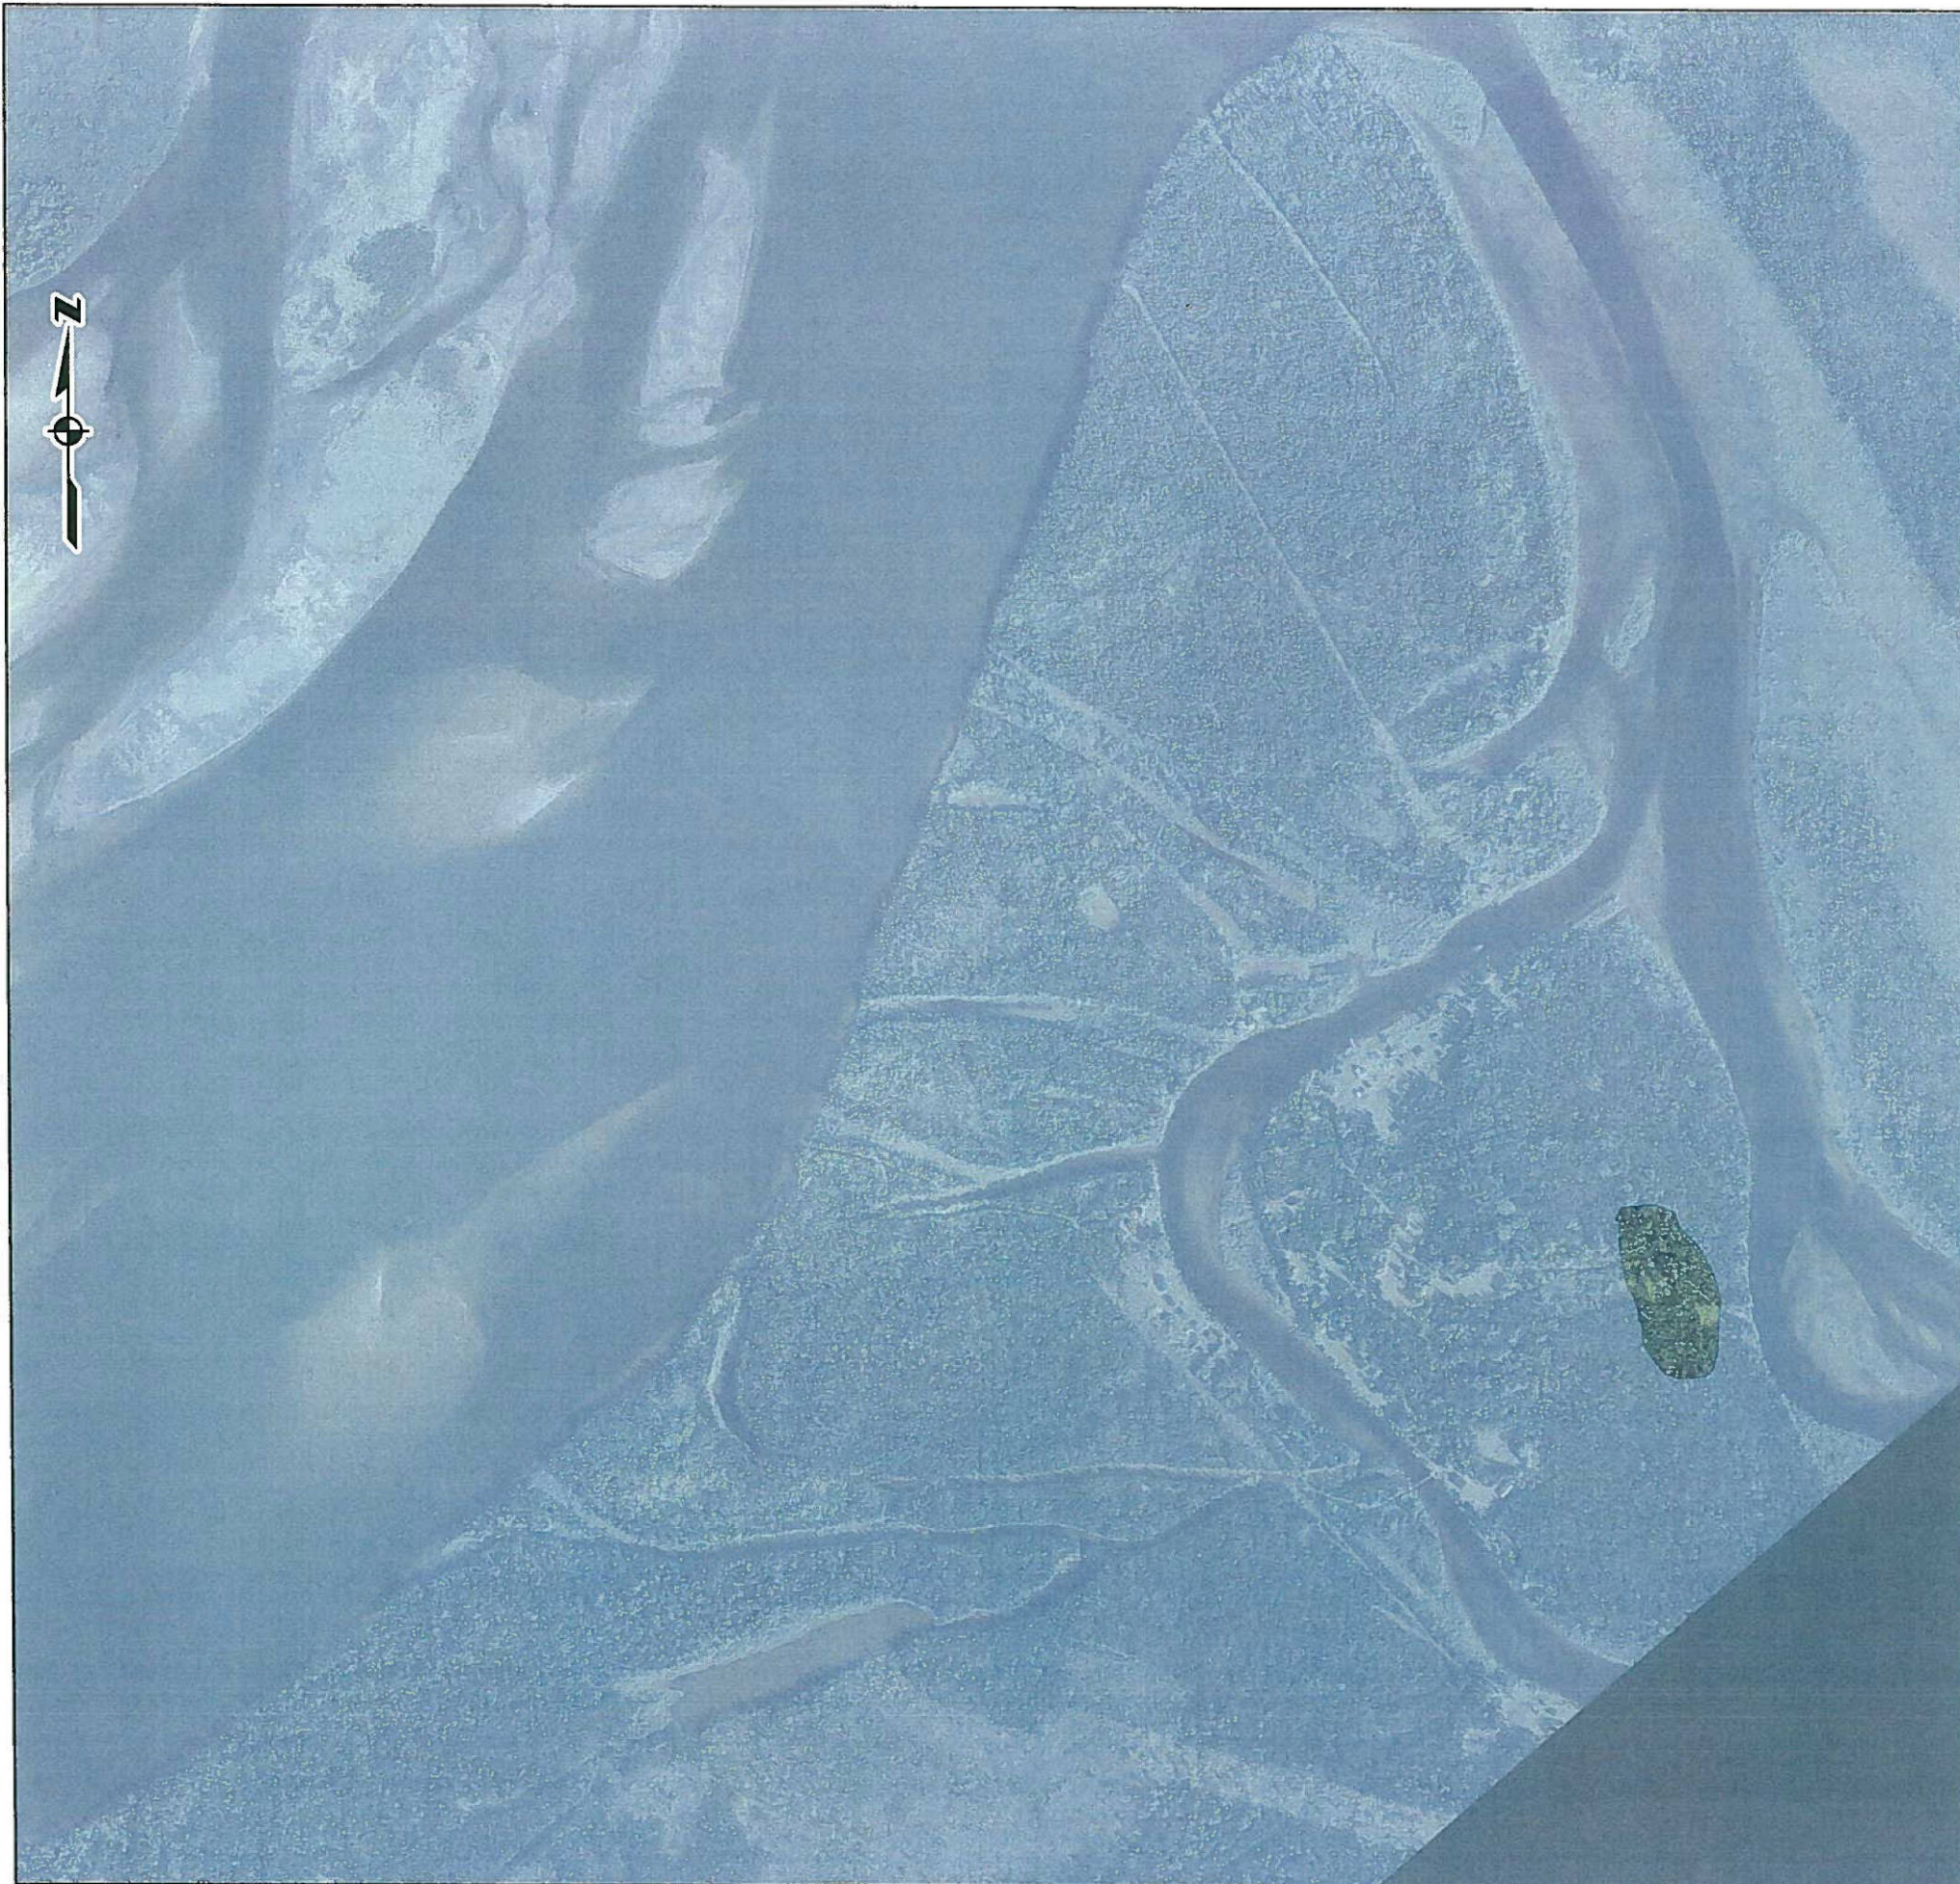
SCALE 1:10000 DRAWING NO. **FIGURE C4-2**
 HATCH PROJECT NO. H-325967

FAIR WEATHER CONDITIONS
 POST GULL ISLAND AND MUSKRAT FALLS
 FAILURE OF GULL ISLAND MAIN DAM AND MUSKRAT
 FALLS NORTH RCC DAM
