THE Lower Churchill PROJECT

April 2008

GI1190 - Dam Break Study Volume 1

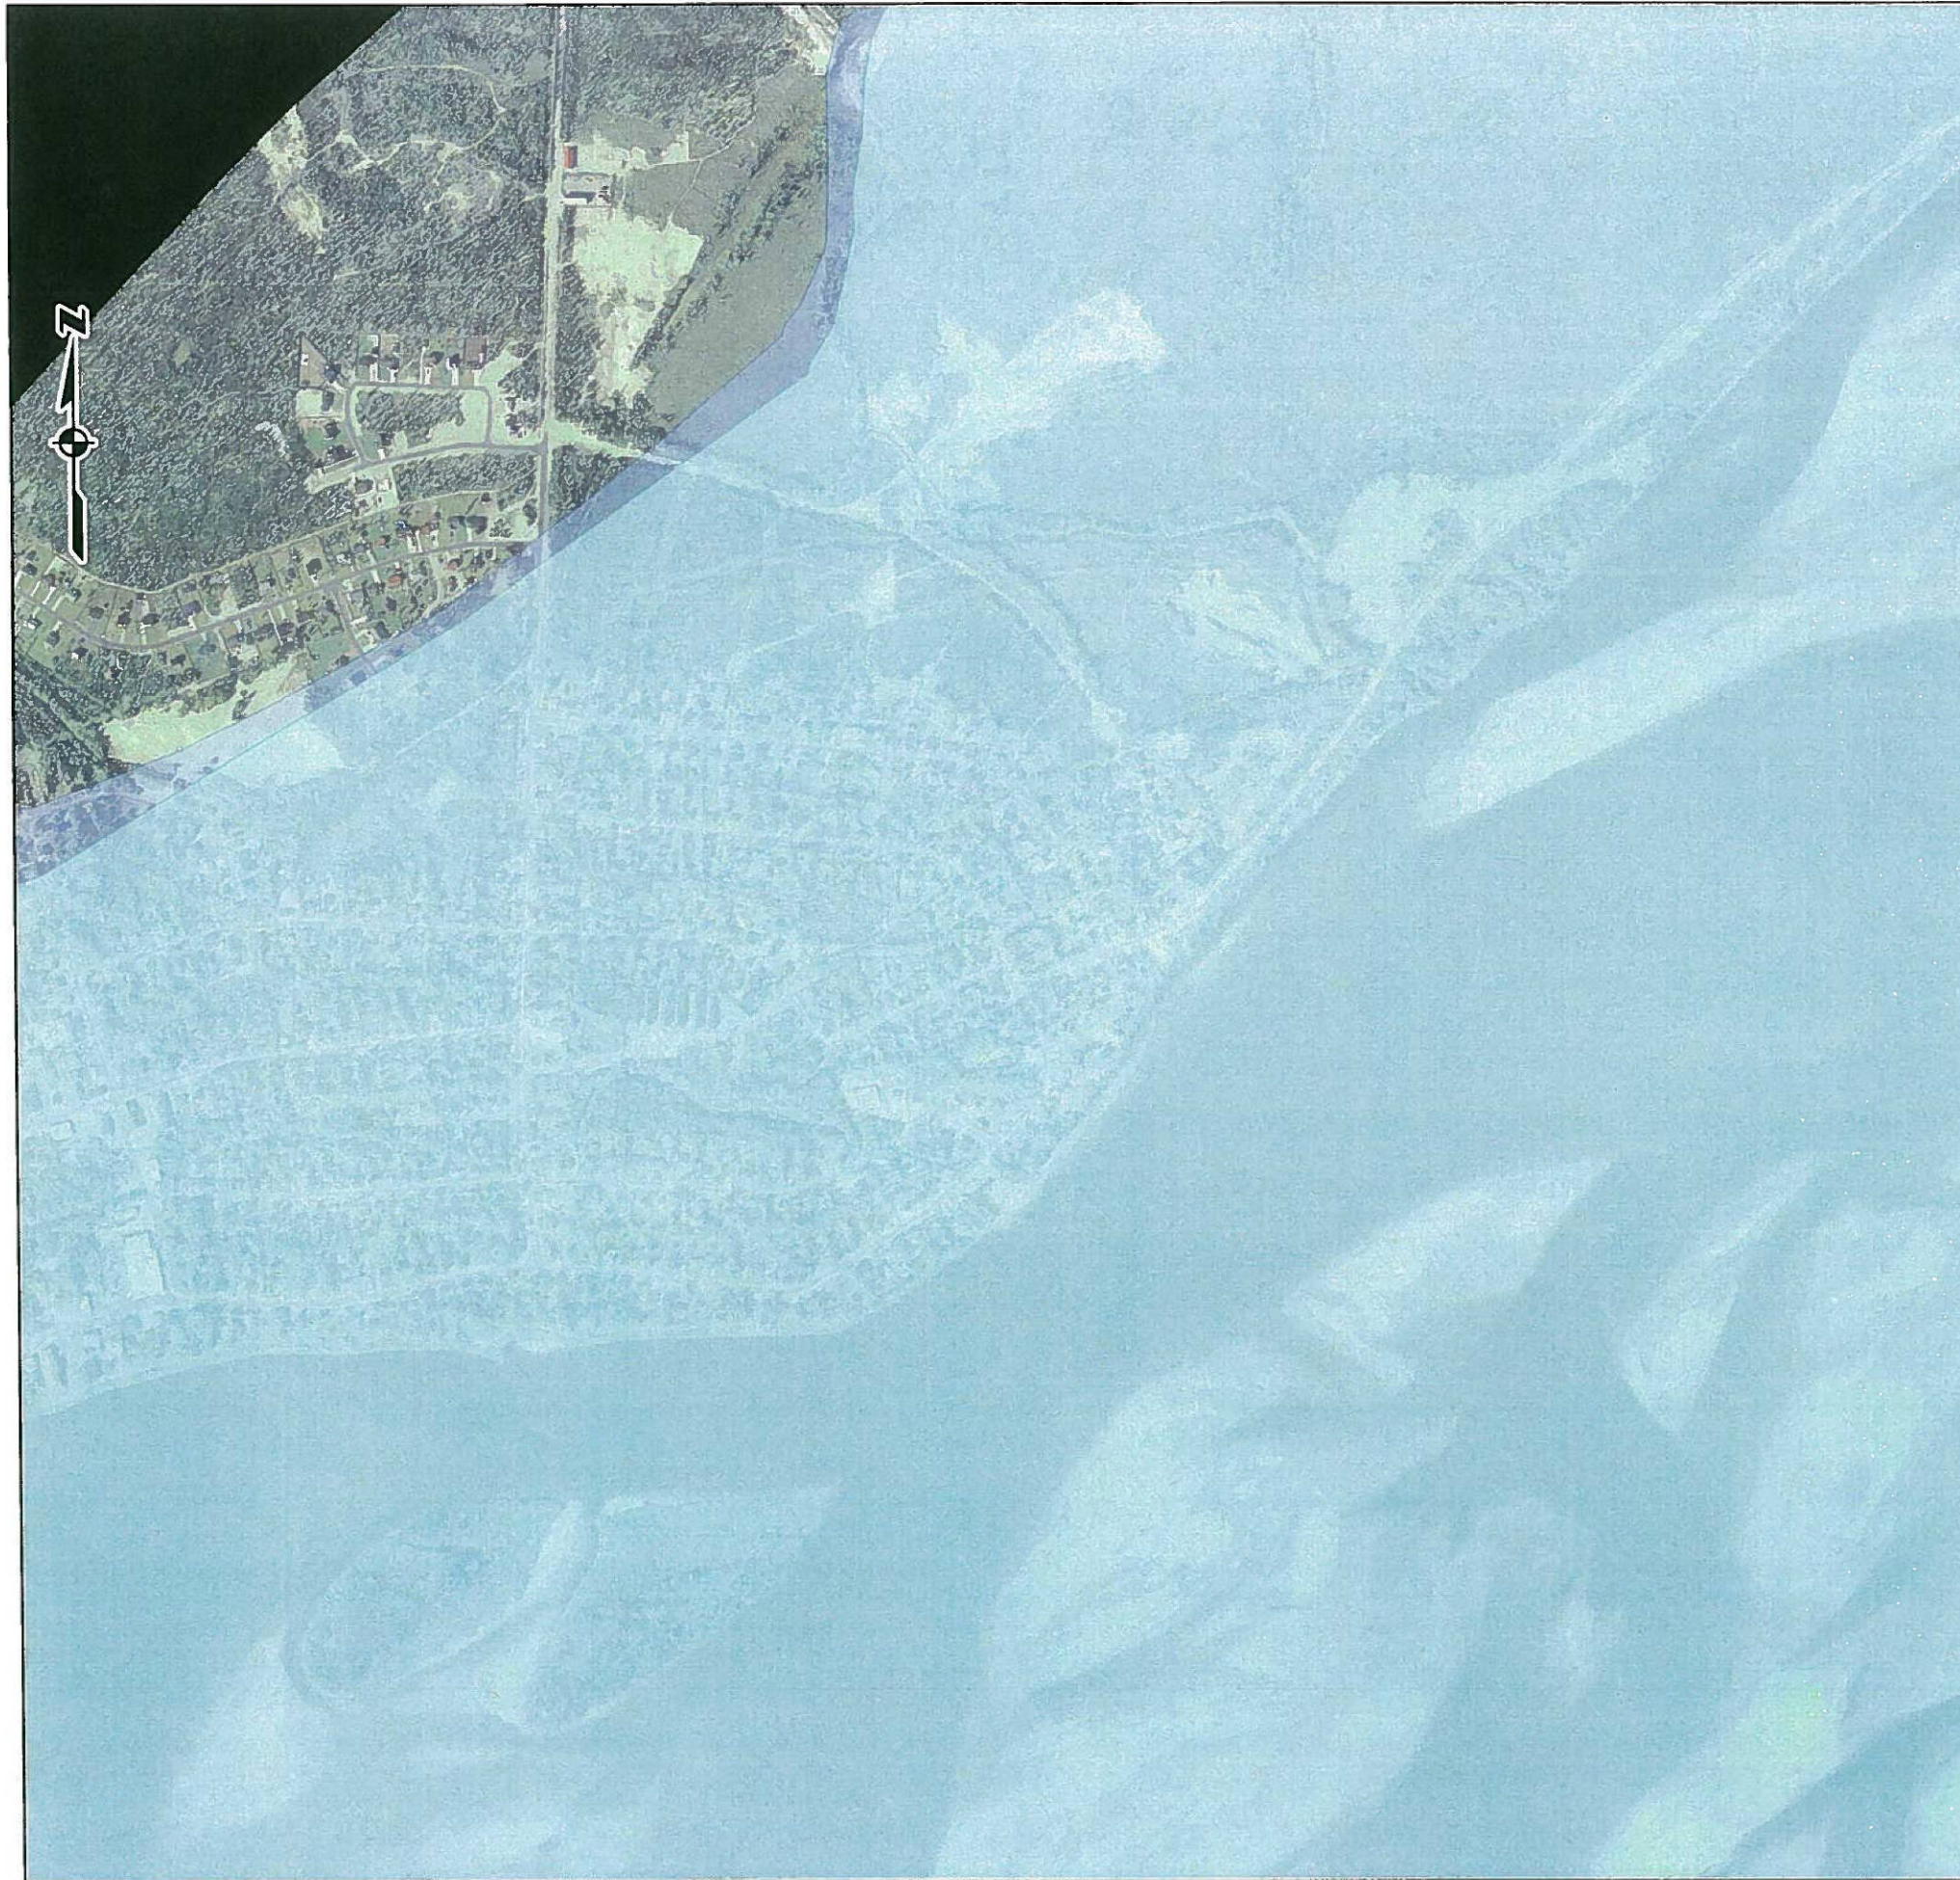
DRAWING NO. FIGURE D1-1

PROBABLE MAXIMUM FLOOD
 POST GULL ISLAND
 FAILURE OF GULL ISLAND MAIN DAM

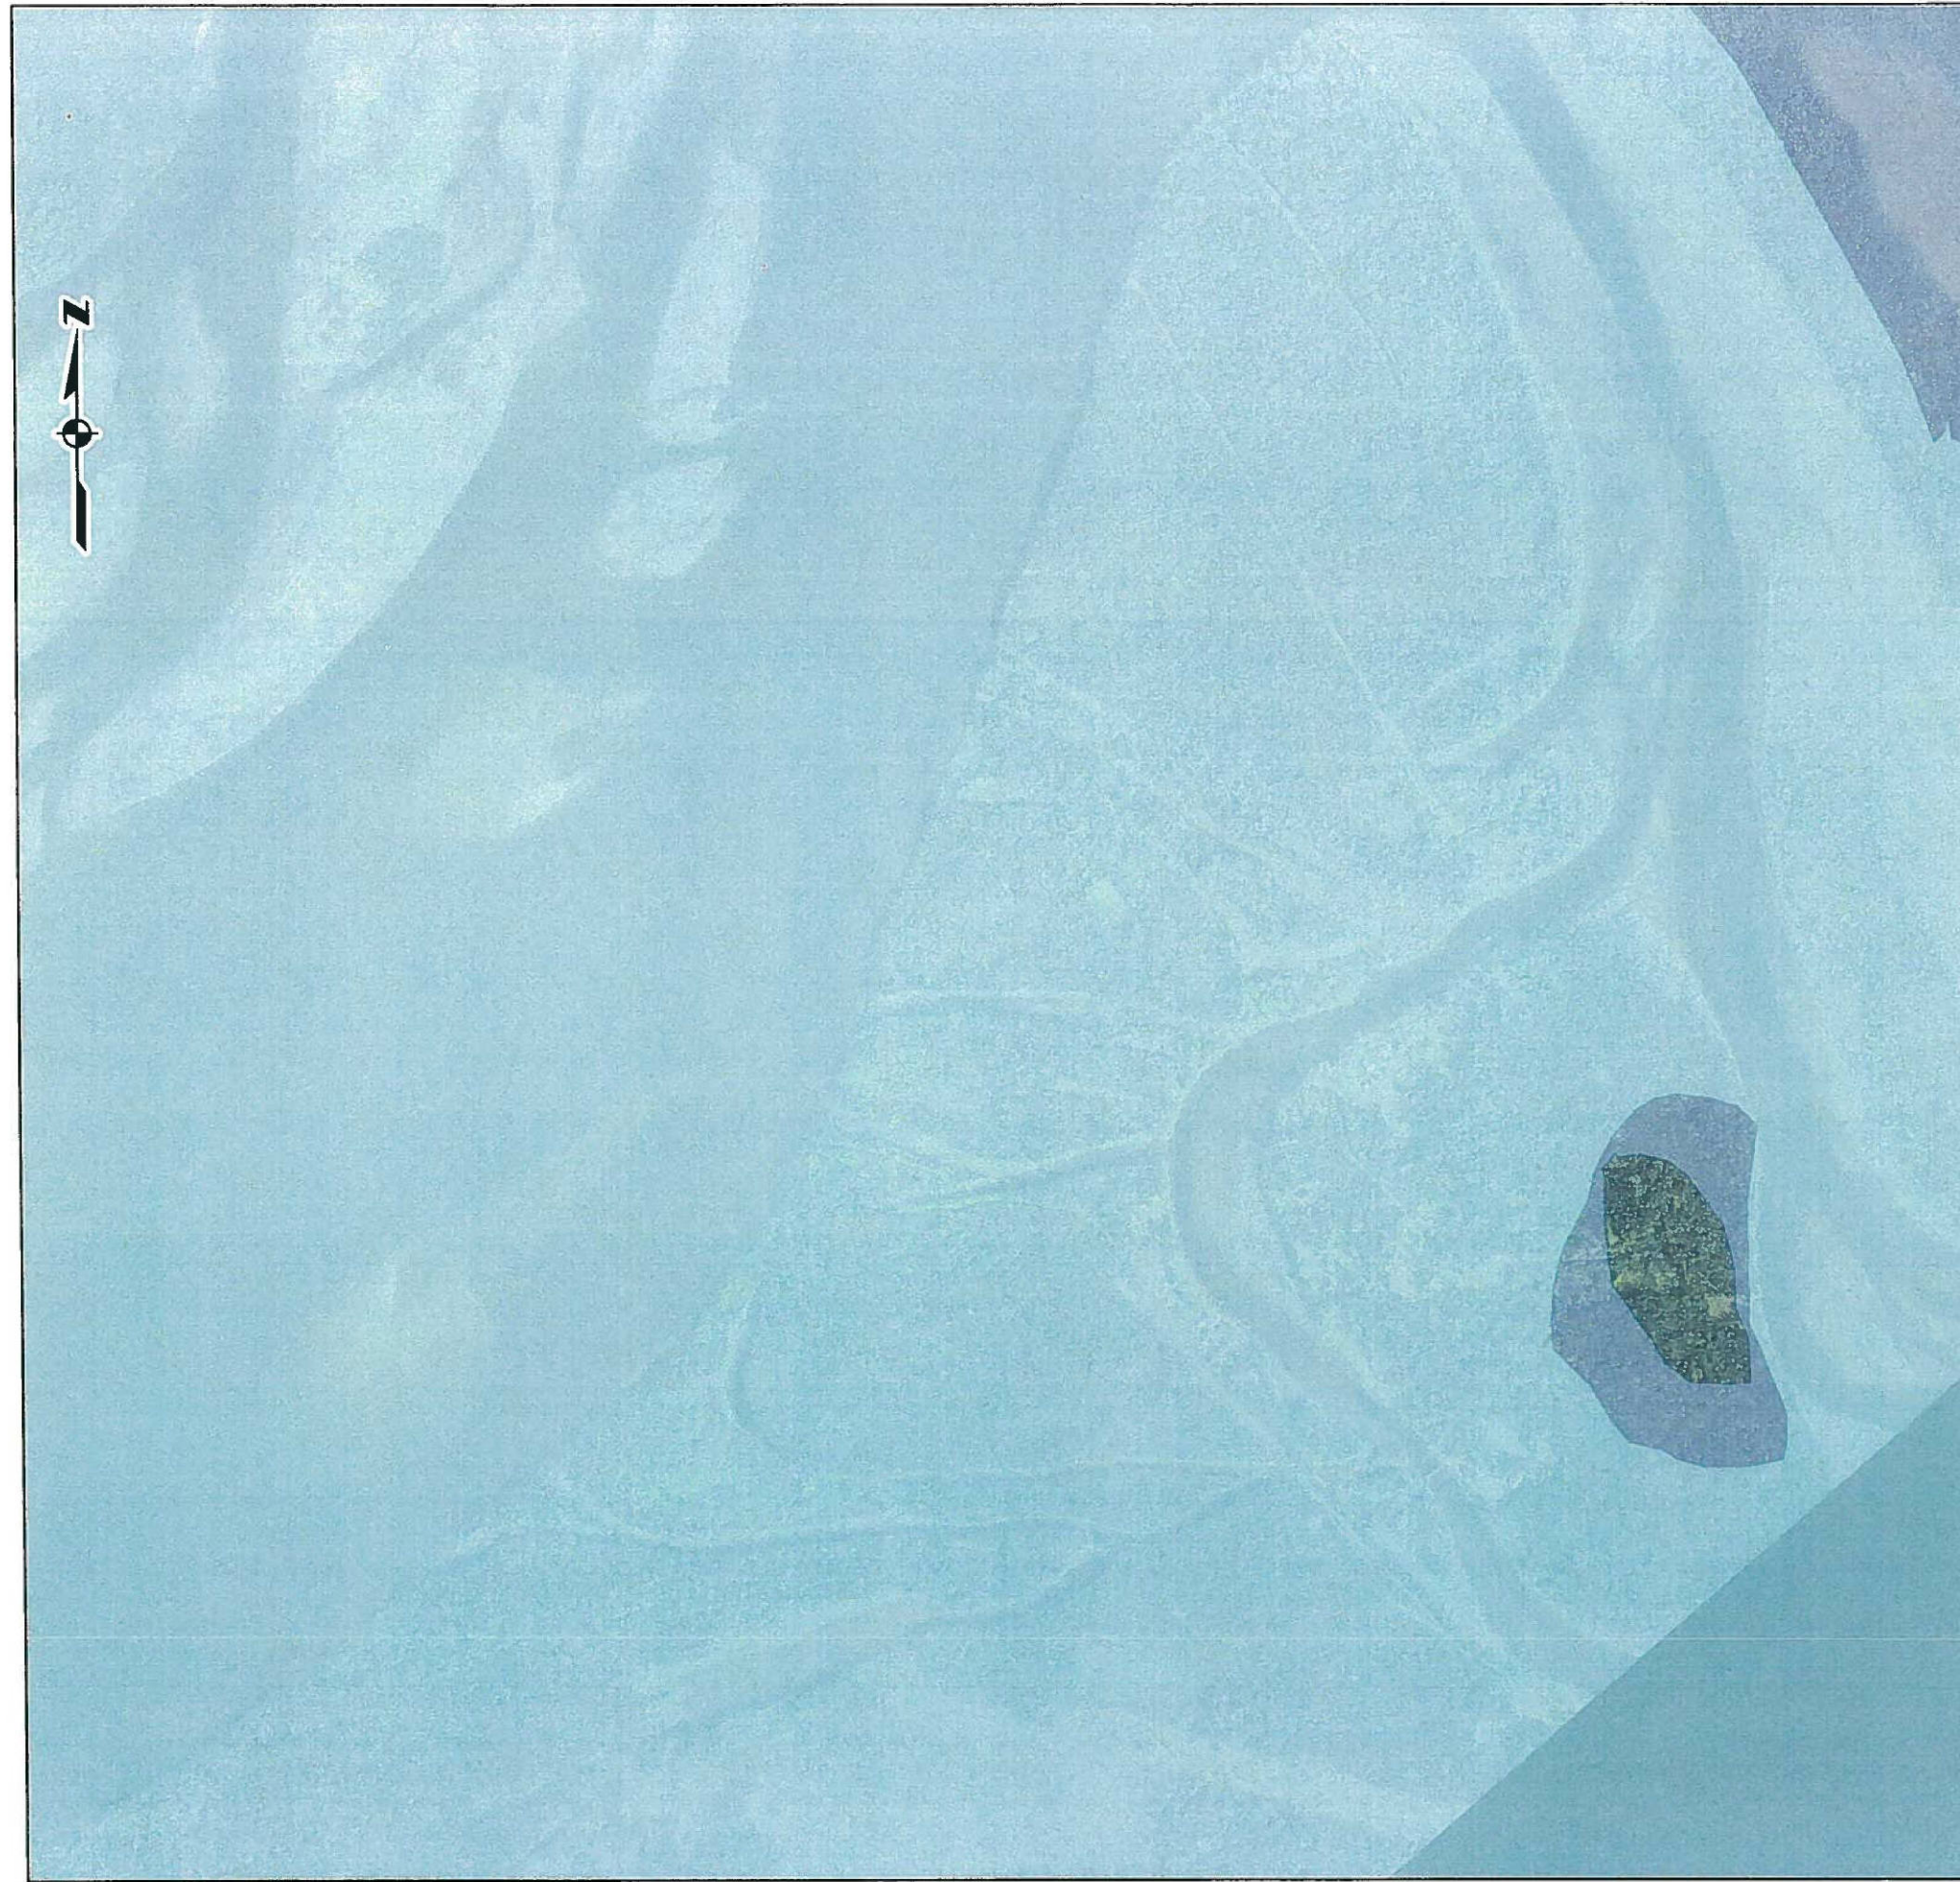
DRAWING NO. **FIGURE D1-2**

PROBABLE MAXIMUM FLOOD
 POST GULL ISLAND
 FAILURE OF GULL ISLAND MAIN DAM

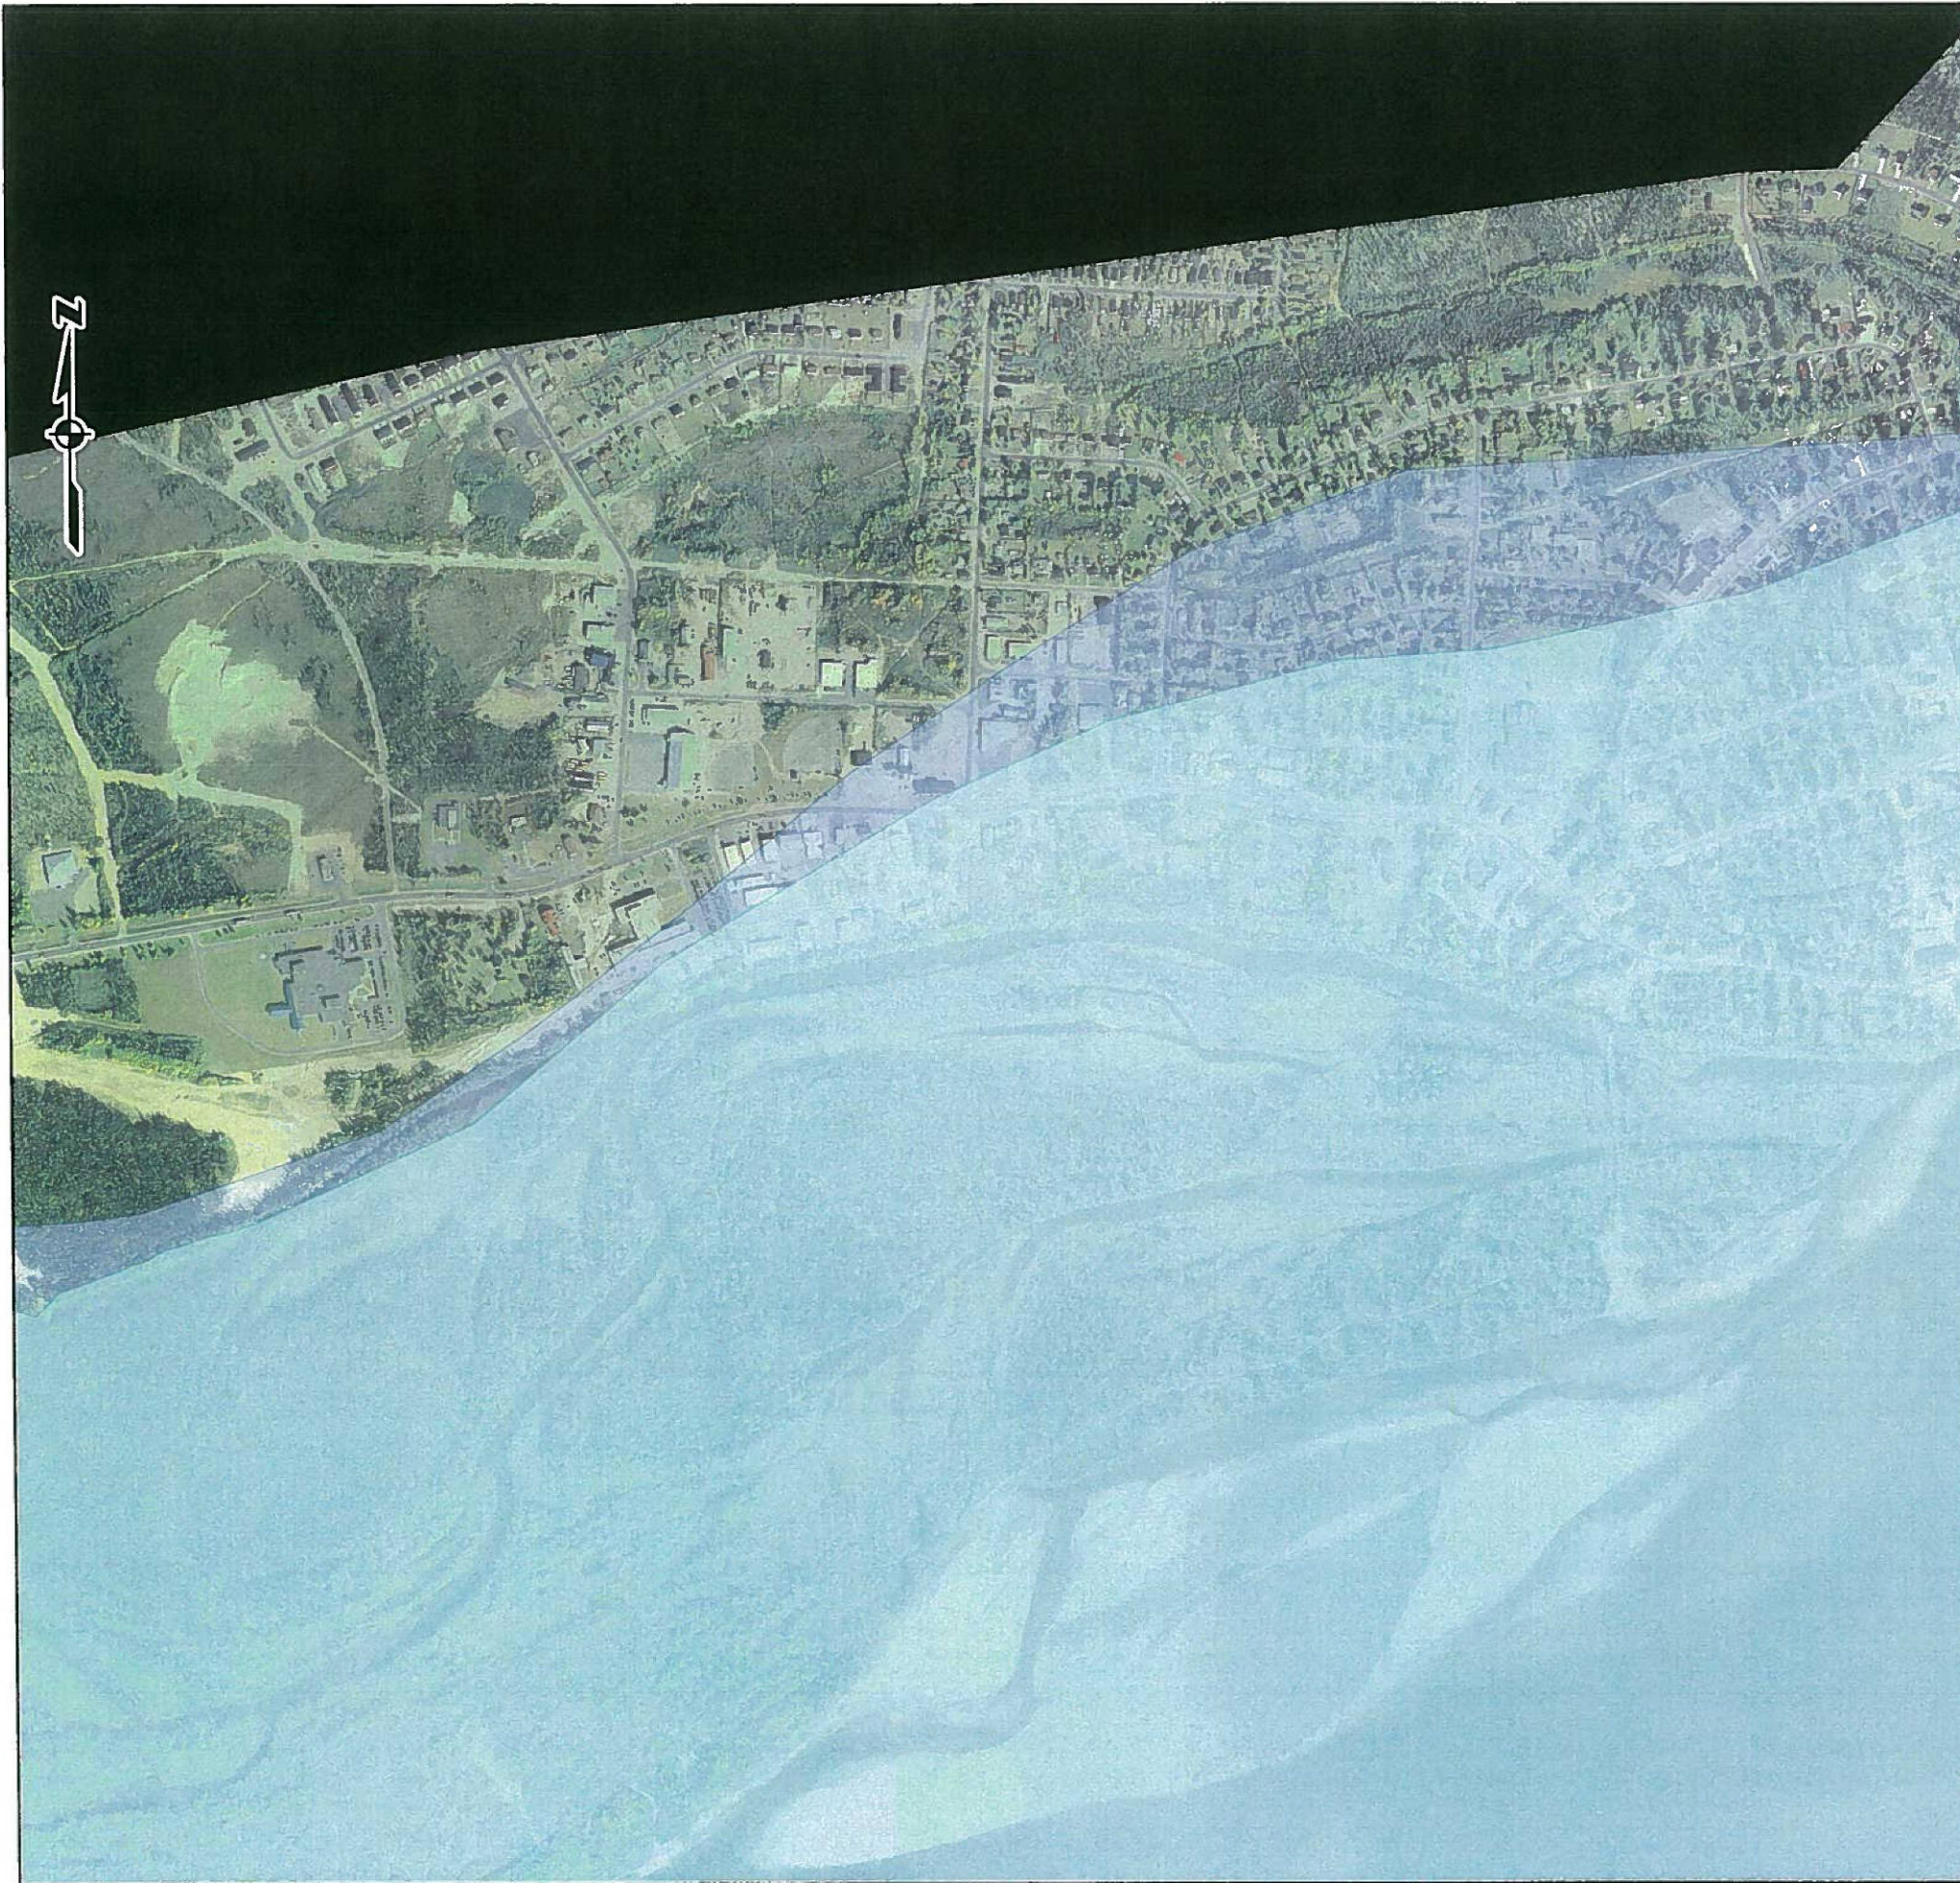
FIGURE D1-3

PROBABLE MAXIMUM FLOOD
 POST GULL ISLAND
 FAILURE OF GULL ISLAND MAIN DAM

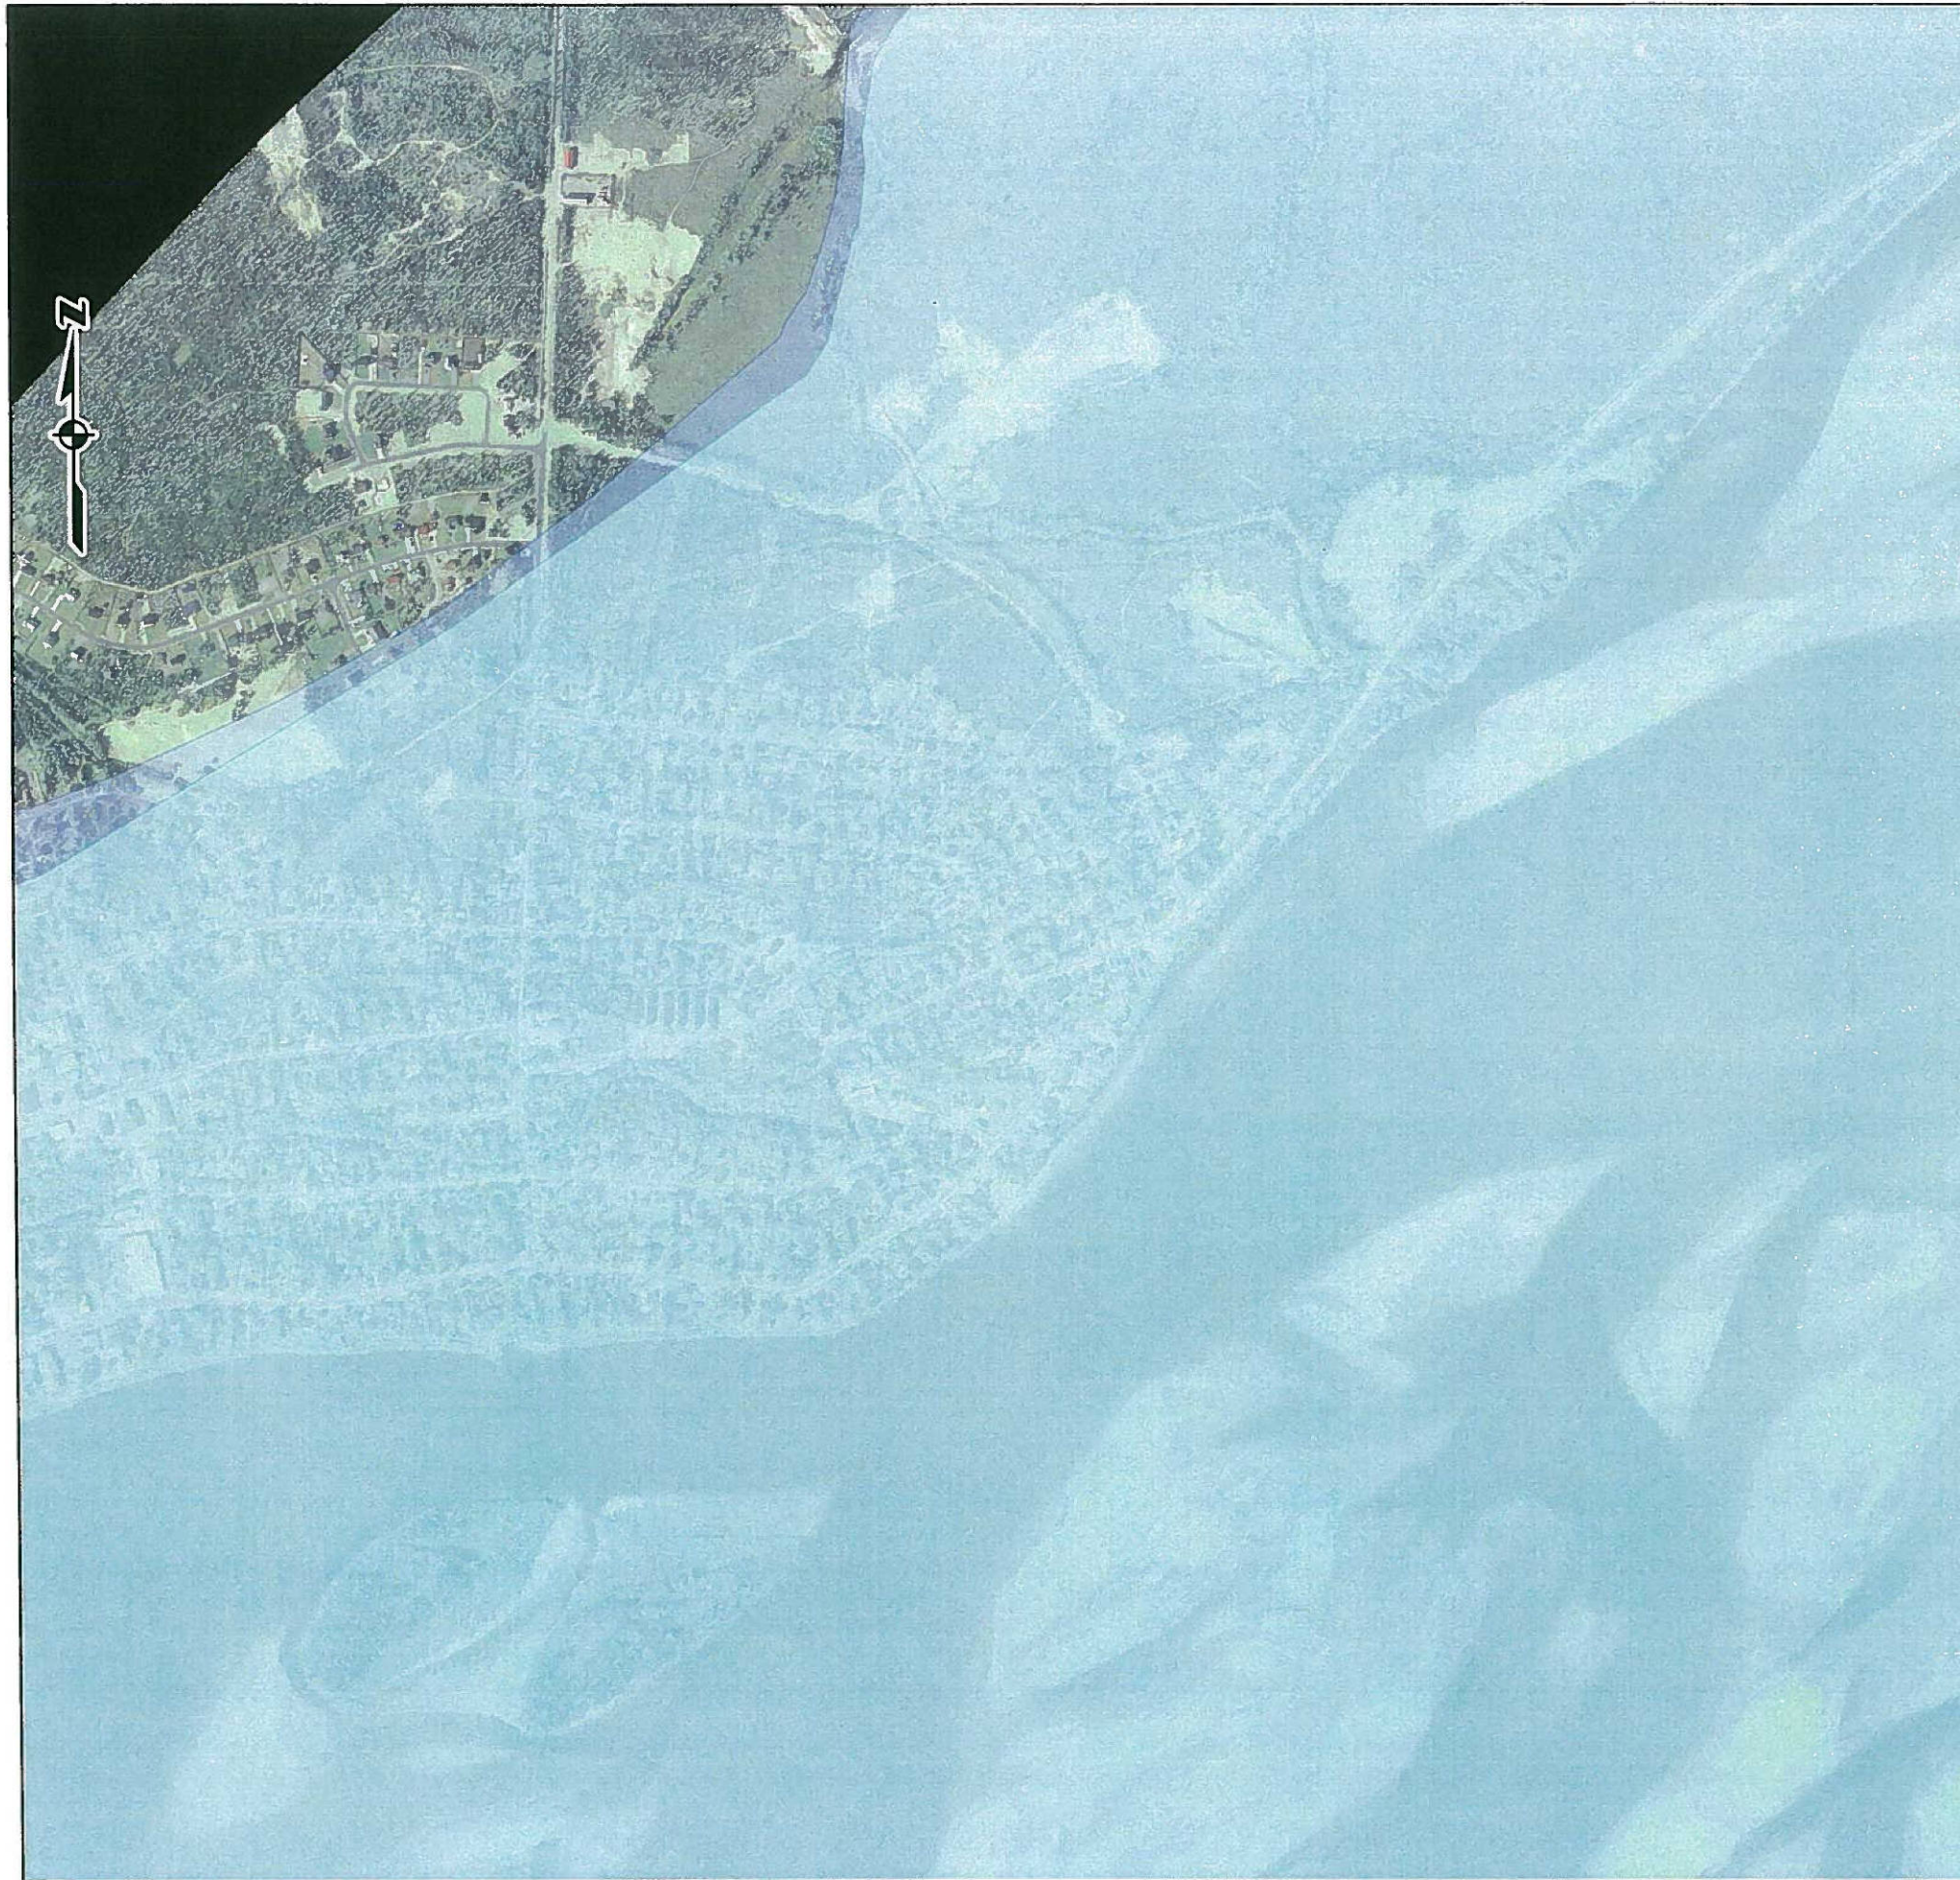
DRAWING NO. FIGURE D2-1

PROBABLE MAXIMUM FLOOD
 POST GULL ISLAND AND MUSKRAT FALLS
 FAILURE OF GULL ISLAND MAIN DAM

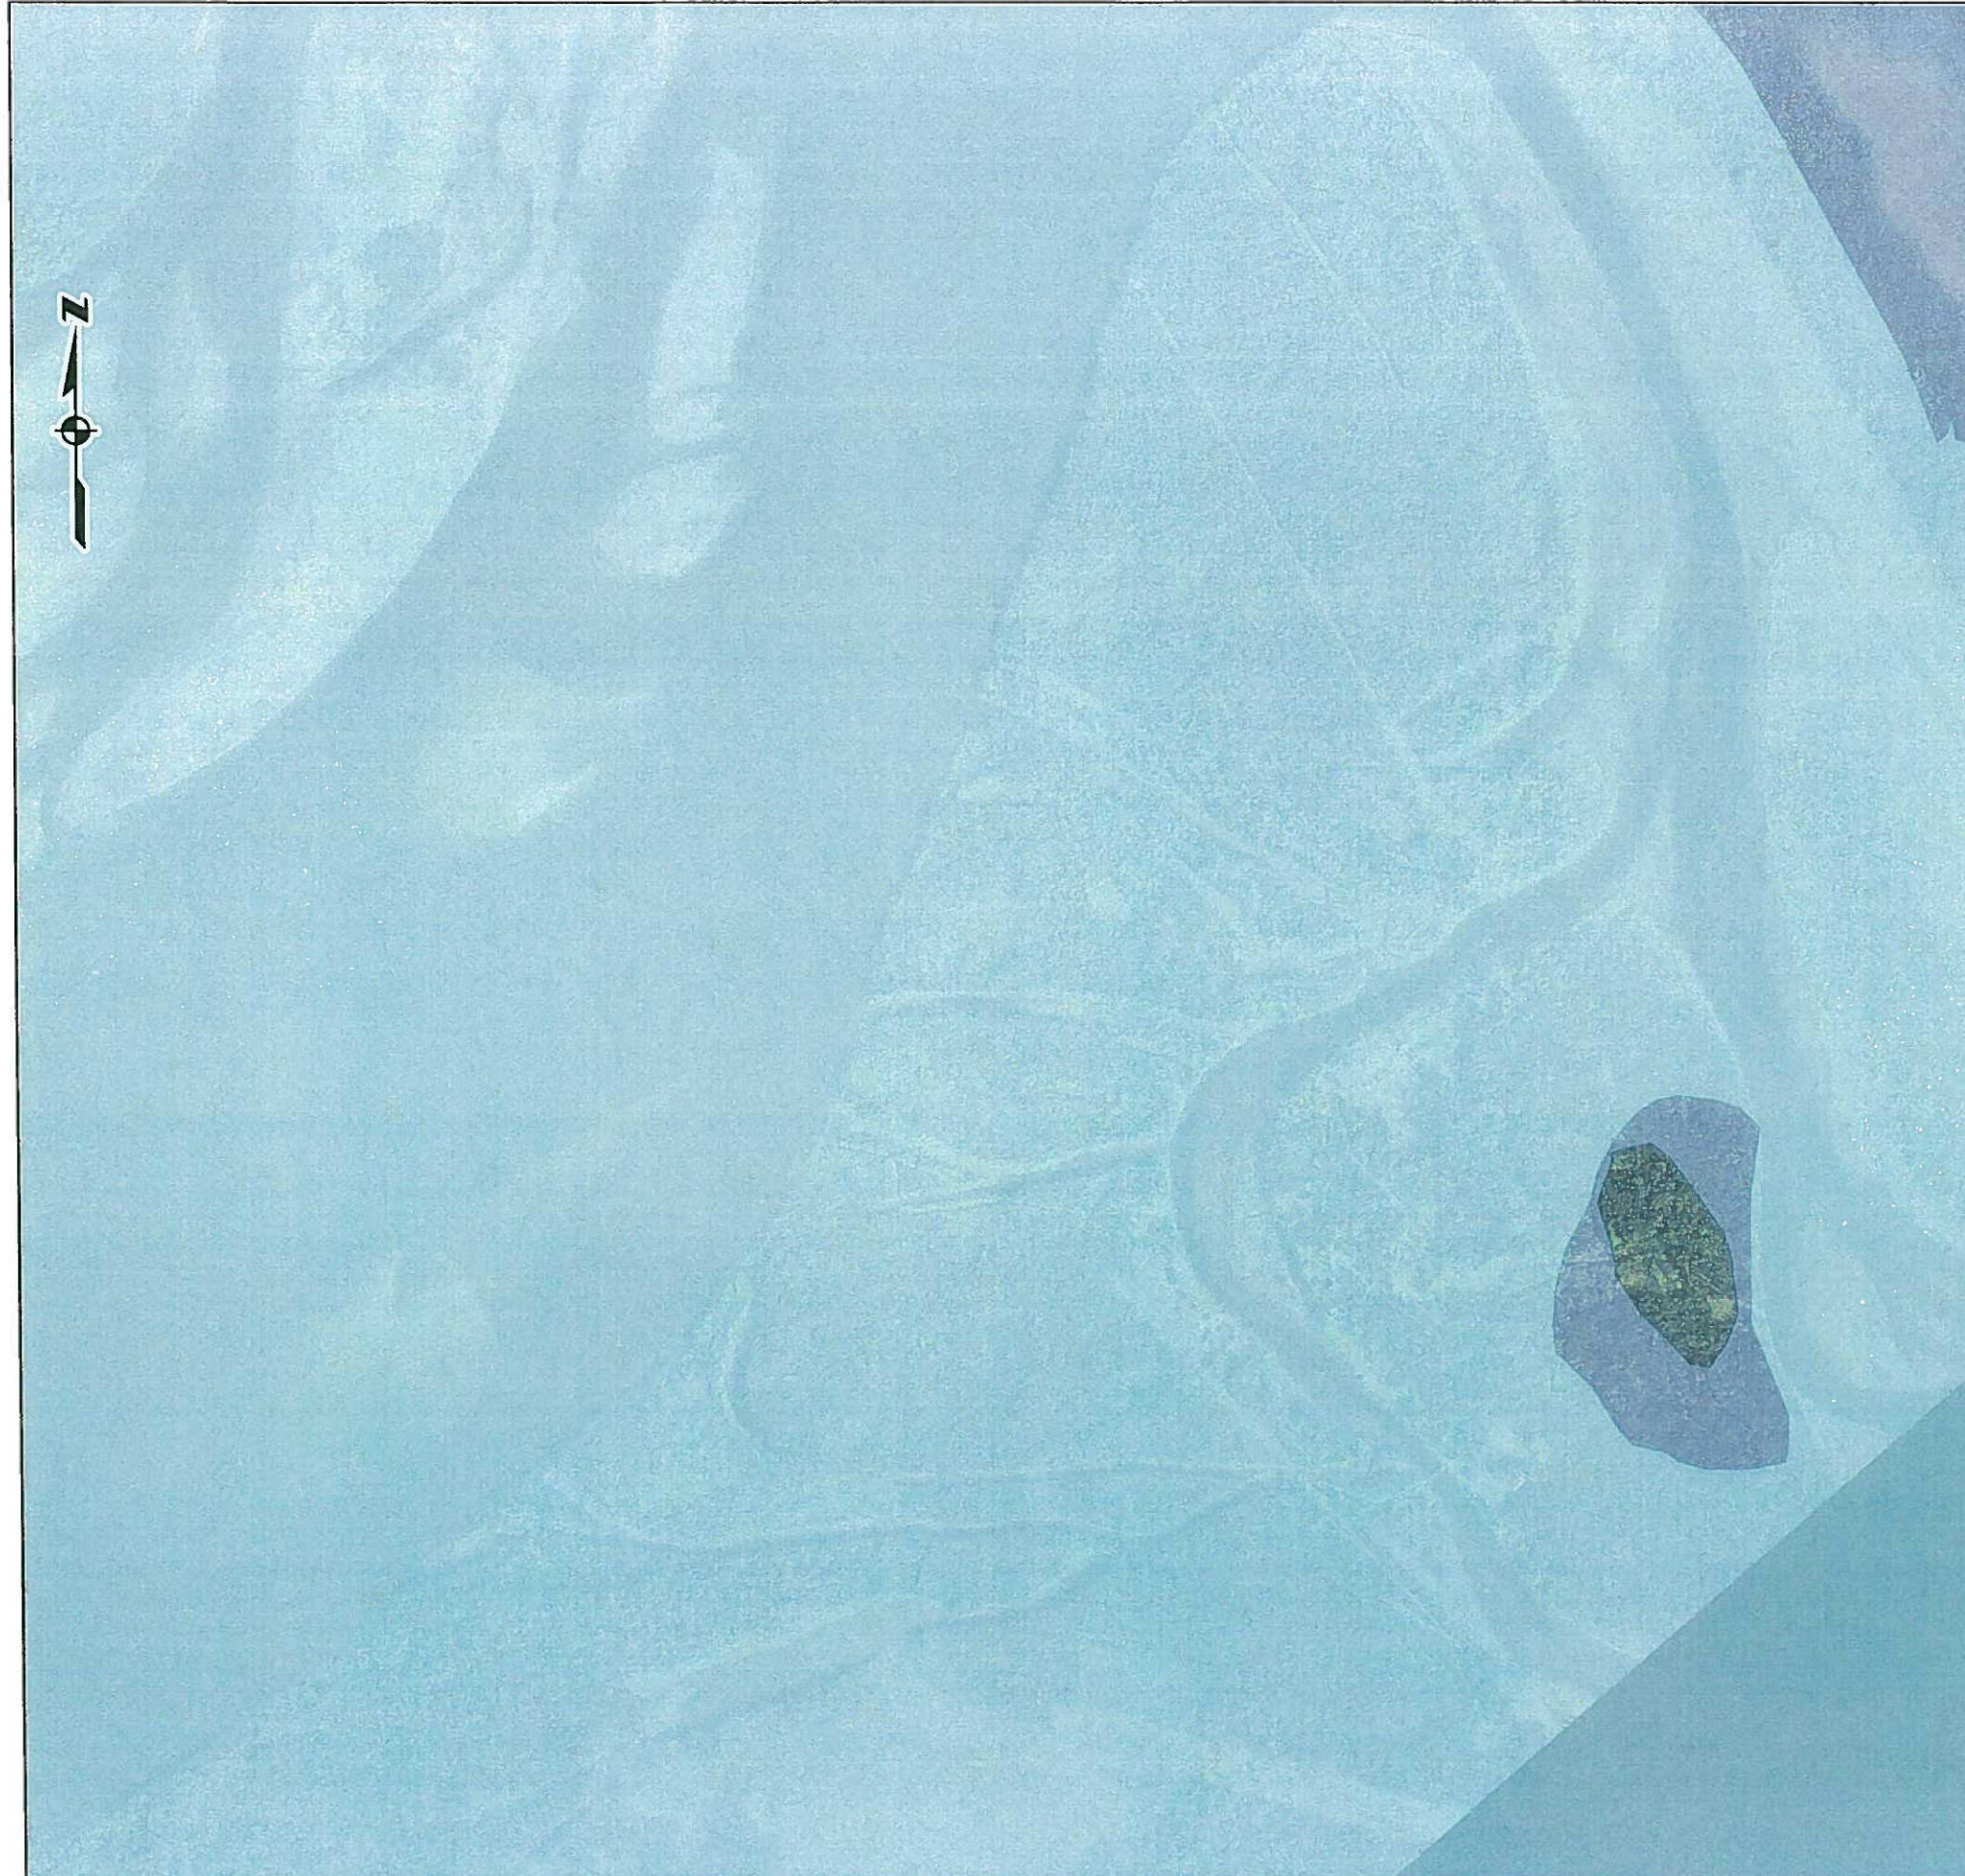
DRAWING NO. FIGURE D2-2

PROBABLE MAXIMUM FLOOD
 POST GULL ISLAND AND MUSKRAT FALLS
 FAILURE OF GULL ISLAND MAIN DAM

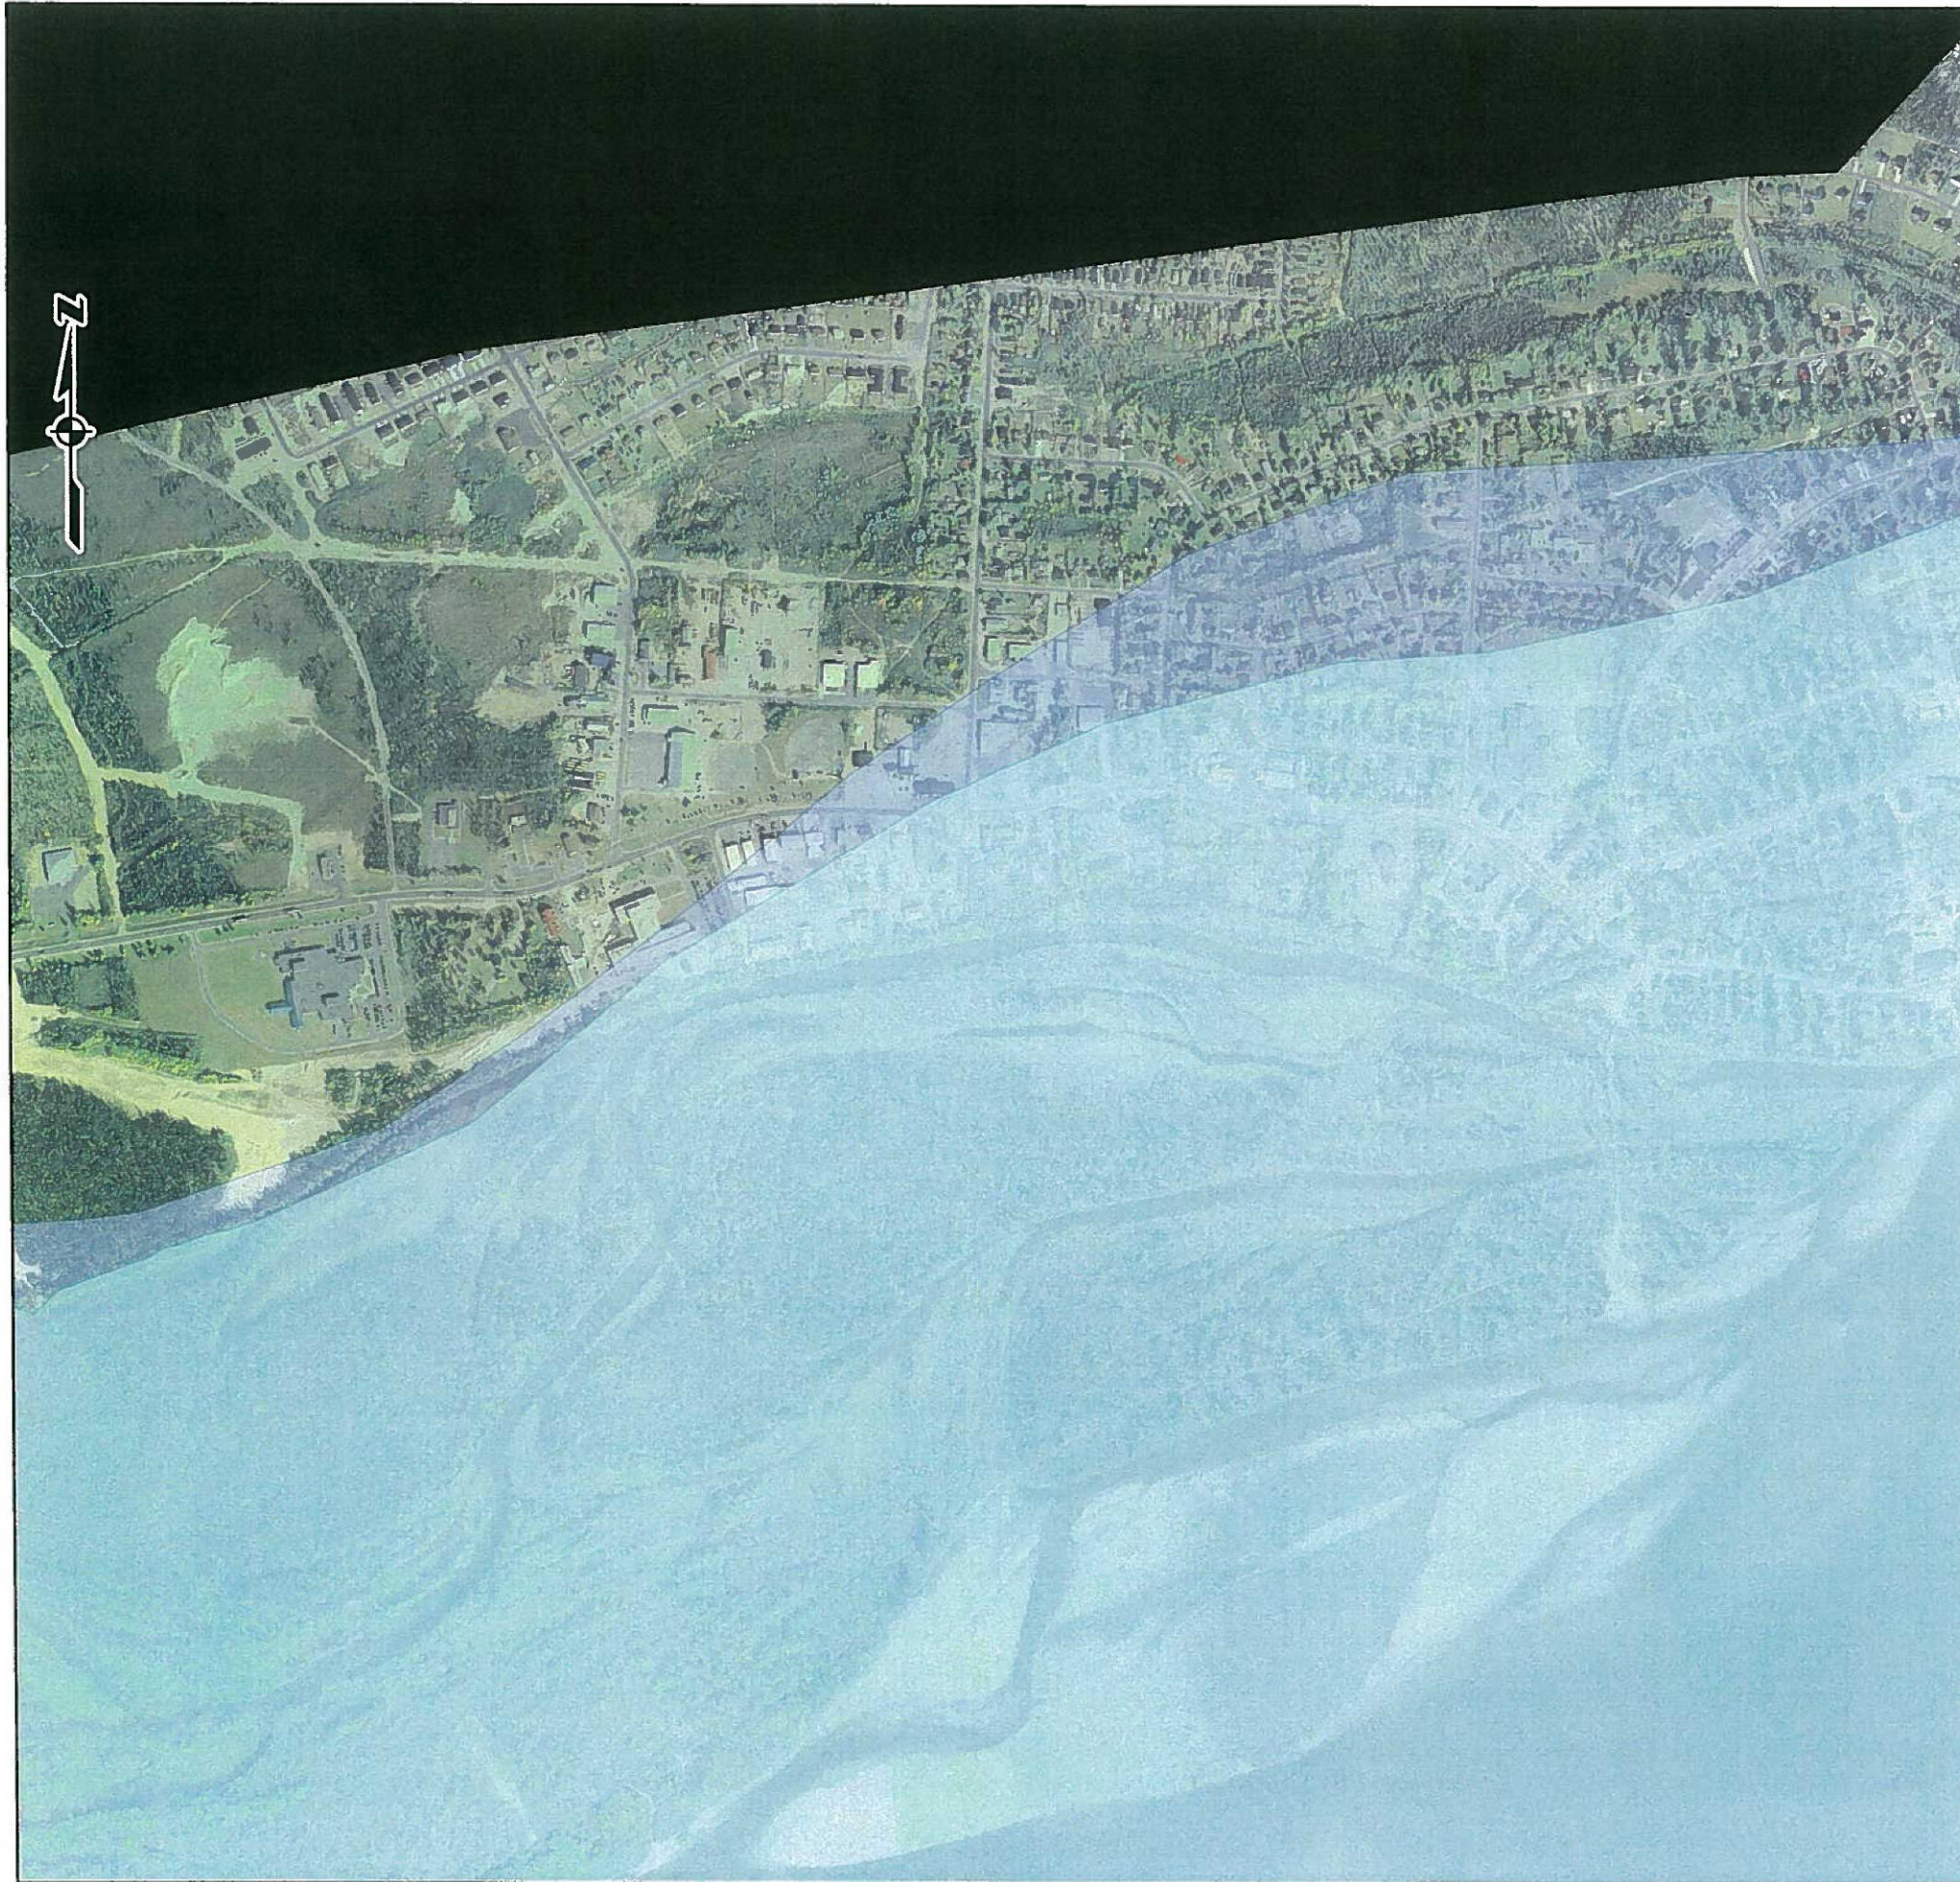
DRAWING NO. FIGURE D2-3

PROBABLE MAXIMUM FLOOD
 POST GULL ISLAND AND MUSKRAT FALLS
 FAILURE OF GULL ISLAND MAIN DAM
