THE Lower Churchill PROJECT

April 2008

GI1190 - Dam Break Study Volume 1

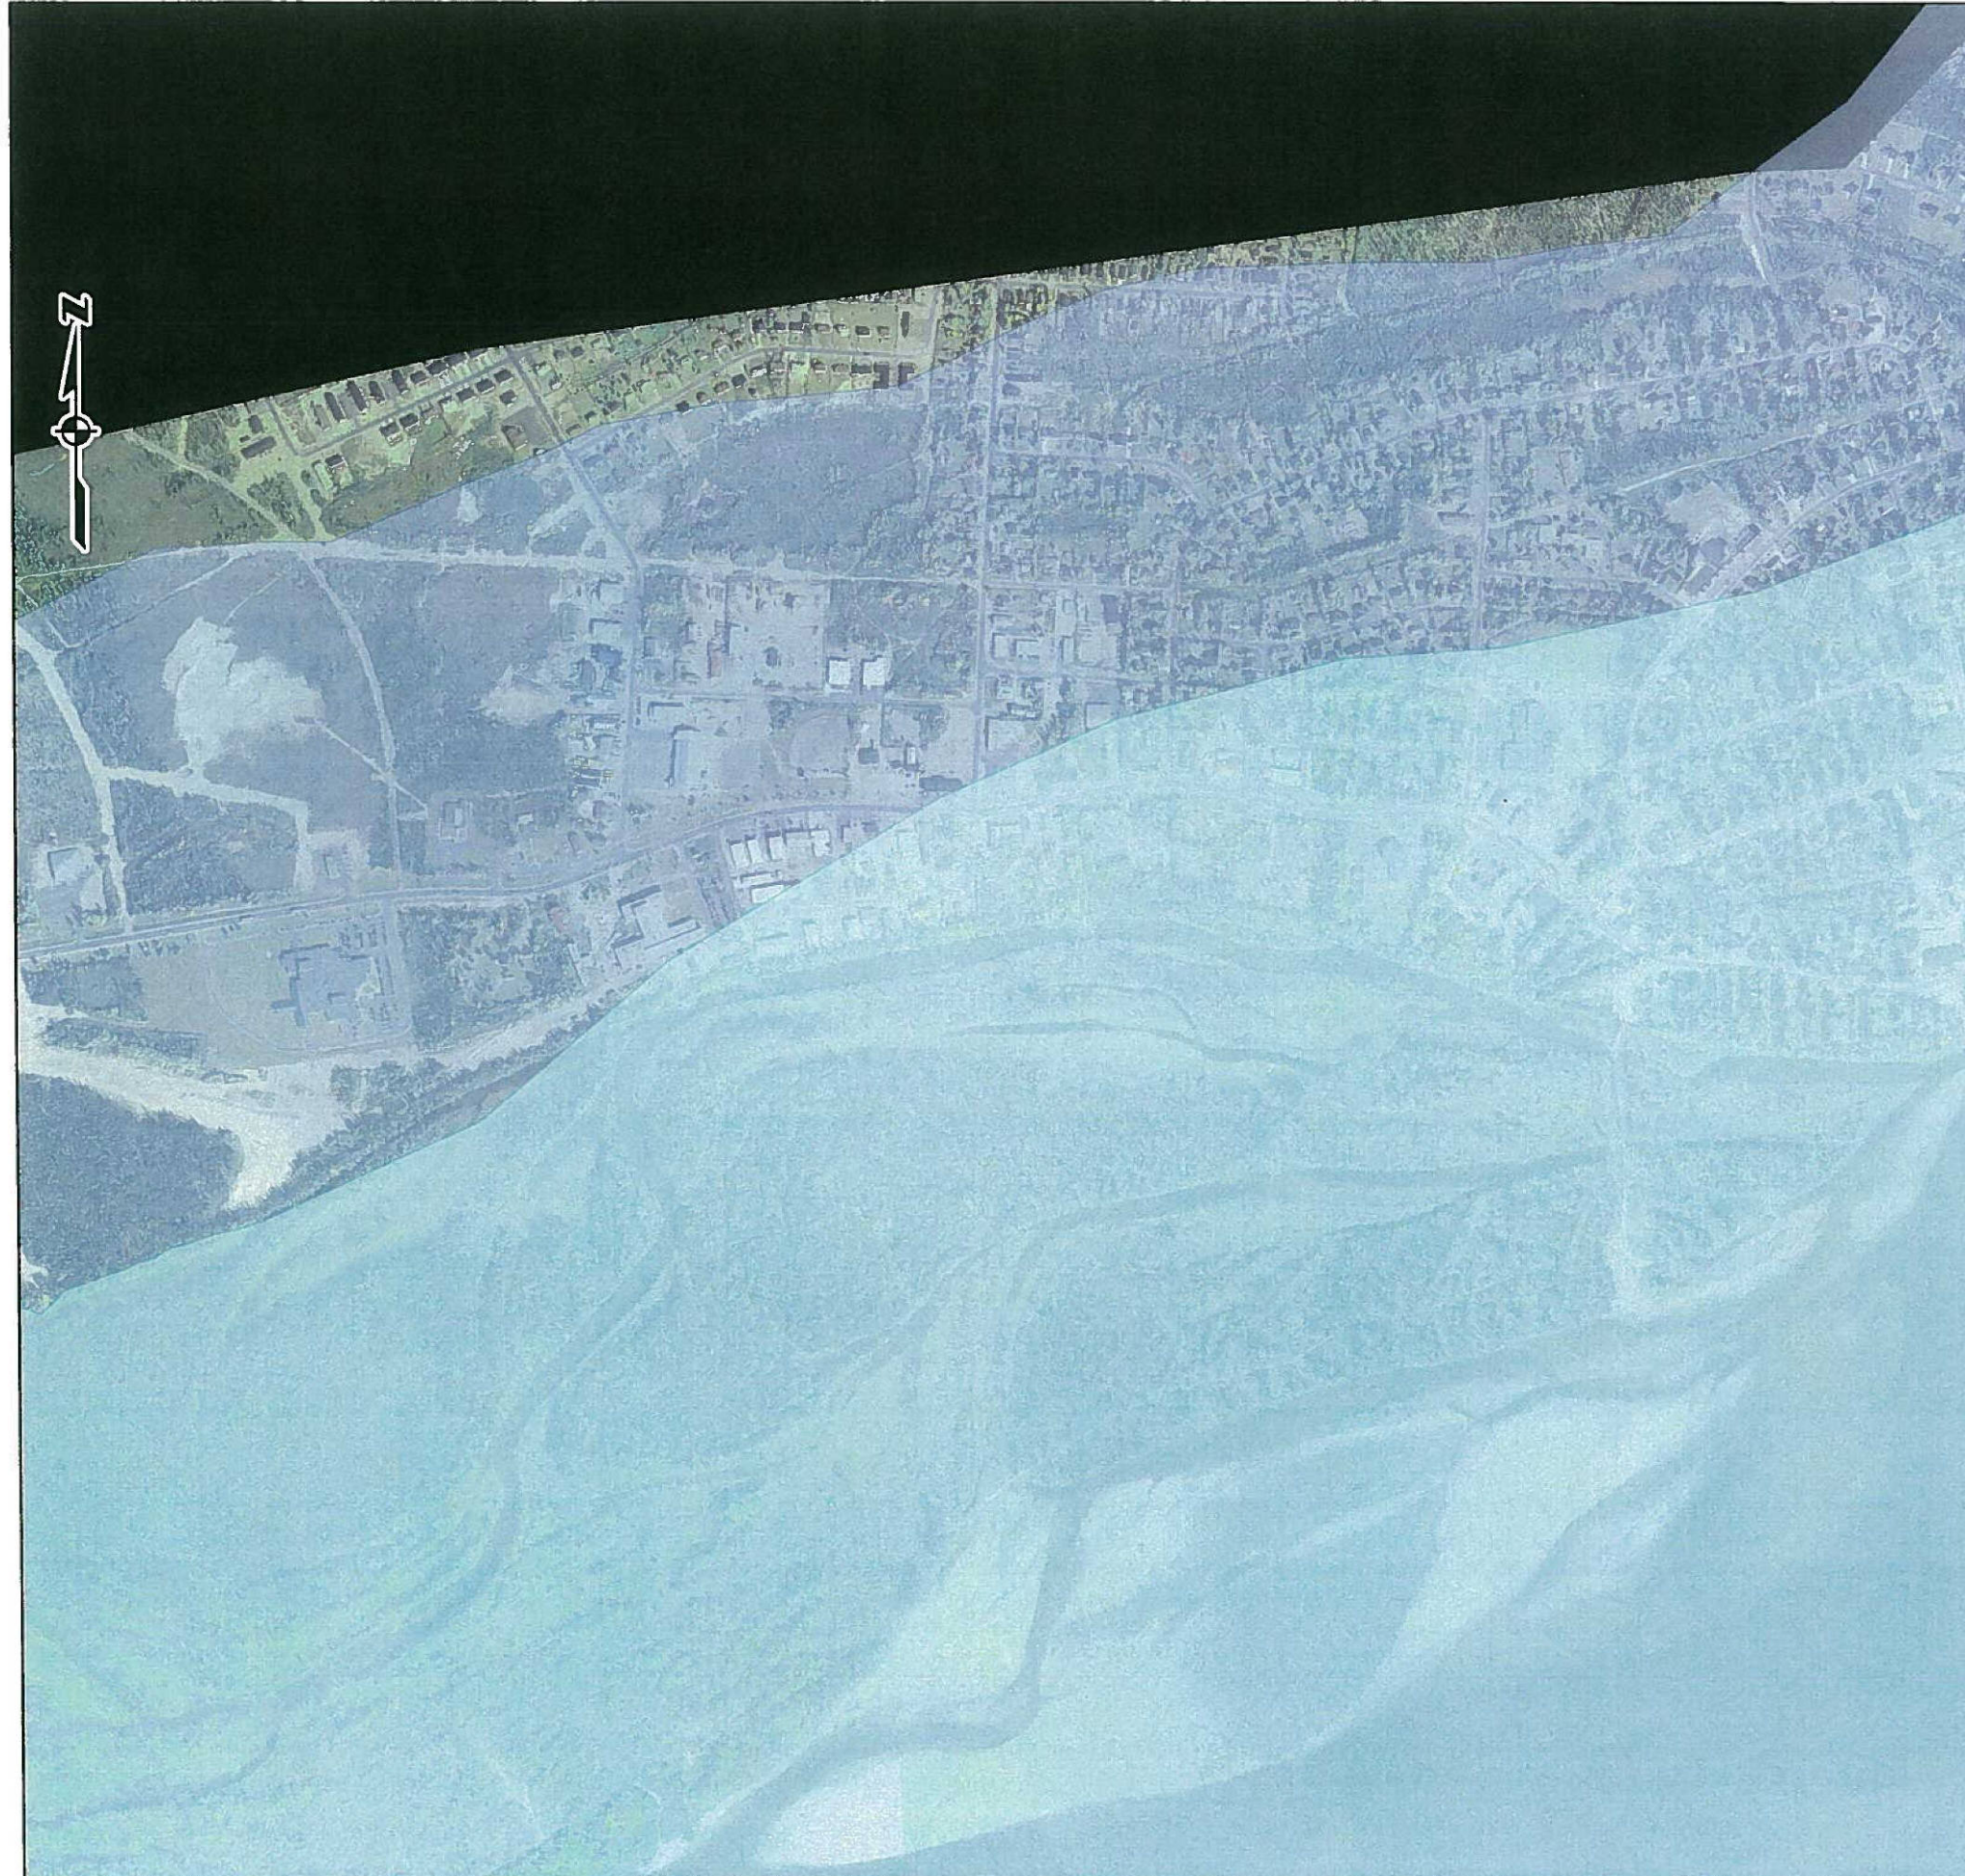
DRAWING NO. **FIGURE D4-1**

- FLOOD INUNDATION
- BREACH INUNDATION

PROBABLE MAXIMUM FLOOD
 POST GULL ISLAND AND MUSKRAT FALLS
 FAILURE OF GULL ISLAND MAIN DAM AND MUSKRAT
 FALLS NORTH RCC DAM

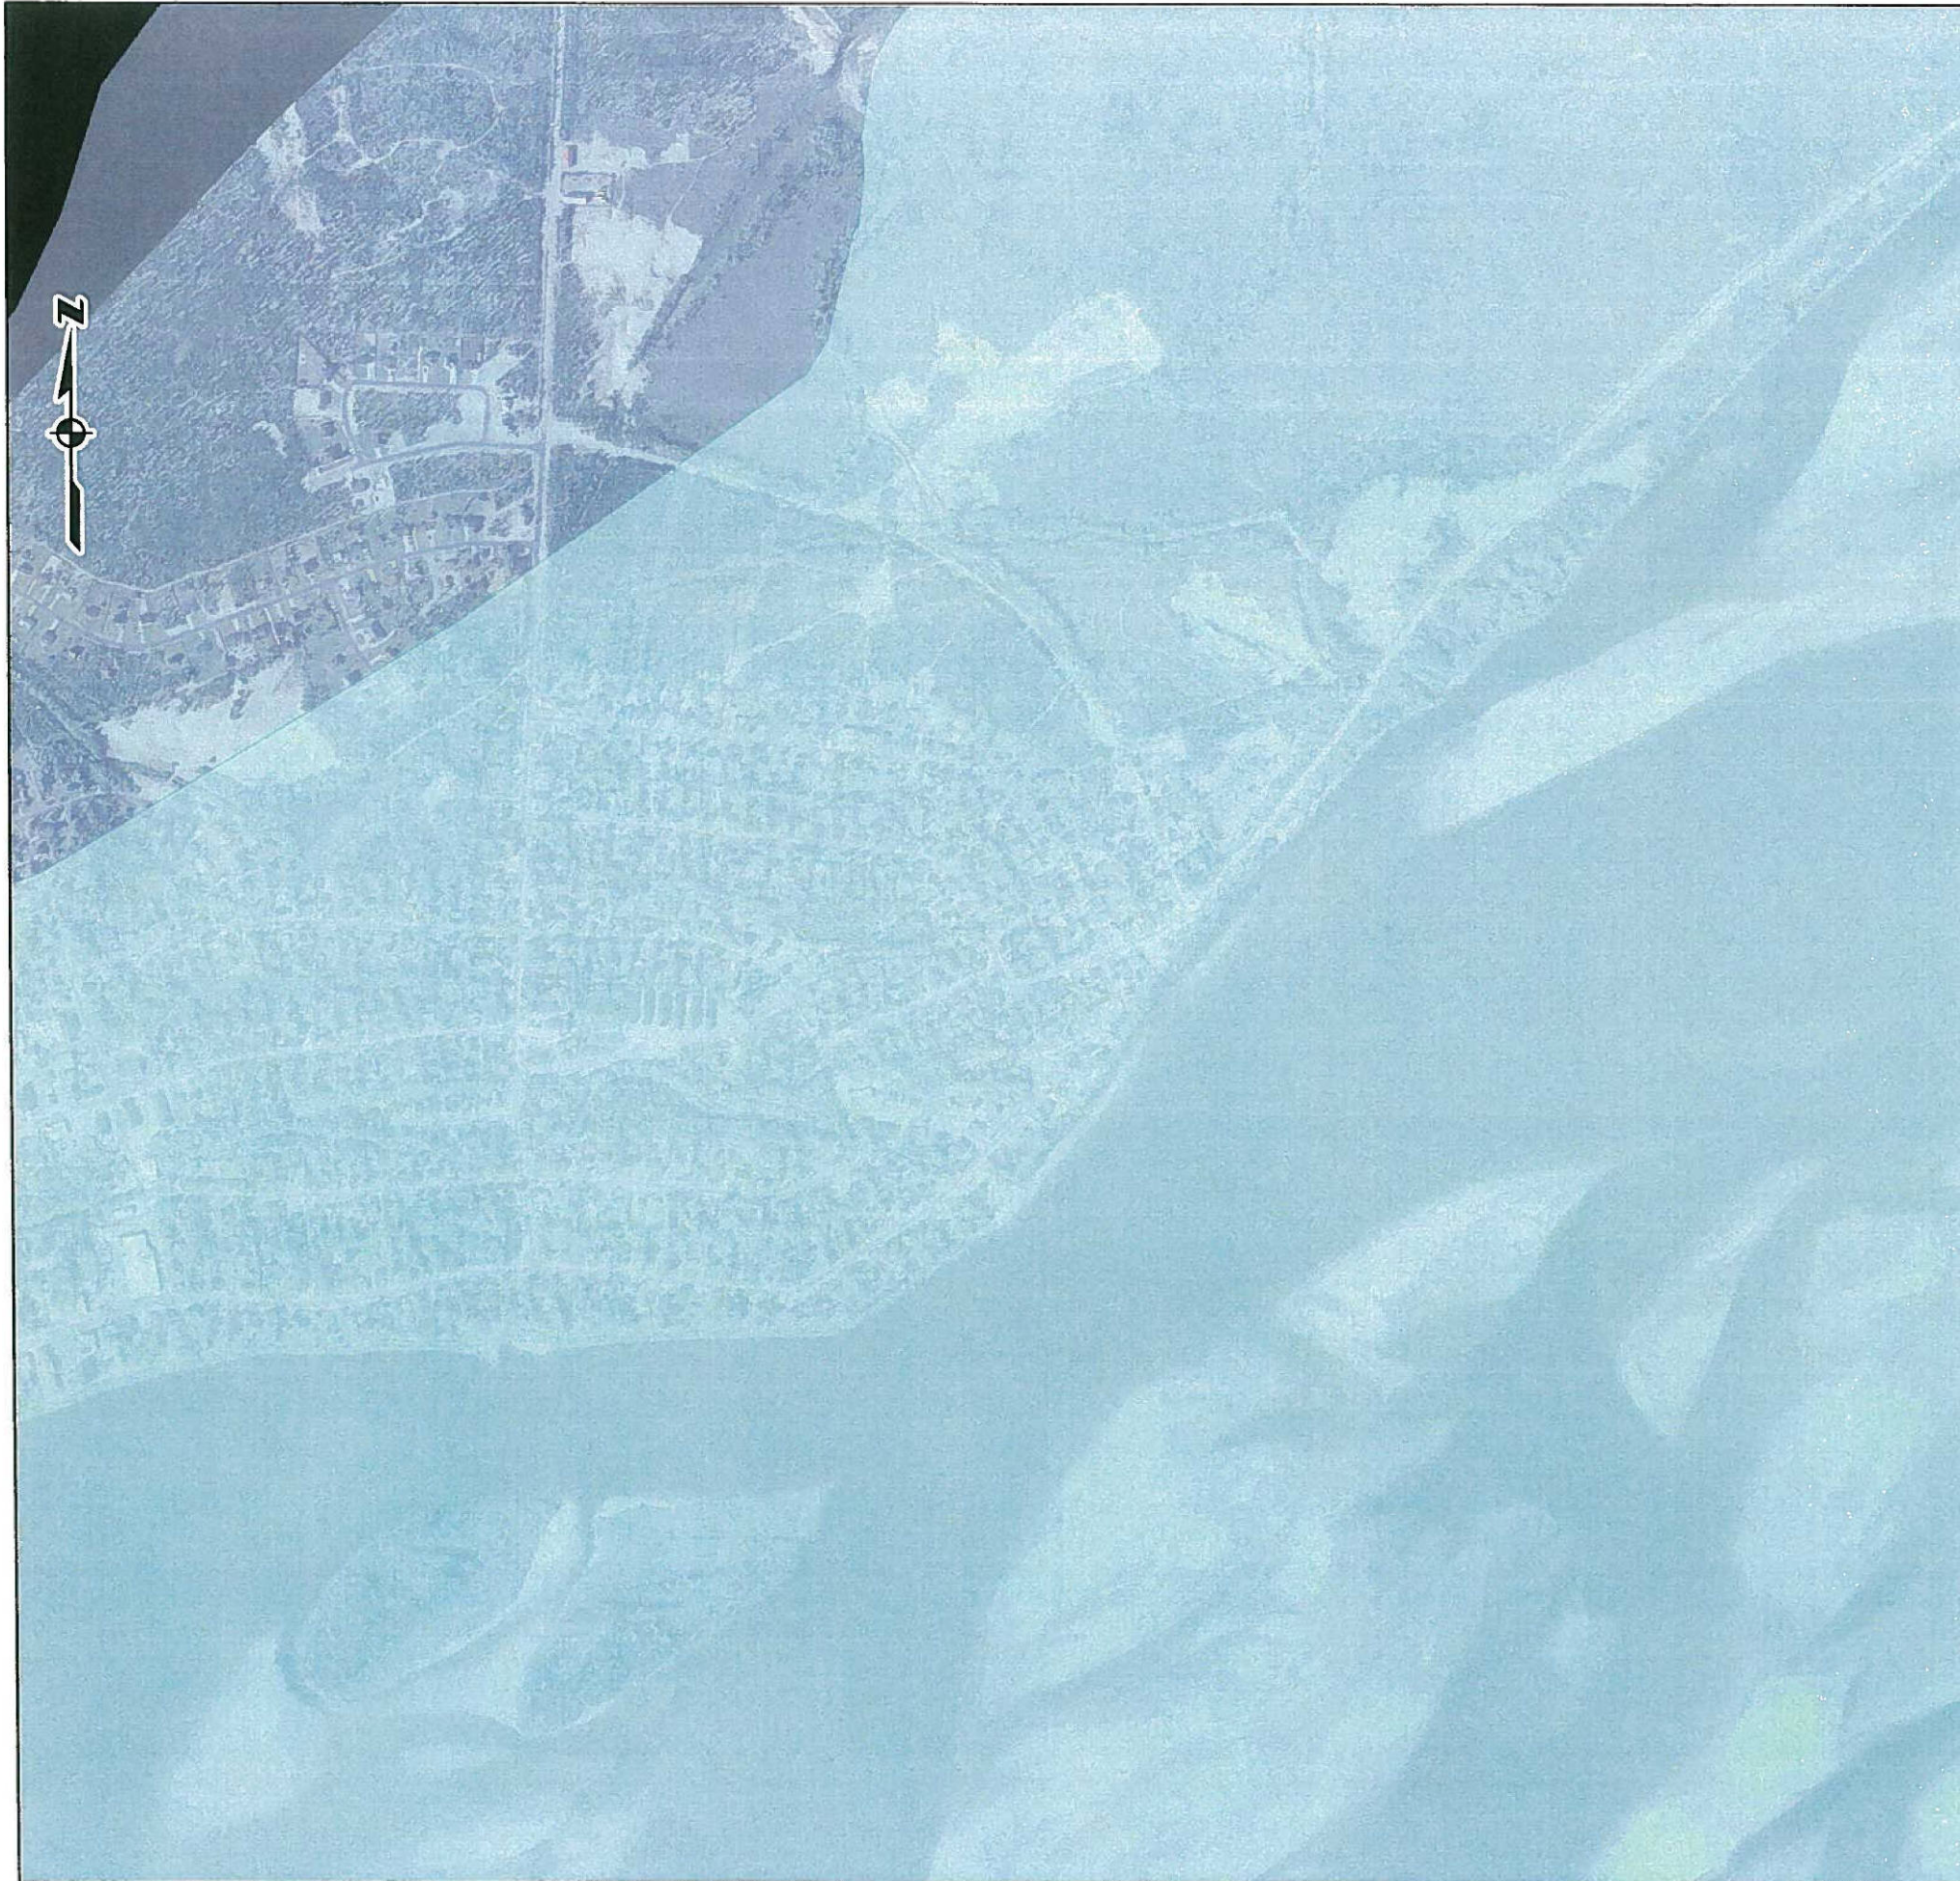
DRAWING NO. **FIGURE D4-2**

- FLOOD INUNDATION
- BREACH INUNDATION

PROBABLE MAXIMUM FLOOD
 POST GULL ISLAND AND MUSKRAT FALLS
 FAILURE OF GULL ISLAND MAIN DAM AND MUSKRAT
 FALLS NORTH RCC DAM
